GROUP	MODEL
Safety Recall Campaign	2011-2014MY Optima (QF/TF) 2012-2014MY Sorento (XMa) 2011-2013MY Sportage (SL)
NUMBER	DATE
SC147 (Rev 1, 6/16/2017)	June 2017

SAFETY RECALL CAMPAIGN

SUBJECT: THETA II ENGINE INSPECTION AND/OR REPLACEMENT

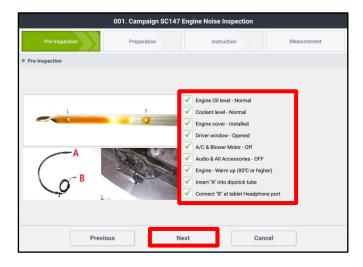
13. Follow the instructions on the screen then select "Next".

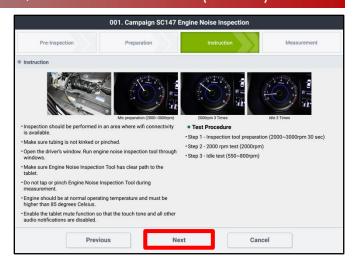
14. Prior to the initial measurement, the program will automatically check if the engine noise tester is installed and operating correctly at engine idle and perform an internal diagnosis.

Begin the second part of the engine noise tester check by selecting "Start".

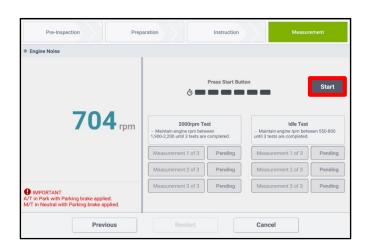
With the vehicle in Park (A/T) / Neutral (M/T), increase and maintain the engine speed at 2,000-3,000 RPM for thirty (30) seconds.

> The program will automatically proceed to the next step when the engine noise tester is ready.

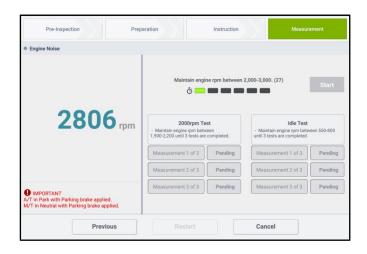
16. With the vehicle in Park (A/T) / Neutral (M/T), begin the "2000rpm Test" by increasing and maintaining engine speed between 1,900-2,100 (2.4L) or 1,900-2,200 (2.0T) RPM until all three (3) measurements are complete.

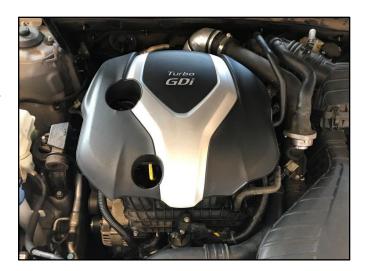
- 2. After removal of the engine from the vehicle, remove all components that will need to be transferred by referring to the applicable Shop Manual on KGIS.
- 3. Place the new engine block on an engine stand.
- 4. Install all removed components from the old engine block onto the new engine block utilizing all parts from Service Kit I and II. Be advised of notes below.

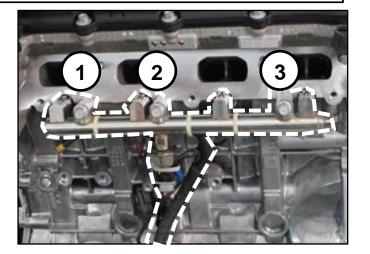
- Refer to TSB ENG083 for special attention and handling procedures of GDI-specific components.
- Prior to installing the delivery pipe, be sure to replace all of the injector Orings and injector retainers.
- Prior to installing the delivery pipe, apply engine oil to the injector Orings.
- When installing the delivery pipe, use caution not to damage the tip of the injector.
- Be sure to replace the delivery pipe retaining bolts and torque them in the sequence shown.

Tightening torque of bolts: 13.7 – 17.4 lb.ft (18.6 – 23.5 N.m, 1.9 – 2.4 kgf.m)

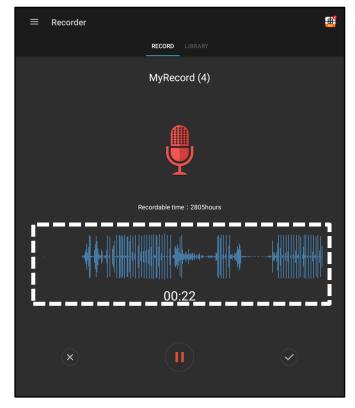
4. Ensure the adapter is connected to the tablet, select the red dot to start the recording.

Tap the dipstick end of the tool on a table.

The waveform should be similar to the image.
