GROUP Safety Recall Campaign	MODEL 2011-2014MY Optima (QF/TF) 2012-2014MY Sorento (XMa) 2011-2013MY Sportage (SL)
	NUMBER SC147 (Rev 5, 09/01/2017)	DATE June 2017
SAFETY RECALL CAMPAIGN		
SUBJECT: THETA II ENGINE INSPECTION AND/OR REPLACEMENT

This bulletin provides the procedure to inspect, and if necessary, replace the engine long block assembly on the following vehicles:

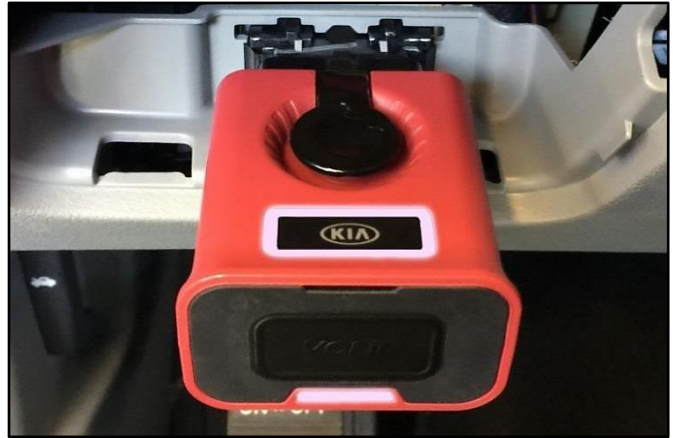
7. Connect the VCI-II to the OBD-II connector and launch the KDS application from the KDS tablet home page.

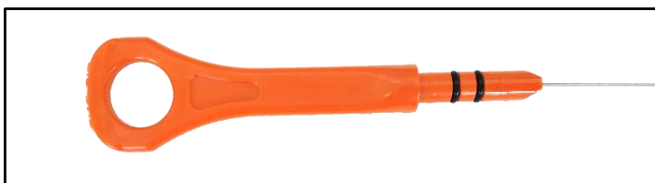
Orange Dipstick (P/N: 26611 2G050QQK)

On all vehicles with an inspection result of “PASS”: Change the oil and filter and refill with 5W-30 oil. Use the new (ORANGE) or verified (RED) dipstick to verify proper oil level after oil change and if applicable, reset the maintenance reminder on the instrument cluster.

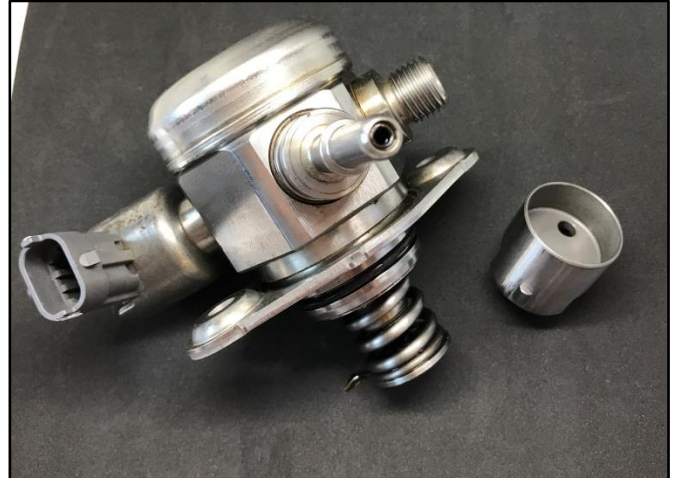
Tightening torques of pipe flare nut:

**19.5 – 23.9 lb.ft (26.5 – 32.4 N.m,
2.7 – 3.3 kgf.m)**

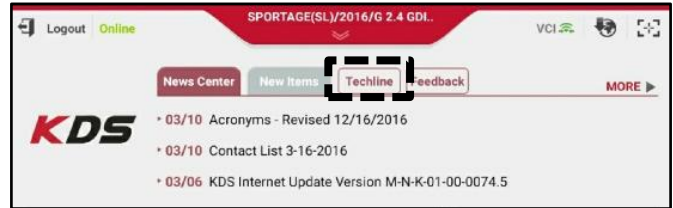
1. Open K-Support in the device Chrome™ browser or select the “Techline” button on KDS home page.

<https://ksupport.kiausa.com>
