GROUP  
**Safety Recall Campaign**

MODEL  
**2011-2014MY  
Optima  
(QF/TF)  
2012-2014MY  
Sorento (XMa)  
2011-2013MY  
Sportage (SL)**

NUMBER  
**SC147 (Rev 13, 01/05/2021)**

**SUBJECT: THETA II ENGINE INSPECTION AND/OR REPLACEMENT**

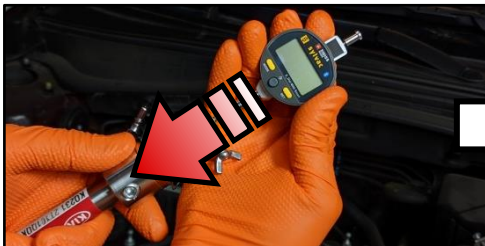
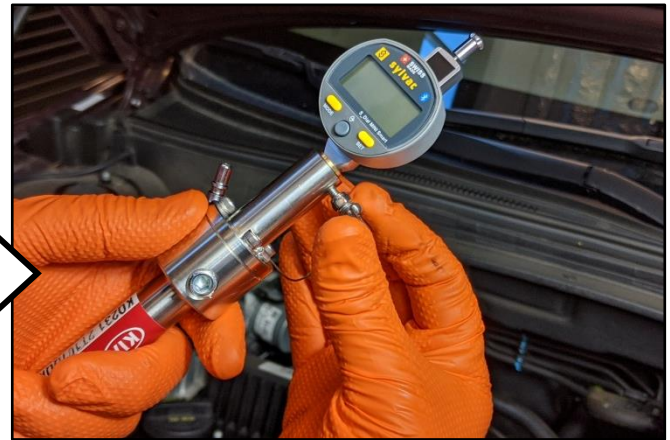
7. Install the Dial Gauge fully into the Probe Rod and secure together by hand tightening the locking wingnut.

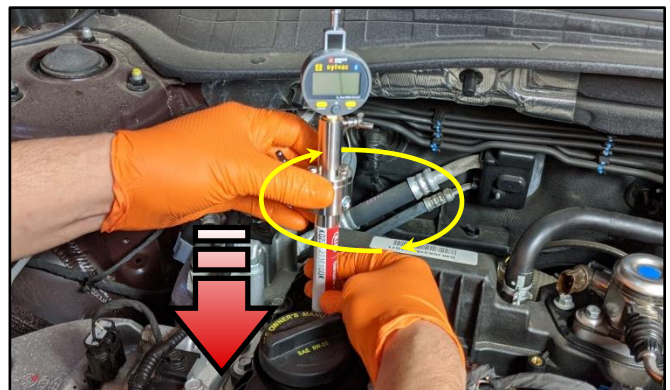
8. **Carefully**, insert the assembled SST Probe Rod and Dial Gauge into the Cylinder 1 spark plug hole and **carefully** turn the SST Crankshaft Rotator **by hand** clockwise until hand tight.

**Damage to cylinder head can occur if spark plug hole is cross-threaded. DO NOT use a wrench to tighten the SST rod.**

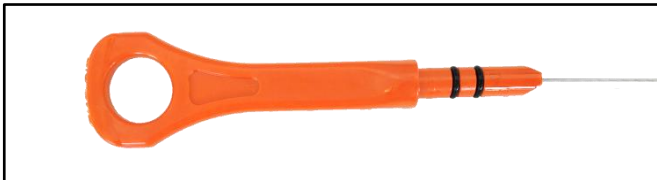
Orange Dipstick (P/N: 26611 2G050QQK)

For 2011-2013MY vehicles only: If the vehicle is equipped with a YELLOW dipstick, discard the dipstick and replace it with a new ORANGE one.

On all vehicles with an inspection result of "PASS": Change the oil and filter and refill with 5W-30 oil. Use the new (ORANGE) or verified (RED) dipstick to verify proper oil level after oil change and if applicable, reset the maintenance reminder on the instrument cluster.
