Dealer Service Instructions for:

Safety Recall T34 / NHTSA 17V-371 PHEV Power Inverter Module

2017-2018 (RU) Chrysler Pacifica PHEV

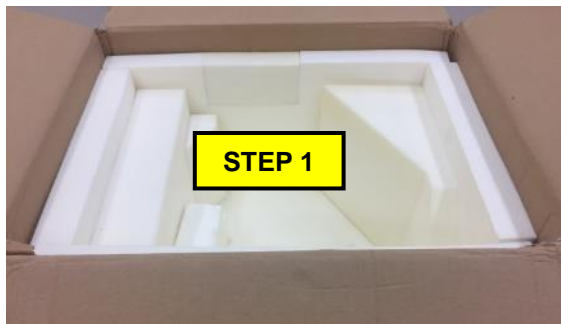
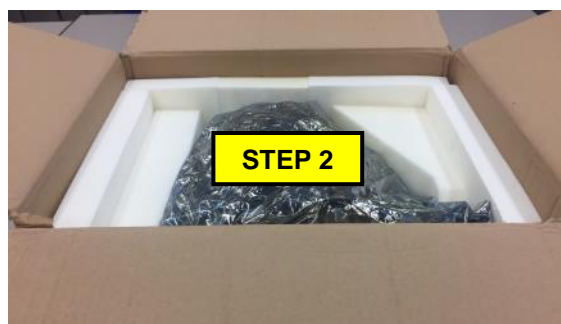
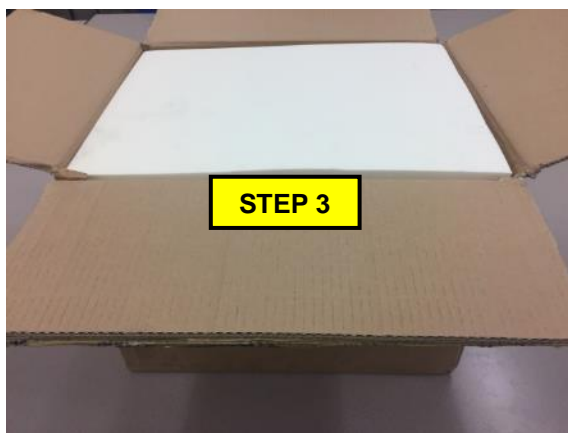
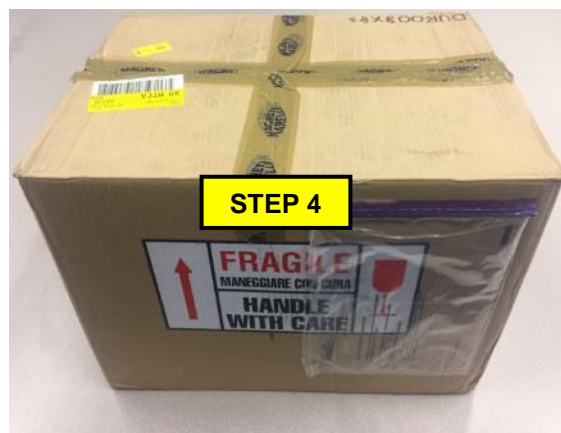
The protective foam packaging and container in which the new PIM is received must be used to protect the replaced PIM during return shipment. Otherwise, the PIM can be damaged inhibiting root cause analysis, and the dealer may be held liable for warranty claims cost.

Packaging steps outlined below:

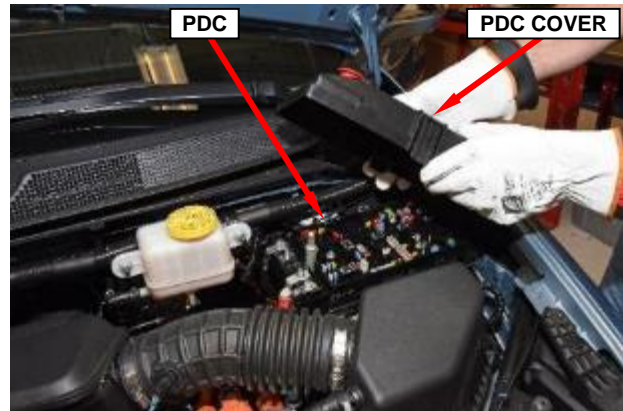
Figure 1 – Power Distribution Center

4. Remove and save the 12-volt Power Distribution Center (PDC) cover (Figure 1).

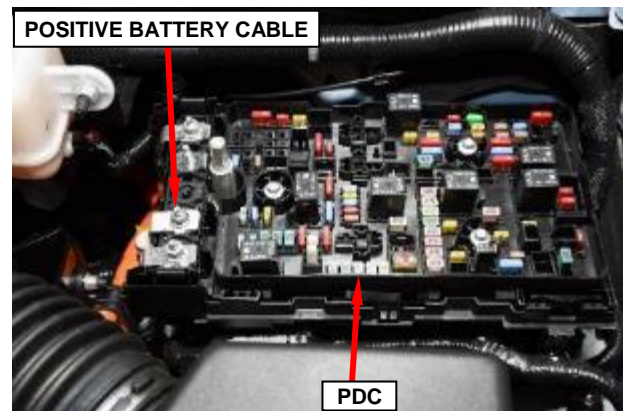
Figure 2 – Positive Battery Cable

5. Remove and save the nut securing the positive battery cable, then disconnect the positive battery cable from the 12-volt PDC (Figure 2).

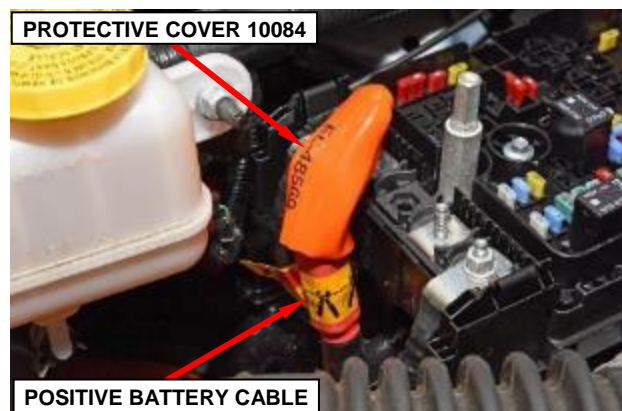
Figure 3 – Cover Cable Terminal

6. Cover the positive battery cable terminal with protective cover 10084 (Figure 3).

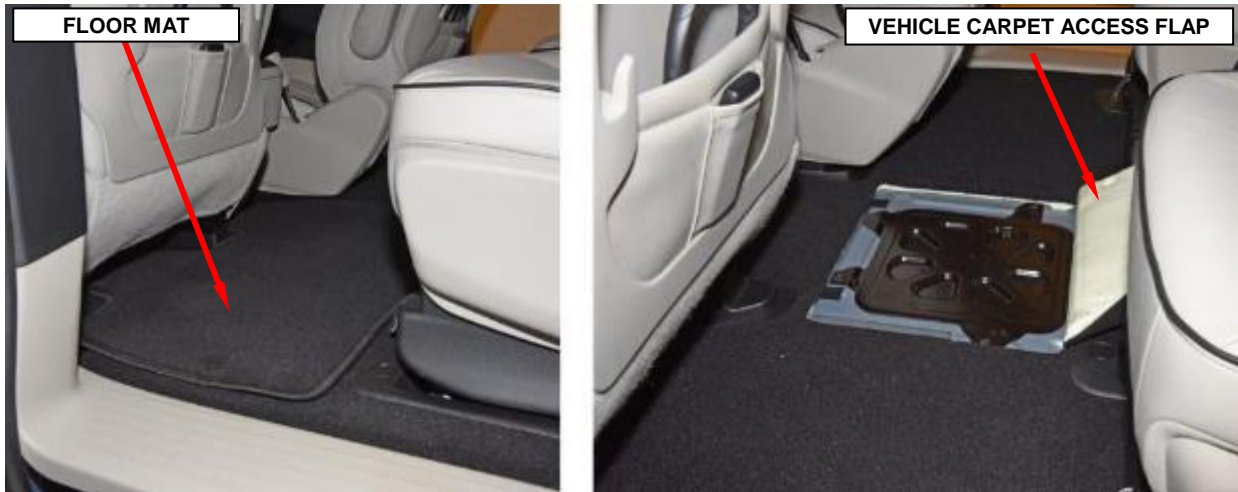
Figure 4 – Vehicle Carpet

- 7. Lift the carpet away from the high-voltage manual service disconnect access cover (Figure 4).

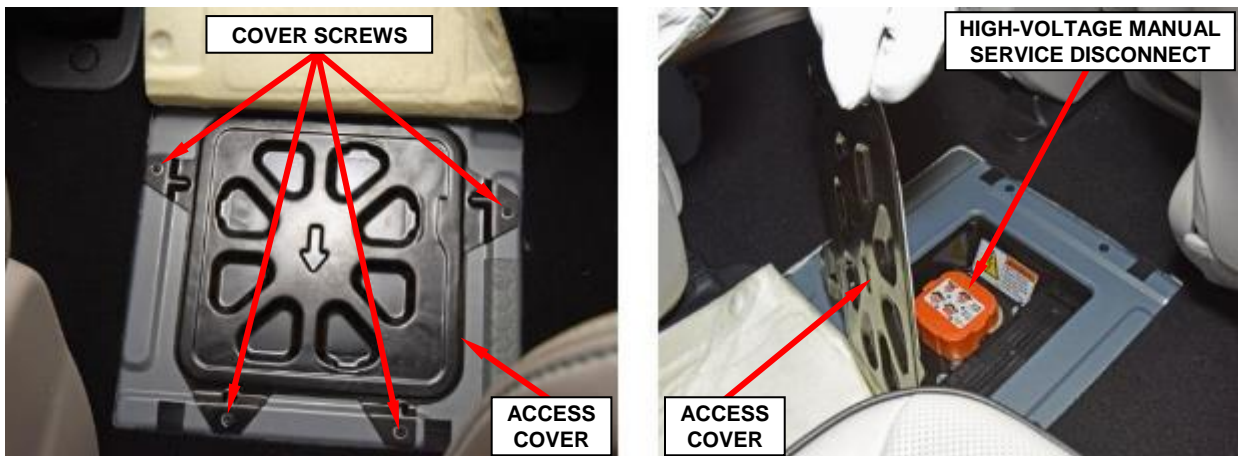
Figure 5 – High-Voltage Manual Service Disconnect Access Cover

- 8. Remove and save the four screws securing the high-voltage manual service disconnect access cover to the floor then remove and save the cover (Figure 5).

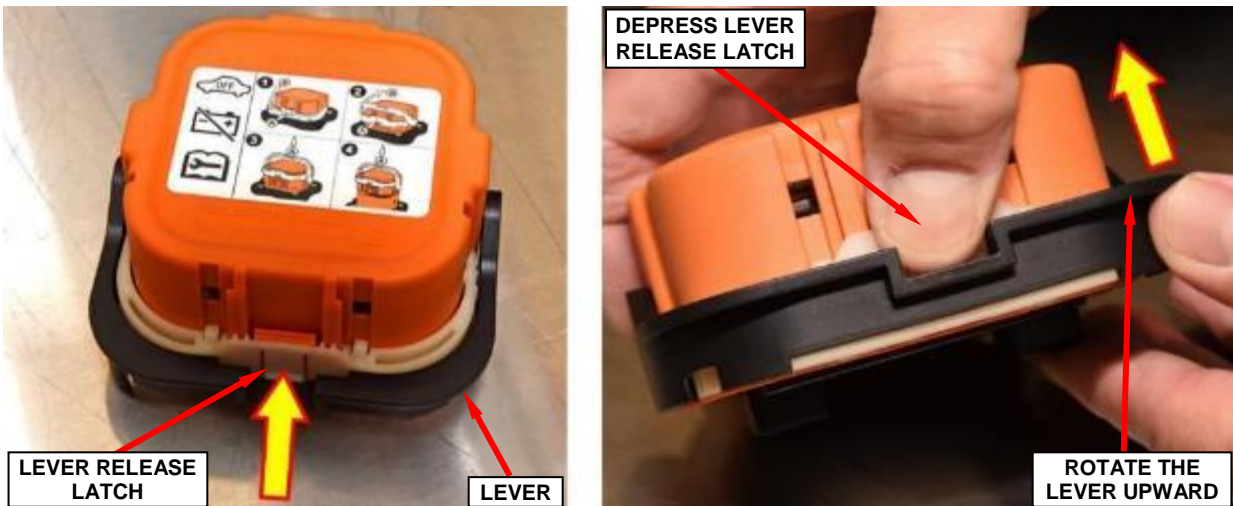
- Depress the lever release latch firmly. With the latch fully depressed, rotate the lever upward. The lever will stop at the 45° position (Figure 6).

NOTE: At this stage, the High Voltage Inter-Lock (HVIL) connection has been broken and the circuit is de-energized.

Figure 6 – High-Voltage Manual Service Disconnect First Stage Latch Release (High-Voltage Manual Service Disconnect Removed from Vehicle for Visual Clarity)

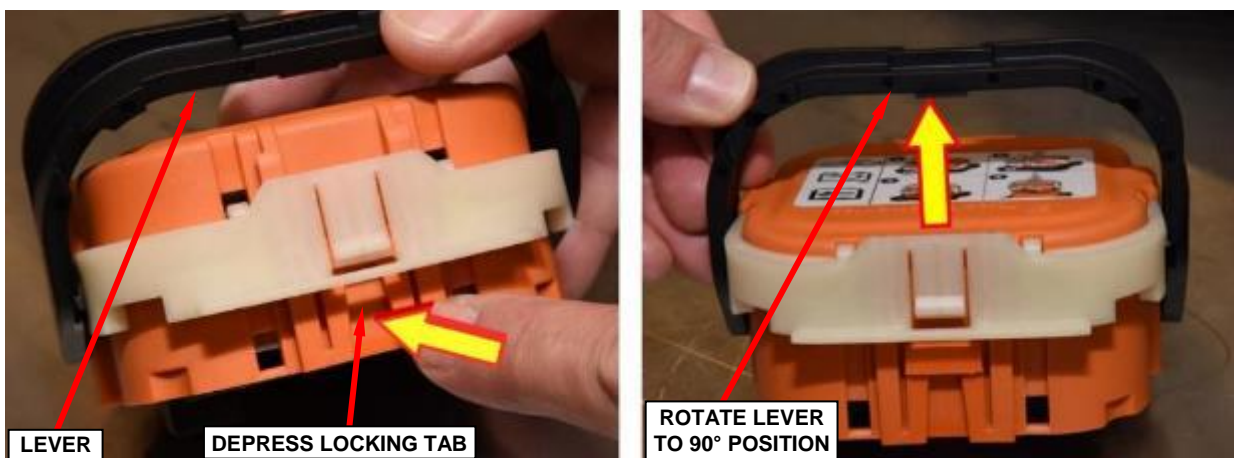
- Depress the locking tab and continue to rotate the lever to the end of travel, 90° position (Figure 7).

Figure 7 – High-Voltage Manual Service Disconnect Second Stage Latch Release (High-Voltage Manual Service Disconnect Removed from Vehicle for Visual Clarity)

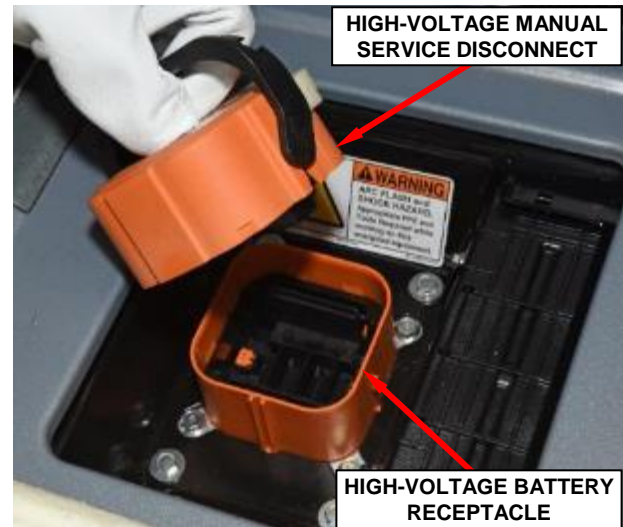
Figure 8 – High-Voltage Manual Service Disconnect and Receptacle

11. Pull straight up on the service disconnect lever to disengage and remove the high-voltage manual service disconnect from the receptacle (Figure 8).

NOTE: Make sure the location of the high-voltage manual service disconnect is always known after removal. It is best practice to place the high-voltage manual service disconnect in a highly visible location when removed.

CAUTION: Ensure the cover gasket is properly seated in the groove prior to assembly onto the PIM. If not seated properly, the gasket will be damaged when the cover fasteners are tightened.
29. Install the single High Voltage Inter-Lock (HVIL) connector to the PIM cover and tighten the two captive screws to 7.8 N·m (69 In. Lbs.) (Figure 13).
30. Remove the safety cover from the high-voltage battery receptacle (Figure 9).
31. Inspect the mounting interface surface of the high-voltage Manual Service Disconnect (MSD) and the receptacle wall to ensure they are clean, and that there are no surface contaminants or foreign objects within the receptacle (Figure 8).

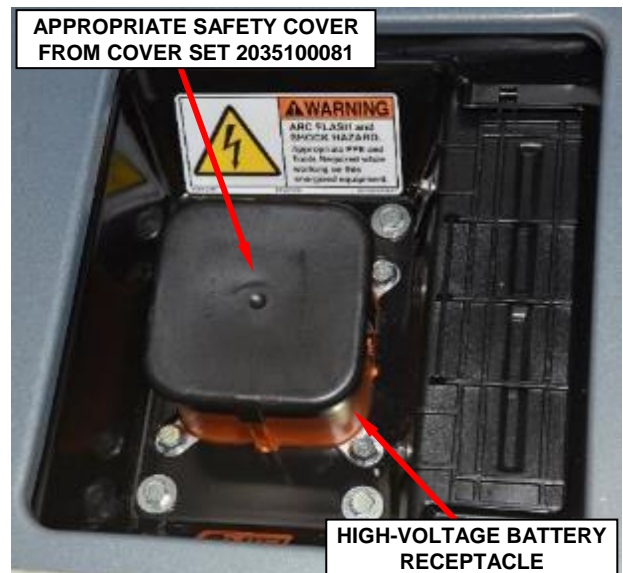
Figure 9 – High-Voltage Battery Receptacle Safety Cover

12. Cap the receptacle on the high-voltage battery with the appropriate cover found in safety cover set 2035100081 to prevent foreign objects from entering the receptacle (Figure 9).

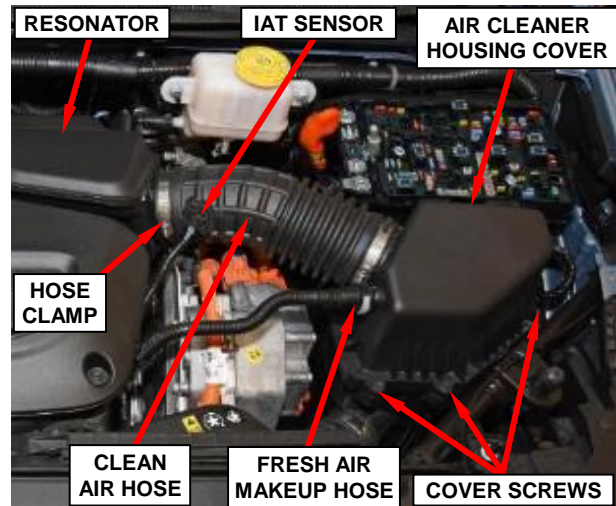
Figure 10 – Air Cleaner Assembly

14. Disconnect the fresh air makeup hose from the air cleaner body (Figure 10).
15. Disconnect the wire harness connector from the Inlet Air Temperature (IAT) sensor (Figure 10).
16. Loosen the clean air hose clamp and disengage the clean air hose from the resonator (Figure 10).

17. Loosen the cover screws and remove the air cleaner housing cover (Figure 10).
18. Remove the air cleaner element (Figure 11).

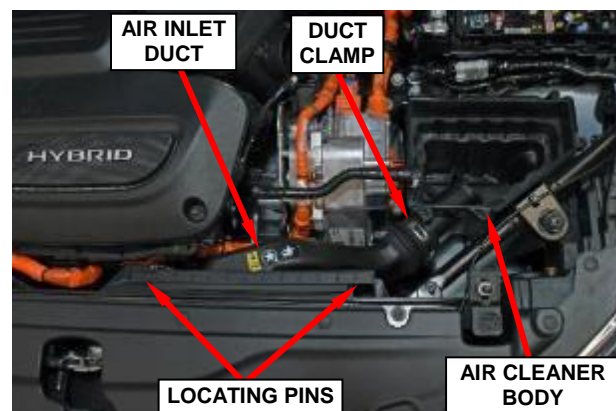
Figure 12 – Air Cleaner Body

19. Loosen the duct clamp and pull the air inlet duct straight up to disengage the locating pins from the rubber mount sockets (Figure 12).
20. Disengage the air cleaner body locating pins from the rubber mount sockets then remove and save the air cleaner body (Figure 12).

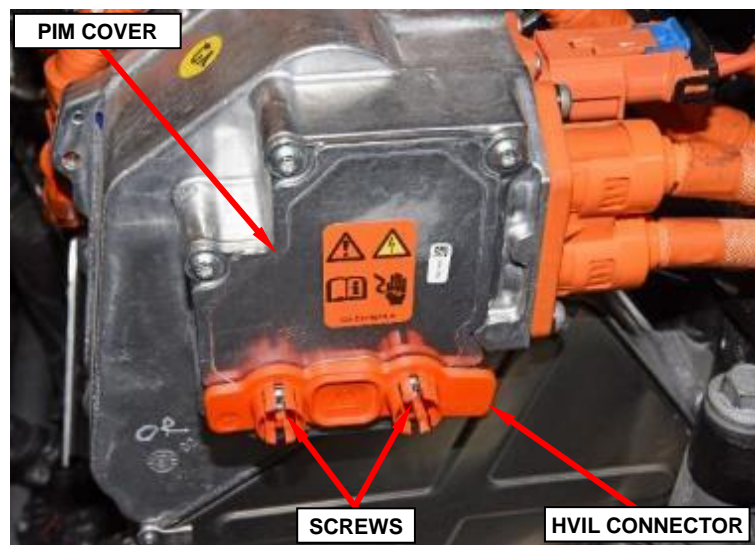
Figure 13 – HVIL Connector

21. Loosen two captive screws then remove and save the single High Voltage Inter-Lock (HVIL) connector from the PIM cover (Figure 13).

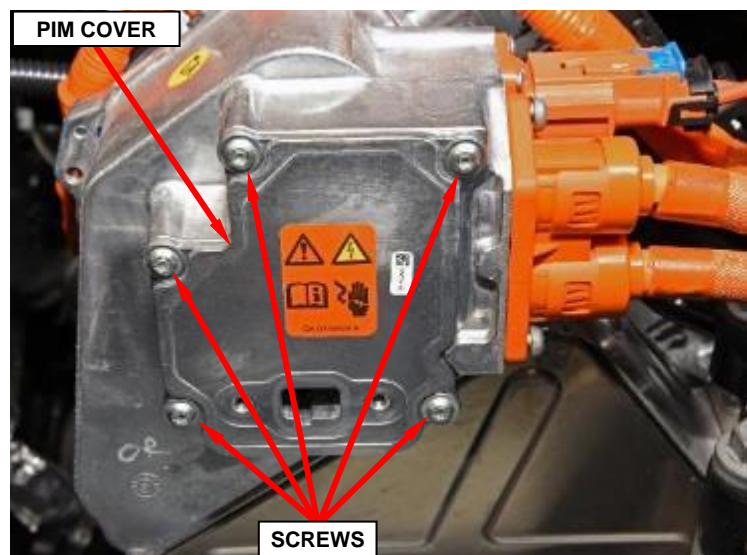
Figure 14 – PIM cover

22. Loosen five captive screws then remove and save the PIM cover (Figure 14).

28. Install the **new** PIM high voltage terminal cover and tighten the five captured screws to 7.8 N·m (69 In. Lbs.) (Figure 14).

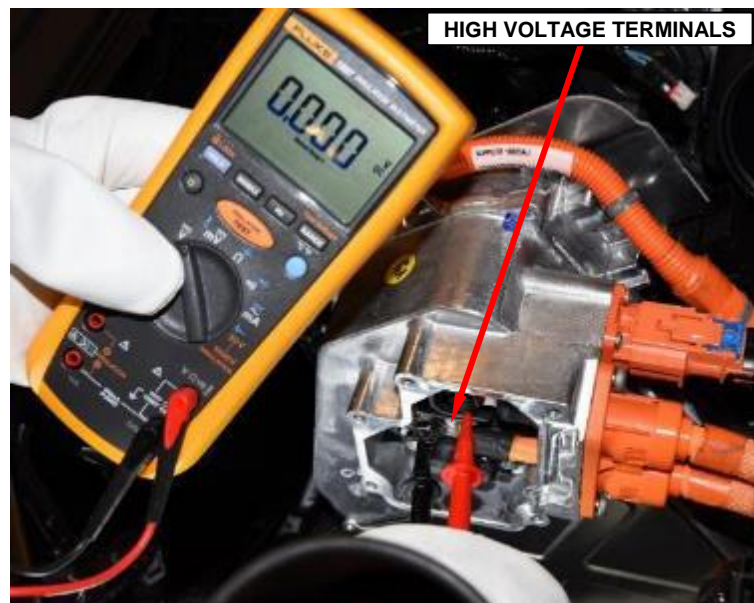
Figure 15 – Check PIM Voltage

23. Measure the voltage between the positive and negative high voltage terminals. Also, measure the voltage between each high voltage terminal and chassis ground (Figure 15). The measured voltage should be near 0-volts.

- If the voltage measured is near 0-volts, the high-voltage components are safe to work on with the exception of the high-voltage battery internal components.

- If the voltage is not near 0-volts, an internal condition exists within the high-voltage battery that is preventing it from being powered down. **Do not attempt to carry out repairs on any of the vehicle's high-voltage components or wiring. Contact the STAR Center for service support.**

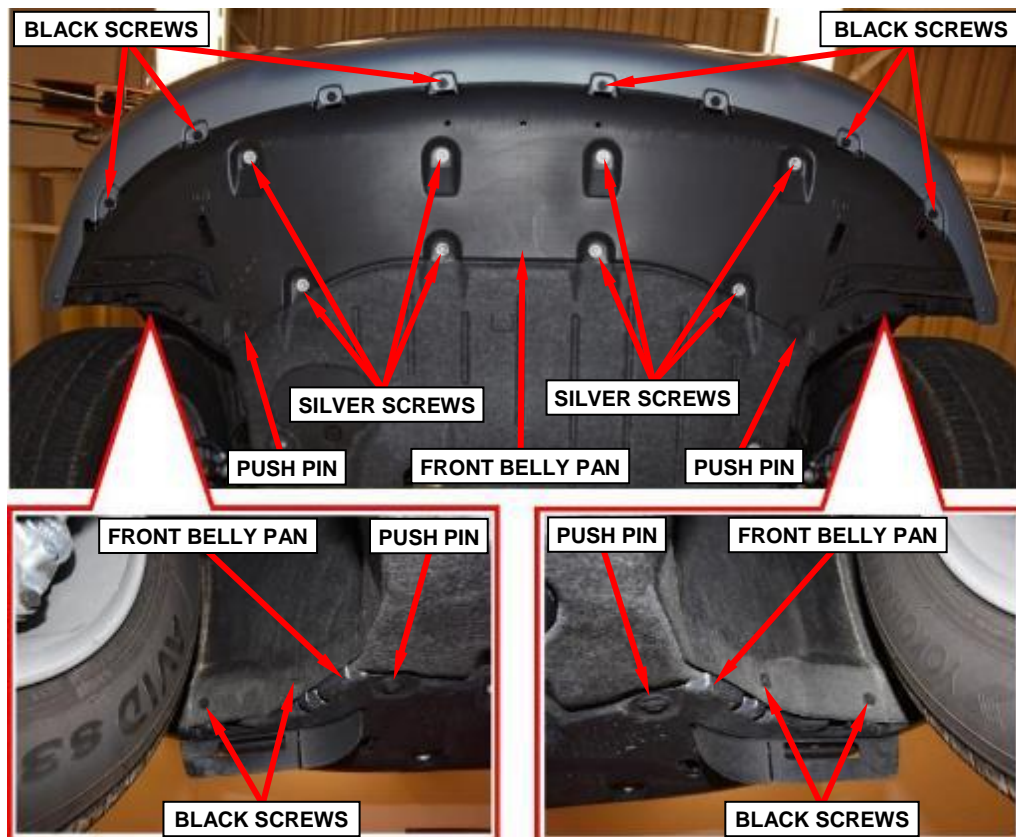
Figure 16 – Front Belly Pan

26. Remove the four black screws (two per side) attaching the wheelhouse splash shields to the front belly pan (Figure 16).

27. Remove the six black front screws (Figure 16).

28. Remove the two push-pin fasteners (Figure 16).

29. Remove the eight silver screws (Figure 16).

30. Remove the front belly pan (Figure 16).

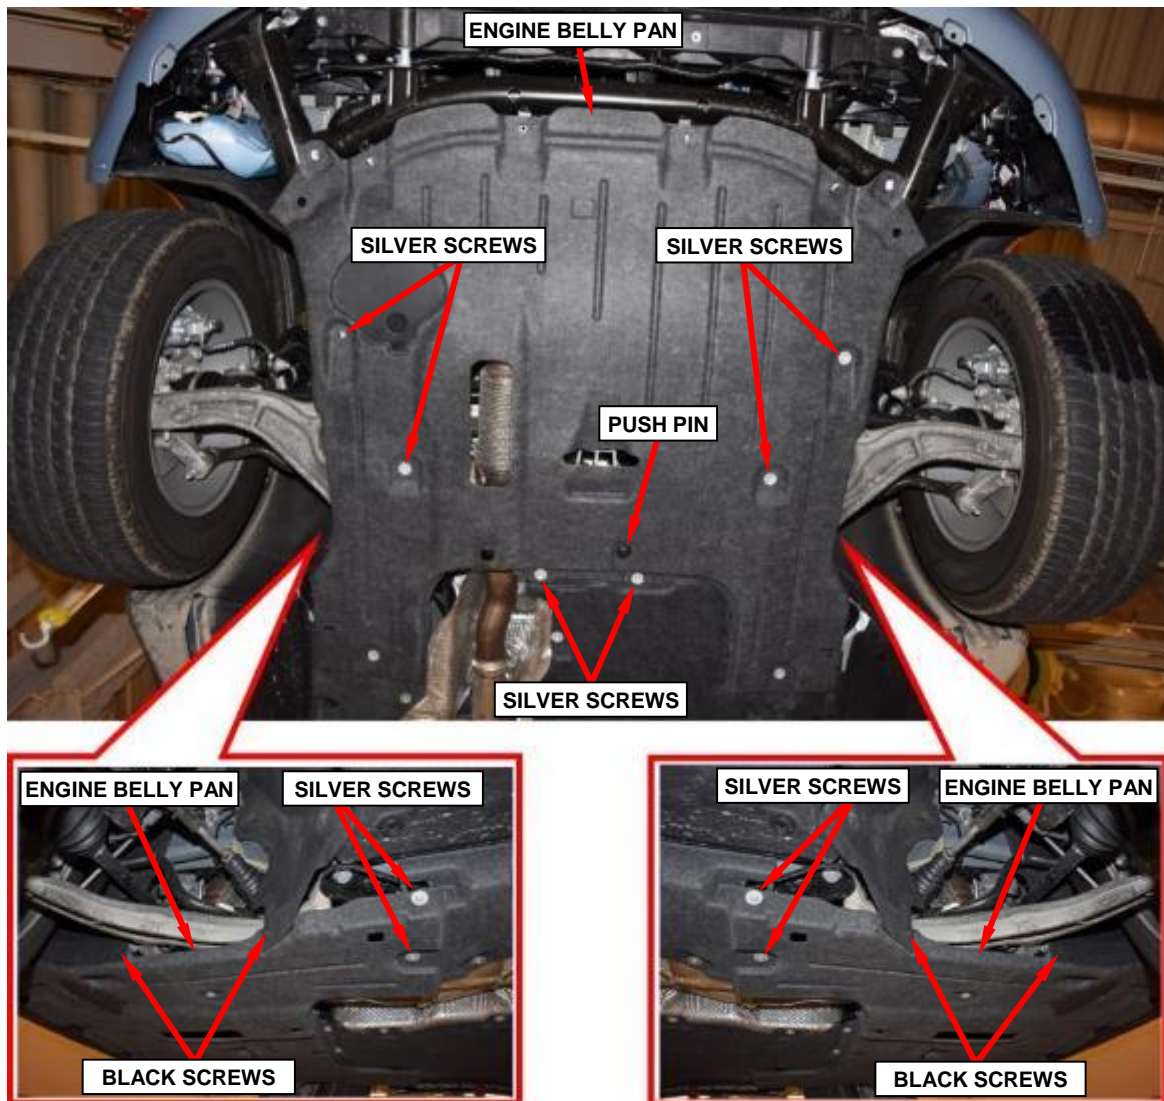
Figure 17 – Engine Belly Pan

31. Remove and save the four black screws (two per side) attaching the wheelhouse splash shields to the engine belly pan (Figure 17).
32. Remove and save the push pin fastener (Figure 17).
33. Remove and save the ten silver screws then remove and save the engine belly pan (Figure 17).
34. Lower the vehicle.

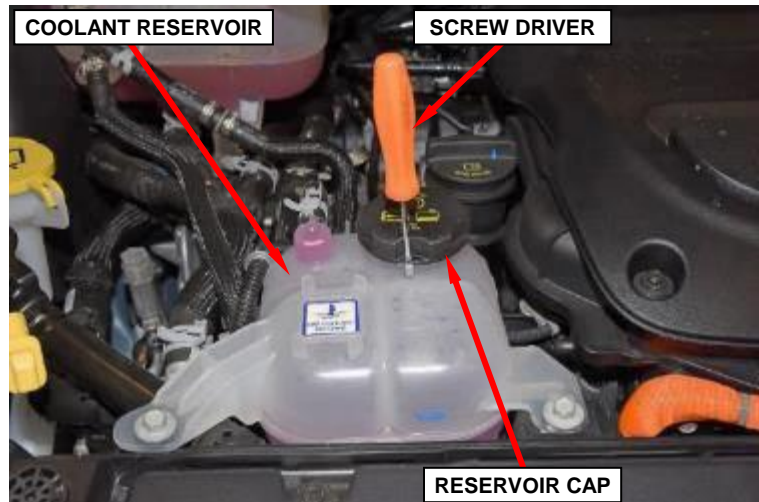
Figure 18 – Power Electronics Coolant Reservoir

35. Loosen the cap on the power electronics cooling system pressurized coolant reservoir to relieve any residual pressure (Figure 18):
- Rotate the cap counterclockwise to align the slots (Figure 18).
 - Insert a screwdriver into the slots and continue rotating the cap counterclockwise (Figure 18).

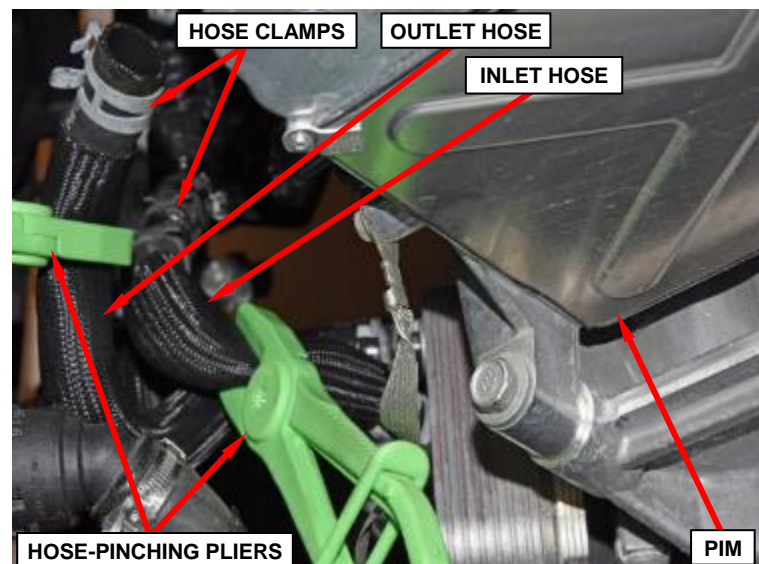
Figure 19 – PIM Coolant Inlet And Outlet Hoses

36. Place a suitable container under the PIM coolant inlet and outlet hoses.
37. Using suitable hose-pinching pliers, clamp-closed the coolant inlet and outlet hoses near the PIM (Figure 19).

38. Loosen the clamps and remove the coolant inlet and outlet hoses from the PIM. Cap the coolant hose ends and the nipples on the PIM (Figure 19).

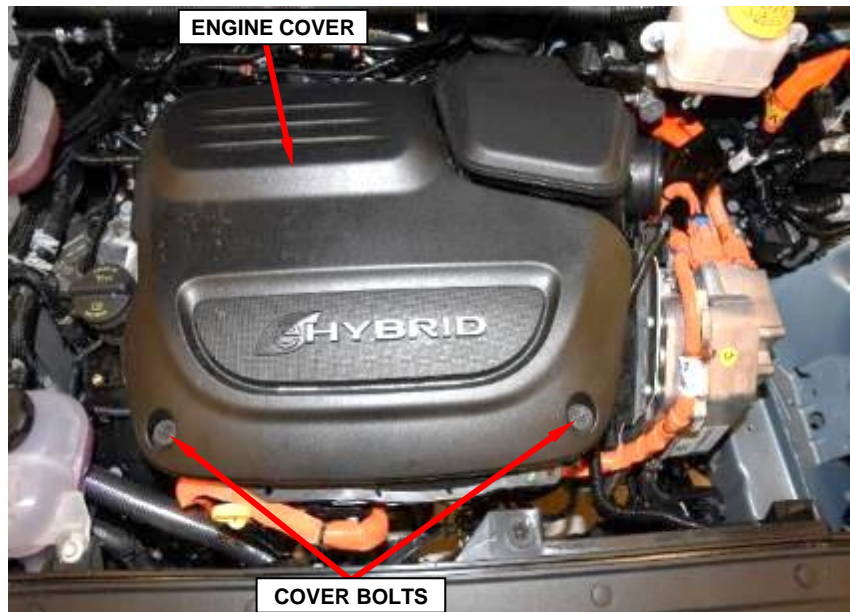
Figure 20 – Engine Cover

39. Remove and save the bolts from the engine cover (Figure 20).

40. Pull upward on the engine cover to release the cover grommets from the ball studs and remove the engine cover (Figure 20).

24. Lubricate the rubber grommets on the engine cover with Mopar® Rubber Bushing Installation Lube.
25. Align the rubber grommets of the engine cover to the ball studs and press firmly downwards (Figure 20).

26. Install the bolts securing the engine cover to the intake manifold and tighten to 10 N·m (7 Ft. Lbs.) (Figure 20).
27. Measure the isolation resistance at the Power Inverter Module (PIM) between the positive high voltage terminal and chassis ground. Also between the negative high voltage terminal and chassis ground. The measured isolation resistance should be greater than 1.1 MΩ and less than 10 MΩ. Compare these isolation resistance values with those taken during High-Voltage Power-Down to verify the integrity of the repair.

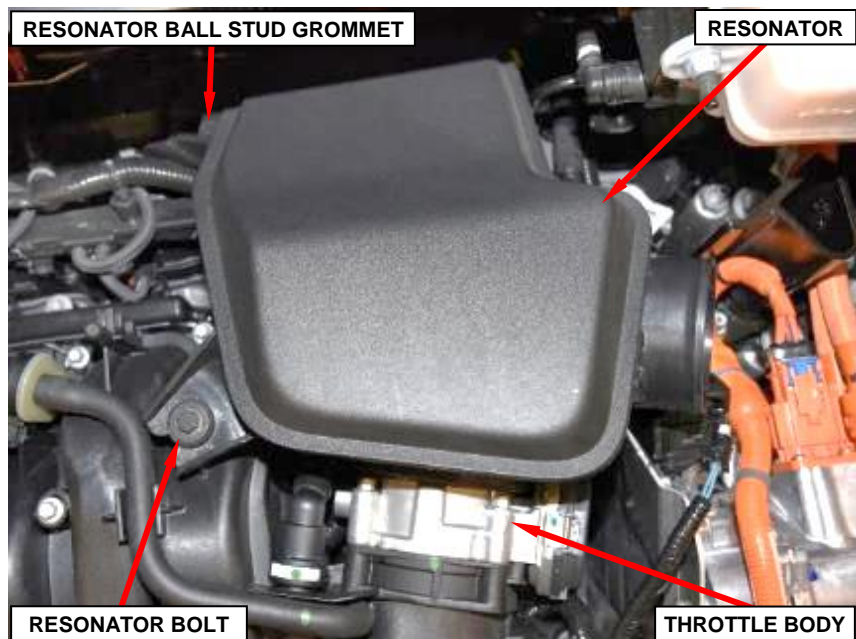
Figure 21 – Resonator

41. Remove and save the bolt from the resonator (Figure 21).

42. Pull the resonator straight up to release the resonator grommet from the ball stud on the right cylinder head cover. Disengage and remove the resonator from the throttle body inlet (Figure 21).

18. Install the high voltage battery cable connector housing into the PIM and tighten the two screws to 11 N·m (97 In. Lbs.) (Figures 23 and 22).
19. Install the high voltage battery cable terminal bolts and tighten to 25 N·m (18 Ft. Lbs.) (Figure 22).
20. Position the high voltage harness to the harness support bracket and tighten the nut to 11 N·m (97 In. Lbs.) (Figure 23).
21. Lubricate the rubber grommet on the resonator with Mopar® Rubber Bushing Installation Lube.
22. Install the resonator to the throttle body inlet. Push the resonator down onto the ball stud on the right cylinder head cover until the rubber grommet is fully seated (Figure 21).
23. Install the bolt securing the resonator to the intake manifold and tighten to 3.5 N·m (31 Ft. Lbs.) (Figure 21).

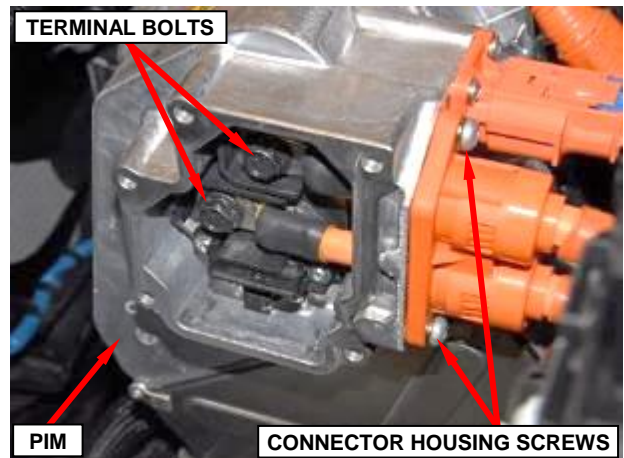
Figure 22 – High Voltage Battery Cables

- 43. Remove and save the high voltage battery cable terminal bolts (Figure 22).
- 44. Loosen the two captive screws securing the high voltage battery cable connector housing to the PIM (Figure 22).

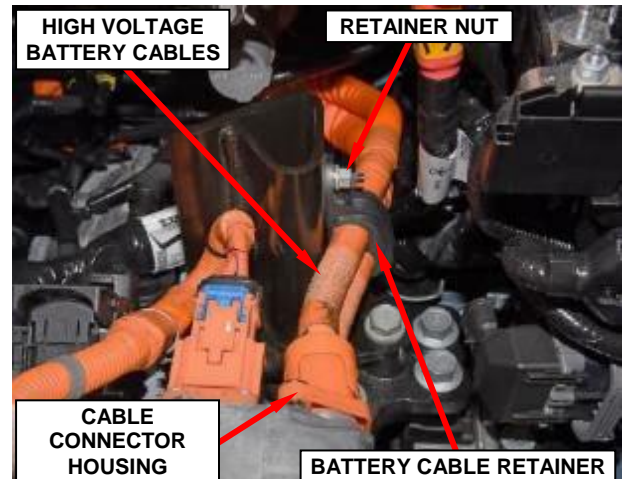
Figure 23 – Battery Cables Retainer

- 45. Remove and save the nut securing the high-voltage battery cable retainer (Figure 23).
- 46. Disengage the high voltage battery cable connector housing from the PIM, (Figure 23).

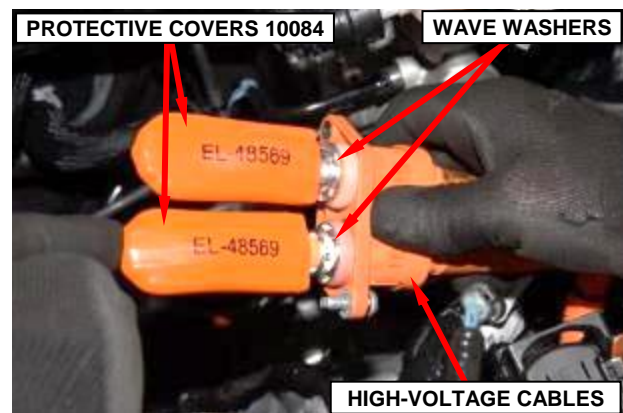
Figure 24 – Protective Covers 10084

NOTE: Ensure the wave washers remain on the high voltage battery cable connector housing during removal of the cables from the PIM housing. If the wave washers are dislodged, reseal them (Figure 24).

- 47. Cover the high-voltage cable terminals with protective covers 10084 (Figure 24) then reposition the high voltage harness to a safe location.

17. Remove the protective covers 10084 from the high-voltage cable terminals (Figure 24).

NOTE: Ensure the wave washers remain on the high voltage battery cable connector housing during installation of the cables to the PIM housing. If the wave washers are dislodged, reseal them (Figure 24).

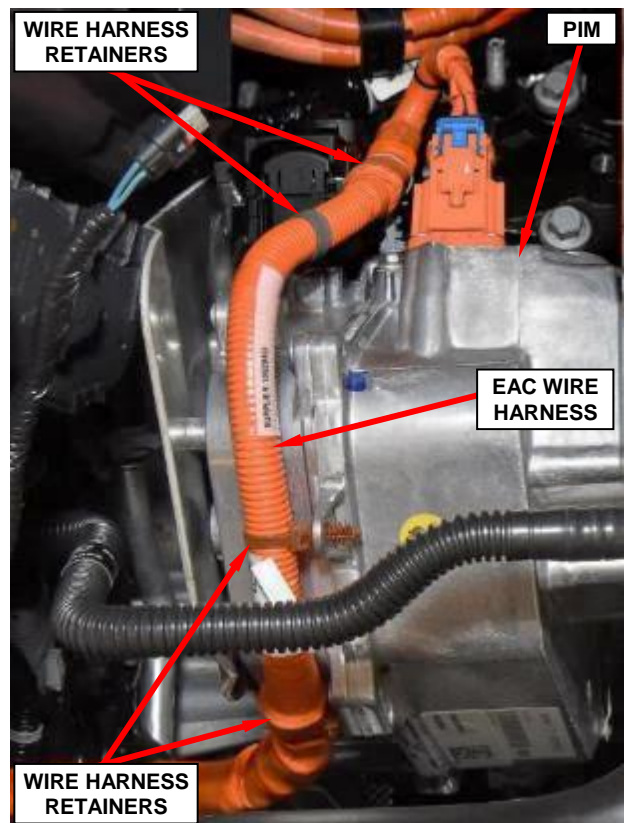
Figure 25 – EAC Wire Harness Retainers

48. Disengage the four wire harness retainers securing the Electric Air Compressor (EAC) wire harness to the PIM (Figure 25).

13. Connect the Electric Air Conditioning (EAC) wire harness electrical connector to the PIM (Figure 26).
14. Slide the EAC electrical connector locking clip forward to lock the EAC electrical connector to the PIM (Figure 26).
15. Position the wire harness and engage the wire harness retainer securing the EAC wire harness to the transmission mount bracket (Figure 26).
16. Position the wire harness and engage the four EAC wire harness retainers to the PIM (Figure 25).

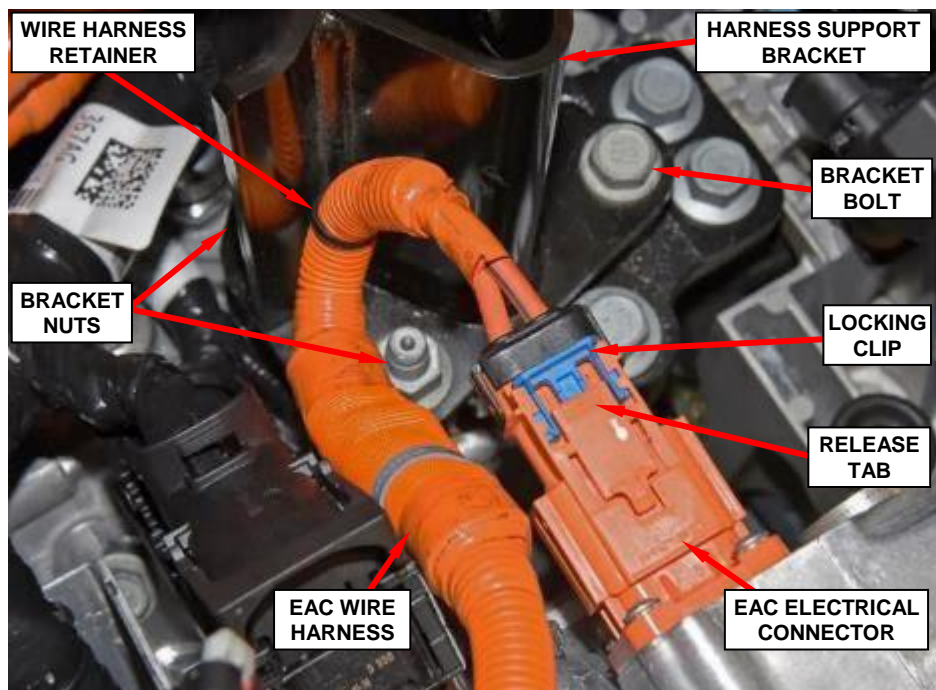
Figure 26 – EAC Electrical Connector and Mount Bracket

49. Disengage the wire harness retainer securing the EAC wire harness to the harness support bracket (Figure 26).

50. Slide the EAC electrical connector locking clip rearward (Figure 26).

51. Depress the EAC electrical connector release tab while pulling the EAC electrical connector rearward to disconnect the EAC electrical connector from the PIM (Figure 26). Reposition the EAC wire harness to a safe location.

52. Remove and save the two nuts and one bolt securing the harness support bracket, then remove and save the bracket (Figure 26).

11. Position the chassis ground cable to the PIM. Install the chassis ground cable stud-nut and tighten to 9 N·m (80 In. Lbs.) (Figure 27).
12. Install the harness support bracket to the transmission mount with two nuts and one bolt. Tighten the bolt and nuts to 115 N·m (85 Ft. Lbs.) (Figure 26).

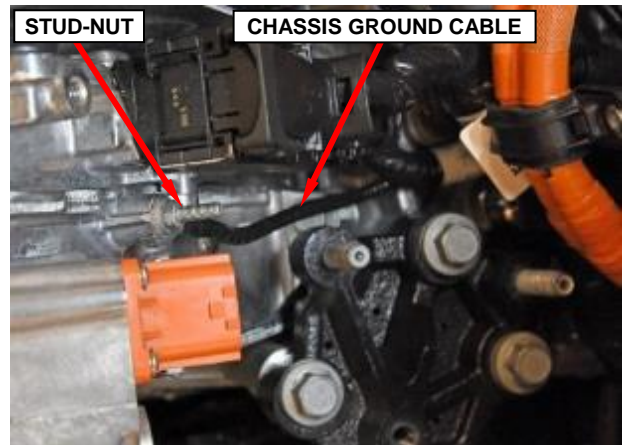
Figure 27 – Chassis Ground Cable

53. Remove and save the stud-nut securing the chassis ground cable to the PIM. Reposition the chassis ground cable from the PIM (Figure 27).

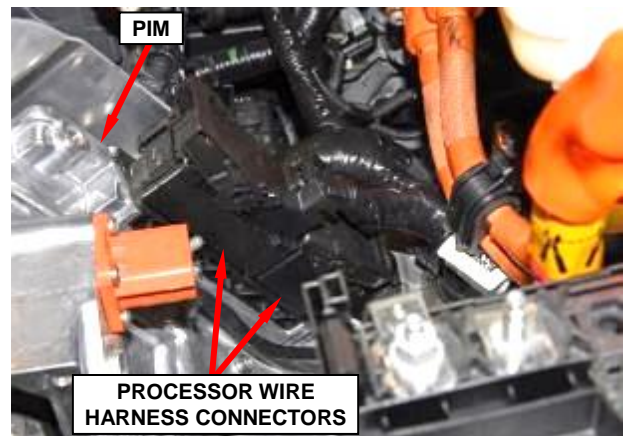
Figure 28 – Processor Connectors

54. Unlock and disconnect the processor wire harness connectors from the PIM (Figure 28). Reposition the connectors.

9. Position the chassis ground cable to the PIM then install and tighten the chassis ground cable bolt to 9 N·m (80 In. Lbs.) (Figure 29).
10. Connect and lock the processor wire harness connectors to the PIM (Figure 28).

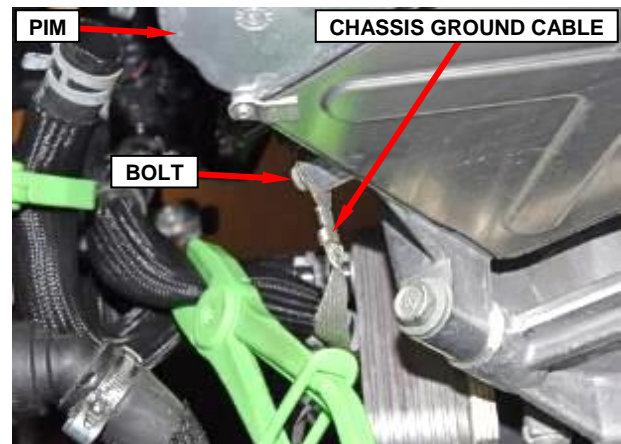
Figure 29 – Chassis Ground Cable

55. Remove and save the bolt securing the chassis ground cable to the PIM (Figure 29). Reposition the chassis ground cable.

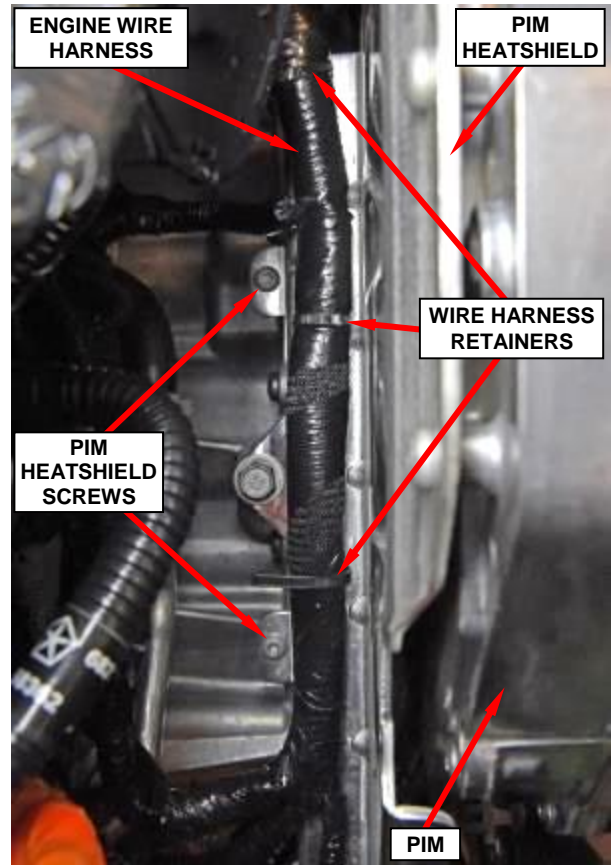
Figure 30 – Engine Wire Harness

- 56. Disengage the three retainers securing the engine wire harness to the PIM heatshield then reposition the engine wire harness (Figure 30).

- 57. Remove and save the four screws from the PIM heatshield then remove and save the PIM heatshield (Figures 30 and 31).

7. Install the PIM heatshield with four screws. Tighten the screws to 11 N·m (97 In. Lbs.) (Figures 30 and 31).
8. Position the engine wire harness and engage the three wire harness retainers to the PIM heatshield (Figure 30). **New** wire harness retainers are supplied with the PIM kit to replace any damaged retainers.

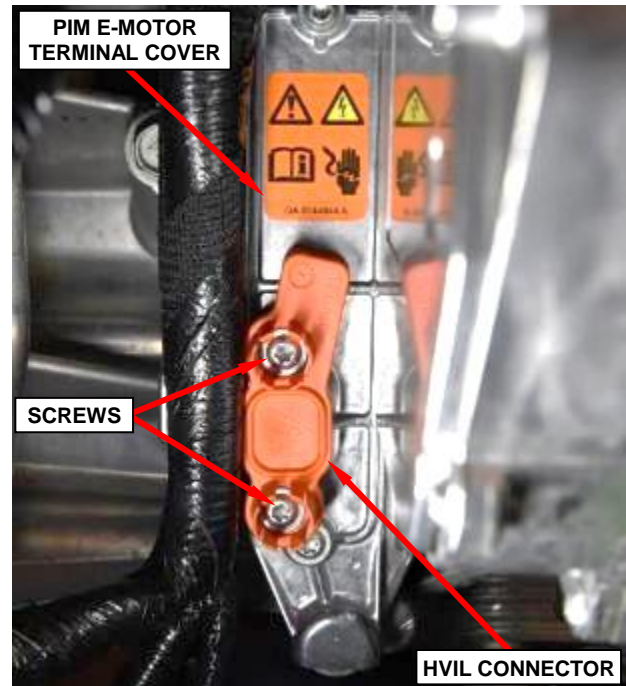
Figure 32 – HVIL Connector

- 58. Loosen the two captured screws then remove and save the HVIL connector from the PIM e-Motor terminal cover (Figure 32).
- 59. Loosen the four captured screws then remove and save the PIM e-Motor terminal cover (Figure 33).
- 60. Loosen the six captured e-Motor electrical terminal bolts to prepare for PIM removal (Figure 34).

6. Install the **new** High Voltage Interlock (HVIL) connector to the PIM e-Motor terminal cover. Tighten the two captured screws to 7.8 N·m (69 In. Lbs.) (Figure 32).

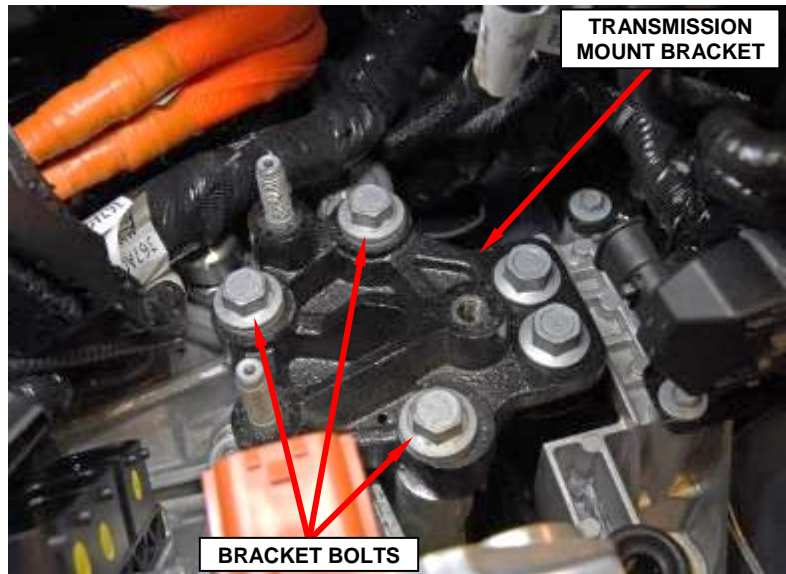
Figure 35 – Left Side Transmission Mount Bracket

- 61. Carefully position a floor jack under transmission to support the transmission.
- 62. Remove three bolts from the left side transmission mount bracket (Figure 35).
- 63. Lower the transmission approximately one inch.
- 64. Remove and save the five bolts securing the PIM to the transmission housing (Figure 36).

3. Using the floor jack, raise the transmission and install the three bolts to the LH engine (transmission) mount bracket. Tighten the bolts to 105 N·m (77 Ft. Lbs.) (Figure 35). Remove the floor jack from the vehicle.
4. Tighten the six captured e-Motor electrical terminal bolts to 11 N·m (97 In. Lbs.) (Figure 34).
5. Install the **new** PIM e-Motor terminal cover to the PIM. Tighten the four captured screws to 7.8 N·m (69 In. Lbs.) (Figure 33).

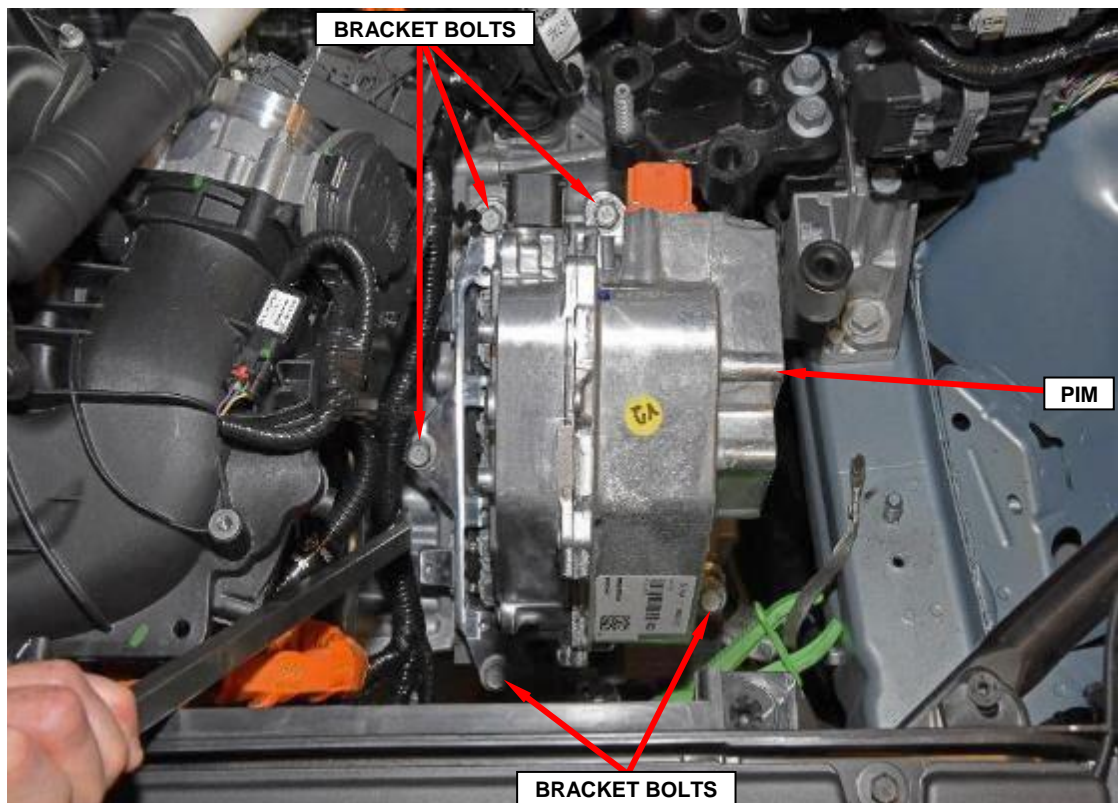
Figure 36 – PIM to Transmission Bolts

- 65. Remove and save the PIM from the transmission housing (Figure 36).

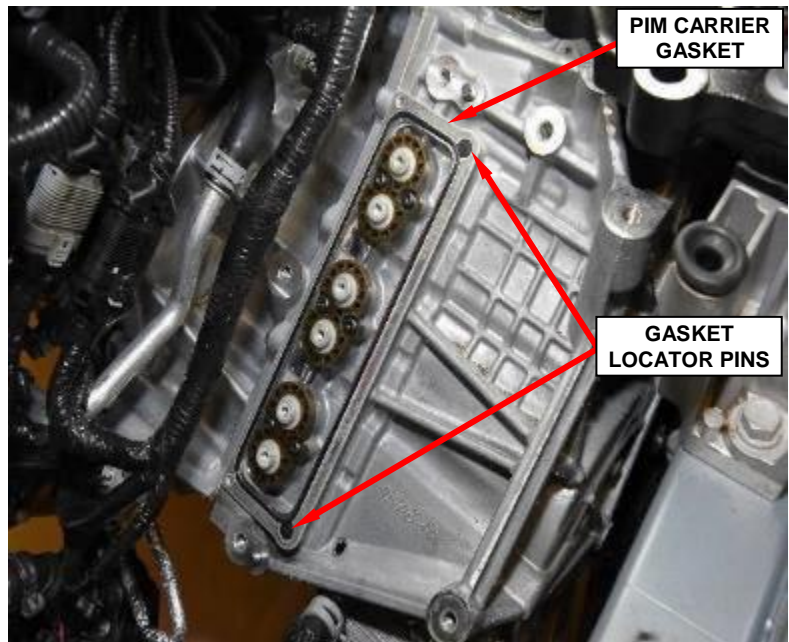
Figure 37 – PIM Carrier Gasket

- 66. Remove and discard the PIM carrier gasket (Figures 37 and 38).
- 67. Set aside for return to manufacturer, the PIM, e-Motor terminal cover, both HVIL connectors, and PIM cover.
- 68. Proceed to **section C. Power Inverter Module (PIM) Installation**

1. Install the **new** PIM carrier gasket to the transmission housing while ensuring that that gasket locator pins are seated in the holes on the transmission housing (Figures 37 and 38).

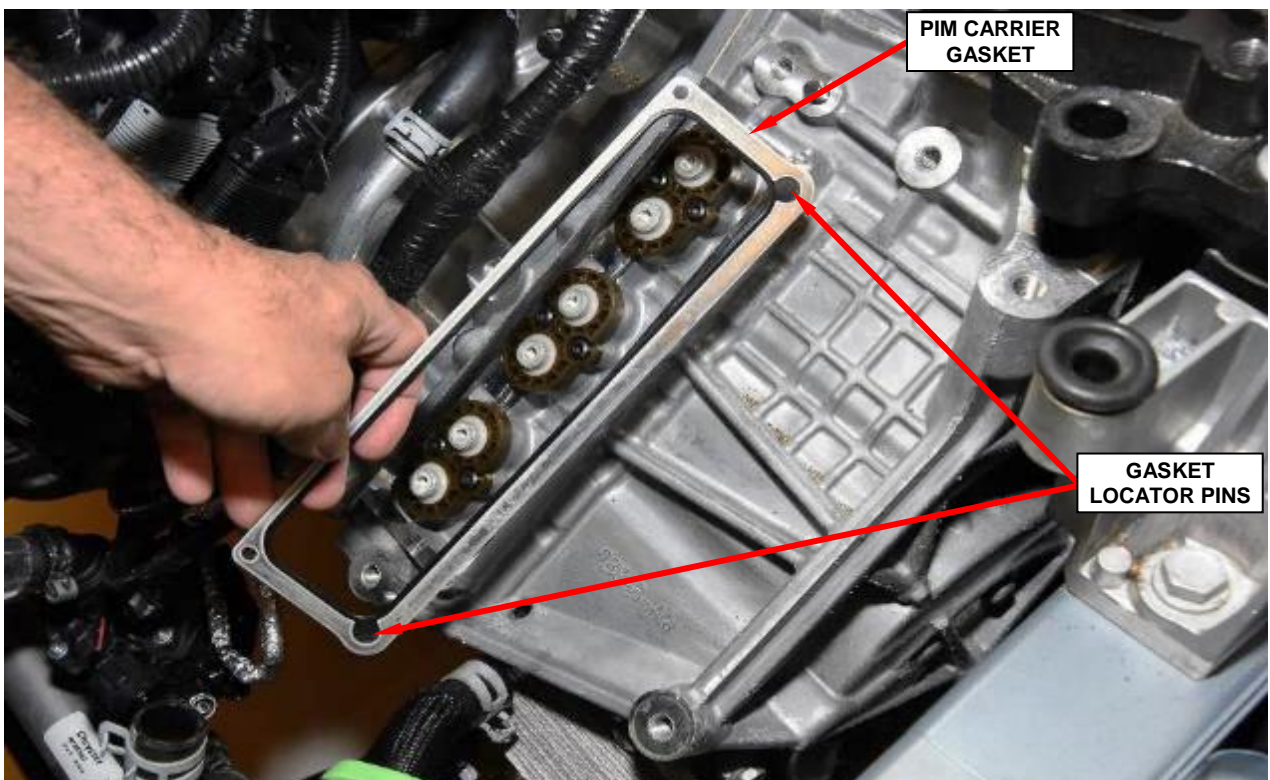
Figure 38 – PIM Carrier Gasket

NOTE: Ensure that the gasket locator pins are facing the transmission and are fully seated into the holes in the transmission housing (Figure 38). If the gasket is not installed correctly, water will enter the high voltage area and cause a loss of mobility.

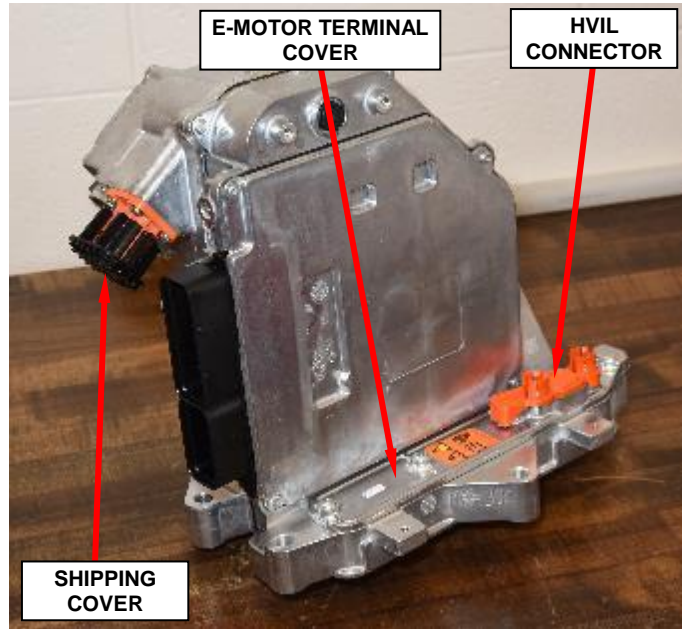
PIM Right Side

NOTE: Use the new PIM covers for installation of the new PIM. Do not reuse the old used covers.

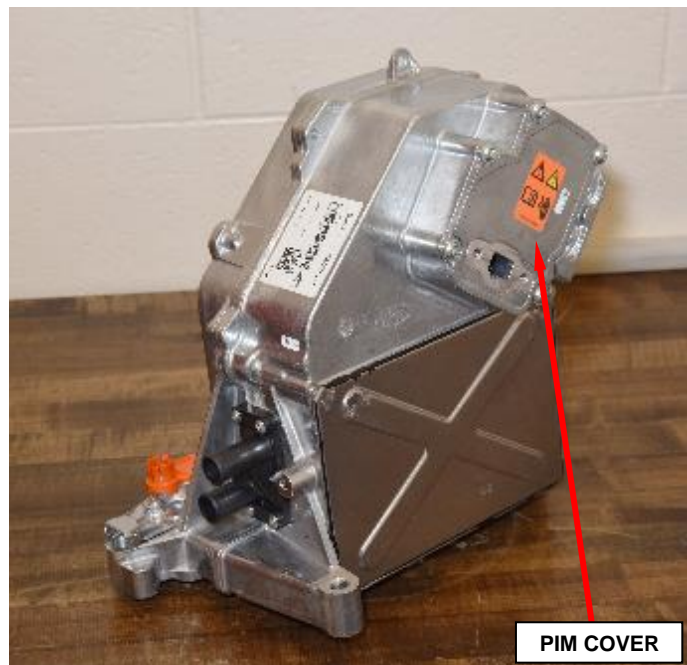
PIM Left Side

NOTE: Install the used covers on the used PIM to prepare the used PIM for return. Follow the PIM return instructions detailed in the parts section on Page 3 of this recall.

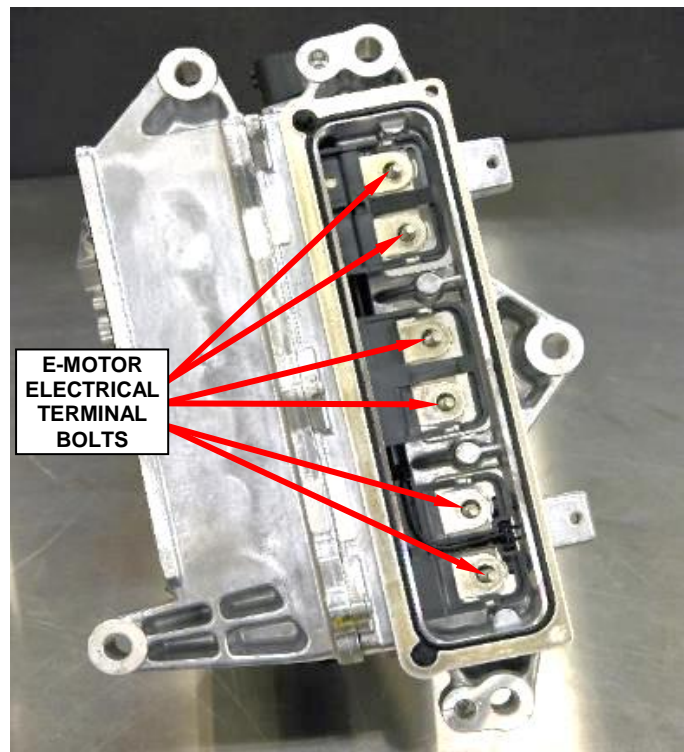
Figure 39 – PIM Carrier Gasket

CAUTION: Do not install a PIM that is missing any of the six captured e-Motor electrical terminal bolts (Figure 39). If any fastener is missing and not accounted for in the dunnage, the PIM must be returned to Mopar as there is a risk it is inside the PIM.
