Dealer Service Instructions for:

Safety Recall T34 / NHTSA 17V-371 PHEV Power Inverter Module

2017-2018 (RU) Chrysler Pacifica PHEV

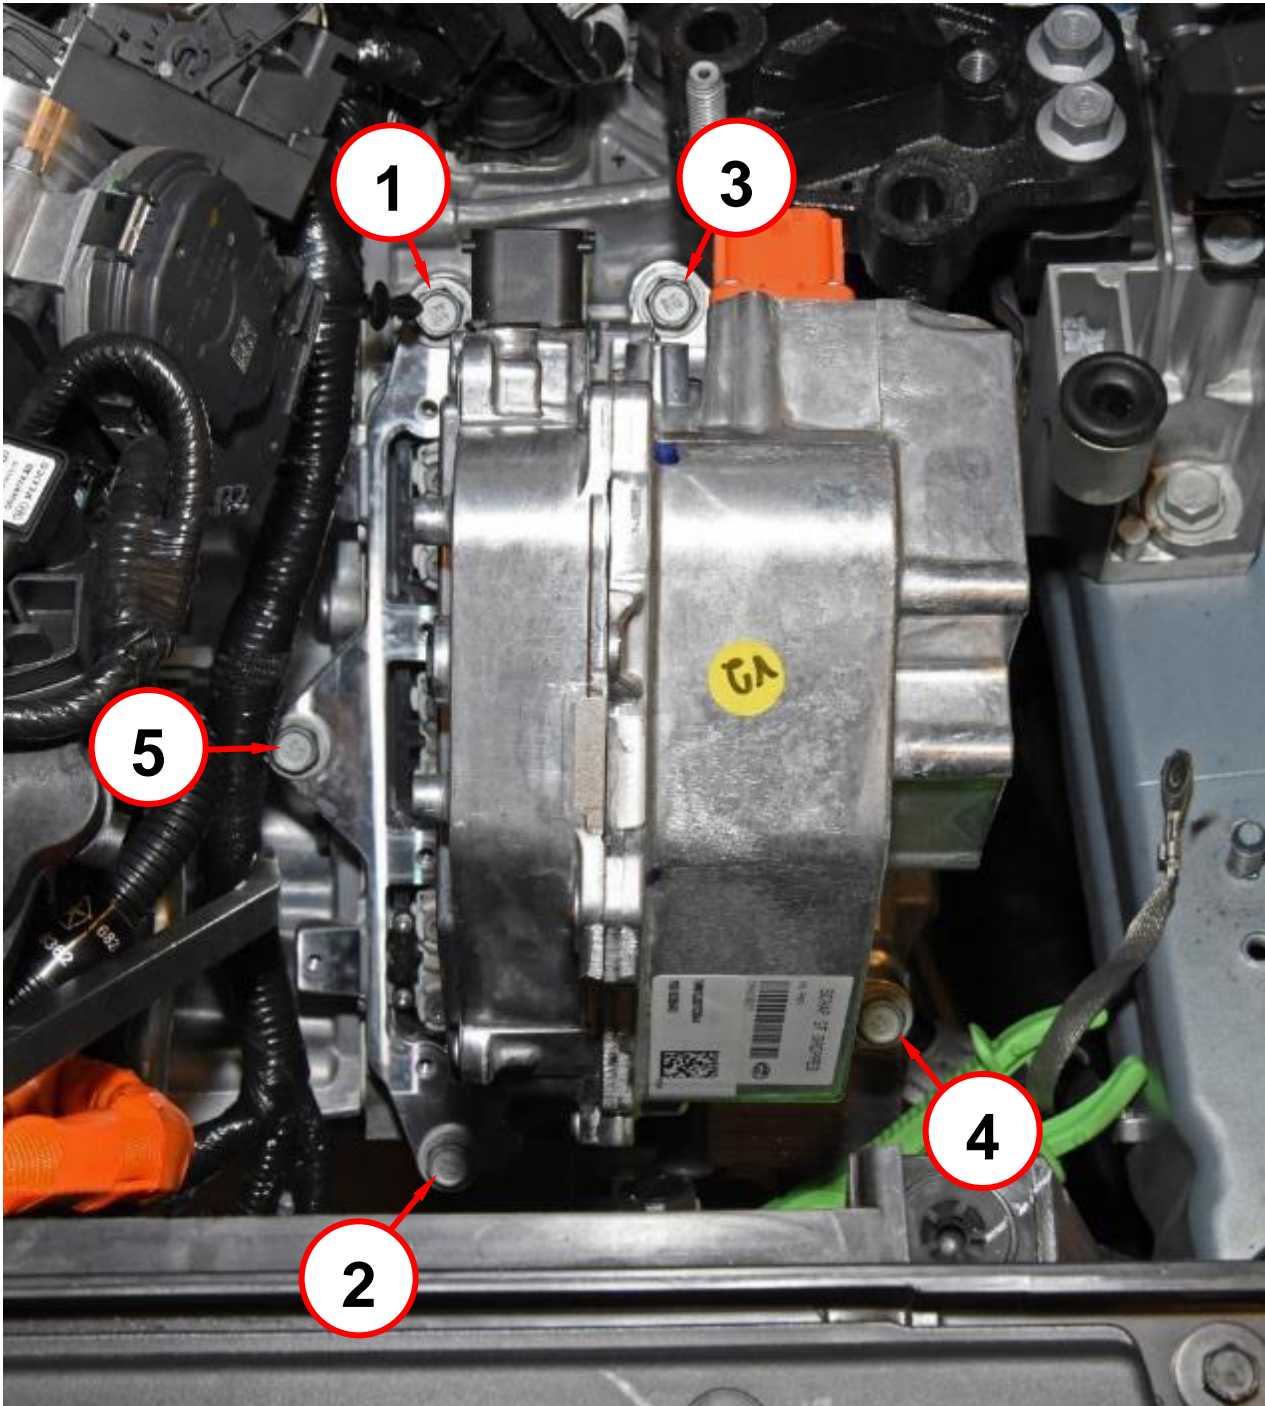
2. Install the **new** PIM to the transmission housing with five bolts. Tighten the bolts in the sequence shown to 62 N·m (46 Ft. Lbs.) (Figure 40).

Figure 40 – PIM to Transmission Bolts Torque Sequence

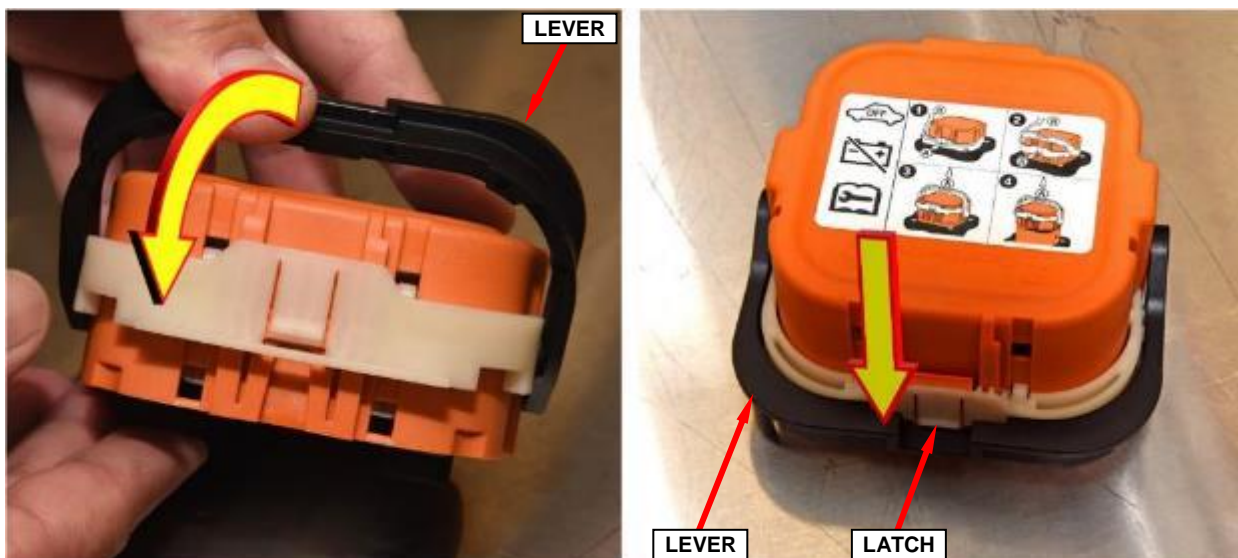
34. Rotate the lever while maintaining a slight force on the high-voltage manual service disconnect. The lever will engage the receptacle and draw the high-voltage manual service disconnect down onto the receptacle as the lever is rotated (Figure 41).
35. Rotate the lever downward until it is fully engaged and locked by the lever release latch. An audible “click” will be heard as the lever latches into position (Figure 41).
36. Gently pull the high-voltage manual service disconnect upward to ensure that it is fully seated in the receptacle and locked. If the manual service disconnect can be removed, repeat **steps 33 – 34**.

**Figure 41 – High-Voltage Manual Service Disconnect Latch Engagement
(High-Voltage Manual Service Disconnect Removed from Vehicle for Visual Clarity)**

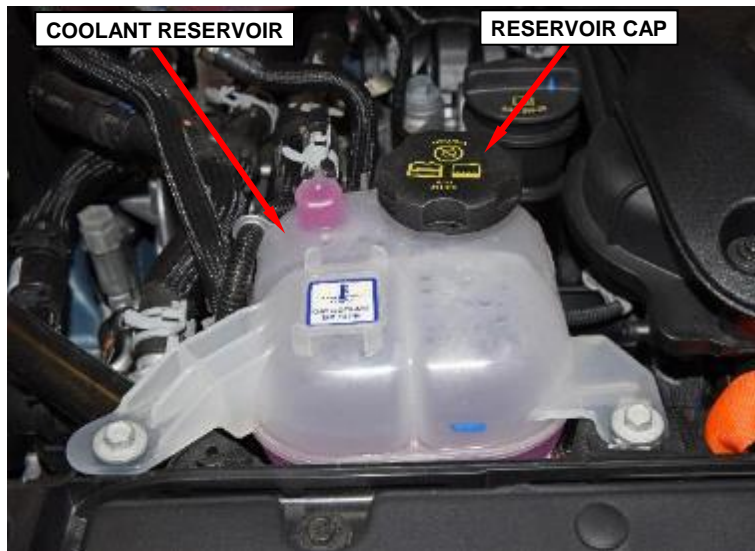
63. Add Mopar® 68163849AB engine coolant to the power electronics cooling system pressurized coolant reservoir through the filler neck until the coolant level reaches the MAX level of the coolant reservoir (Figure 43).

Figure 43 – Power Electronics Coolant Reservoir
