SI B65 13 17  
Audio, Navigation, Information, Safety Systems

## RECALL CAMPAIGN 17V-495: REPLACE DRIVER'S AIR BAG MODULE (PSDI-X) EXPANSION

BMW is conducting a Voluntary Safety Recall of BMW X3 (F25) and M6 (F12/F13) vehicles involving the driver's air bag module (PSDI-X)

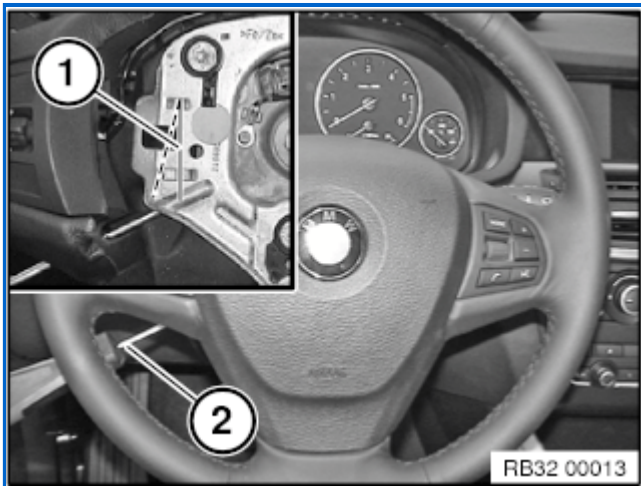
Insert Torx screwdriver T25 (2) at an angle into concealed opening on reverse side of steering wheel until a spring resistance is felt (approx. 1.5 cm).

Press spring leg (1) inward until airbag is unlocked.
