## RECALL CAMPAIGN 17V-495: REPLACE DRIVER'S AIR BAG MODULE (PSDI-X) EXPANSION

BMW is conducting a Voluntary Safety Recall of BMW X3 (F25) and M6 (F12/F13) vehicles involving the driver's air bag module (PSDI-X)

This Recall Campaign involves Model Year 2011-2013 BMW X3 (F25) and M6 (F12/F13) vehicles.

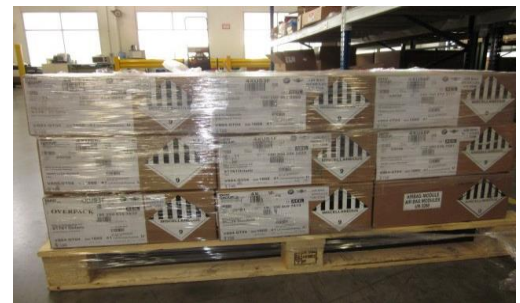
Place the recall airbag components neatly on a pallet, and securely shrink-wrap them to the pallet.

**Note:** The total height of the pallet and boxes cannot exceed 60 inches.

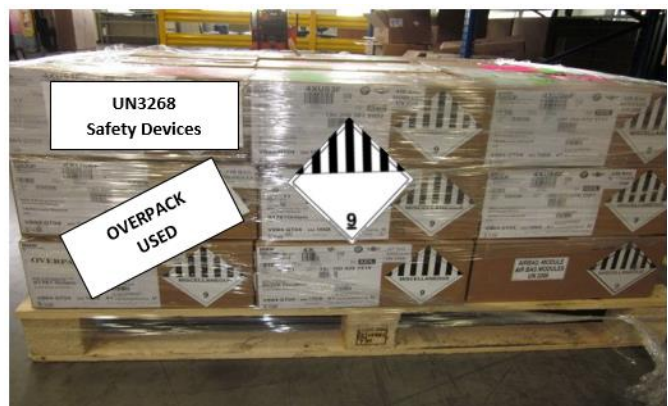
Securely attach the following labels on each side of the shrink-wrapped pallet.

- o Class 9 Label
- o UN3268 Safety Device \*
- o OVERPACK USED \*
