## RECALL CAMPAIGN 17V-495: REPLACE DRIVER'S AIR BAG MODULE (PSDI-X) EXPANSION

BMW is conducting a Voluntary Safety Recall of BMW X3 (F25) and M6 (F12/F13) vehicles involving the driver's air bag module (PSDI-X)

This Recall Campaign involves Model Year 2011-2013 BMW X3 (F25) and M6 (F12/F13) vehicles.

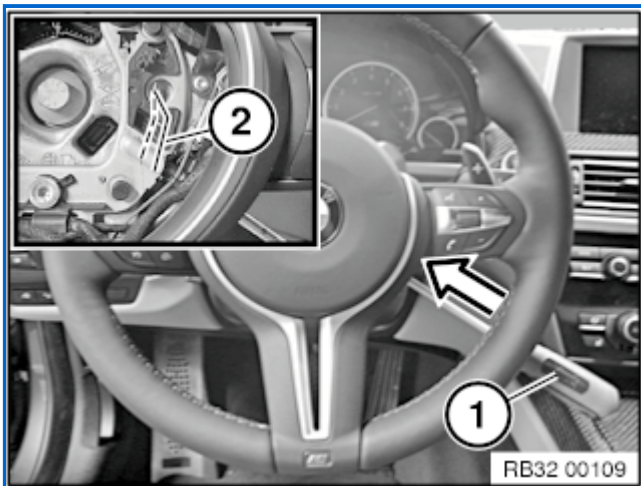
Insert Torx screwdriver T27 (1) straight into concealed opening until a spring resistance can be felt.

Press in wire spring clip (2) with Torx screwdriver T27 (1) in direction of arrow until the airbag unit is unlocked.

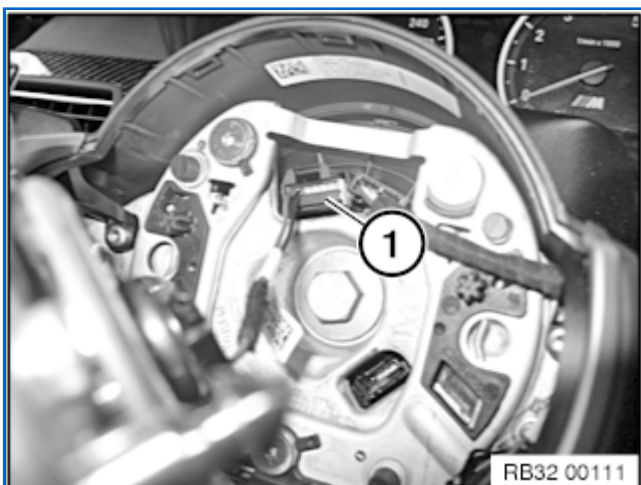
Raise airbag unit towards rear.

Disconnect plug connections(1) and remove airbag unit.

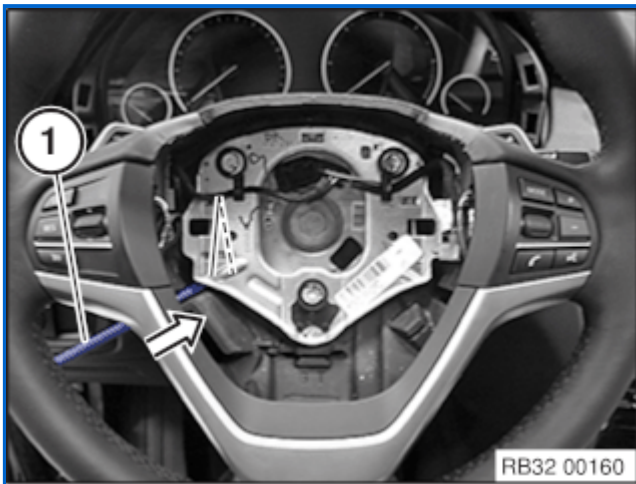
Insert Torx screwdriver T30 (1) at an angle into concealed opening on reverse side of steering wheel until a spring resistance is felt (approx. 2 cm).

Increase pressure on spring leg using Torx screwdriver T30 (1) until airbag unit is released.

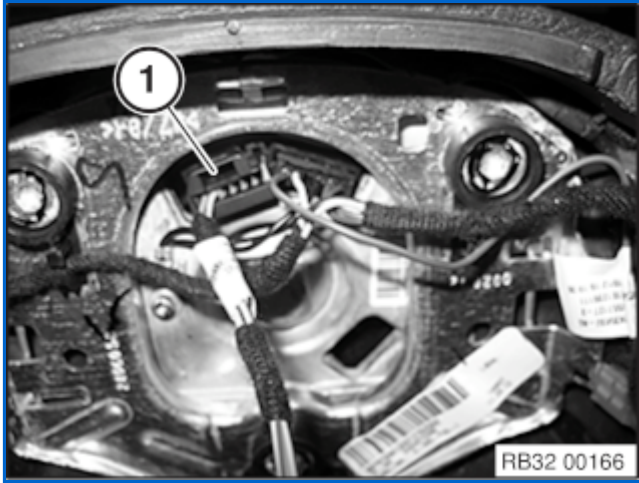
Tilt airbag unit towards rear.

Disconnect electrical connectors (1) and remove airbag unit.
