Safety Recall Code: 80C6

Auxiliary Heater & Software

U.S.A. & CANADA: Certain 2013-2016 MY Audi A5 Cabriolet, A4 Sedan, A4 allroad, Q5 and A5 Coupe

Replace the auxiliary heater and install updated software.

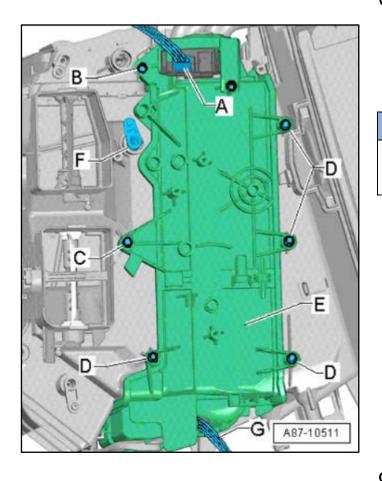
Vehicles with Criteria 22 (2-Zone climate system):

- Disconnect connector <A> (for the Right Temperature Door Motor -V159-).
- Remove bolts <B, C and D>.
- Remove right heater core housing <E>.

When removing right heater core housing, pay attention to the lever on the door for the instrument panel vent <F> so it is not damaged.
