December 2023
FL780AB
NHTSA #18V-491
Transport Canada #2018-387
SIXTH REVISED NOTICE

Subject: Cascadia ICUC Bulb Check Function

Models Affected: Specific Freightliner Cascadia vehicles manufactured May 3, 2016, through July 11, 2018, and equipped with a certain ICUC.

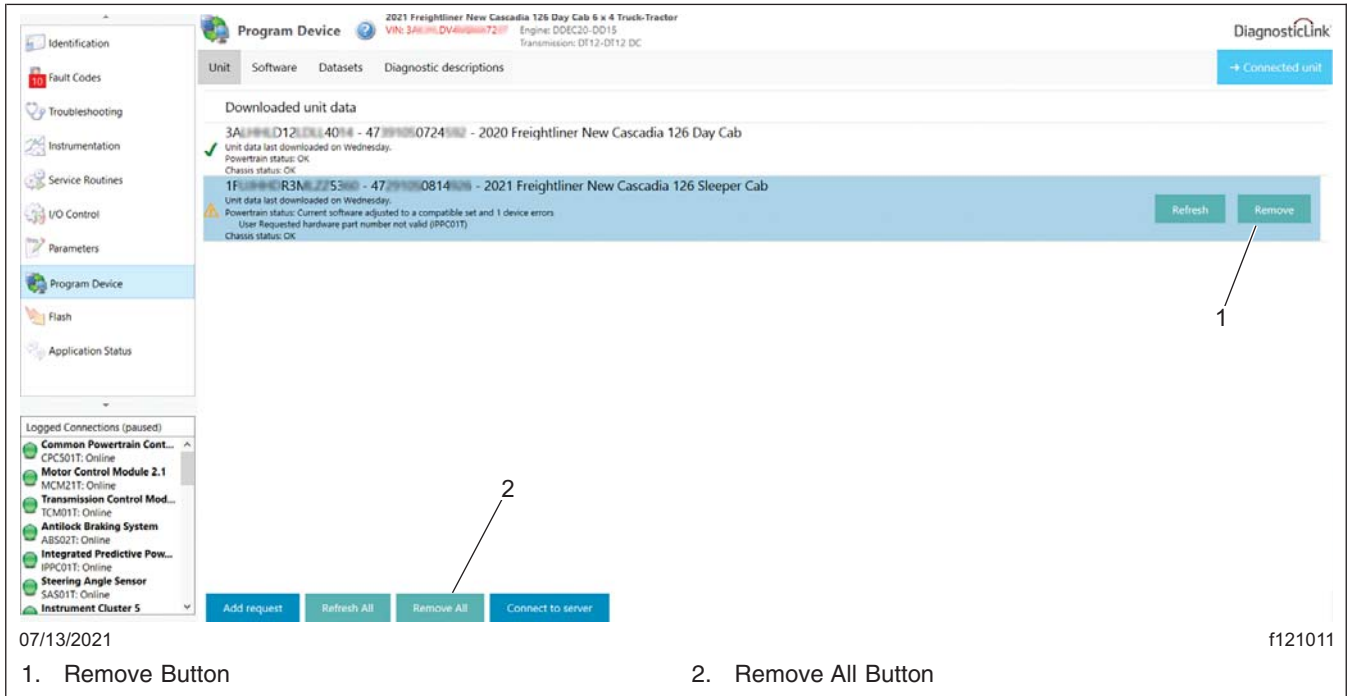
Fig. 4, Removing the VINs

- Go to 'Program Device,' and make sure that the vehicle identification number (VIN) that appears is correct. If not, remove each VIN by selecting the 'Remove' button located at the far right-hand side of that VIN. To remove all the VINs at once, select the 'Remove All' button at the bottom of the screen. See [Fig. 4](#).

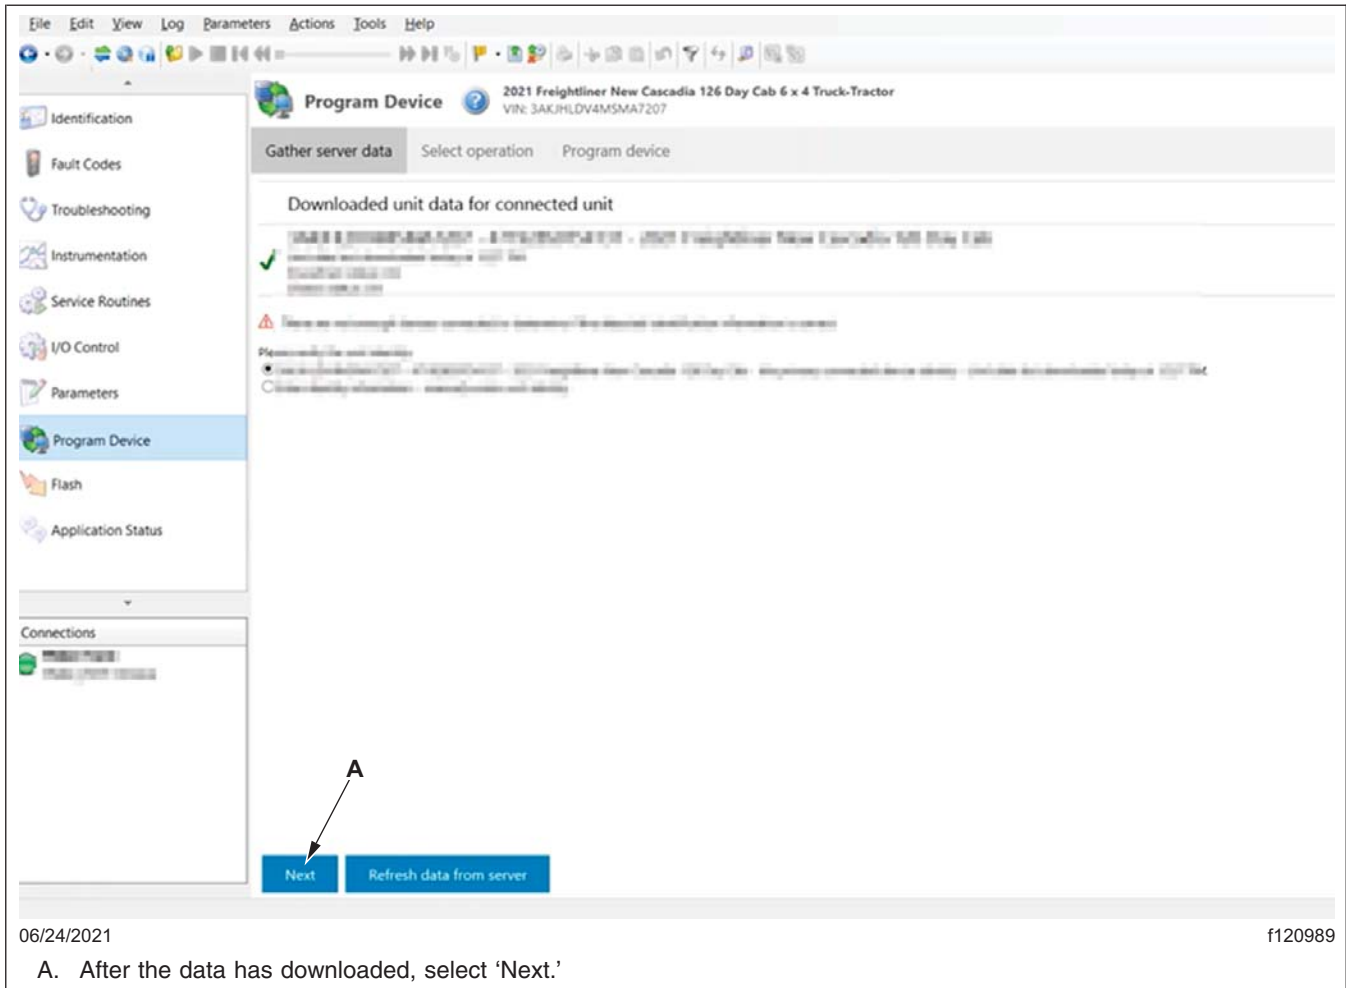
Fig. 8, Data Downloaded from the Server

9. When the data has finished downloading, select 'Next.' See [Fig. 8](#).

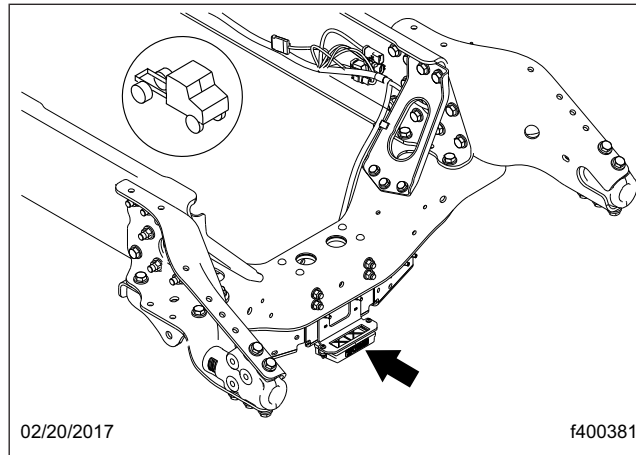
Fig. 22, TPMS Receiver

8. Disconnect the wiring harness and the antenna cable from the TPMS ECU receiver. See [Fig. 22](#).

9. Remove the two flange-head capscrews, then remove the TPMS ECU receiver.
10. Use the existing bolt holes and the two M6 x 1 flange-head capscrews to attach the new TPMS ECU receiver to the vehicle. Tighten the capscrews 7 to 10 lbf-in (79 to 113 N-cm).
11. With the ignition key at the OFF position, connect the wiring harness and the antenna cable to the TPMS ECU receiver.
12. Install the front bumper. For instructions, see **Group 31** of the *New Cascadia Workshop Manual*.
13. Connect batteries, then turn the ignition key to the ON position.
14. Wait 10 seconds, then follow the DTNA_ECUSwap prompts. Select 'OK.' Continue to follow the prompts to transfer the configuration to the new TPMS ECU. When complete, the message 'ECU Configuration has been successfully transferred' will be displayed.

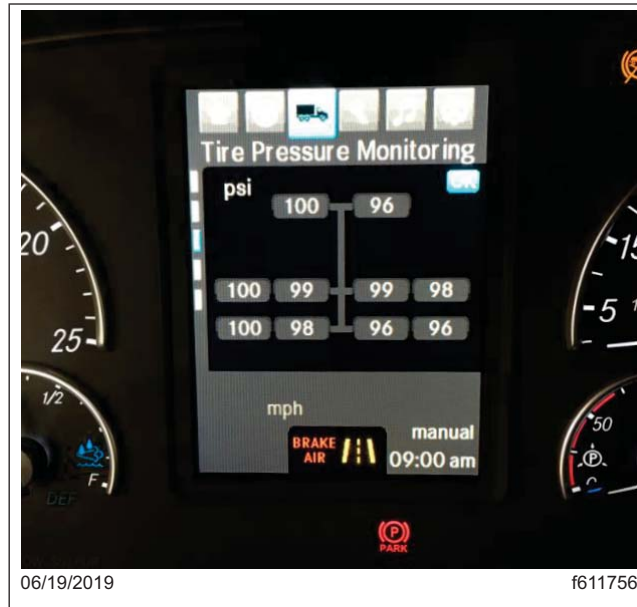
Fig. 23, ICUC Tire Pressure Monitoring Screen

15. Turn the ignition key to the ON position, then verify that the TPMS sensor readings are present. Use the left-hand side steering wheel buttons to navigate to the ICUC Tire Pressure Monitoring screen, shown in **Fig. 23**. Tire pressures should be present for each configured axle.
