GROUP Safety Recall Campaign	MODEL 2015-2018MY Sedona (YP)
	NUMBER SC164	DATE June 2018
SAFETY RECALL CAMPAIGN		
SUBJECT: POWER SLIDING DOOR ACTUATION LOGIC IMPROVEMENT (SC164)

This bulletin provides the procedure to improve the software logic of Power Sliding Door (PSD) Module on some 2015-2018MY Sedona (YP) vehicles, produced from July 21, 2014 through December 6, 2017, equipped with Power Sliding Doors which contain an automatic stop and reversal feature that is designed to reverse the movement of the door back to open when an obstruction is sensed. The original programming of the PSD Module is set to a threshold level that may not detect certain obstruction types and locations/placements. As a result, the Power Sliding Door may not reverse course in the presence of certain obstructions. If the door closes on an occupant, there is an increased risk of injury.

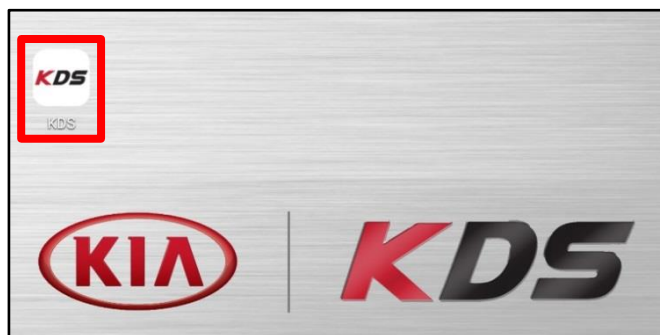
3. Confirm communication with VCI (A) and then configure the vehicle (B) using the **AUTO VIN** (C) feature.
