Safety Recall

Code: 74D5

Subject	Passenger Occupant Detection System (PODS)																							
Document History	<table border="1"> <thead> <tr> <th style="background-color: #c00000; color: white;">Date</th> <th colspan="3" style="background-color: #c00000; color: white;">Summary</th> </tr> </thead> <tbody> <tr> <td>10/17/2025</td> <td colspan="3"> Updated claiming and work instructions to allow for the use of normal service parts. General formatting updates. <i>NOTE: PODS service kits come with a new PODS ECU. Programming of the PODS ECU in a service kit is NOT required.</i> </td> </tr> <tr> <td>11/20/2018</td> <td colspan="3">Original publication</td> </tr> </tbody> </table>				Date	Summary			10/17/2025	Updated claiming and work instructions to allow for the use of normal service parts. General formatting updates. <i>NOTE: PODS service kits come with a new PODS ECU. Programming of the PODS ECU in a service kit is NOT required.</i>			11/20/2018	Original publication

Repair Overview

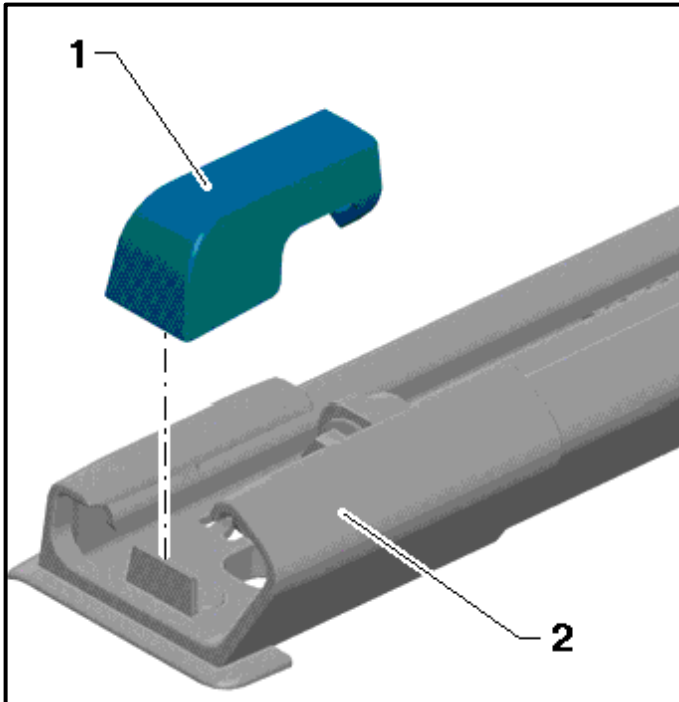
- Push the headrest into the lowest position.
- Move the passenger front seat to the full-rearward position.
- Pry off the front spindle cover <1> from the seat rail cover <2> using the Trim Removal Wedge -3409- (or equivalent).

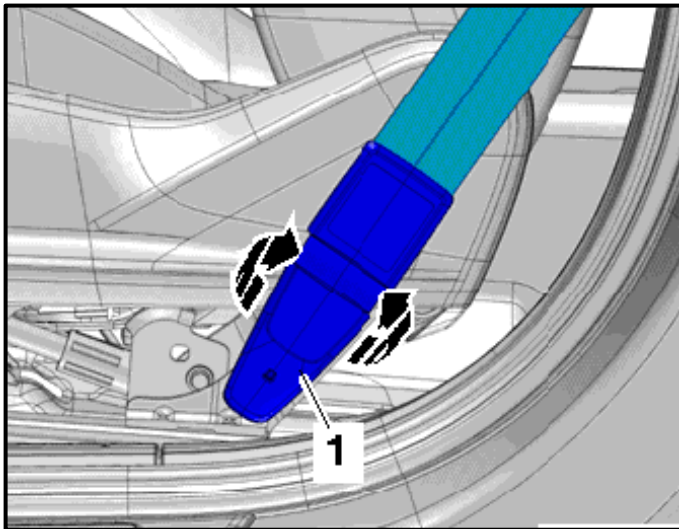
- Unclip the cover <1> on the belt relay <arrows> and fold it upward.

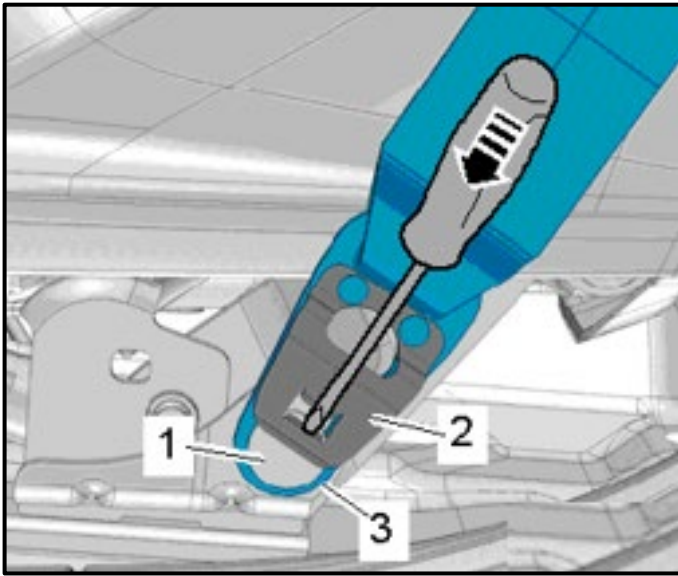
- Release the spring catches <2> by inserting a small screwdriver in the opening in the spring <arrow>.
- Slide the belt end fitting <3> downward and disengage at the pin <1>.

- The spring <2> can bend if removed incorrectly. Replace the three-point seat belt if the spring is bent or distorted. Damage to the seat belt is not covered under this action.
- Only move the spring <2> far enough to unlock the tab on the spring. Do not overextend the spring.

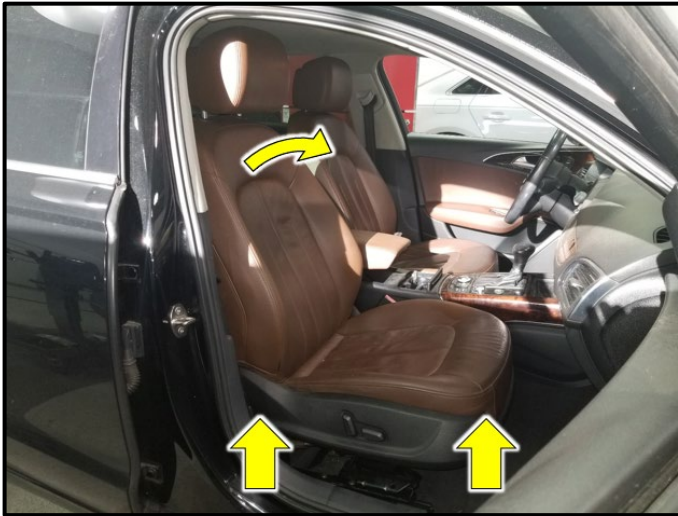
- Move the passenger front seat height adjustment to the fully raised position and tilt the backrest fully upright.

If the seat is not in fully raised and tilted fully upright, the seat motor will obstruct the removal of the PODS sensor connector.

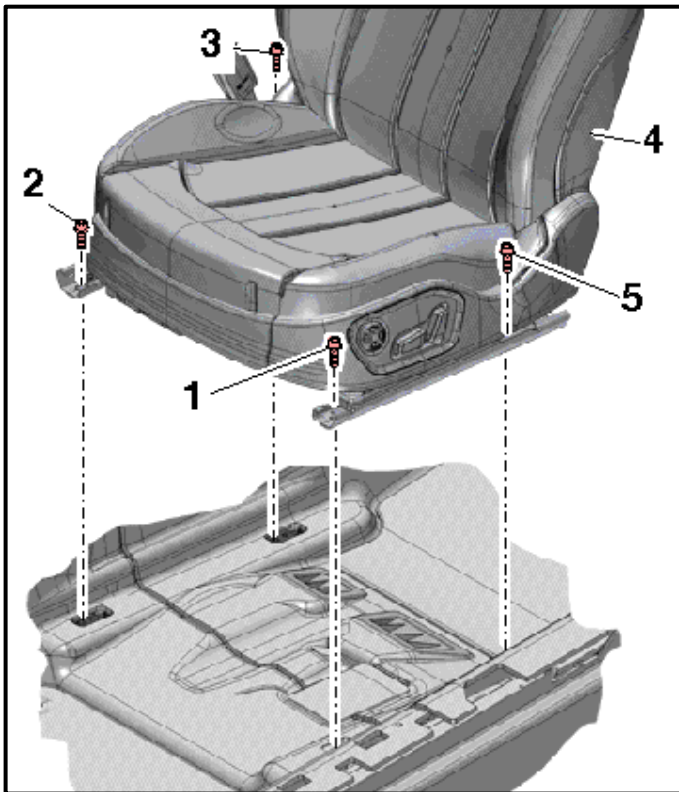
- Remove the bolts <3 and 5> from the rear of each seat rail.
- Move the seat <4> to the full rearward position.
- Remove the bolts <1 and 2> from the front of each seat rail.
- Position the seat rear of center in the seat rails.

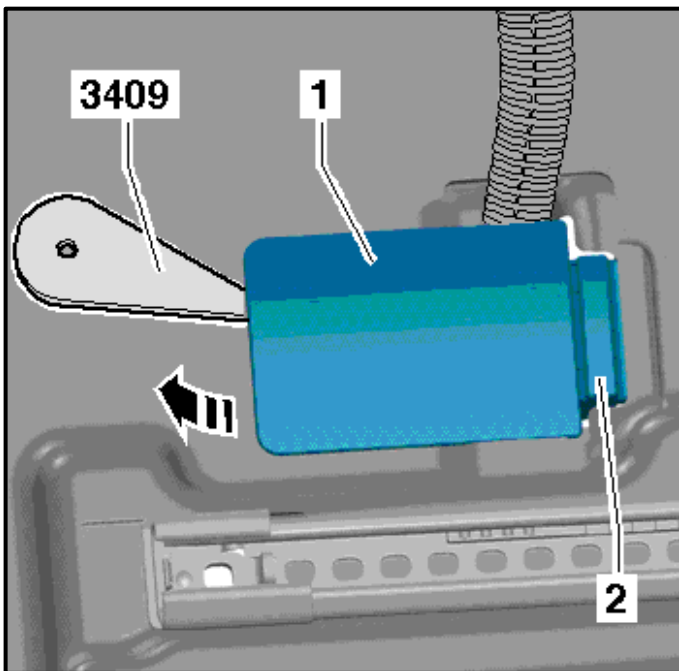
- Using Trim Removal Wedge -3409- (or equivalent), release the front of the cover <1> and remove it as shown <direction of arrow>.

The connector station shown here is located in the vehicle floor under the front passenger seat.

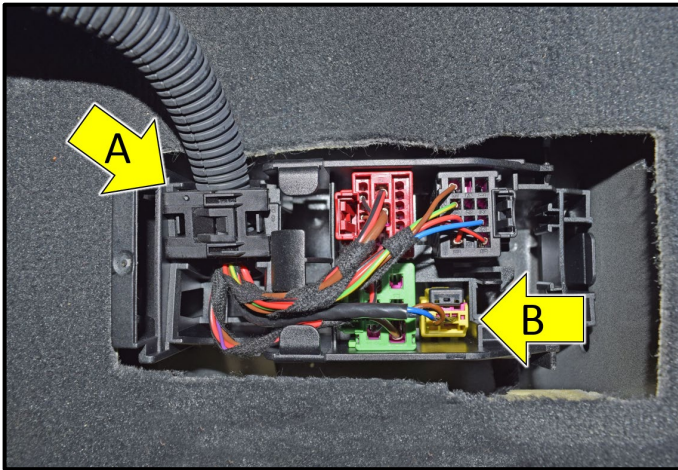
- Release the retaining tabs and remove the wiring bracket <arrow A> from the connector station.

The number of connectors present in the connector station will vary based on vehicle equipment.

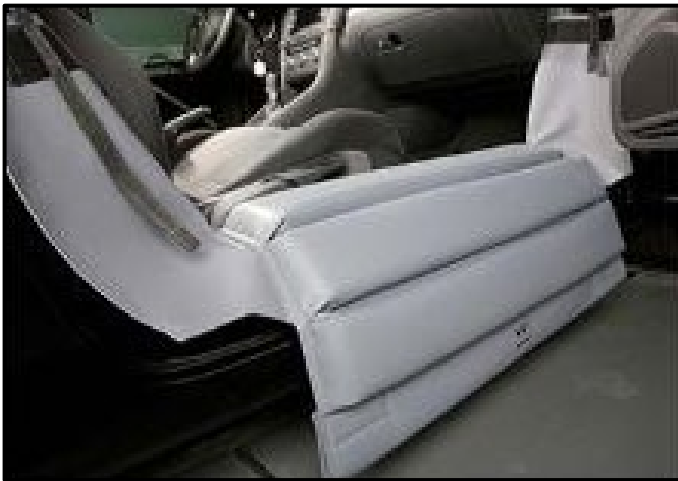
- To protect the sill panel before removing the front seat, install the Universal Vehicle Protector -VAS871001- <as shown>.
- Carefully remove the front seat from the vehicle.

Due to the weight and size of the front passenger seat, assistance from a second technician may be helpful in removing the seat.

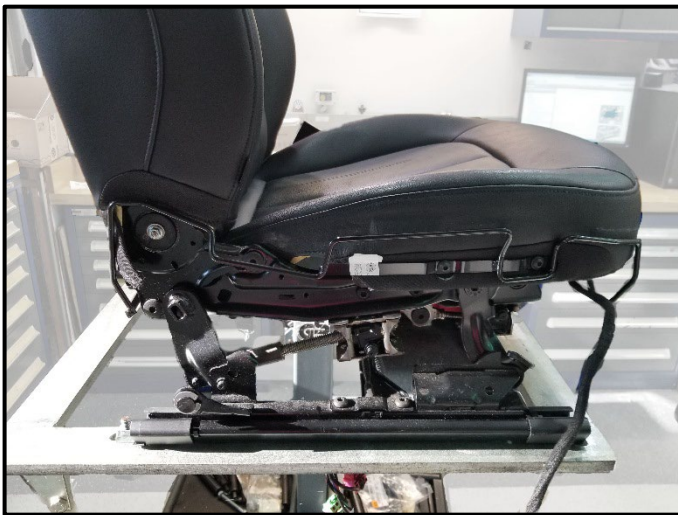
- Attach the Seat Repair Fixture -VAS6136- to the Engine and Transmission Holder -VAS6095-.
- Fasten the front seat onto the Seat Repair Fixture -VAS6136-.

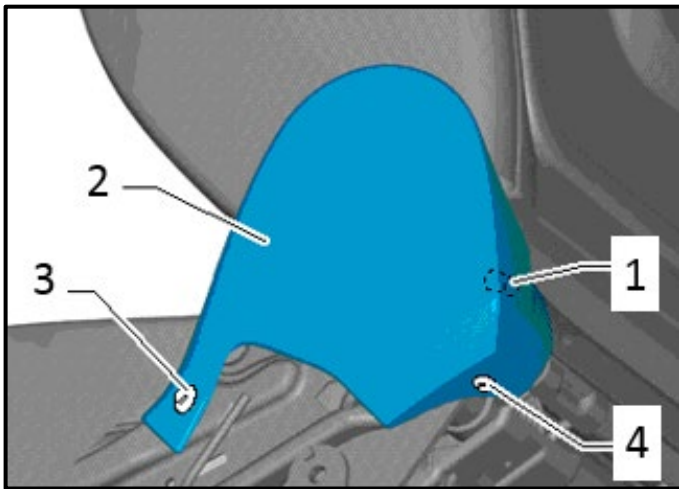
- Remove the expanding rivets <3 and 4>.
- Disengage and remove the tunnel-side trim <2> from the seat back hinge.

Use caution during removal of the trim. The mounting tab <1> may break if not properly disengaged. Damage to the trim is not covered by this action.

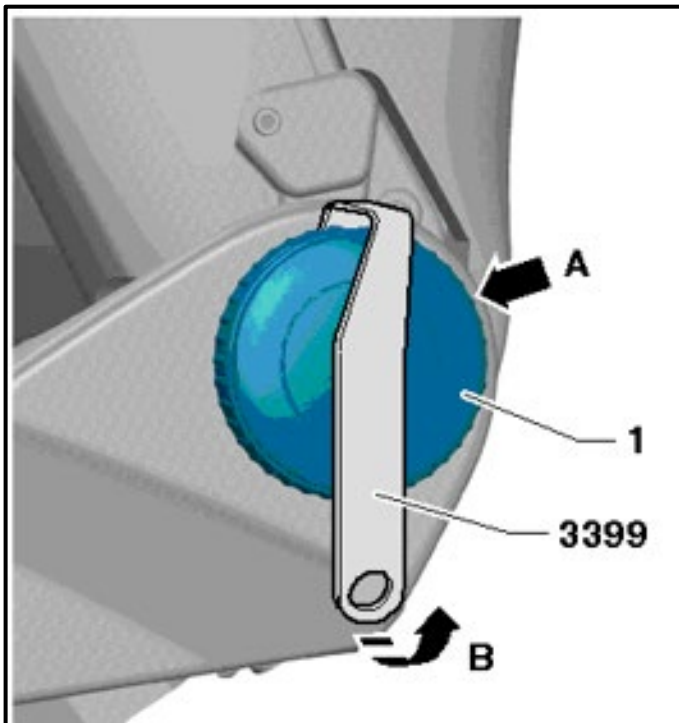
On vehicles equipped with a MANUAL seat:

- Turn the seat back adjustment wheel <1> until one catch is visible from behind <arrow A>. Use a flashlight if necessary.
- Using the Assembly Tool -3399-, carefully pry the adjustment wheel off the seat <direction of arrow B>.
- Turn the seat back adjustment wheel 120° further and repeat the process.
- Remove the seat back adjustment wheel.

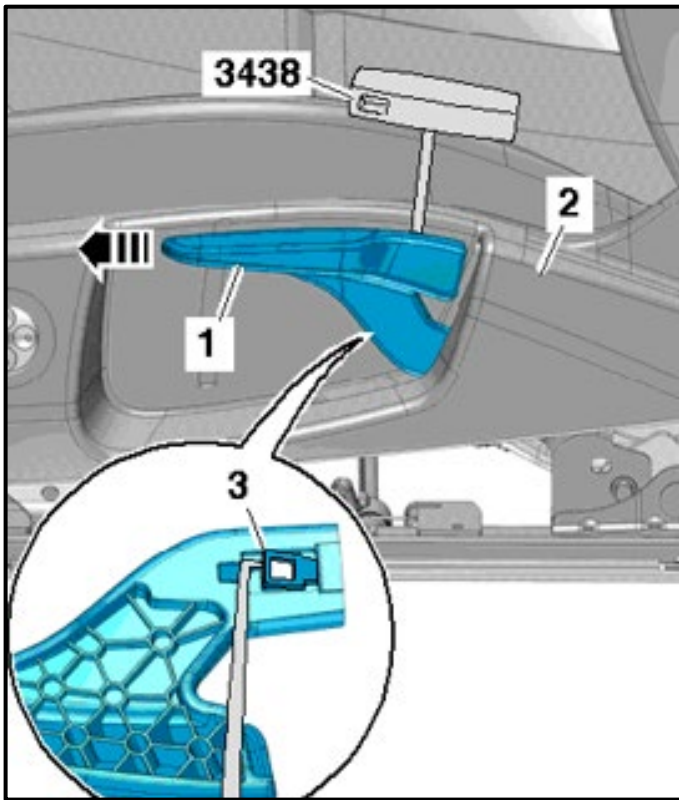
On vehicles equipped with a MANUAL seat:

- Pull the seat height adjustment handle <1> upward and hold it in the fully-raised position.
- Carefully pull the seat height adjustment handle away from the seat.
- Guide the T-Handle Hook -3438- between the seat height adjustment handle and the seat trim <2>.
- Using the T-Handle Hook -3438-, release the fastening tab <3>.
- With the fastening tab released, remove the seat adjustment handle from the lever <direction of arrow>.

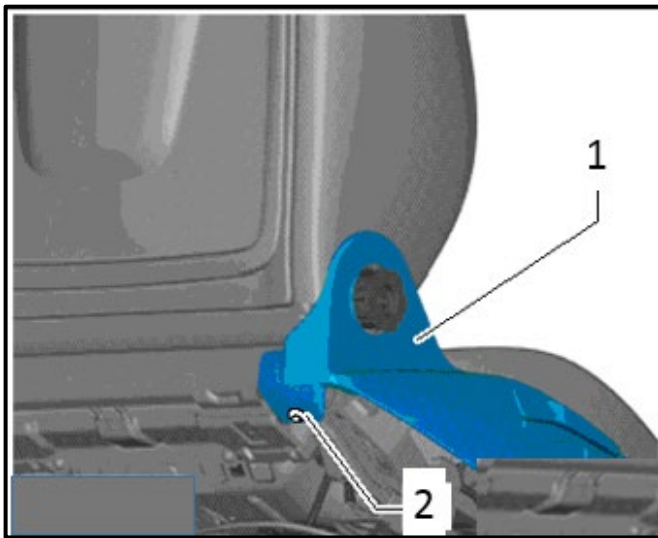
- Remove the expanding rivet <2> from the sill-side seat trim <1>.

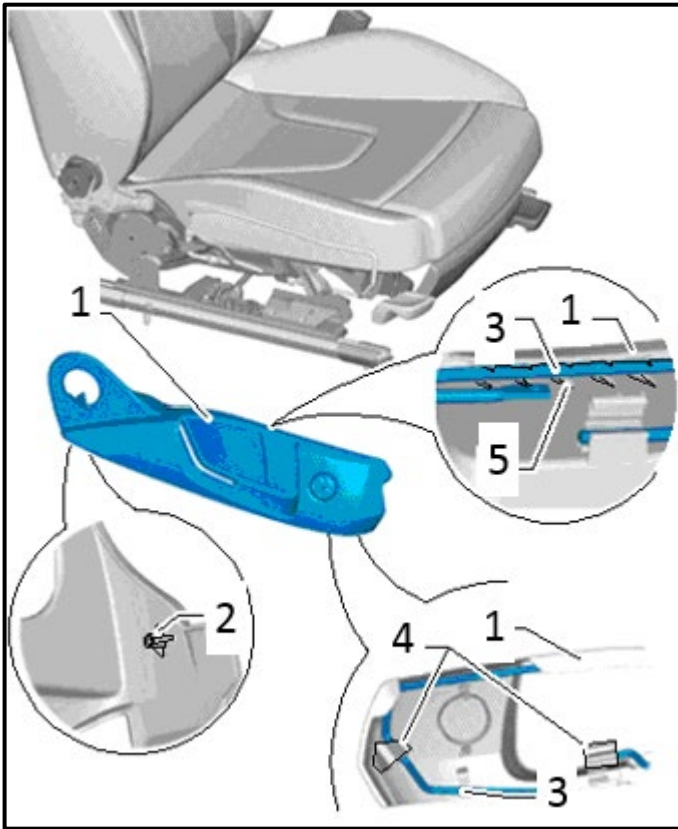
- Open the mounting clips <4> on the seat trim.
- Unclip the bracket <3> and, if present, release the wiring harness from the sill-side trim.
- Pull the trim <1> slightly forward off the bracket and remove it in an upward direction.

Use caution during removal of the trim. The mount <5> and the tab <2> may break if not properly disengaged. Damage to the trim is not covered by this action.

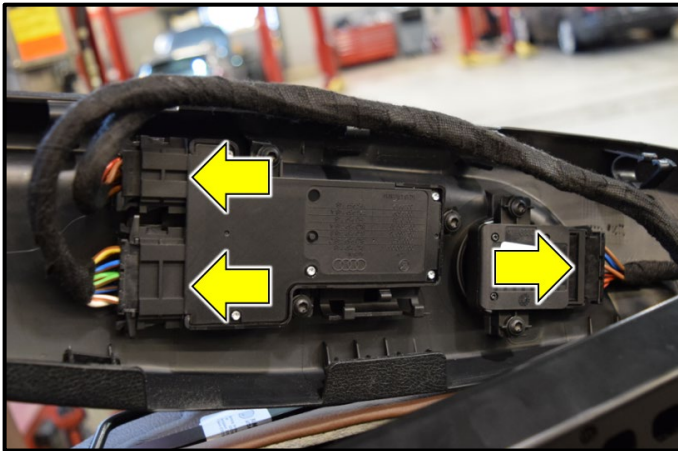
- Disconnect the electrical connectors <arrows>.
- Remove the seat trim panel.

The number of connectors present may vary.

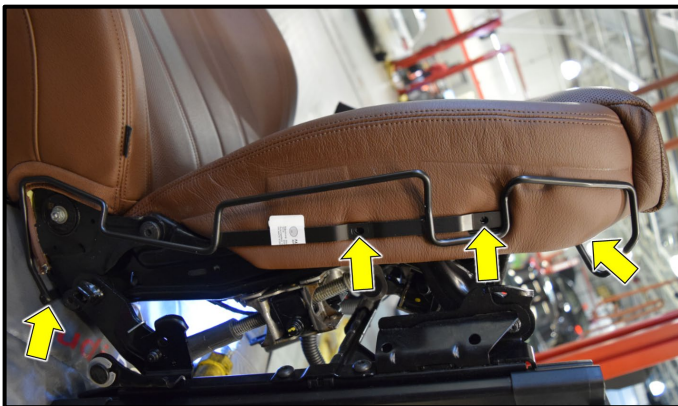
- Remove the four fastening screws <arrows> from the mounting bracket.
- Remove the mounting bracket from the seat.

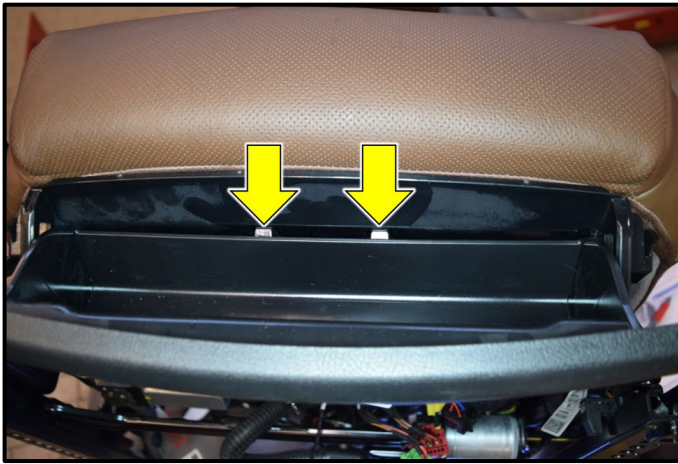
Vehicles with Criteria 02, 03 and 04:

- Open the storage compartment located on the lower front portion of the seat.
- Release the two tabs <arrows> and fully open the storage compartment.

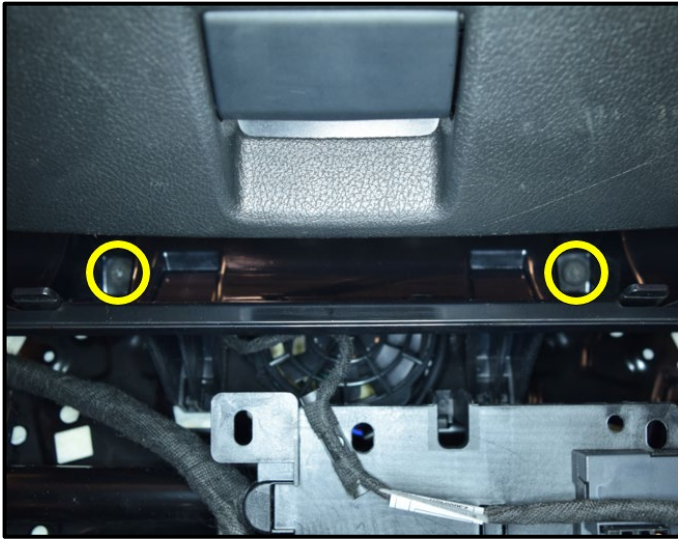
- Hold the storage compartment in the full-open position, and remove the mounting screws <circles>.
- Remove the storage compartment from the seat.

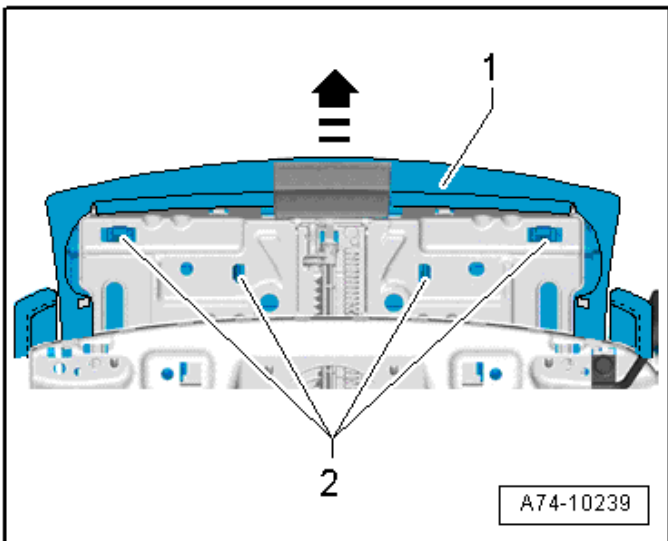
Vehicles with Criteria 01:

- Pull the seat depth adjuster all the way out.
- Unclip the tabs <2>.
- Move the support with the seat cushion and seat cover <1> for the seat depth adjuster as far as possible upward <arrow> so that the tab remains unlocked.

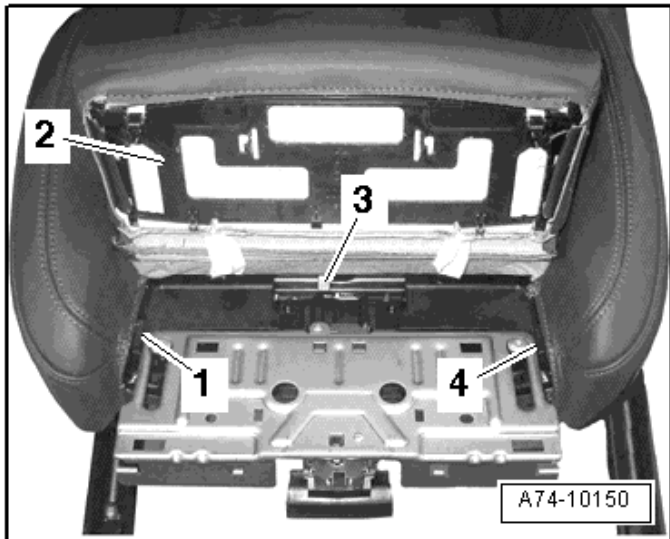
- Remove the support <2> with the seat cushion and seat cover for the seat depth adjuster upward and toward the front.
- Unclip the cover retaining strips <1, 3 and 4> and rear cushion.

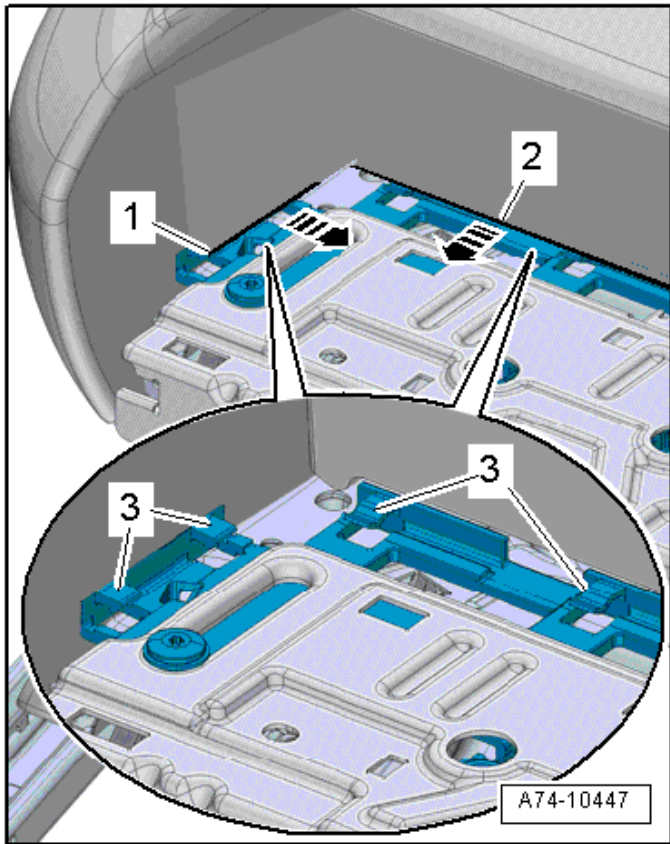
- Unclip the retaining channels <1 and 2> in direction of <arrow> out from the tabs <3>.

! NOTE
 The tabs <3> are easily damaged. Use caution during removal and installation.

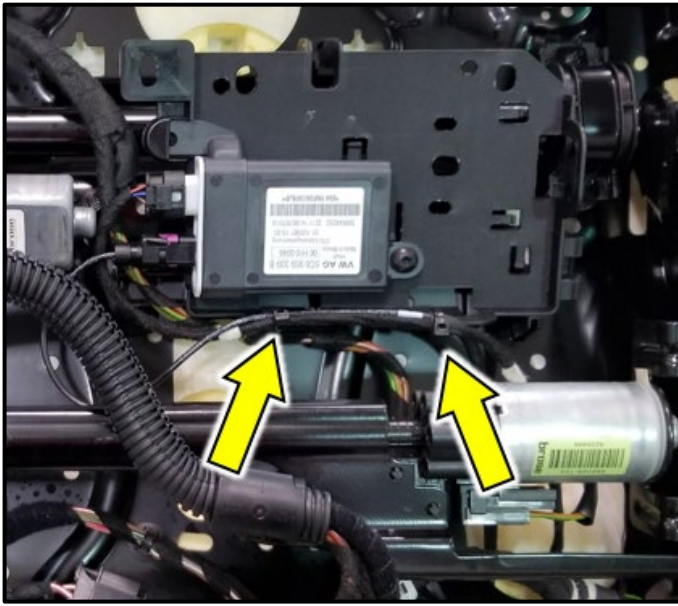
- Cut cable ties <arrows>.

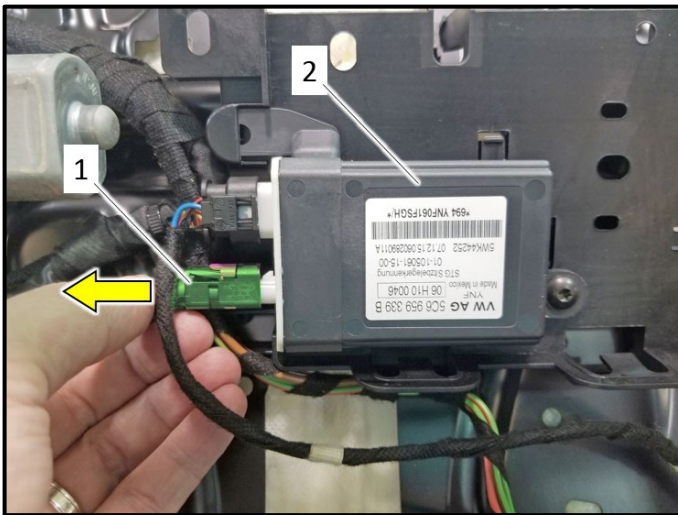
The connector must be removed exactly parallel with the PODS ECU. The center pin in the PODS ECU is fragile and must not be bent during removal. A damaged center pin will cause PODS faults. Damage to PODS ECU is not covered under this action.

- During the 74D5 recall repair it is ok to disconnect the sensor mat from the PODS ECU.
- The replacement PODS mats do not come with a new PODS ECU.
- The existing PODS ECU will be updated with new parameters during this recall repair.

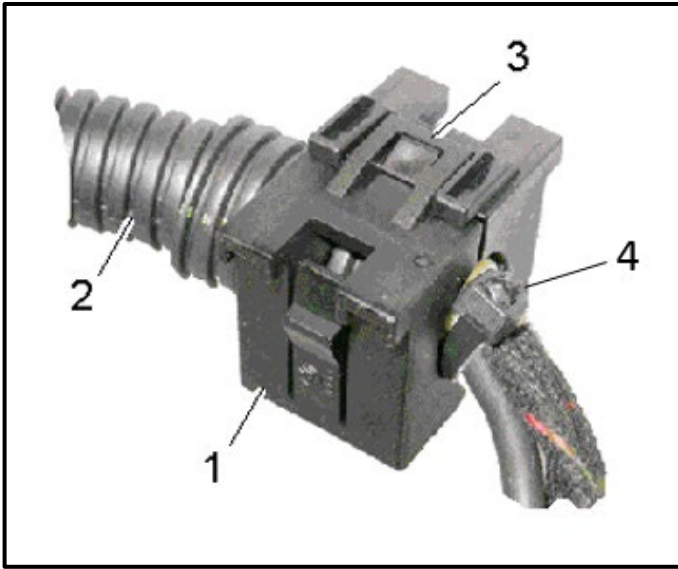
Vehicle with Criteria 01, 02 and 03:

- Using the Trim Removal Wedge -3409- (or equivalent), release the retainer <3> and open the front cable holder <1>.
- Remove the wiring bracket from the corrugated tube <2>.
- Cut cable tie <4>.

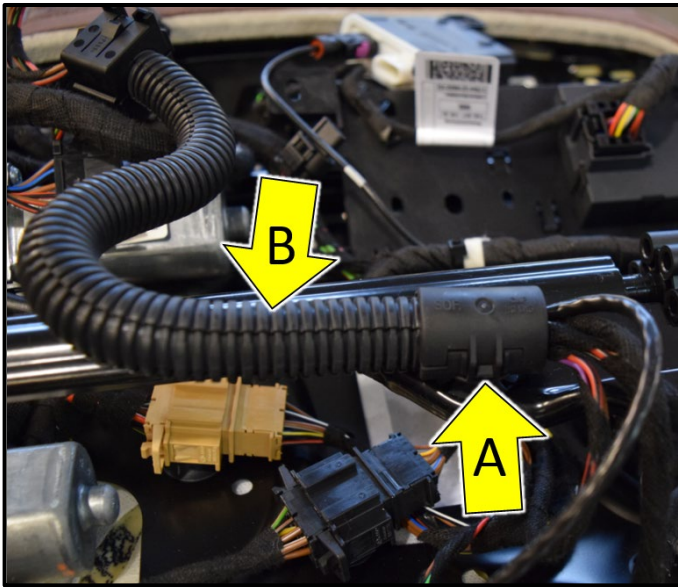
- Using a small, flat-blade screwdriver (or equivalent), open the rear wiring bracket <arrow A>.
- Remove the corrugated tube <arrow B> from the bracket.
- Remove the outer corrugated tube from the wiring harness.

i	TIP
<ul style="list-style-type: none"> • Take photos of the wiring harness routing. • To aid in proper reassembly, the wiring harness should be marked with a paint pen, masking tape, etc. to mark the position of the corrugated tube.

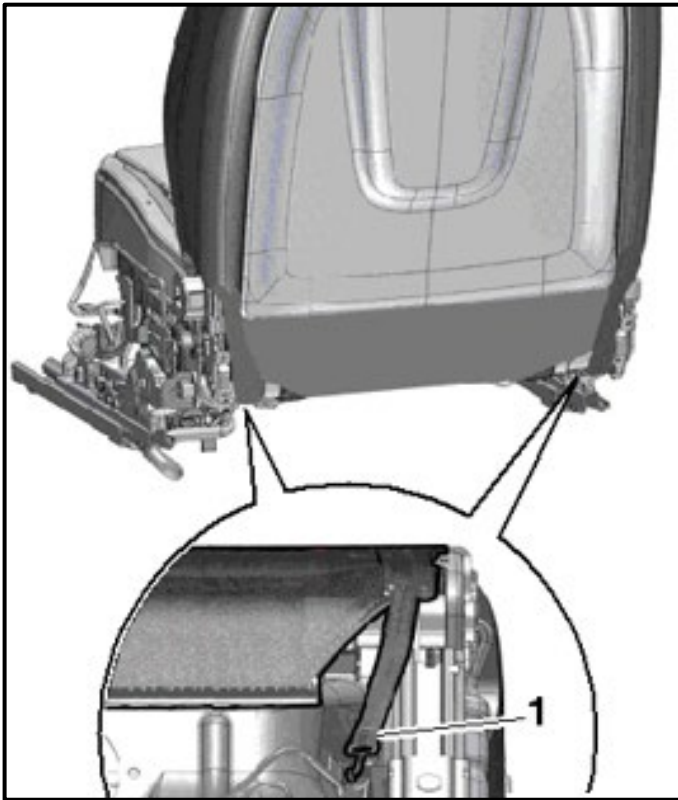
- Detach the rubber strap <1> from the left and right side at the bottom of the seat pan.

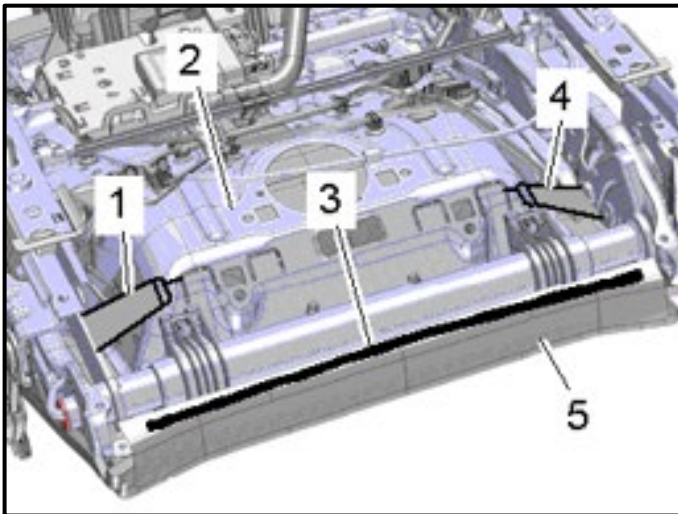
- Take photos of the seat wiring harness routing.
- Release the hooks <1 and 4> from the lower seat frame <2>.
- Disconnect and free up any wiring connectors that are present.
- Using Seat back Panel Tool -3370-, detach the molding <3> of the seat cover <5> in the rear of the seat.

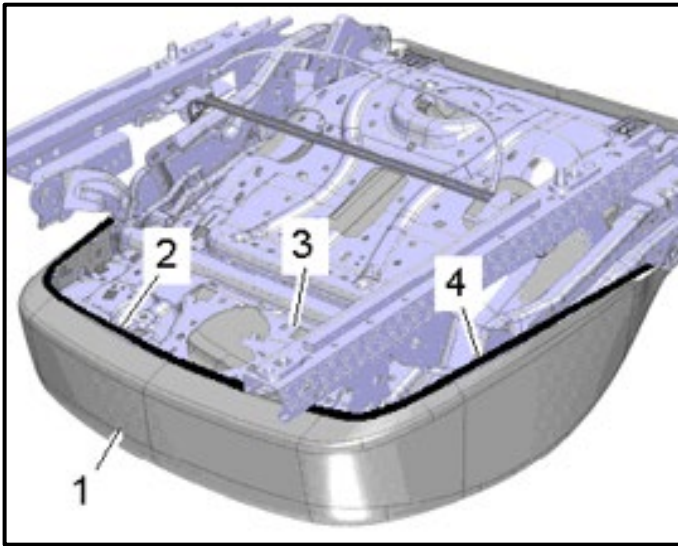
- Using Seat back Panel Tool -3370-, detach the molding <2 and 4> of the seat cover in the front and side areas.
- Remove the seat cover <1> with the seat cushion from the lower seat frame <3>.
- During seat cover and cushion removal, free up the wiring harness for the seat heating and PODS unit.

The backrest does not require removal to perform this repair.

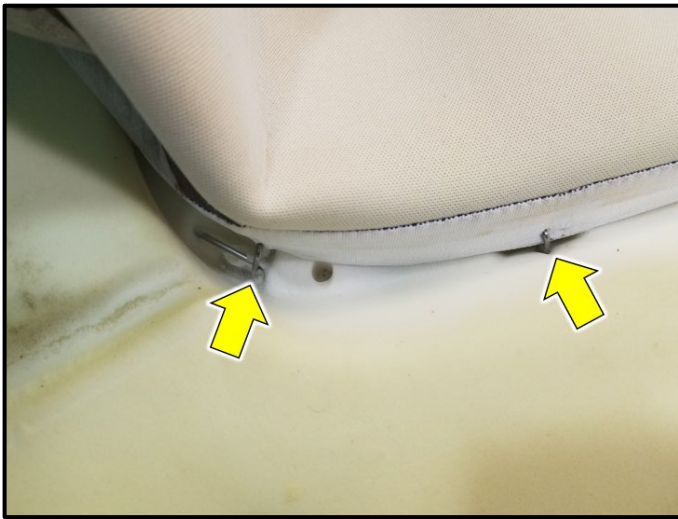
- The seat cover is fastened to the seat cushion using wire upholstery clips.
- Carefully peel the seat cover back to expose the clips <arrows>.

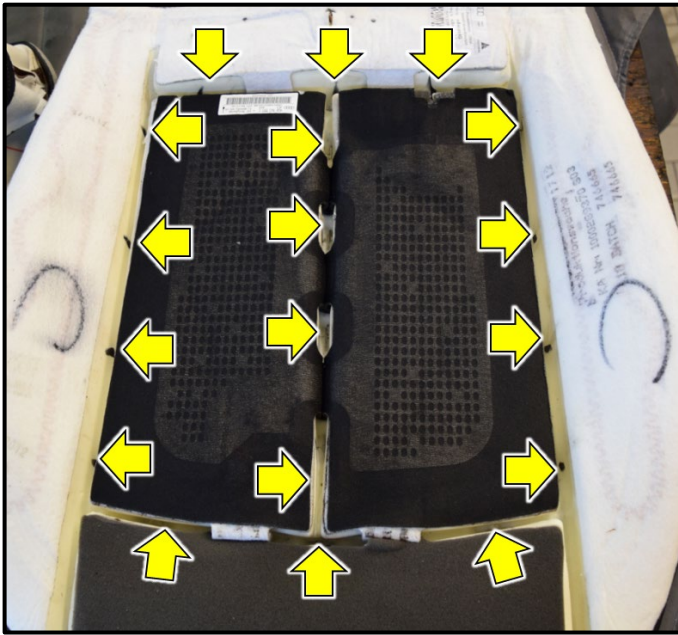
- With the seat cover pulled back, cut and remove the upholstery clips <arrows> using appropriate side-cutting pliers.
- Fully remove the seat cover from the seat cushion.

- When looking at the seat cushion from the top down, the upholstery clips are located approximately where shown <arrows>.
- During disassembly, start cutting the clips along the outside perimeter, then work inward until all the clips have been removed.

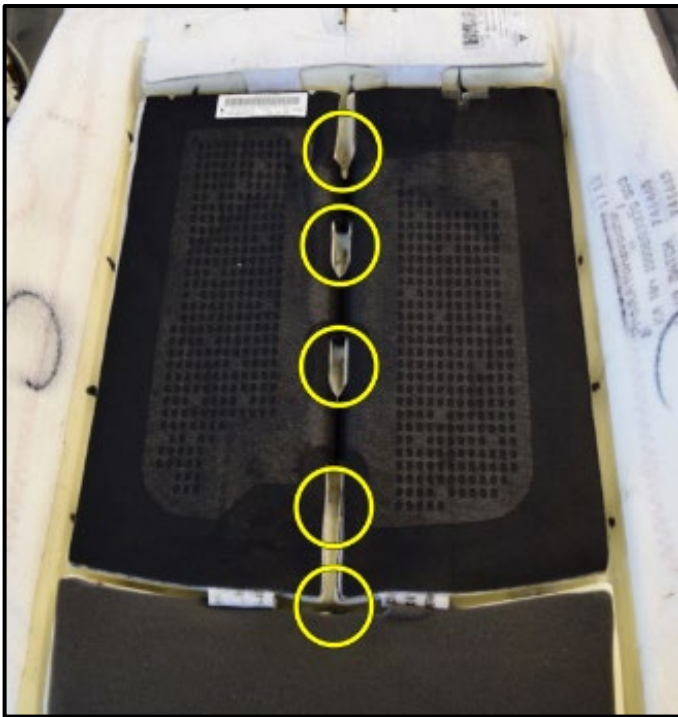
- Position the seat cover onto the replacement seat cushion/PODS mat assembly.
- Starting at the center row of the seat cushion, install and fasten the upholstery clips where shown <circles> using upholstery clip pliers -VAG1634- (or equivalent).

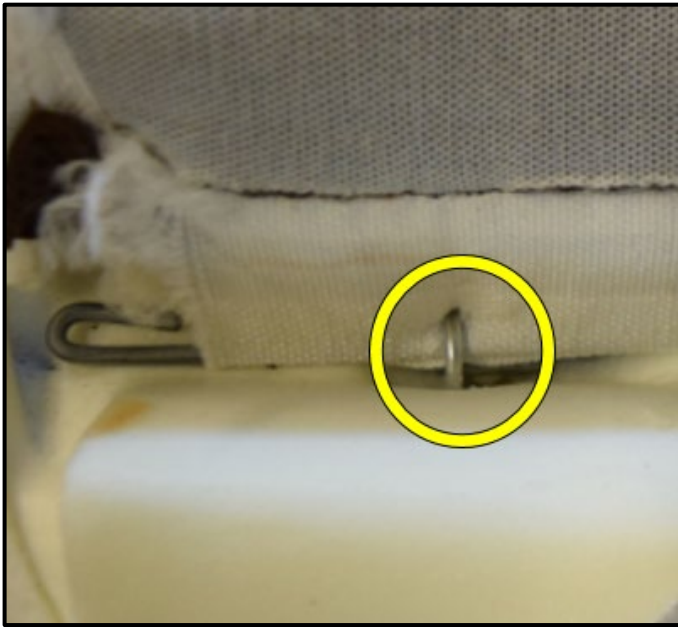
- Prior to fully clamping the upholstery clips closed, be sure each upholstery clip engages BOTH the webbing on the bottom side of the seat cover AND the fastening wire molded into the seat cushion as shown <circle>.

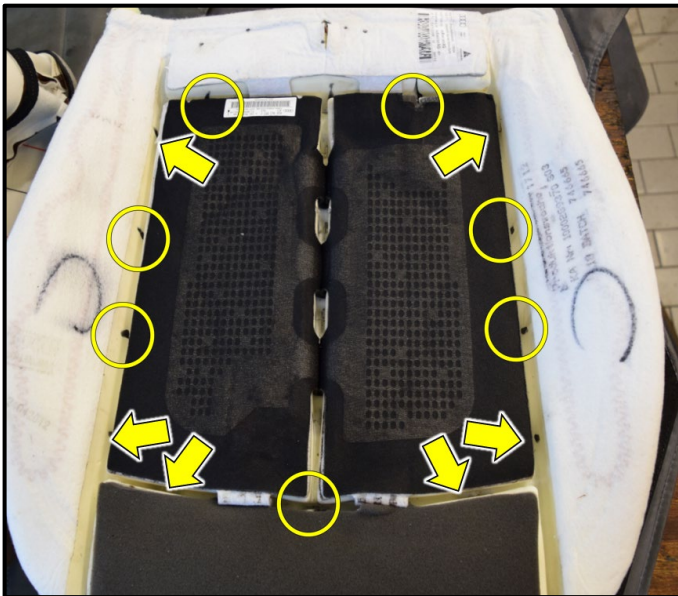
- Install additional remaining upholstery clips around the perimeter of the seat cushion where shown <circles>.
- Install the corner upholstery clips <arrows> last. This allows additional accessibility for installing the inboard upholstery clips.

! NOTE	
Basic seat shown. Seat cover installation for "Sport/Super-sport" seats is similar.

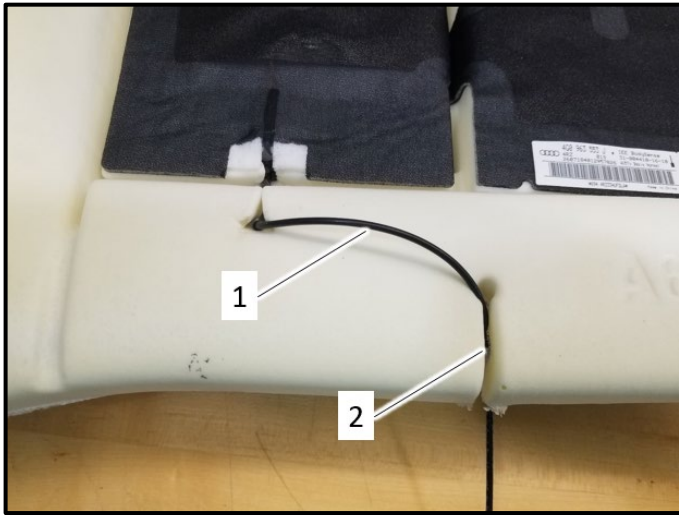
- Ensure the PODS wiring <1> is routed through the opening <2> in the seat cushion.

Version without seat heater shown. For versions with seat heater, the seat heater wiring is also routed through opening <2>.

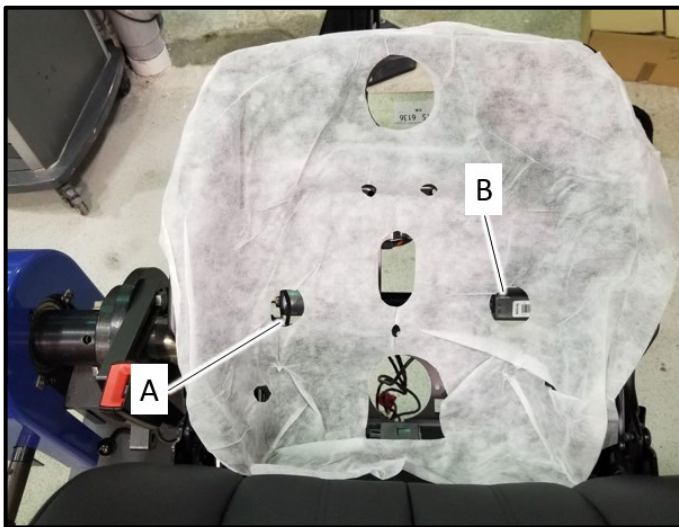
- The PODS wiring will be routed through hole <A>.
- The seat heater wiring (if equipped) will be routed through hole .

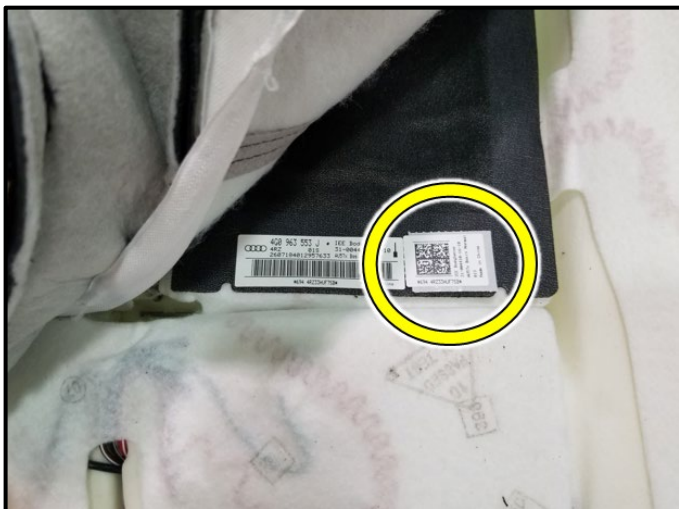
- Locate the QR code sticker <circle> on the new PODS mat and tear off at the perforation.

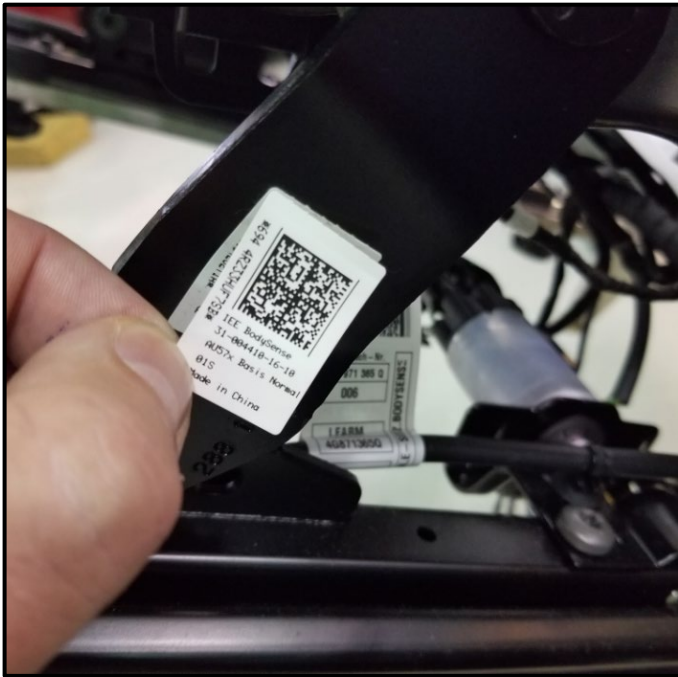
- Apply the QR code sticker over the existing sticker on the seat frame.

The location of the existing sticker on the seat frame may vary.

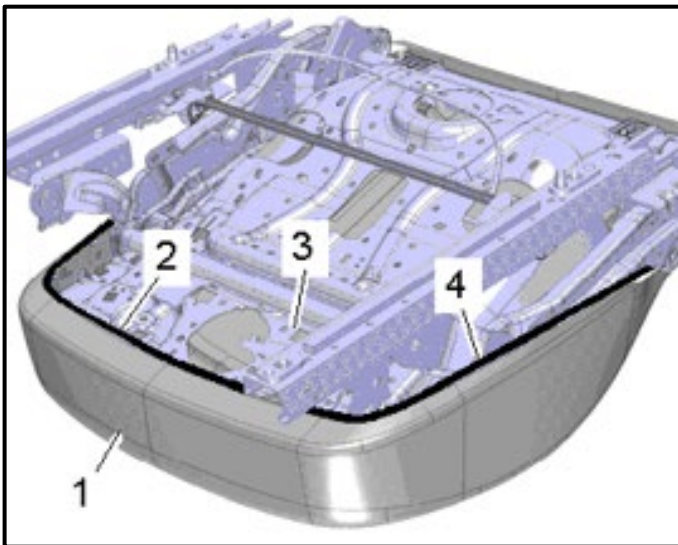
- Inspect the seat cover position on the seat cushion to ensure it appears properly centered.
- Route the wiring harness for the seat heating element and the PODS unit through its original location at the rear center of the seat cushion.
- Reinstall the seat cover <1> with the seat cushion onto the lower seat frame <3>.
- Reattach the molding of the seat cover <2 and 4> onto the front and sides of the lower seat pan as shown.

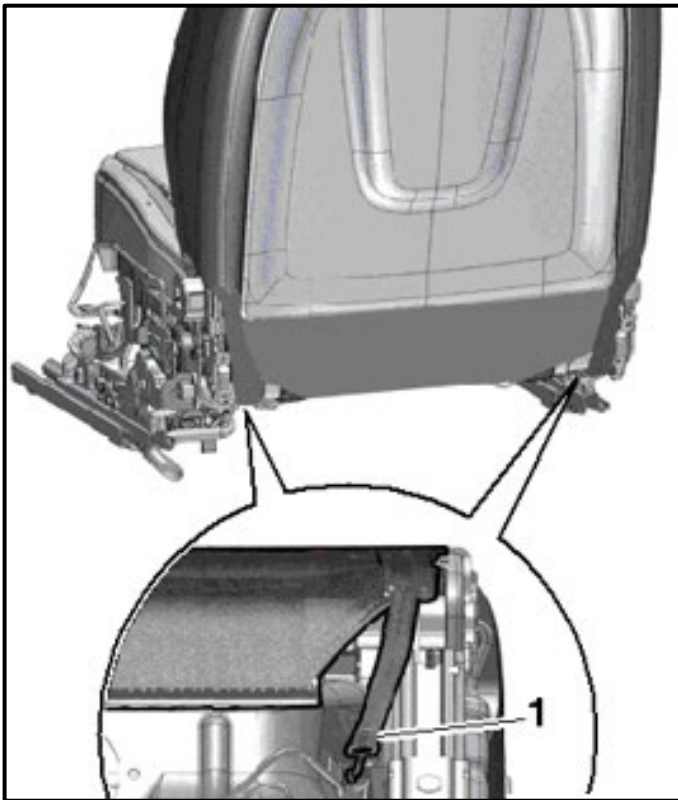
- Reattach the molding <3> of the seat cover <5> onto the rear of the seat.
- Reconnect the hooks <1 and 4> onto the lower seat frame <2>.
- Reroute and reconnect the wiring as necessary. Refer to previously taken photographs.

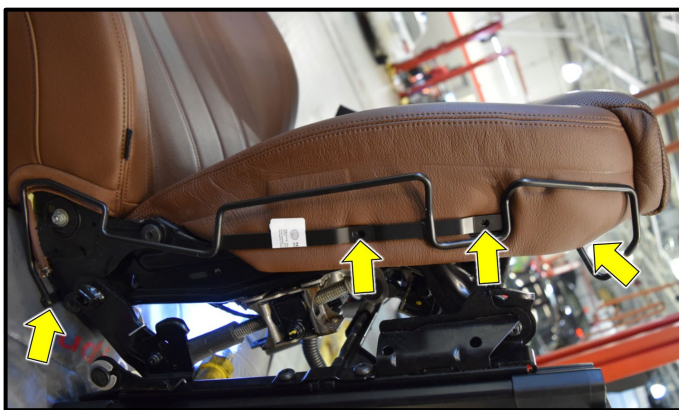
- Install new tie wraps <arrows>.

- The PODS ECU cable must be routed in a way so that no tension is put on the connector.
- The cable should be looped as shown in the photo.

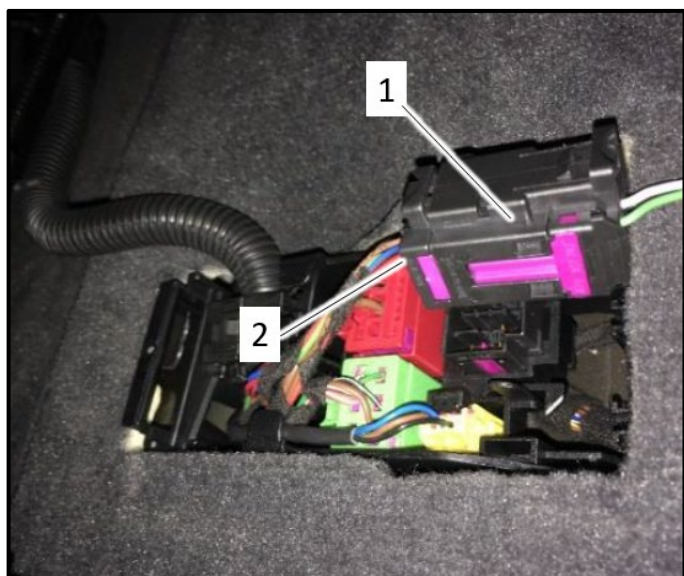
- Connect Programmer connector <1> to PODS connector <2> on the seat wiring harness.

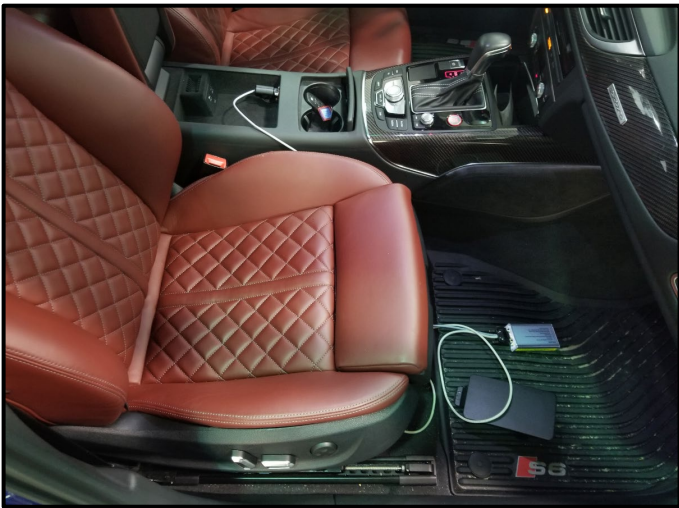
- Plug in 12V outlet <1>.

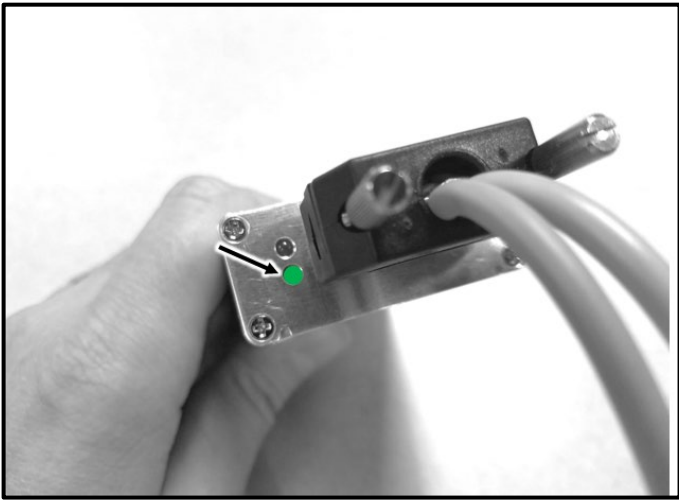
- Lights <arrows> will flash alternately.

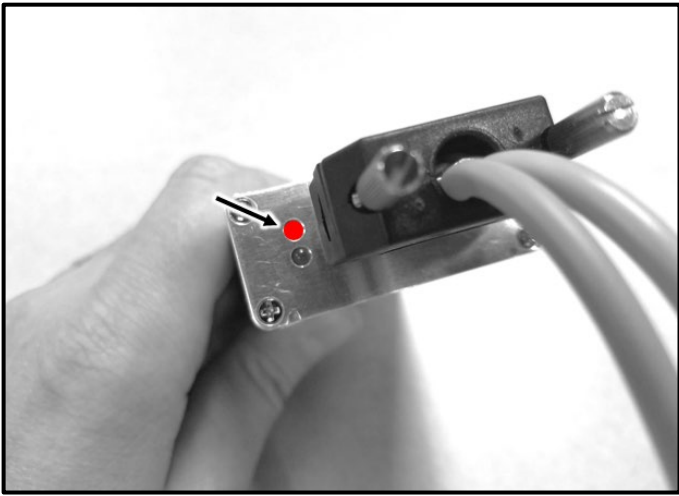
- Send requests for an additional PODS Programmer to 74D5programmer@vw.com
- Include the following in the request:
 - Reason for request.
 - Dealer code.
- If the start-up procedure fails, the red and green lights will flash simultaneously.
- This means the maximum number of stored records has been reached.
- If this situation is encountered, contact Audi Technical Assistance for further direction.
