## Safety Recall: 2019 Insight: Rear Backup Camera

Update the audio unit/audio navigation unit software using the audio-navigation system update USB flash drive.

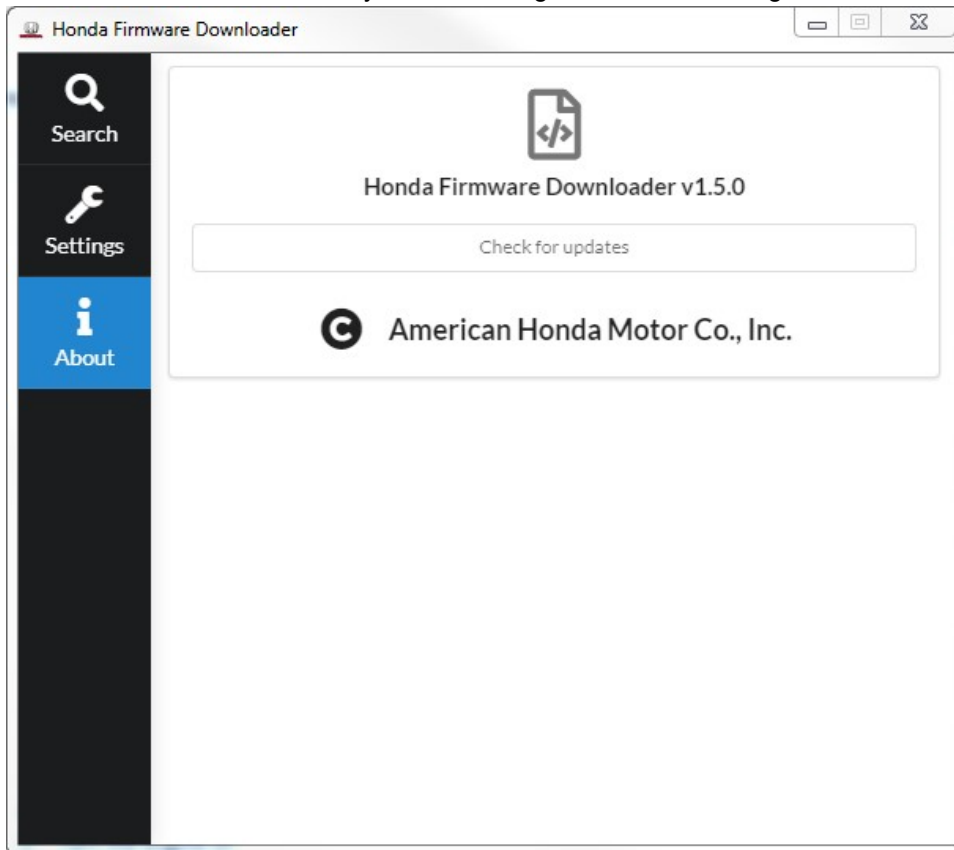
1. From your computer's desktop, open Honda Firmware Downloader. Refer to job aid *Honda Firmware Downloader* for additional information.
2. Select **About**, and make sure you are running version 1.5.0 or higher.

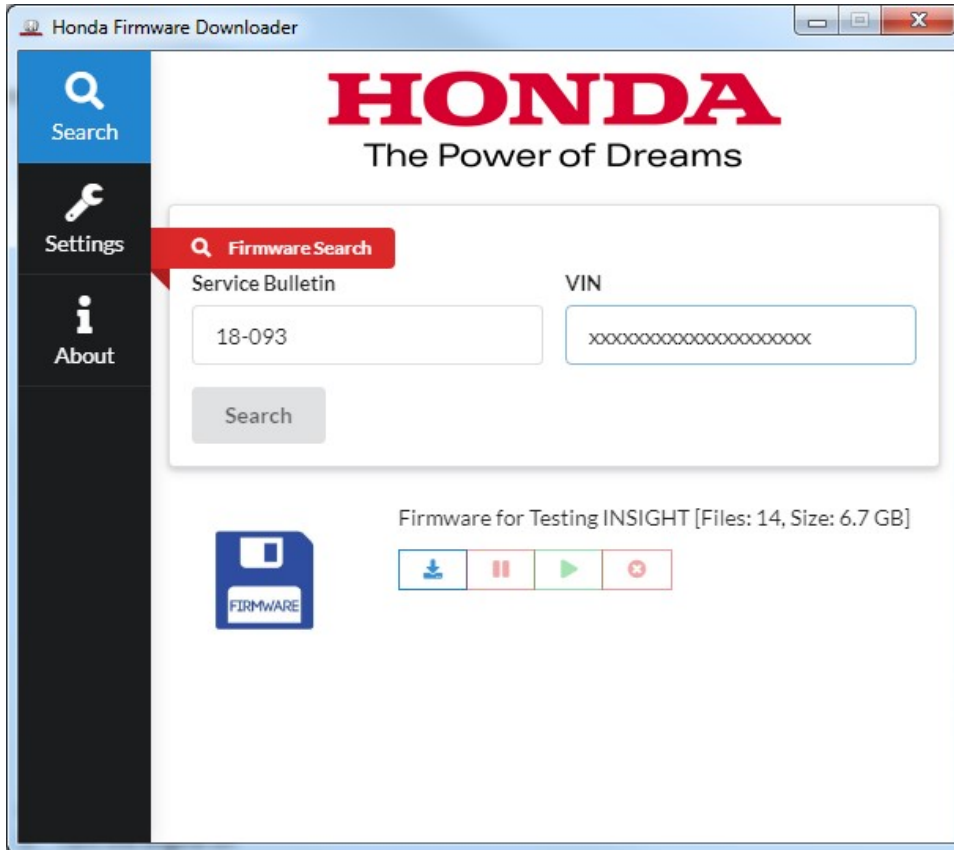
3. Enter the service bulletin number and the VIN, then select the Download icon when the software appears.

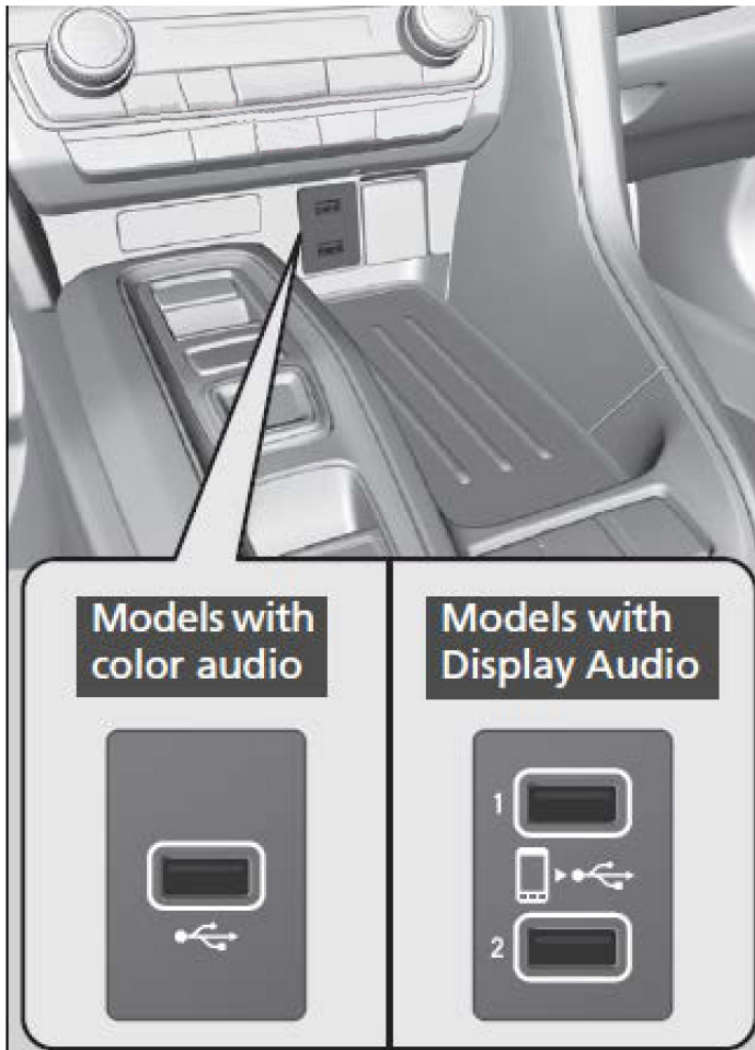
3. Insert the USB flash drive into USB Port 1.

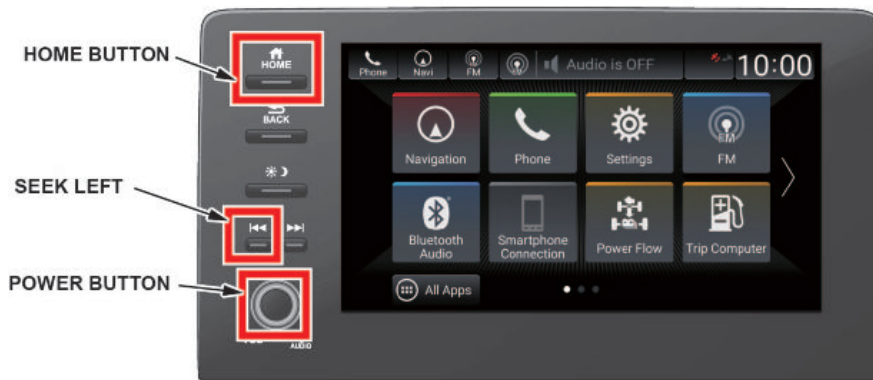
4. From the **Home** screen, press and hold the **HOME+POWER+SEEK LEFT** for at least **5 seconds** to enter the **Diagnosis Menu**.

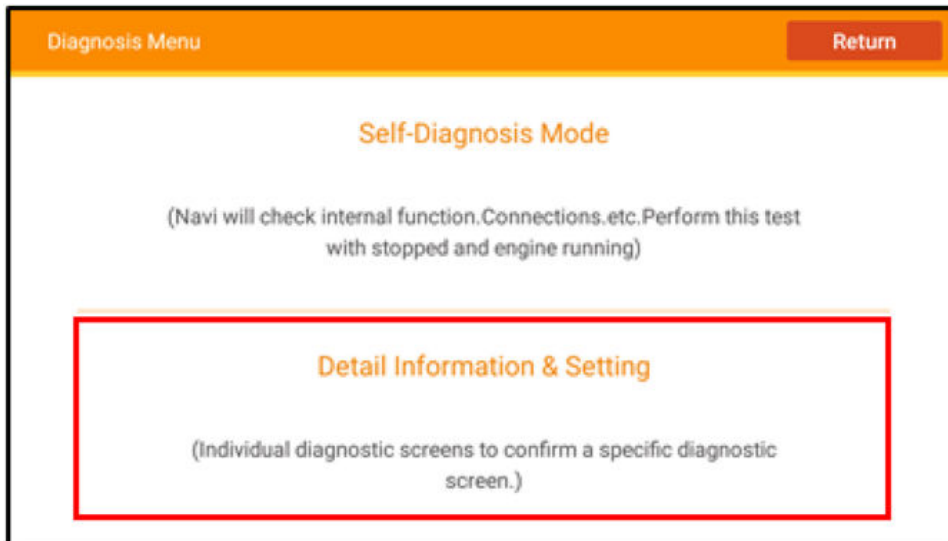
5. From the **Diagnosis Menu**, select **Detail Information & Setting**.

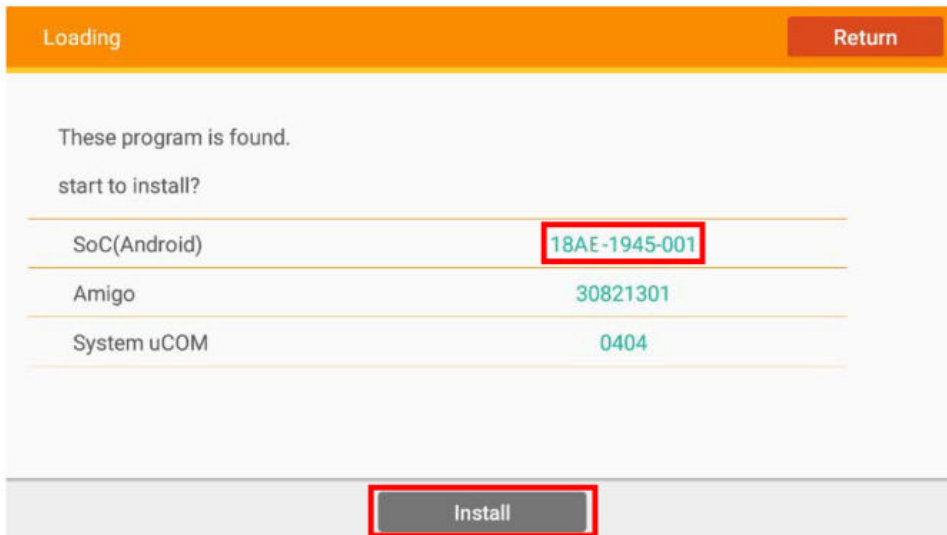
8. Verify that the software version is **18AE-1945-001**. If the version is correct, select **Install** to begin the update.

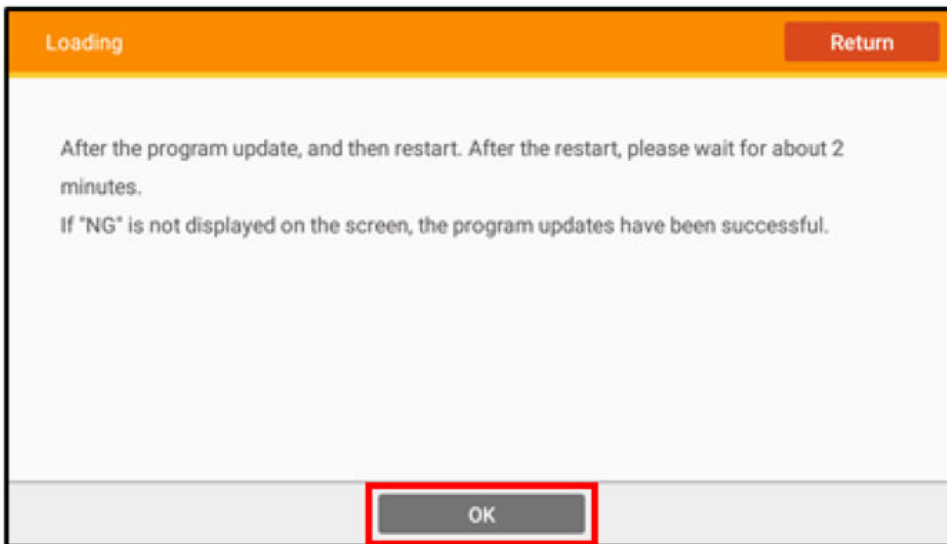
9. Once you select **Install**, a notification will appear. Press **OK**.

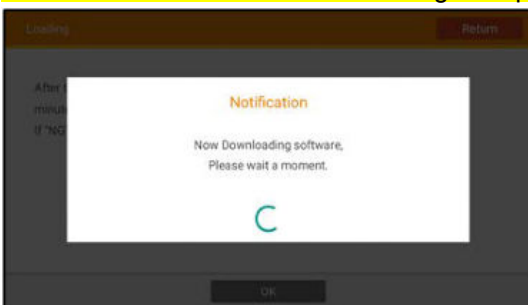
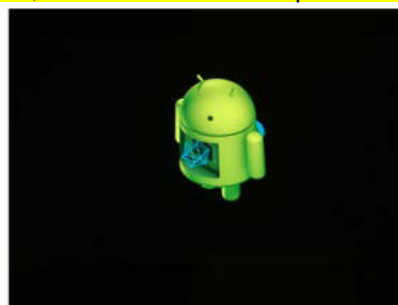
During the updating process, the audio unit will reset several times. **If the battery voltage drops, ignition is cycled, or the USB flash drive is removed during the update, the audio unit will be permanently damaged.**

Once complete, the system will reboot and load to the **Home** screen.

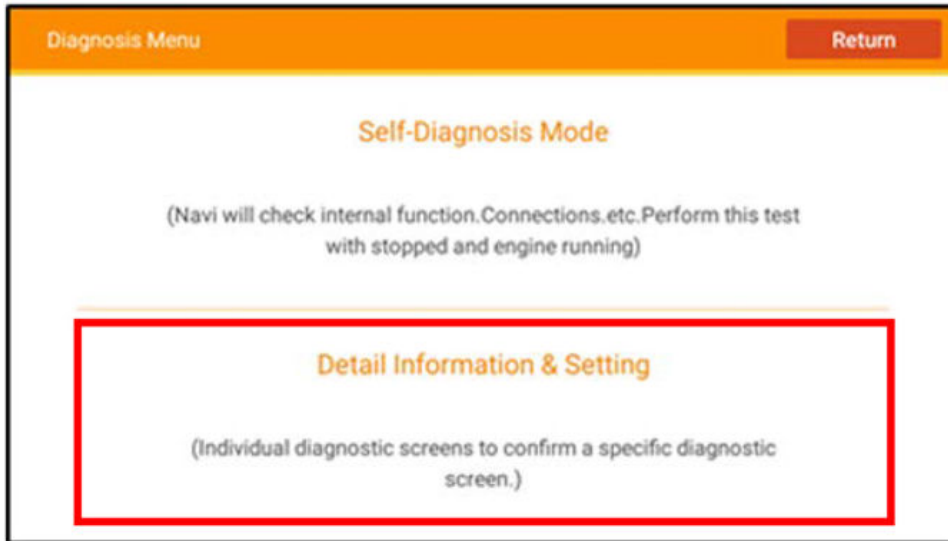
1. From the **Home** screen, press and hold the **HOME+POWER+SEEK LEFT** for at least **5 seconds** to enter the **Diagnosis Menu**.
2. From the **Diagnosis Menu**, select **Detail Information & Setting**.

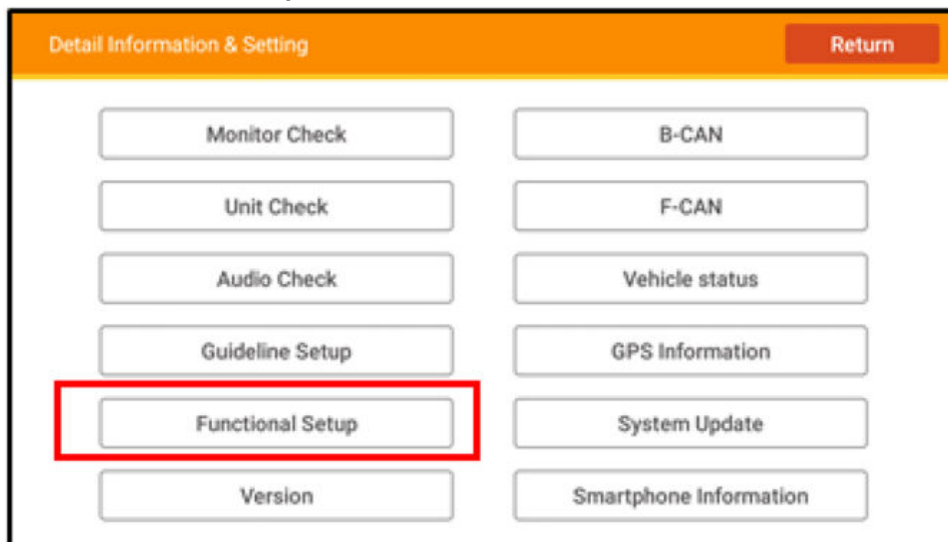
3. Select **Functional Setup**.

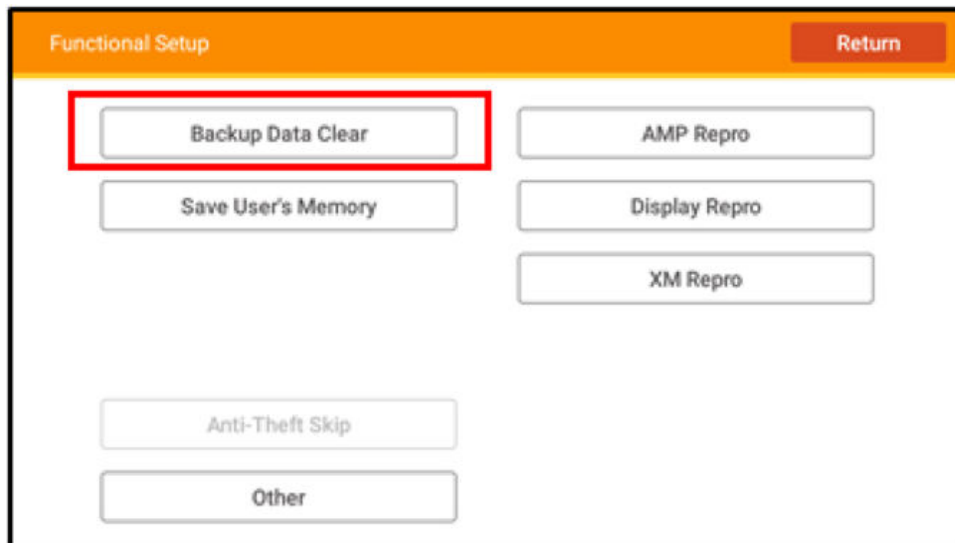
4. Select **Backup Data Clear**.

The screenshot shows a menu titled "Functional Setup" with an orange header bar. In the top right corner of the header is a "Return" button. The main area contains several buttons: "Backup Data Clear" (highlighted with a red rectangle), "AMP Repro", "Save User's Memory", "Display Repro", "XM Repro", "Anti-Theft Skip", and "Other".

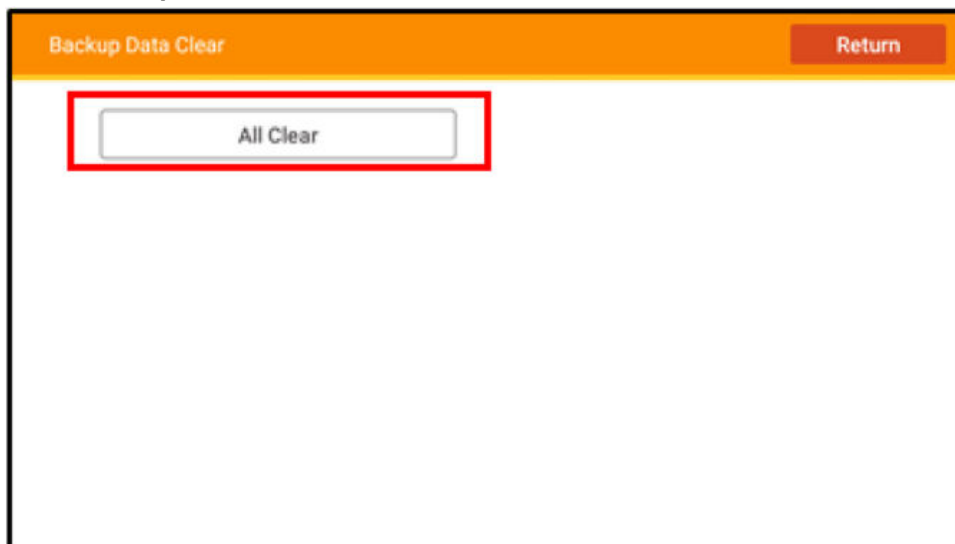
5. In the **Backup Data Clear** menu, select **All Clear**.

The screenshot shows a menu titled "Backup Data Clear" with an orange header bar. In the top right corner of the header is a "Return" button. The main area contains a single button: "All Clear" (highlighted with a red rectangle).

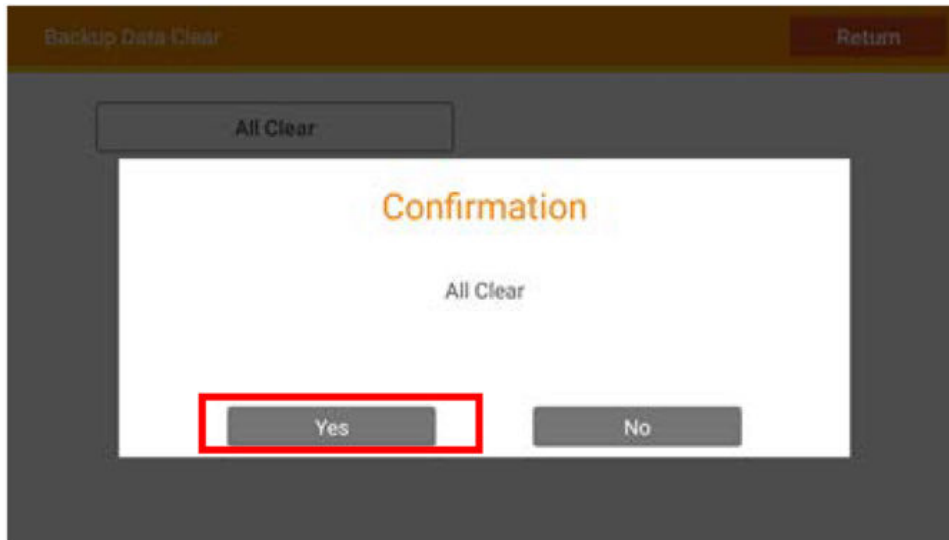
6. When you see the **Confirmation All Clear** message, press **Yes**. Do not turn the engine or ignition off during the data reset.

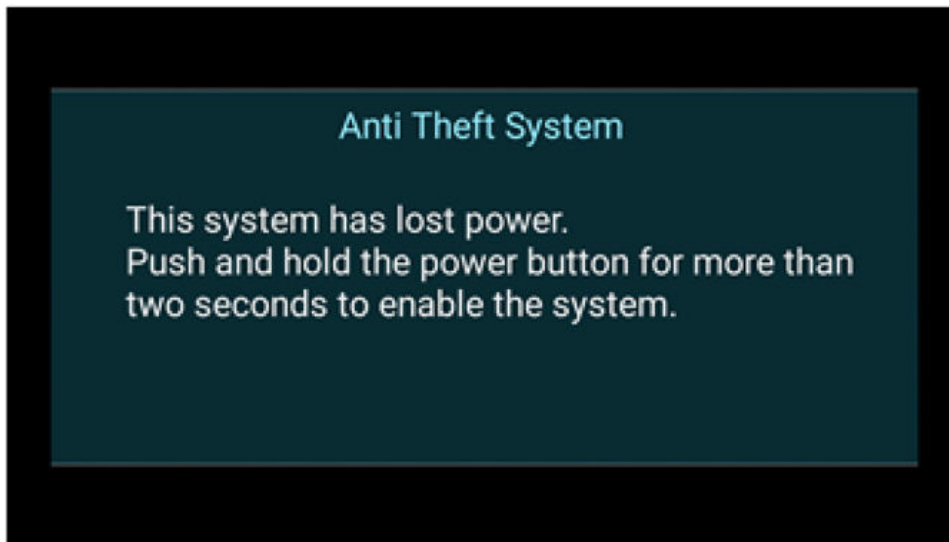
7. After the **Backup Data Clear** is complete, the **Anti-Theft System** screen will display. With the engine on, press and hold the Power button to bypass the screen.

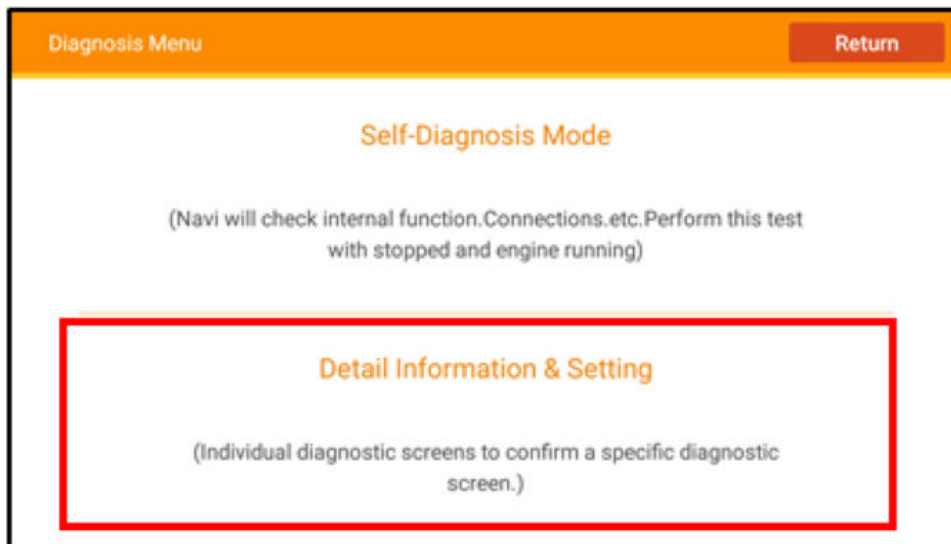
1. From the **Home** screen, press and hold the **HOME+POWER+ SEEK LEFT** for at least **5 seconds** to enter the **Diagnosis Menu**.
2. From the **Diagnosis Menu**, select **Detail Information & Setting**.

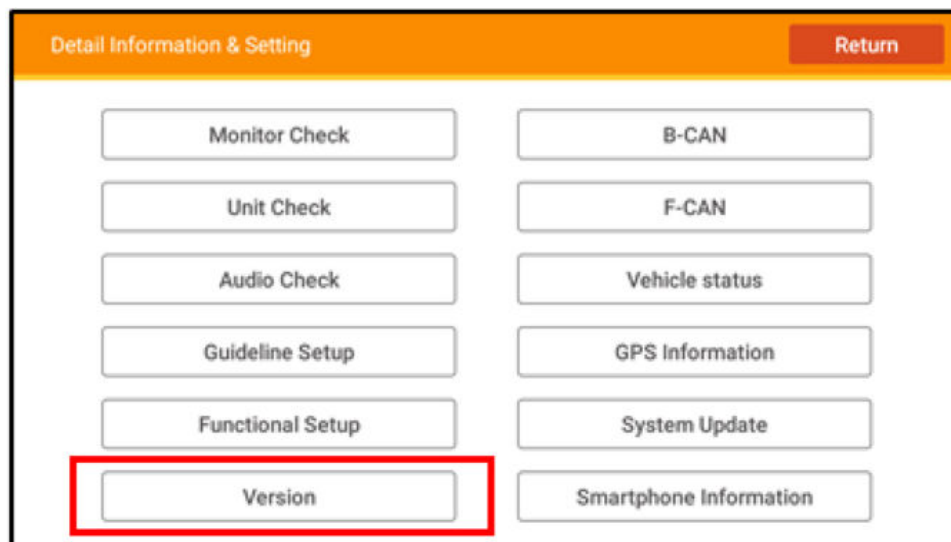
3. Select **Version**.

4. Make sure the **Build Number** reads **18AE-1945-001**.
