**September 21, 2018**

Version 2

## Safety Recall: 2018 Accord: Rear Backup Camera

Update the audio unit/audio navigation unit software using the audio-navigation system update USB flash drive.

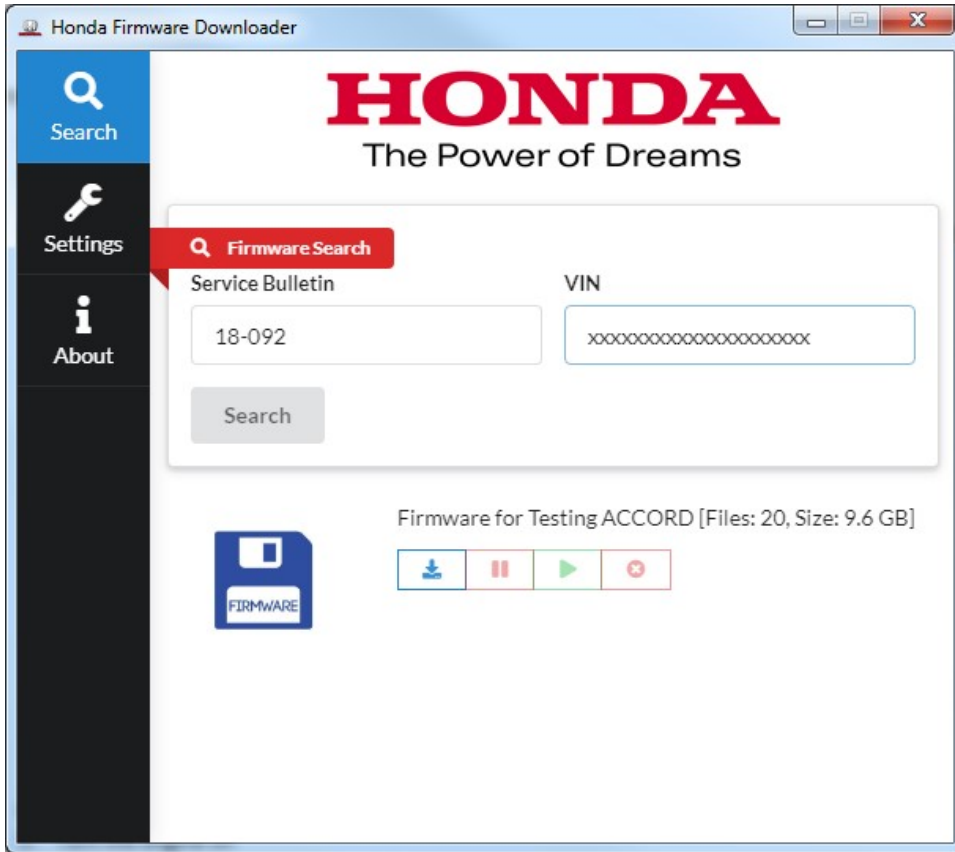
3. Enter the service bulletin number and the VIN, then select the Download icon when the software appears.

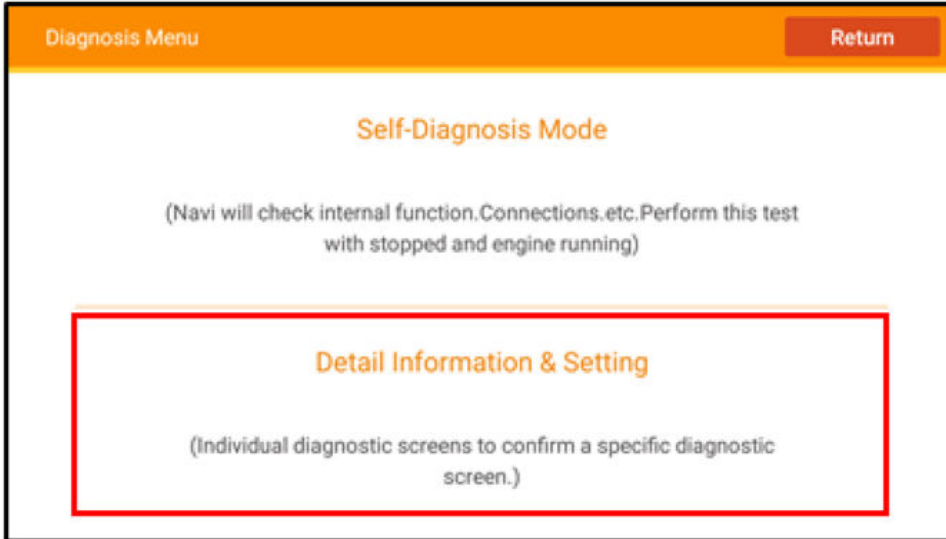
4. From the **Home** screen, press and hold the **HOME+POWER+SOURCE** for at least **5 seconds** to enter the **Diagnosis Menu**.
5. From the **Diagnosis Menu**, select **Detail Information & Setting**.

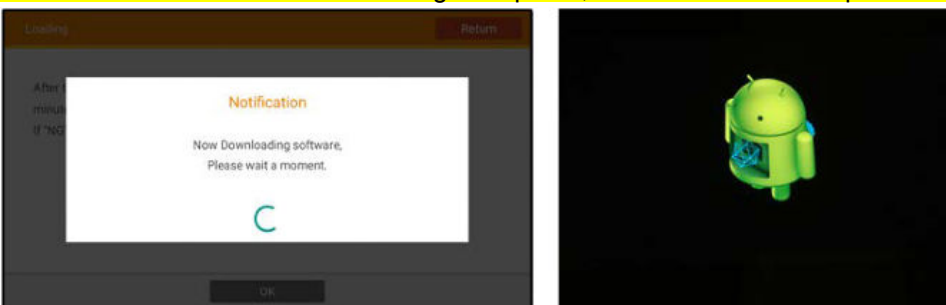
During the updating process, the audio unit will reset several times. **If the battery voltage drops, ignition is cycled, or the USB flash drive is removed during the update, the audio unit will be permanently damaged.**

Once complete, the system will reboot and load to the **Home** screen.

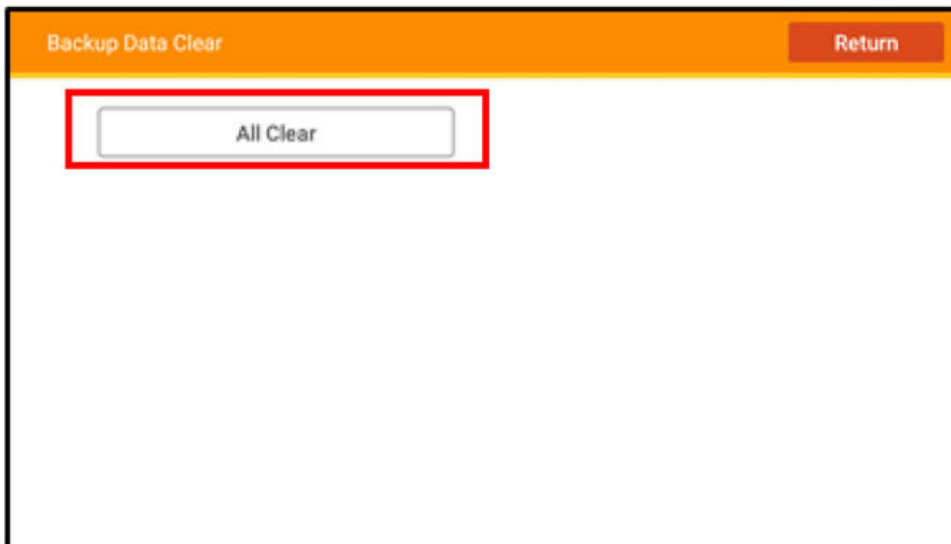
5. In the **Backup Data Clear** menu, select **All Clear**.

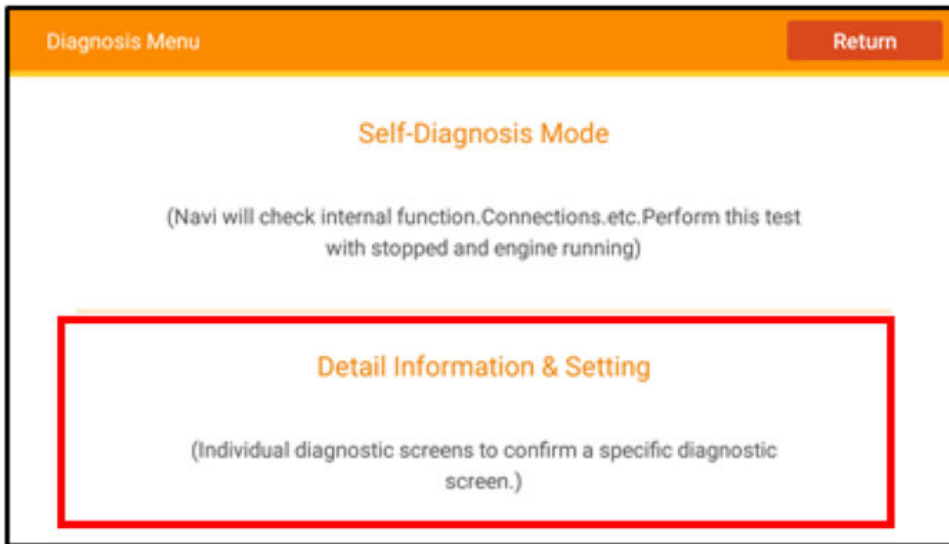
1. From the Home screen, press and hold the **HOME+POWER+SOURCE** for at least **5 seconds** to enter the **Diagnosis Menu**.
2. From the **Diagnosis Menu**, select **Detail Information & Setting**.
