**A. VEHICLE INSPECTION PROCEDURE**

**1. Subject vehicles**

2009 Mazda6 (HP) through 2013 Mazda6 (HZ) vehicles, which were originally sold in, or currently or previously registered in Salt Belt States listed below.

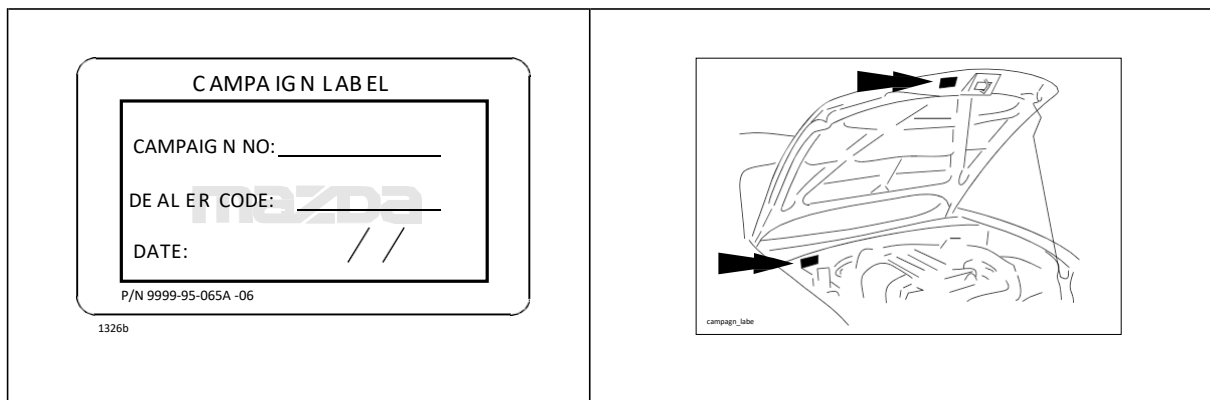
Perform a Warranty Vehicle Inquiry using your eMDCS System and inspect vehicle for Campaign Labels **Recalls 2818I** attached to the vehicle's hood or bulkhead. Refer to eMDCS System - Warranty Vehicle Inquiry Results table below.

**NOTE:** Be sure to verify Recall number as the vehicle may have multiple Recall labels.
