TECHNICAL INSTRUCTIONS

SAFETY RECALL J0V

HYBRID SYSTEM SOFTWARE UPDATE

**CERTAIN:
2012-2014 PRIUS V**

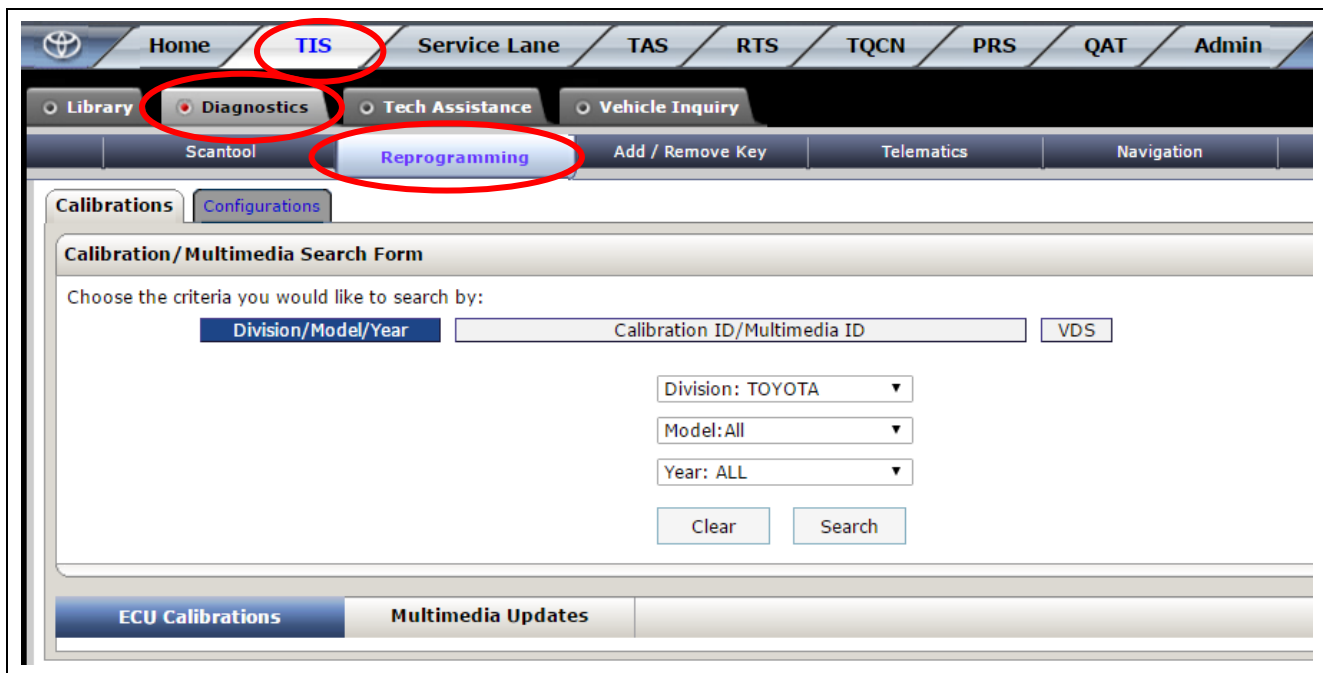
a. In TIS, select the following:

- TIS / Diagnostics / Reprogramming

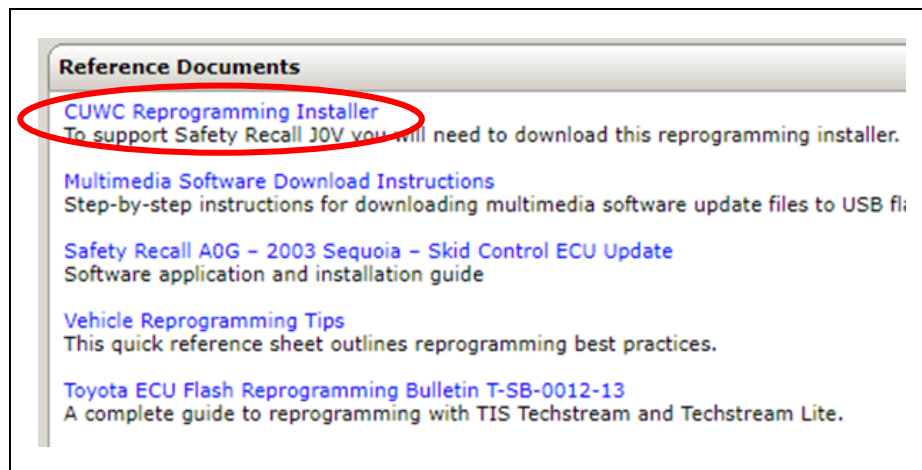
b. On the right side of the screen, select the following from the Reference Documents:

- CUWC Reprogramming Installer
- Follow the on-screen instructions to complete the installation.

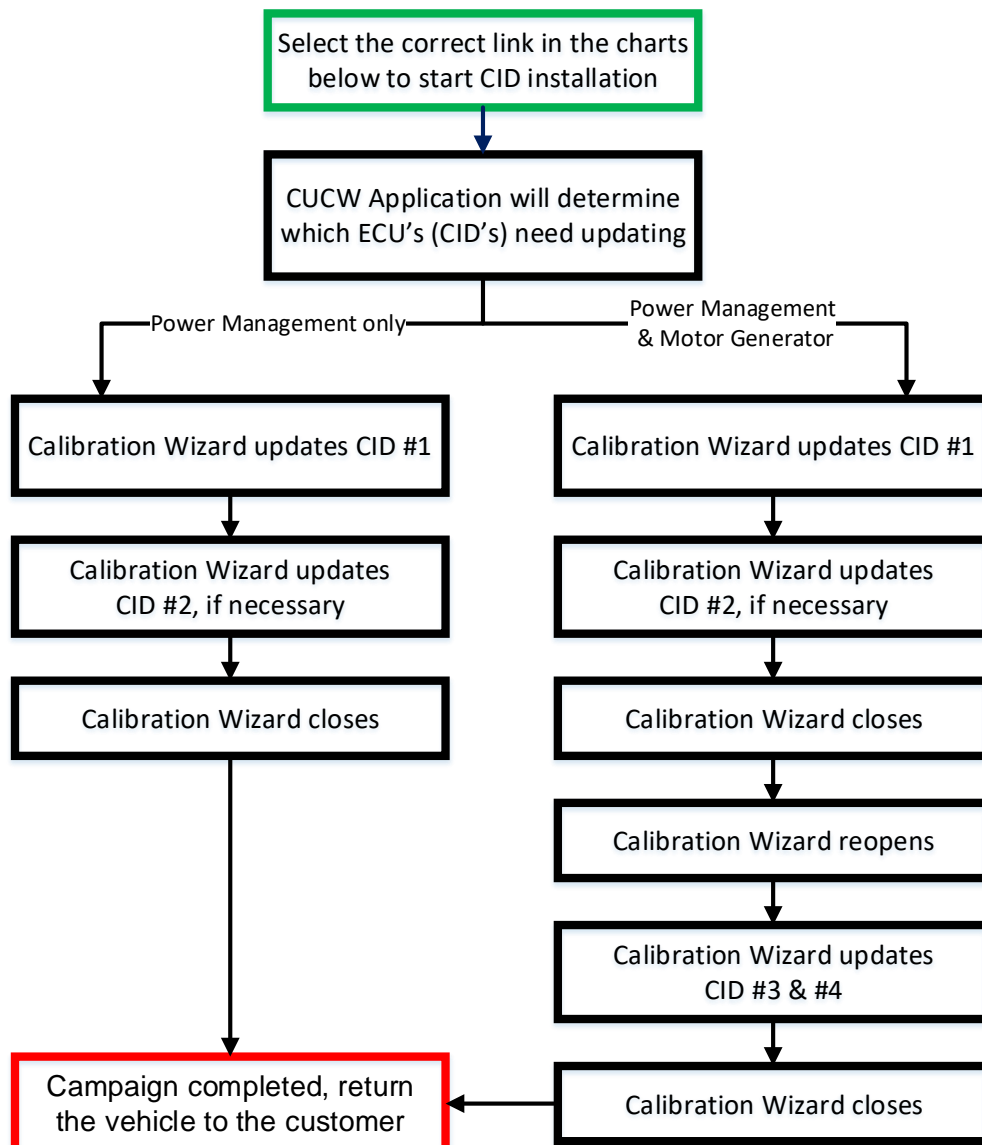
CID #1: Power Management Main
CID #2: Power Management sub

CID #3: Motor Generator #1
CID #4: Motor Generator #2

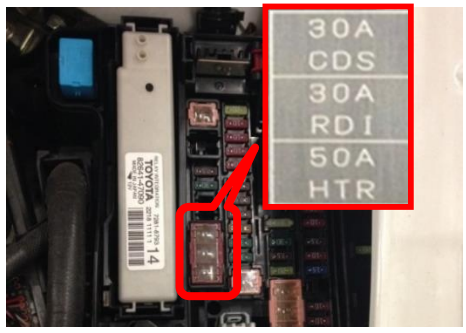
1. **REINSTALL JOINT FUSE INTO ENGINE ROOM FUSE BOX**
 - a. Confirm the joint fuse orientation before reinstalling because the joint fuse can be installed in either direction.
 - b. Reinstall the joint fuse that encases the CDS (30A), RDI (30A) and HTR (50A).

BE SURE TO ORIENT THE FUSE AS SHOWN ON THE FUSE BLOCK COVER.

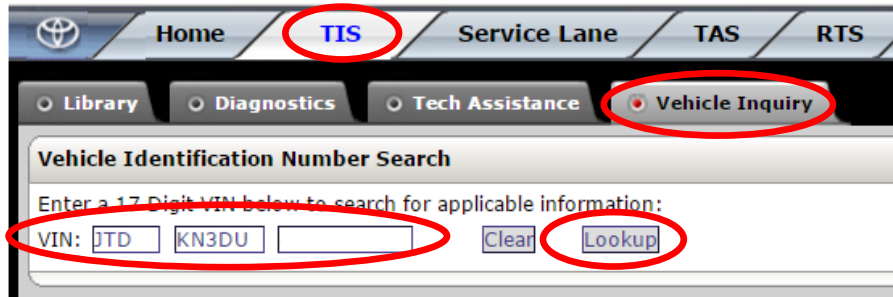
a. Proceed to the following location:

- TIS / Vehicle Inquiry / (input VIN #) / Lookup

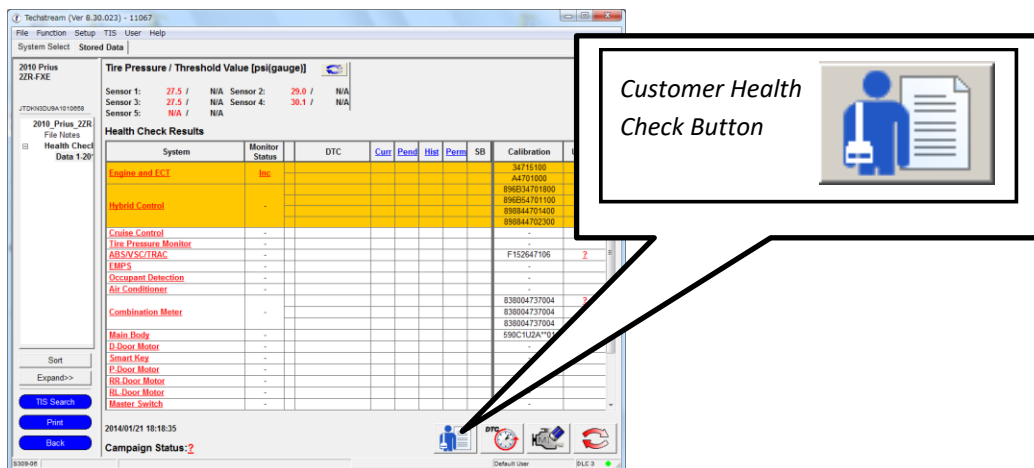
- a. From the Stored Data tab, select the Customer Health Check Report button (TIS will launch when button is pressed).

The screenshot shows the TIS software interface with the 'Health Check Results' tab selected. A callout box points to the 'Customer Health Check Button' icon, which is a blue person icon with a document. The interface displays various vehicle data, including tire pressure, engine and ECT status, and a list of systems with their respective status and calibration values.

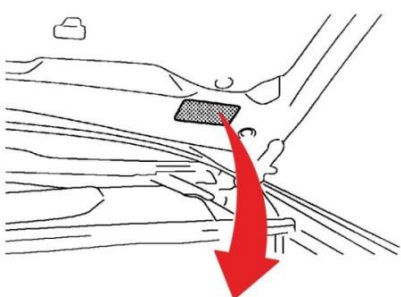
a. Fill out the label.

b. Affix the label to the under-side of the hood.
