TECHNICAL INSTRUCTIONS

SAFETY RECALL J0V

HYBRID SYSTEM SOFTWARE UPDATE

CERTAIN:
2012-2014 PRIUS V

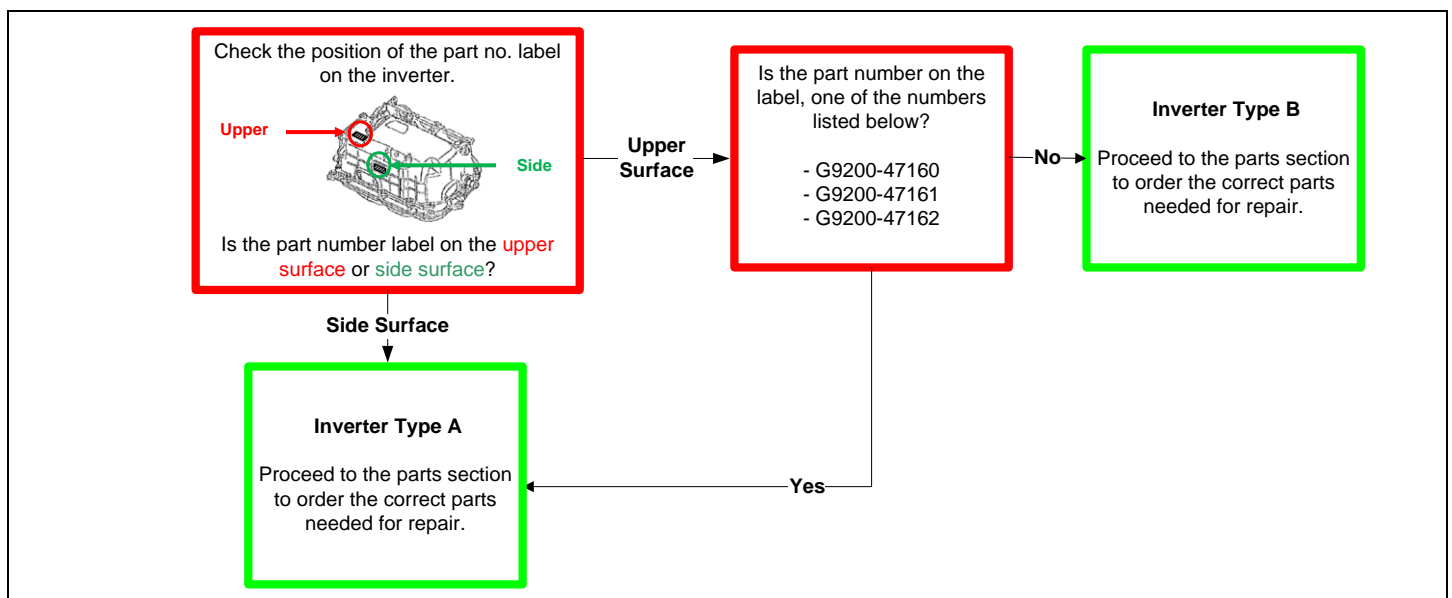
1. DETERMINE INVERTER ASSEMBLY TYPE

- a. Using the flowchart below determine the inverter type (A or B).

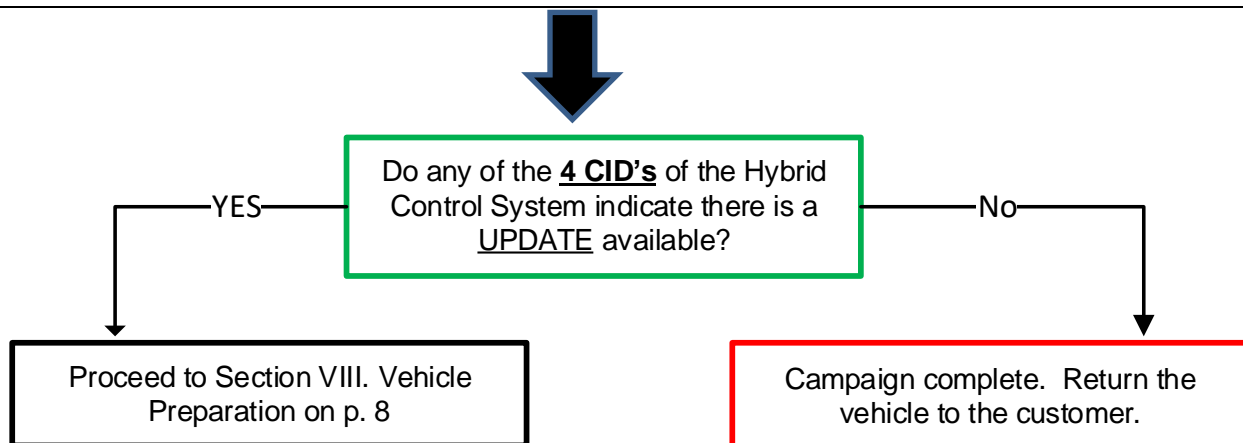
- Locate the Update column for the Hybrid Control System in the Stored Data tab.
- Determine the status of the **4 CID's** for the Hybrid Control ECU; indicated by a **YES** or **NO** in the Update column.

Note: It's possible that all 4 CID's need to be updated, as well as it's possible that only 1, 2 or 3 of the 4 CID's need to be updated. If any of the CID's indicate 'Yes', proceed with the update procedure.

The screenshot shows the Techstream interface for a 2014 Prius. The 'Stored Data' tab is selected. Under 'Health Check Results', it states: 'Health Check does not display live data. Changes in vehicle condition will not update automatically. To update Health Check, click the Refresh button.' Below this is a table with columns: System, RoB, Calibration, and Update. The 'Hybrid Control' system is highlighted, and its four CID's are listed with their update status.

- A red circle around 'Stored Data' in the top menu.
- A red circle around 'Hybrid Control' in the system list.
- A red circle around the 'Update' column header.
- A red circle around the 'Yes' value for CID 896B34747100.
- A red arrow pointing to the four CID's for the Hybrid Control System.
- A red arrow pointing to the 'Status of available Update' column.

Diagram shown if from a Prius. Prius V will be similar.

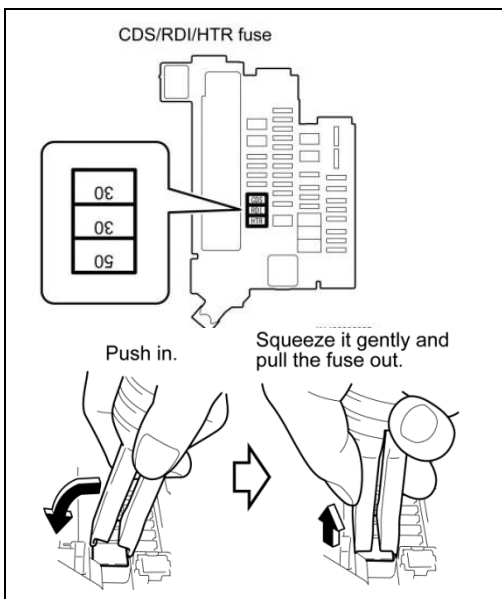
6. REMOVE JOINT FUSE FROM ENGINE ROOM FUSE BOX

- Confirm the joint fuse orientation before removal because the fuse can be installed in either direction.
- Using the fuse puller remove the joint fuse that encases the CDS (30A), RDI (30A) and HTR (50A).

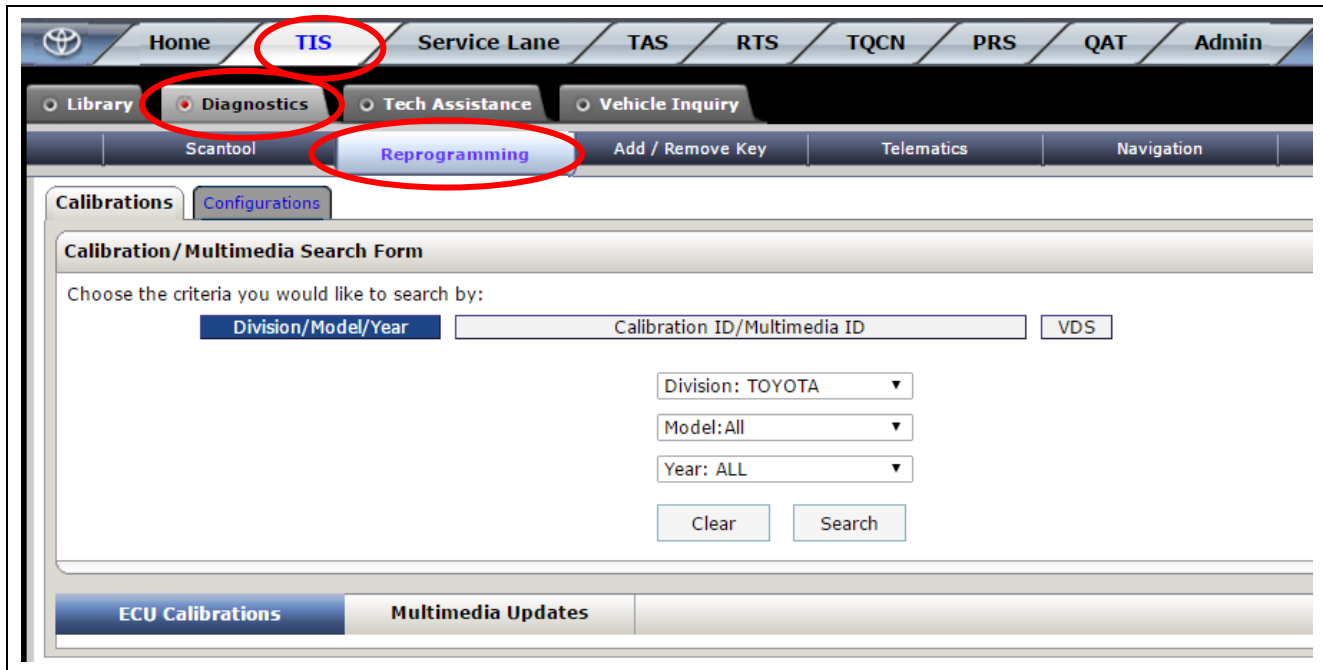
a. In TIS, select the following:

- TIS / Diagnostics / Reprogramming

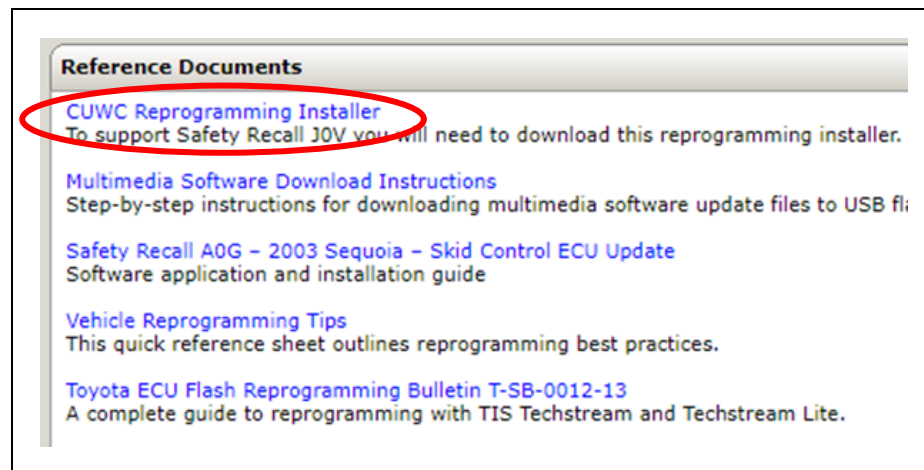
b. On the right side of the screen, select the following from the Reference Documents:

- CUWC Reprogramming Installer
- Follow the on-screen instructions to complete the installation.

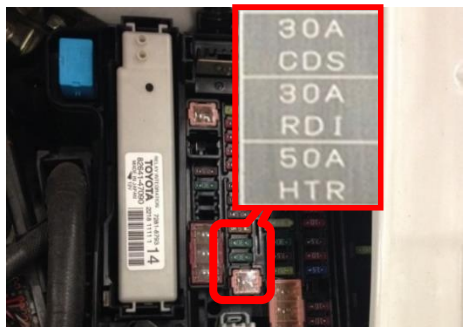
1. **REINSTALL JOINT FUSE INTO ENGINE ROOM FUSE BOX**
 - a. Confirm the joint fuse orientation before reinstalling because the joint fuse can be installed in either direction.
 - b. Reinstall the joint fuse that encases the CDS (30A), RDI (30A) and HTR (50A).

BE SURE TO ORIENT THE FUSE AS SHOWN ON THE FUSE BLOCK COVER.

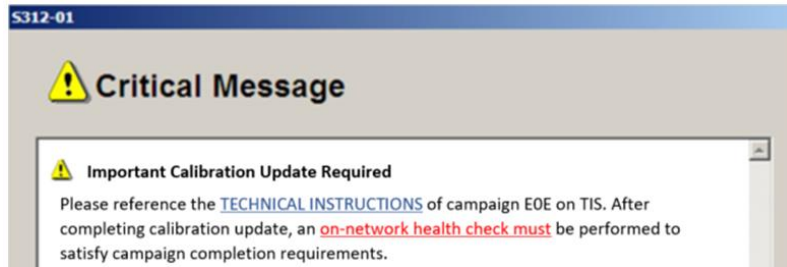
Note: If you receive the following message **after** the Verification Health Check, you have not properly completed the Required Calibration Updates!!

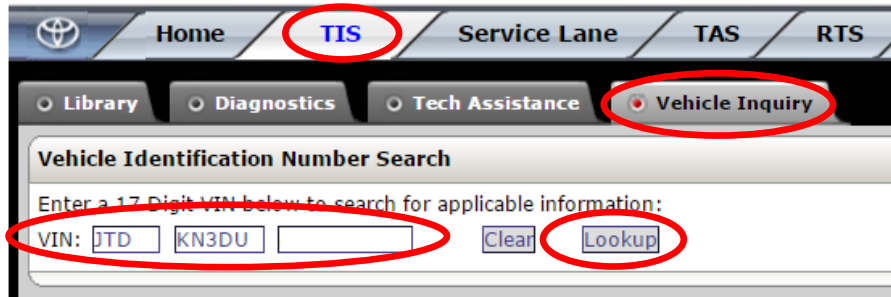
a. Proceed to the following location:

- TIS / Vehicle Inquiry / (input VIN #) / Lookup

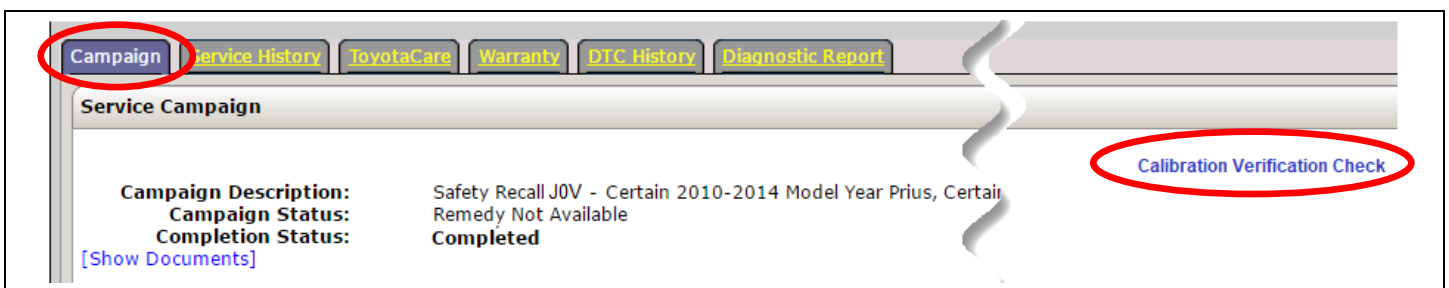
b. Proceed to the following location:

- Campaign tab / Calibration Verification Check for Safety Recall J0V
- Input your TIS login password for verification

Note: If the Calibration Verification Check link does not appear, the technician signed onto TIS does not meet the certification requirement of this campaign.

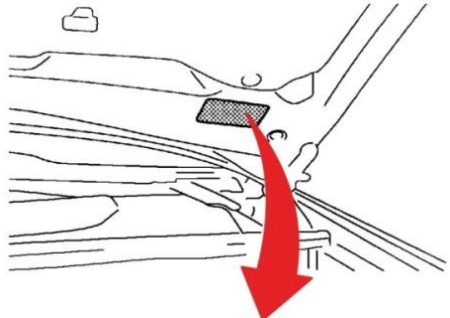
a. Fill out the label.

b. Affix the label to the under-side of the hood.
