TECHNICAL INSTRUCTIONS

SAFETY RECALL J0V

HYBRID SYSTEM SOFTWARE UPDATE

**CERTAIN:
2010-2014 PRIUS**

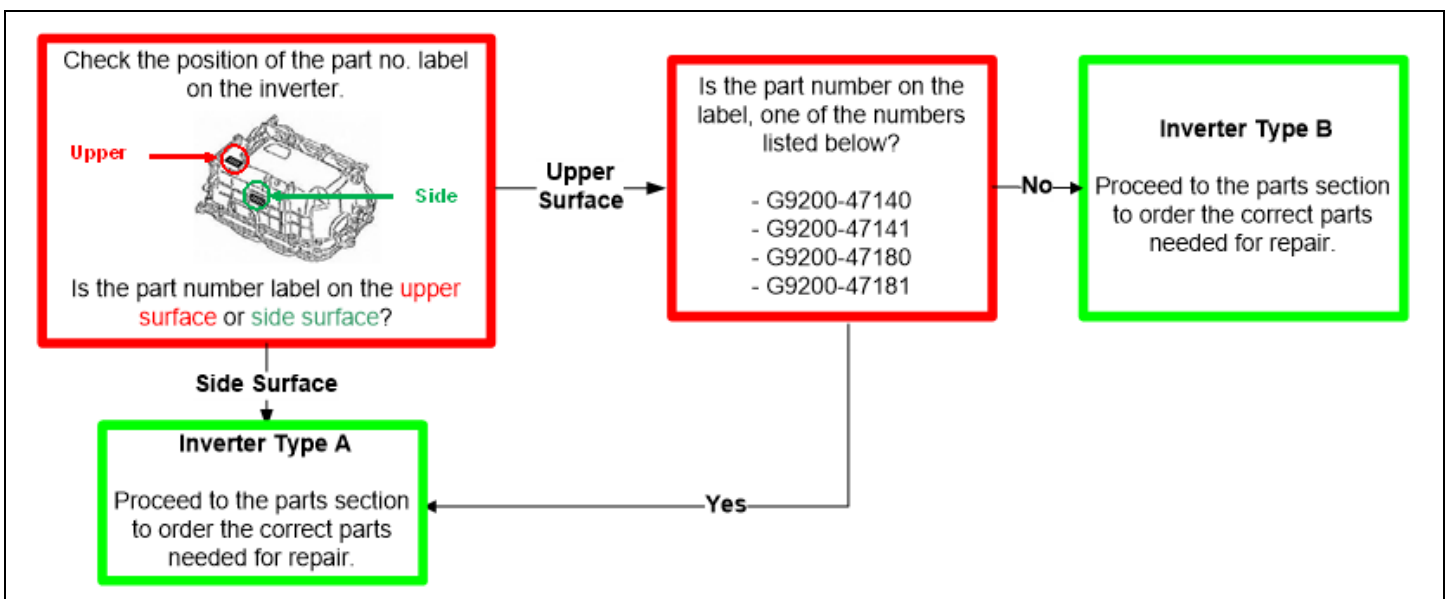
1. DETERMINE INVERTER ASSEMBLY TYPE

- a. Using the flowchart below determine the inverter type (A or B).

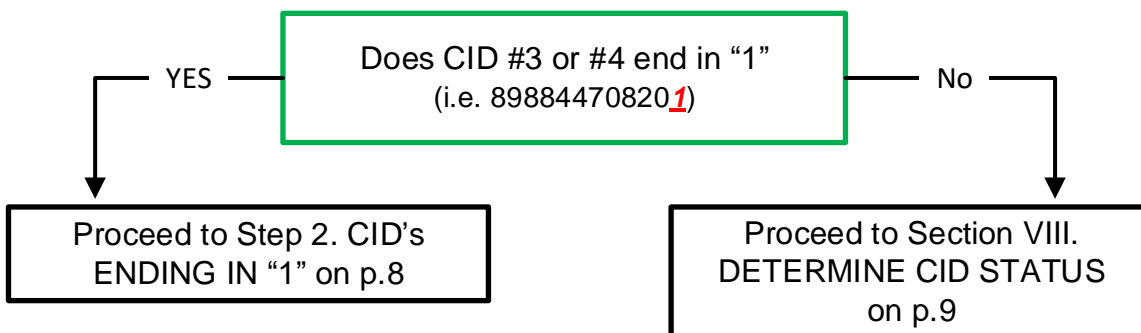
- Identify the Hybrid Control CID #3 & #4 from the Stored Data tab.
- Determine if the last digit of CID #3 & #4 is a "0" or a "1".

The screenshot shows the Techstream interface for a 2014 Prius. The 'Stored Data' tab is selected. The 'Hybrid Control' system is highlighted in the left sidebar. A table displays CID values for various systems. The following table represents the data shown in the screenshot:

System	RoB	Calibration	Update
Engine and ECT	-	34754000	No
	-	A4701000	No
	-	896B34747100	Yes
	-	896B57502000	No
	-	898844708200	No
	-	898844709200	No
Cruise Control	-	-	-
Tire Pressure Monitor	-	-	-
ABS/VSC/TRAC	-	F152647216	No
EMPS	-	JCU315F0	No
Transmission Control	-	-	-

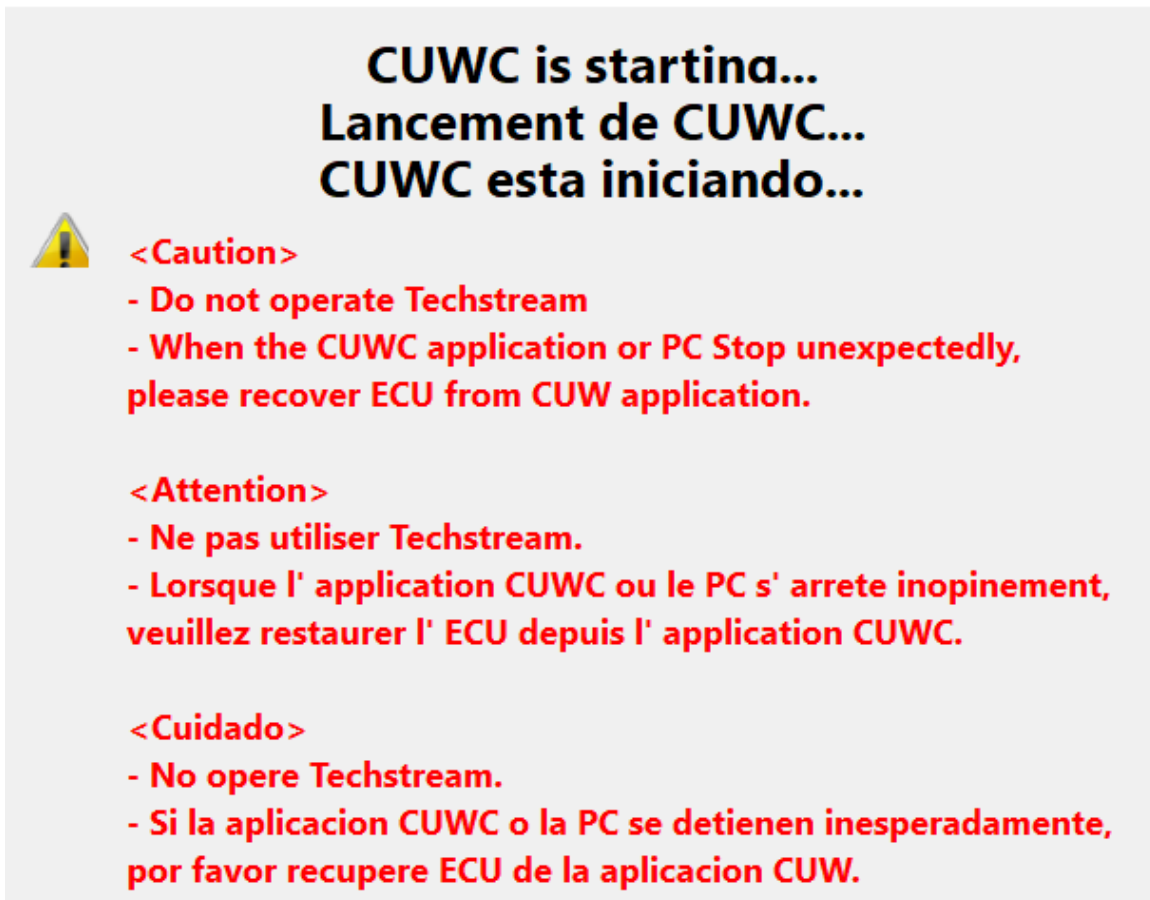
Message displayed during CID update process:

The following message will appear when the CUWC installation application is running. This image cannot be closed manually. **When the installation of all necessary CID's is complete, the image will close.**

CUWC is starting...
Lancement de CUWC...
CUWC esta iniciando...

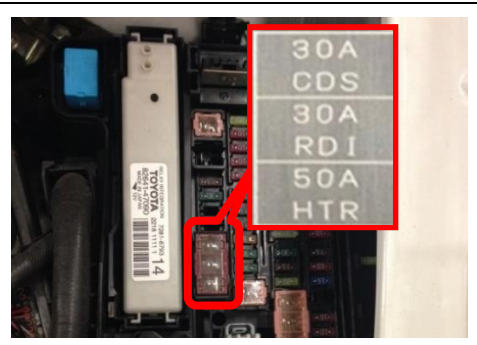
1. **REINSTALL JOINT FUSE INTO ENGINE ROOM FUSE BOX**
 - a. Confirm the joint fuse orientation before reinstalling because the joint fuse can be installed in either direction.
 - b. Reinstall the joint fuse that encases the CDS (30A), RDI (30A) and HTR (50A).

BE SURE TO ORIENT THE FUSE AS SHOWN ON THE FUSE BLOCK COVER.

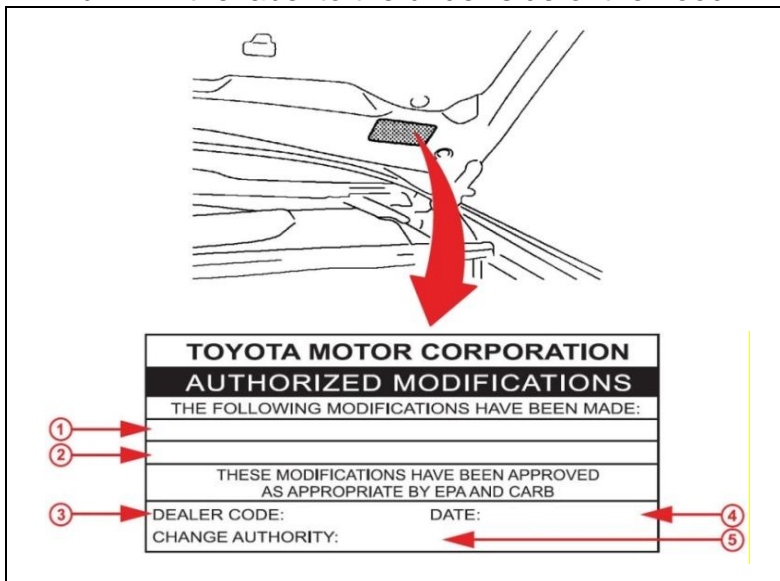
7. ATTACH THE AUTHORIZED VEHICLE MODIFICATION LABEL

- a. Fill out the label.
- b. Affix the label to the under-side of the hood.

1	Hybrid Control System
2	(Calibration ID's)
3	(Dealer Code)
4	(Date Completed)
5	Safety Recall J0V

Calibration ID's listed for the Hybrid Control System after completing the final Health Check. The CID's will vary for car to car.
