TECHNICAL INSTRUCTIONS

SAFETY RECALL JOV

HYBRID SYSTEM SOFTWARE UPDATE

CERTAIN: 2010-2014 PRIUS

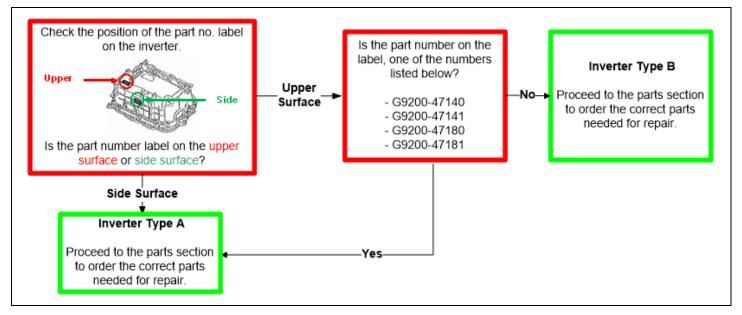
1. DETERMINE INVERTER ASSEMBLY TYPE

a. Using the flowchart below determine the inverter type (A or B).

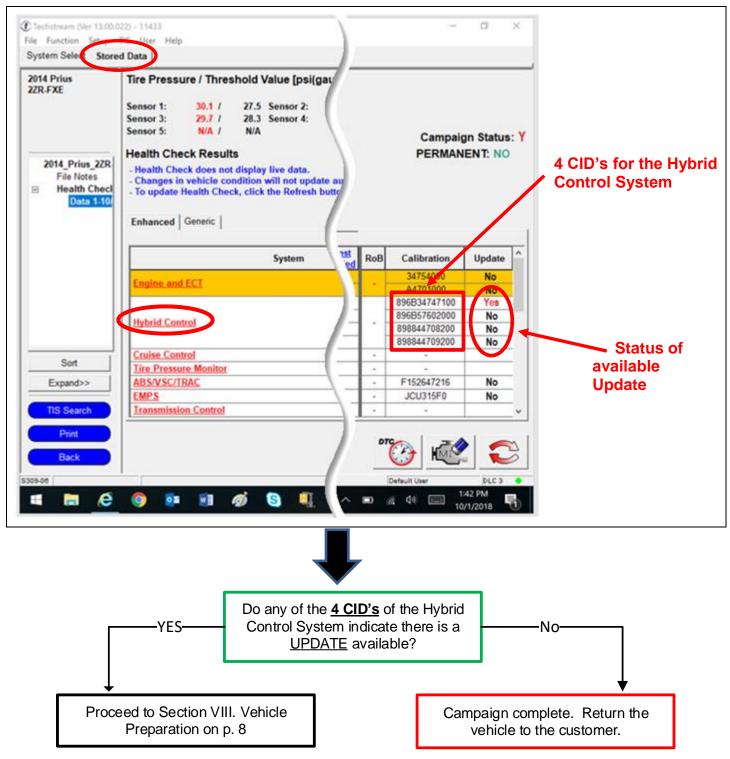
VII. DETERMINE CID STATUS

1. DETERMINE STATUS of HYBRID CONTROL SYSTEM CID's

- a. Locate the <u>Update</u> column for the Hybrid Control System in the <u>Stored Data</u> tab.
- b. Determine the status of the <u>4 CID's</u> for the Hybrid Control ECU; indicated by a <u>YES</u> or <u>NO</u> in the Update column.
- Note: It's possible that all 4 CID's need to be updated, as well as it's possible that only 1, 2 or 3 of the 4 CID's need to be updated. If any of the CID's indicate 'Yes', proceed with the update procedure.

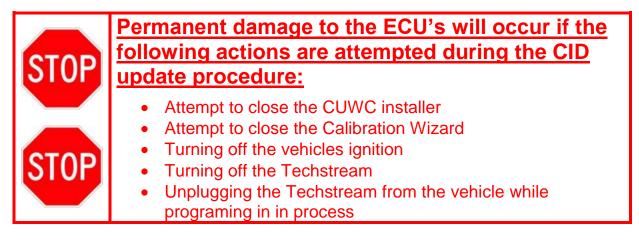
Installation of the CUWC Reprograming Installer is required on each Techstream to install the new format of Calibration ID's. This new format will automatically, if needed, run the Calibration Wizard twice to complete the installation of updated CID's in both the Power Management and Motor Generator ECU's.

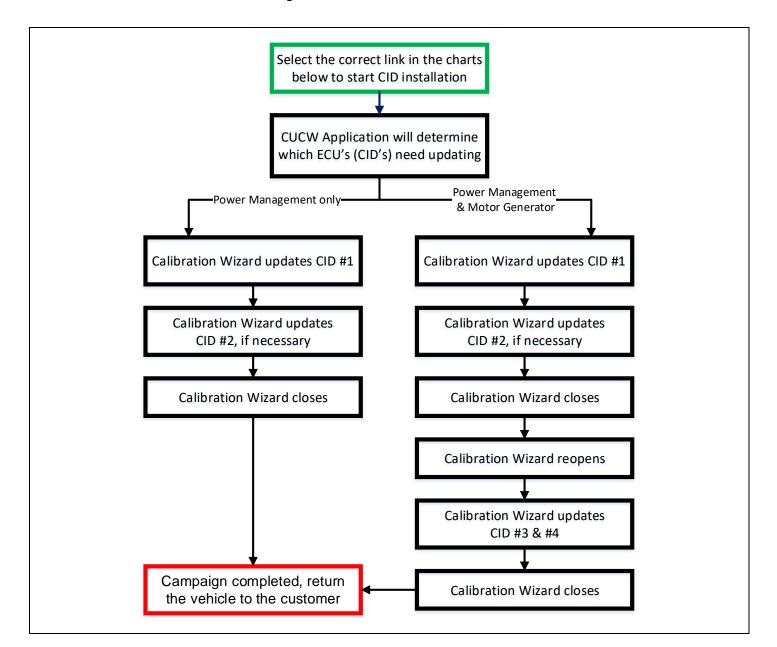
MULTIPLE CID'S MAY BE UPDATED

The CUWC Application will update the Hybrid Control System CID #1 (PM Main) using the Calibration Wizard, as required for Safety Recall JOV. Additionally, it will update CID #2, #3, and #4 of the Hybrid Control System using the Calibration Wizard, as needed, if the vehicle has not had Safety Recall EOE completed. When selecting an installation link from the charts below, please understand that the Calibration Wizard may **AUTOMATICALLY** run twice to complete the installation. The first installation will update CID #1 (PM Main) as required on all vehicles, and update CID #2 (PM sub) if necessary. The Calibration Wizard will then close as normal. If CID's #3 and #4 need to be updated, the Calibration Wizard will **AUTOMATICALLY** open again and compete these installations. DO NOT exit the application or shut off the vehicle or Techstream while the large CUWC text box is present on the screen. Permeant damage to the ECU will occur.

CID #1: Power Management Main CID #2: Power Management sub

CID #3: Motor Generator #1 CID #4: Motor Generator #2

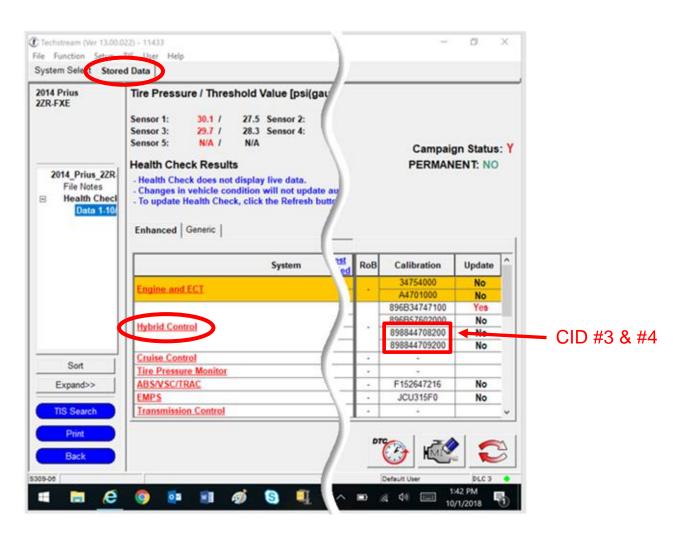
2. INSTALLATION OF CID'S

- a. Identify the Hybrid Control CID #3 & #4 from the Stored Data tab.
- b. Referencing the correct model year in the chart's below, identify the chart that has the correct CID #3 & #4.
- c. Select the Group # link (blue text) to begin the update process.
- d. Follow the instruction on the screen to complete the installation.

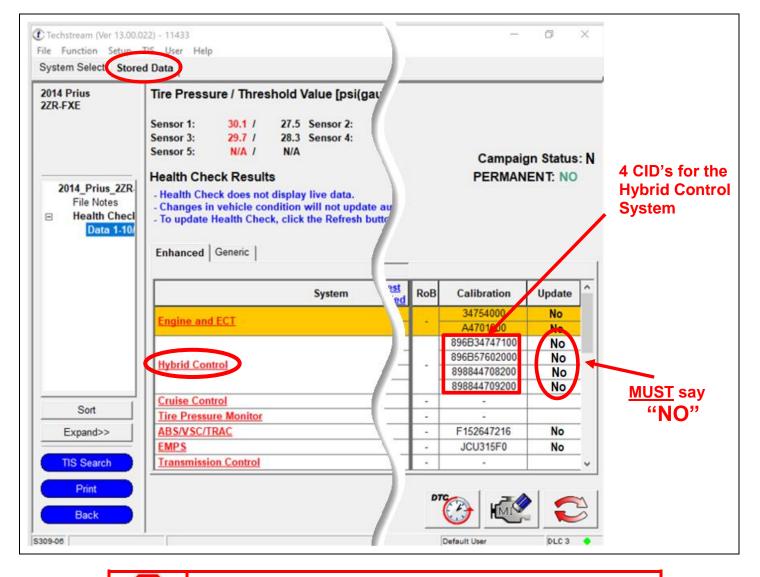
a. On the Stored Data tab, confirm the following for the Hybrid Control System:

• The Update column lists "No" for all 4 Hybrid Control System CID's

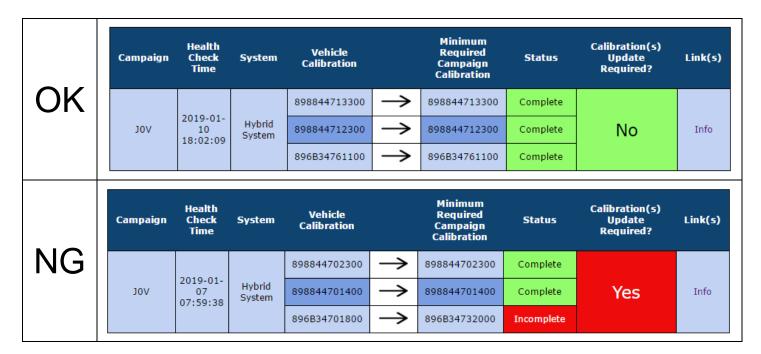
2. PERFORM CALIBRATION VERIFICATION CHECK

- c. Review the status of the Calibration(s) Update Required.
 - OK: The CID's have successfully loaded. The Calibration(s) Update Required column will say "No" in a green box. Proceed to the next step.
 - NG: The CID's did not successfully update. The Calibration(s) Update Required column will say "Yes" in a red box. Review these instructions and retry the installation process again.

Note: Although there are 4 CID's for the Hybrid Control System, CID #2 will not be displayed on the Calibration Verification Check. However, the judgement shown in the Calibrations(s) Update Required column does reflect the status of all 4 CID's. There is no need to manually check CID #2.

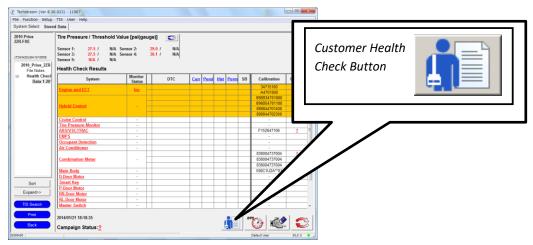
3. PRINT CUSTOMER HEALTH CHECK REPORT

a. From the Stored Data tab, select the Customer Health Check Report button (TIS will launch when button is pressed).

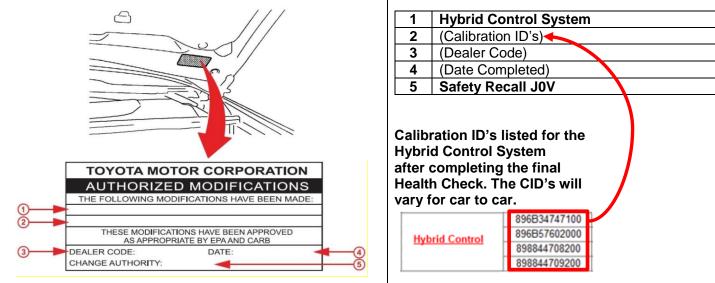
4. ATTACH THE AUTHORIZED VEHICLE MODIFICATION LABEL

- a. Fill out the label.
- b. Affix the label to the under-side of the hood.
