TECHNICAL INSTRUCTIONS

SAFETY RECALL J0V

HYBRID SYSTEM SOFTWARE UPDATE

**CERTAIN:
2012-2014 PRIUS V**

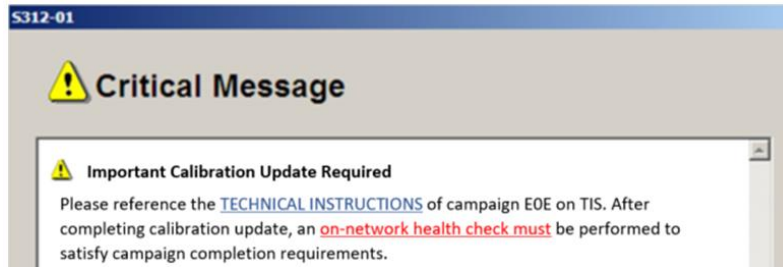
Note: If you receive the following message **after** the Verification Health Check, you have not properly completed the Required Calibration Updates!!

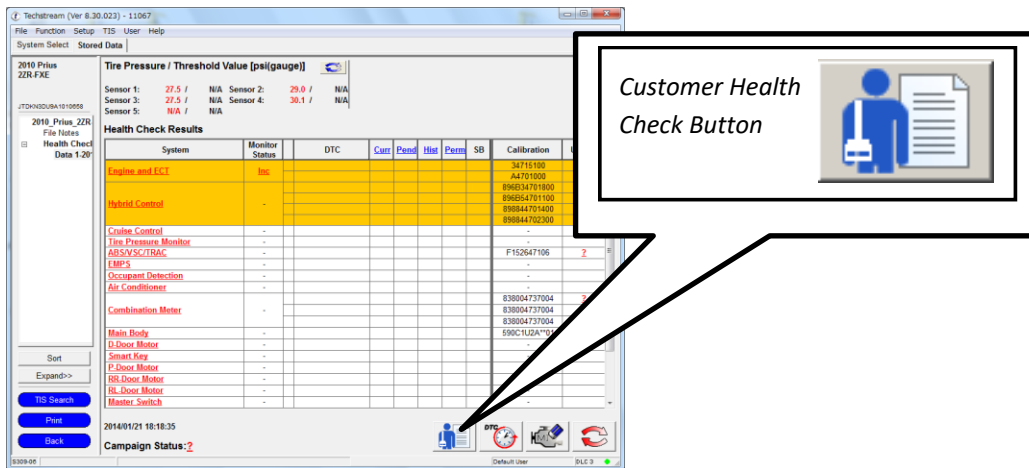
2. PRINT CUSTOMER HEALTH CHECK REPORT

- From the Stored Data tab, select the Customer Health Check Report button (TIS will launch when button is pressed).

- Log in to TIS.
- Input Vehicle Mileage and Repair Order number.
- Check the "Performed" campaign button for campaign J0V.
- Select the Report button.
