TECHNICAL INSTRUCTIONS

SAFETY RECALL J0V

HYBRID SYSTEM SOFTWARE UPDATE

**CERTAIN:
2012-2014 PRIUS V**

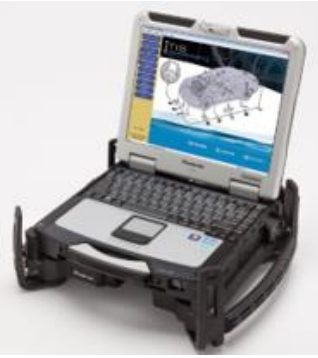
- From the menu at the top of the screen, select: Setup / Techstream Configuration.
- Continue to the third setup screen: Required Information.
- Verify that "US Dealer 1" is selected as the User Type.

Example:
TOYOTA/LEXUS/SCION Dealers in the U.S. for one.tis.toyota.com upgrade

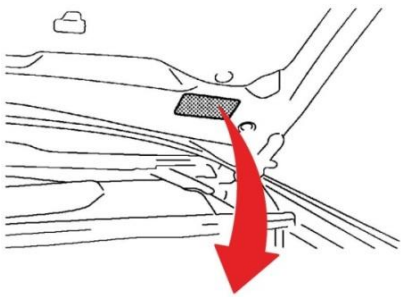
a. Fill out the label.

b. Affix the label to the under-side of the hood.
