Compliance Recalls

Codes: 90L3/90L4

Subject	Instrument Cluster Coding														
Release Date	December 05, 2018														
Affected Vehicles	<p><u>Compliance Recall 90L3</u></p> <table border="1"> <thead> <tr> <th>Country</th> <th>Model Years</th> <th>Models</th> </tr> </thead> <tbody> <tr> <td>USA & CANADA</td> <td>2018-2019</td> <td>Atlas (without keyless entry)</td> </tr> </tbody> </table> <p><u>Compliance Recall 90L4</u></p> <table border="1"> <thead> <tr> <th>Country</th> <th>Model Years</th> <th>Models</th> </tr> </thead> <tbody> <tr> <td rowspan="2">USA & CANADA</td> <td>2018-2019</td> <td>Tiguan (without keyless entry)</td> </tr> <tr> <td>2019</td> <td>Jetta (without keyless entry)</td> </tr> </tbody> </table> <p><i>Check Campaigns/Actions screen in Elsa on the day of repair to verify that a VIN qualifies for repair under this action. Elsa is the <u>only</u> valid campaign inquiry & verification source.</i></p> <ul style="list-style-type: none"> ✓ Campaign status must show "open." ✓ If Elsa shows other open action(s), inform your customer so that the work can also be completed at the same time the vehicle is in the workshop for this campaign. 	Country	Model Years	Mo

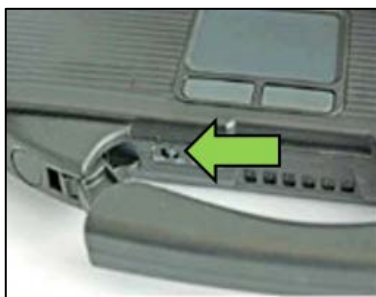
VAS 6150 & VAS 6150A
(Front panel behind handle)

- ✓ **The Bluetooth function of the scan tool is physically switched off <see pictures below>.**

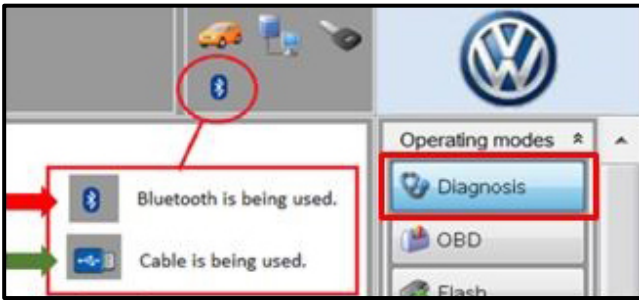
- Confirm that scan tool is communicating with the diagnostic head by USB <Green Arrow>.
 - If the Bluetooth symbol is shown <Red Arrow> then disconnect the diagnostic head from the vehicle and reconnect the USB cable to the diagnostic head and then reattach to the vehicle.
- Upon ODIS startup, verify the “Diagnosis” operating mode is selected <as shown>.
