August 2019
FL803AB
NHTSA #18V-903
Transport Canada #2018-714
REVISED NOTICE

Subject: Eaton AMT Clutch Assemblies

Models Affected: Specific Freightliner 108SD, 114SD, 114SD RHD, 122SD, Argosy, Business Class M2, Cascadia, and Columbia vehicles; and Western Star 4700, 4900, and 5700 vehicles manufactured April 10, 2017, through July 2, 2018, equipped with an Eaton Automated Manual Transmission (AMT) clutch assembly.

The Transmission Electronic Control Units (TECUs) will be reprogrammed with updated software to mitigate the possibility of unintended vehicle movement.

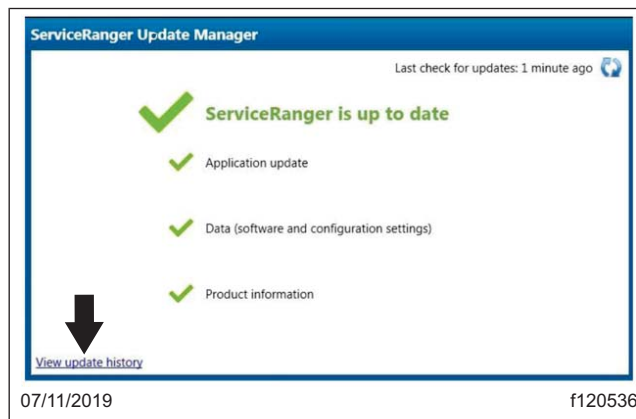
Fig. 2, Selecting View Update History

- 2.2 Select "View update history." See [Fig. 2](#).

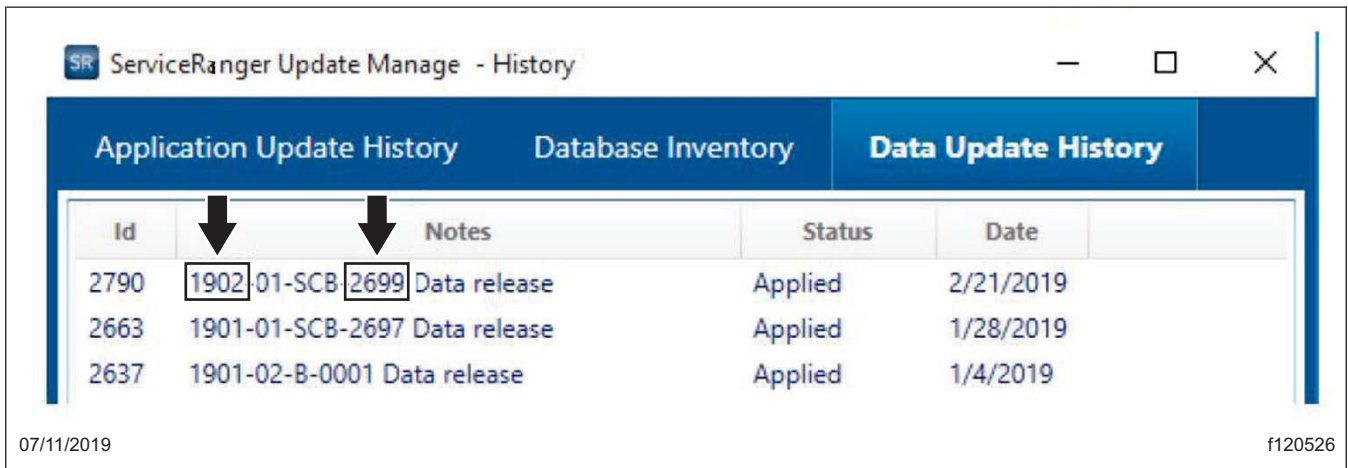
Fig. 4, Verifying the Release Number

2.4 Verify 1901-01-SCB-2682 Data release or greater is Applied. See [Fig. 4](#).

- If Data release Applied is less than 1901-01-SCB-2682, go to step 3.
 - If Data release Applied is equal to or greater than 1901-01-SCB-2682, go to step 4.
3. Update ServiceRanger Data release to the latest version.
- 3.1 Connect the computer to the internet.
- 3.2 Left click the "SR" icon to open the ServiceRanger Update Manager. See [Fig. 1](#).

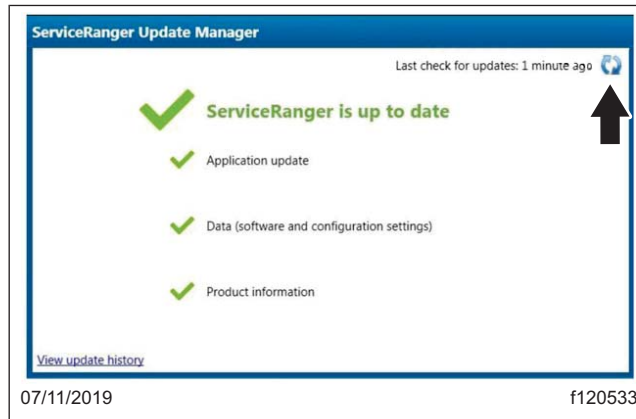
Fig. 5, Selecting the Update Icon

3.3 Select the update icon in the top, right-hand corner. See **Fig. 5**.

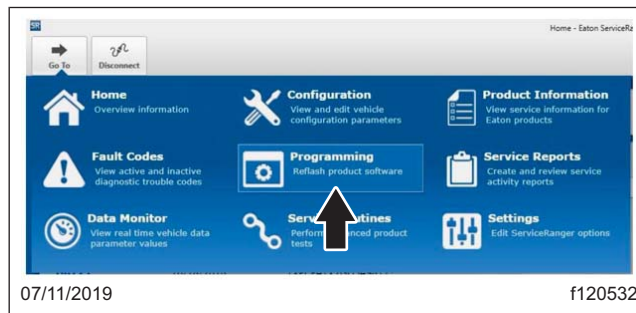
Fig. 6, Selecting the Programming Panel

- 4.1 Close vehicle cab doors. Note that this limits activity of vehicle/component modules on the vehicle data link.
- 4.2 Turn the key to the ON position.
- 4.3 Connect ServiceRanger.
- 4.4 Go To "Programming." See **Fig. 6**.

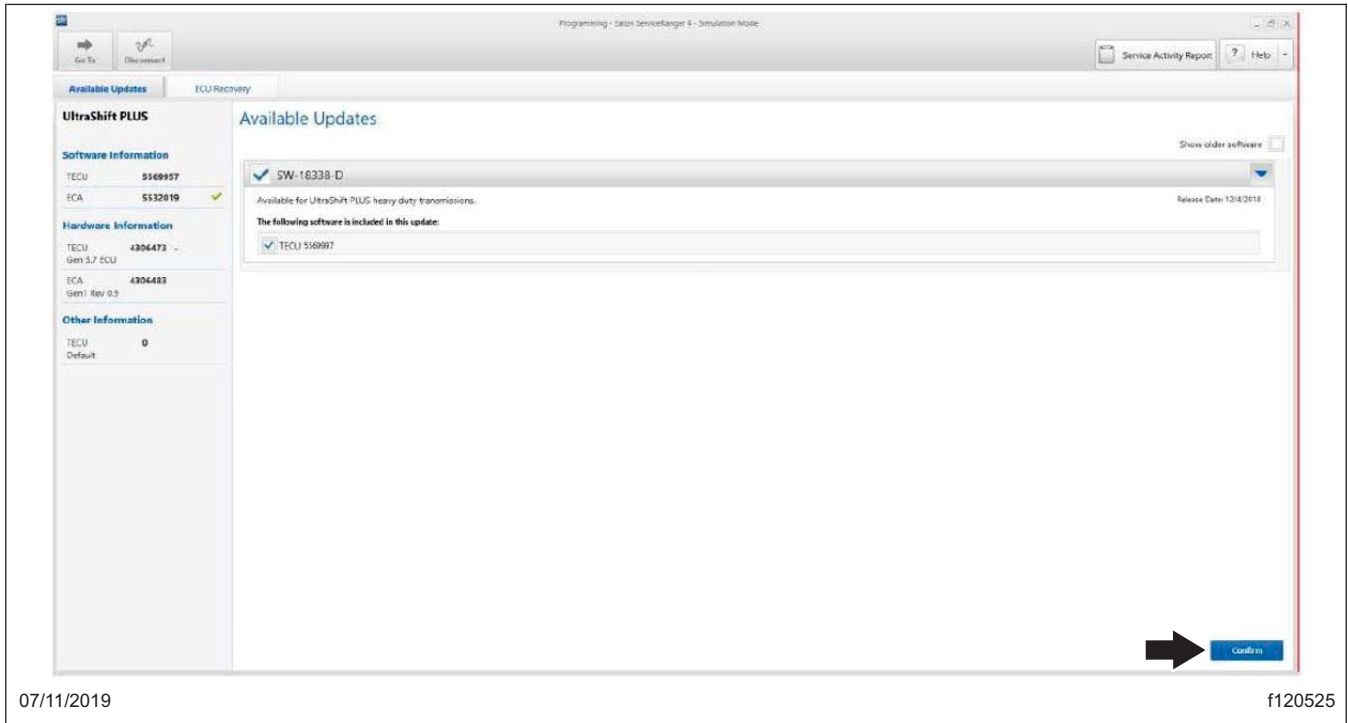
Fig. 8, Selecting Confirm

4.6 Select "Confirm." See Fig. 8.

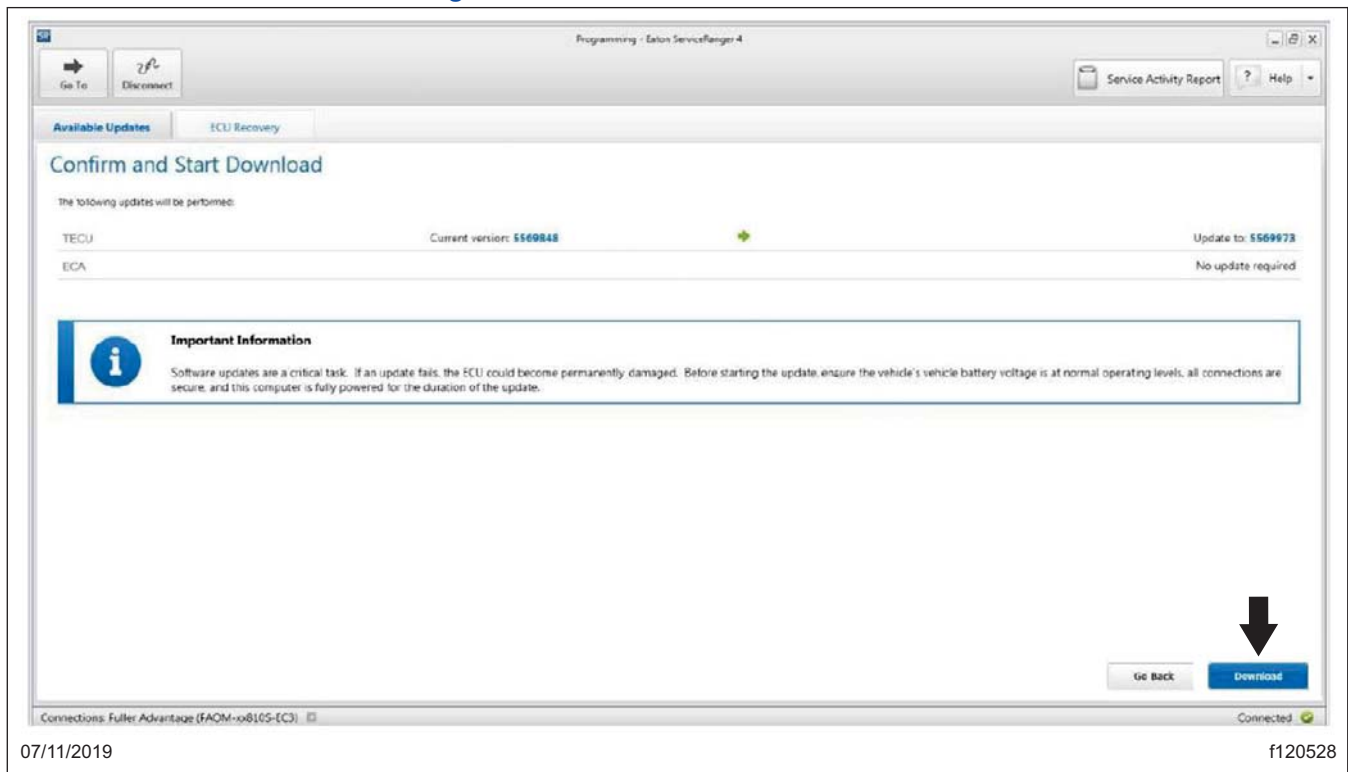
Fig. 9, Clicking Download

4.7 Select "Download." See Fig. 9.

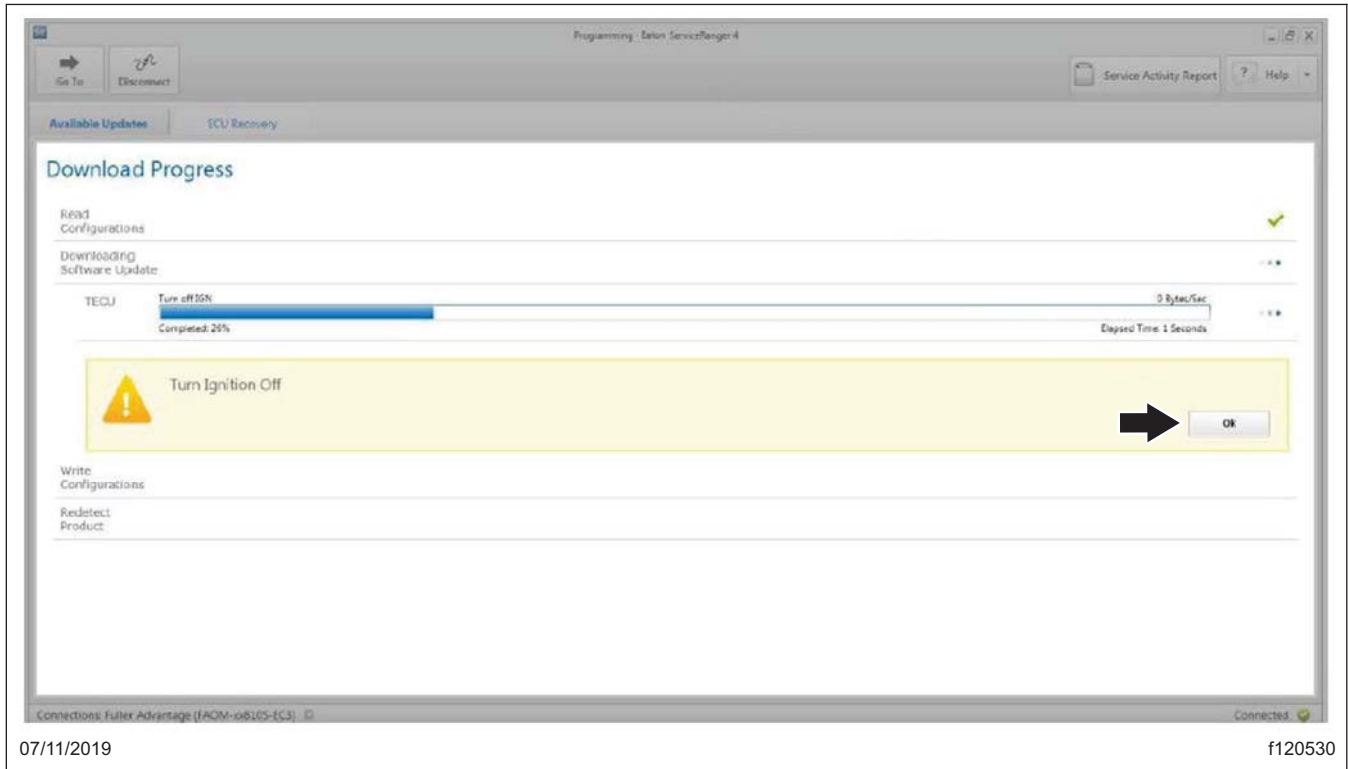
Fig. 10, Clicking on OK

- 4.8 Turn the ignition off when prompted and wait 2 minutes. Note that this limits activity of vehicle modules on the datalink.
- 4.9 After waiting 2 minutes, select "OK." See [Fig. 10](#).

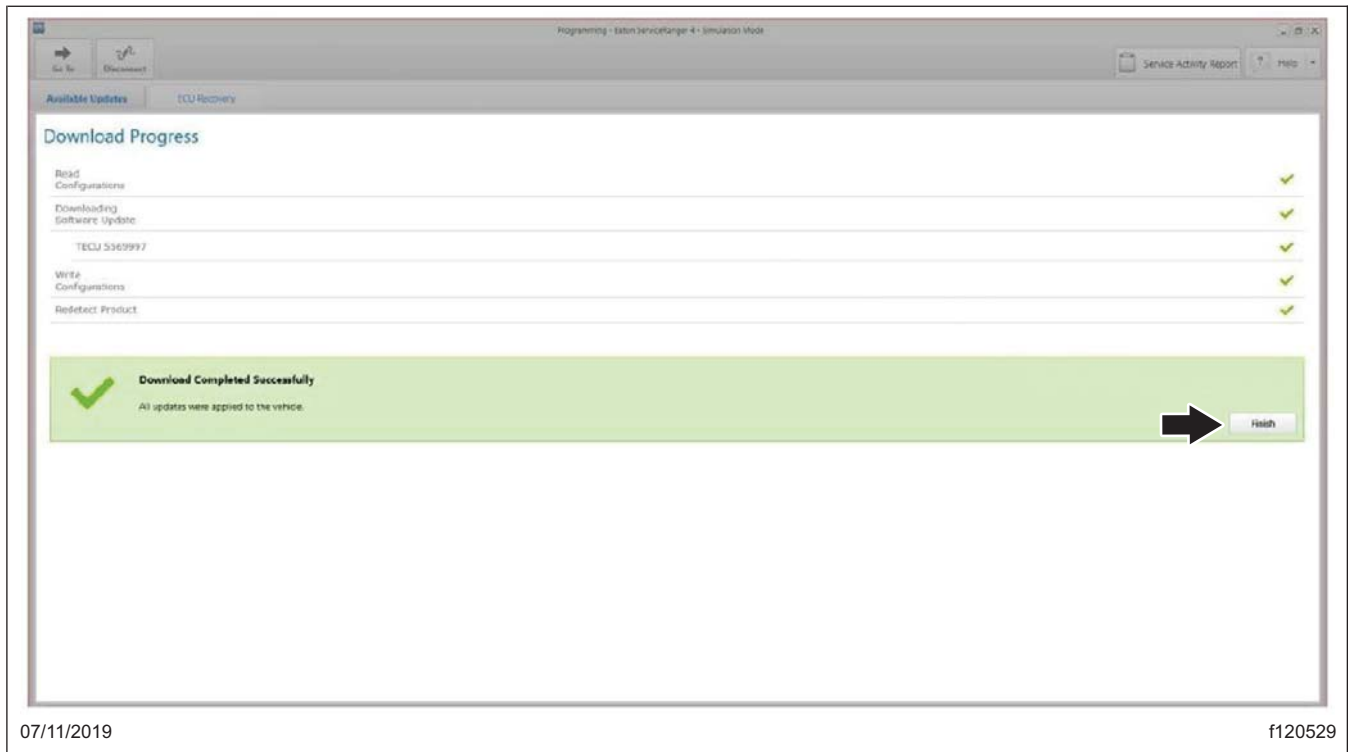
Fig. 11, Selecting Finish when Prompted

- 4.10 Turn the ignition to the ON position when prompted.
- 4.11 Select OK.
- 4.12 Select "Finish" when prompted. See [Fig. 11](#).
- 4.13 Select "Disconnect."
- 4.14 Turn the ignition to the OFF position and allow 2-3 minutes for the TECU to perform a complete power-down.
