PRODUCT CAMPAIGN BULLETIN

APPLICABILITY: 2018 Model Year Legacy, Outback, and BRZ Vehicles

NUMBER: WTZ-85R

SUBJECT: Harman Kardon Head Unit FMVSS 111 Noncompliance Recall

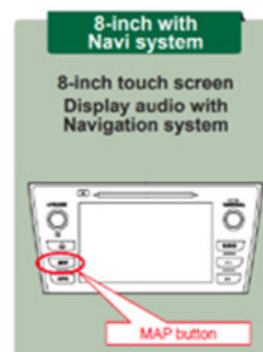
Multimedia System Type	Descriptive Features
8.0 Inch Audio / Navigation System	Map Button in Top Row Center

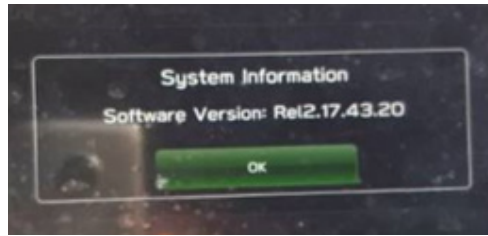
(EXAMPLE photo)

- Confirm the current Software Version ID. If the Current Version is **Rel_U0.18.43.20**, **Rel_A1.19.12.20** or **Rel_A1.19.17.20**, **STOP** as the latest update has already been installed. Refer to TSB 15-211-17R to see the latest software version information as well as a history of prior updates. Software versions Rel2.17.43.20 (or later) are acceptable to complete and close this recall. Otherwise, proceed to **Step 2** below.

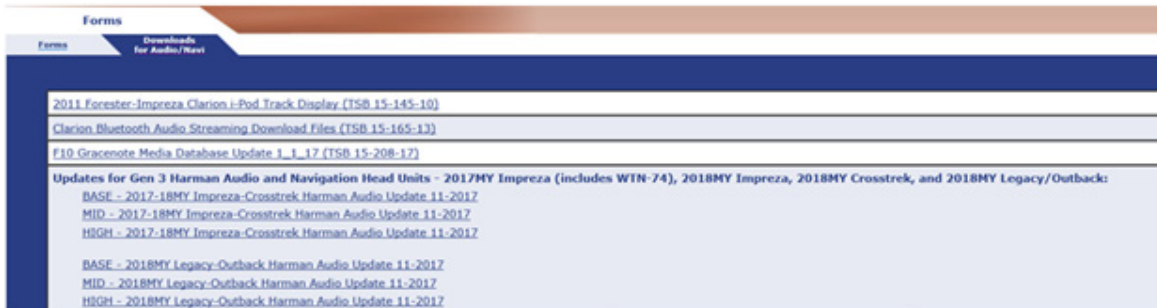
- If the files are being **downloaded from Subarunet**, they will be .zip files and must be unzipped before they can be used. An EXAMPLE image of the Subarunet links page is provided below.
