## PRODUCT CAMPAIGN BULLETIN

**APPLICABILITY:** 2018 Model Year Legacy, Outback, and BRZ Vehicles

**SUBJECT:** Harman Kardon Head Unit FMVSS 111 Noncompliance Recall

**NUMBER:** WTZ-85R

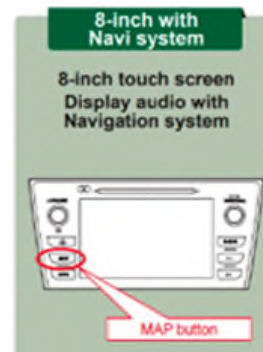
Multimedia System Type	Descriptive Features
8.0 Inch Audio / Navigation System	Map Button in Top Row Center

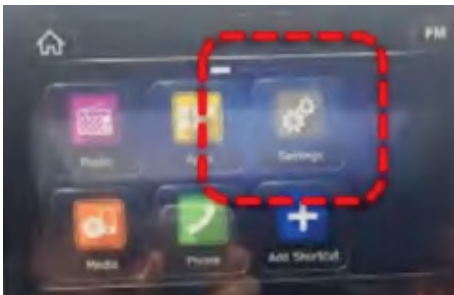
- After starting the engine, from the HOME screen, touch “Settings”.

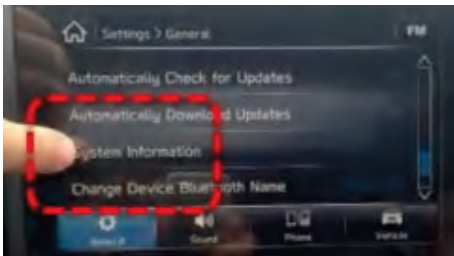
- From the Settings > General screen, scroll down to and then touch “System Information”.

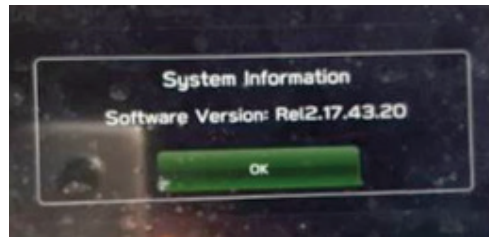
(EXAMPLE photo)

- Confirm the current Software Version ID. If the Current Version is **Rel\_UO.18.43.20 or later per TSB 15-211-17R, STOP** as this latest update has already been installed. Otherwise, proceed to **Step 2** below.

Refer to TSB 15-211-17R to see the latest software version information as well as a history of prior updates. Software versions Rel\_UO.18.43.20 (or later) are acceptable to complete and close this recall.

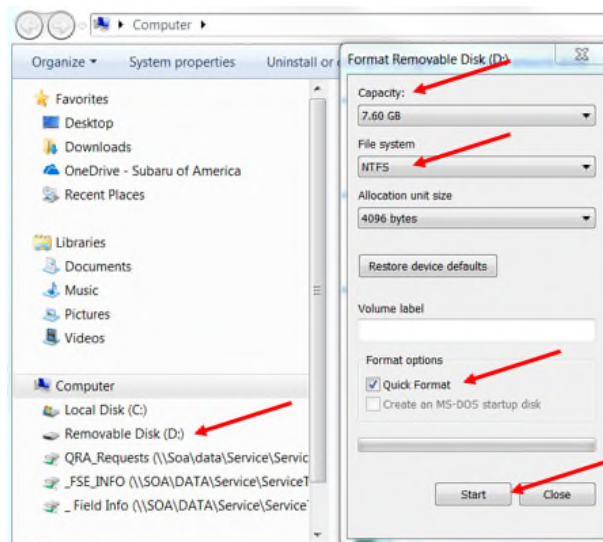
- Make sure the USB flash drive contains no other files.
- Right click on the corresponding “Removable Disk”.
- Select “Format”.
- From the File System drop-down menu, select “NTFS”
- Check the “Quick Format” box (if not already done).
- Click on “Start” to format the USB flash drive.

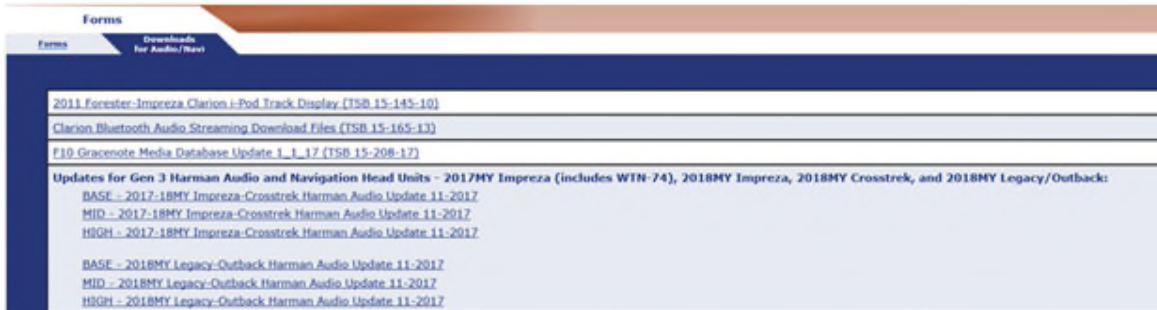
- If the files are being **downloaded from Subarunet**, they will be .zip files and must be unzipped before they can be used. An EXAMPLE image of the Subarunet links page is provided below.

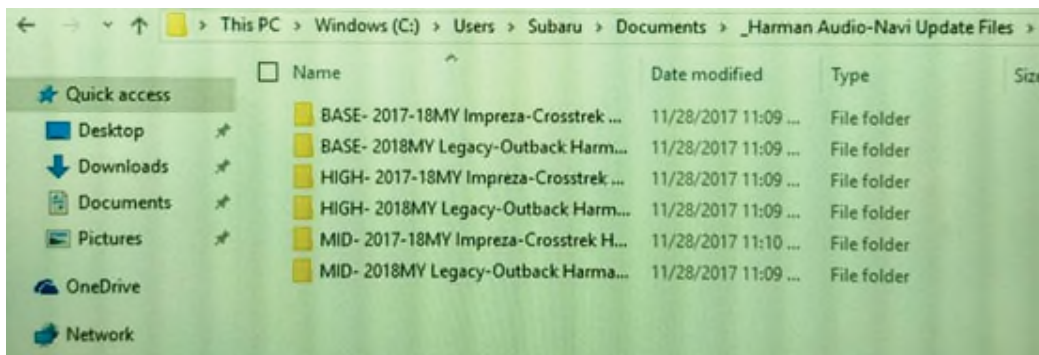
- Go to My Documents on the GUI screen to display the list of available update files shown below.
- Sort by Date Modified to bring the most recent files to the top of the list. The folder is named: \_Harman Audio-Navi Update Files. It contains the six folders shown in the EXAMPLE photos below.

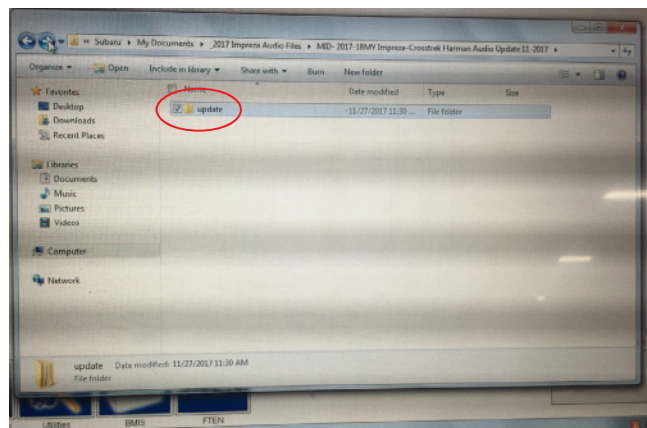
- Double-click on the required file (for this example, select the file entitled “HIGH-17-18 Impreza-18 Crosstrek-18-Legacy-Outback-18-BRZ-HARMAN AUDIO UPDATE-NOVEMBER 2018”) and the Update file will display as shown.

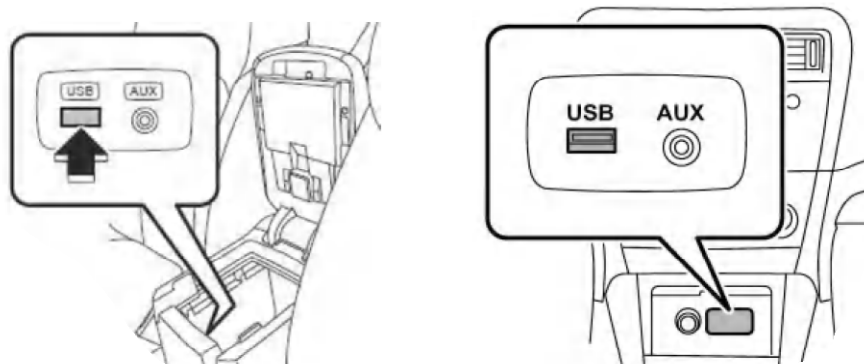
- With the engine idling (or GR8 connected), plug the flash drive into the USB Port.

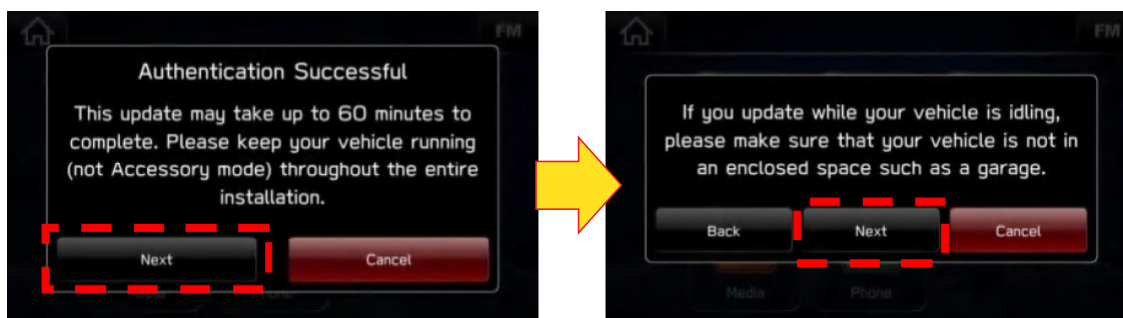
- After the unit “authenticates” the USB flash drive, press “Next” and after the second screen is displayed, press “Next” again.

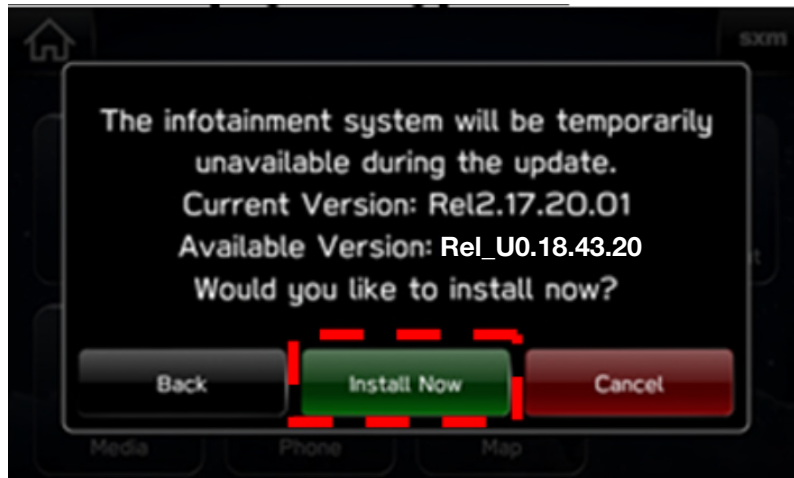
- The current and available software version information will be displayed. The Available Version I.D should be **Rel\_U0.18.43.20**.

- After confirming the Available Version, press “Install Now” to start the reprogramming process.

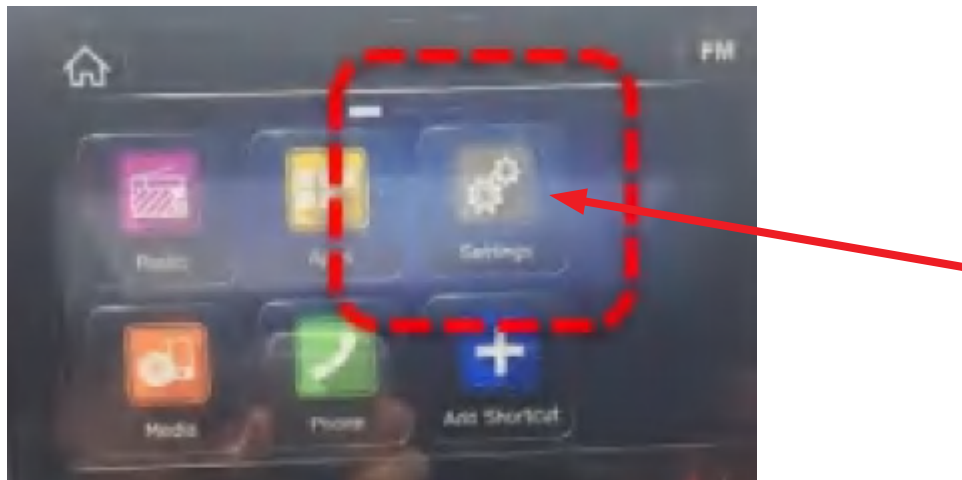
- Turn the ignition back ON. The STARLINK screen should be displayed. If the STARLINK screen is not displayed, perform **Step 5** again and be sure to **WAIT AT LEAST 3 MINUTES** before proceeding.
- In some cases, the radio presets may not appear initially.
- From the HOME screen, touch “Settings”.

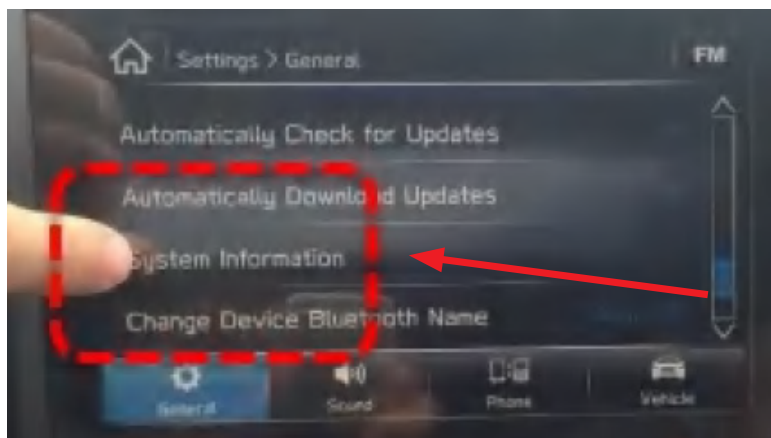
- From the Settings > General screen, scroll down to and then touch “System Information”.

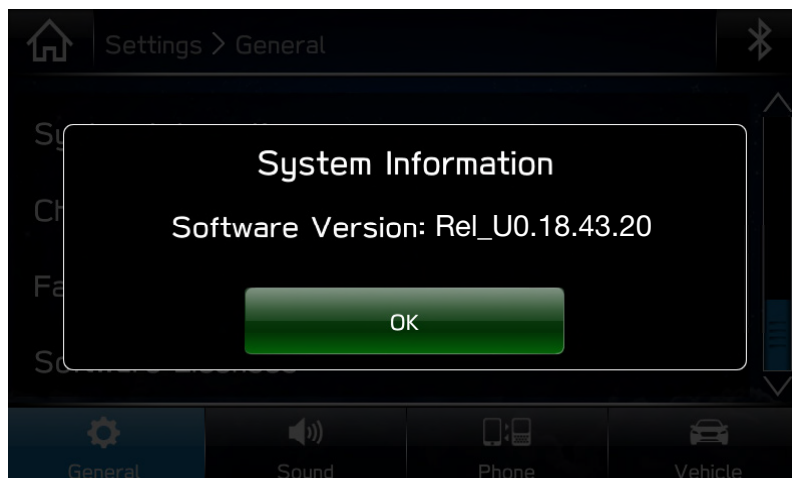
- Confirm Software Version is now “Rel\_UO.18.43.20”.
