PRODUCT CAMPAIGN BULLETIN

APPLICABILITY: 2018 Model Year Legacy, Outback, and BRZ Vehicles

SUBJECT: Harman Kardon Head Unit FMVSS 111 Noncompliance Recall

NUMBER: WTZ-85R
DATE: 01/03/19
NHTSA ID: 18V-935
REVISED: 07/29/19

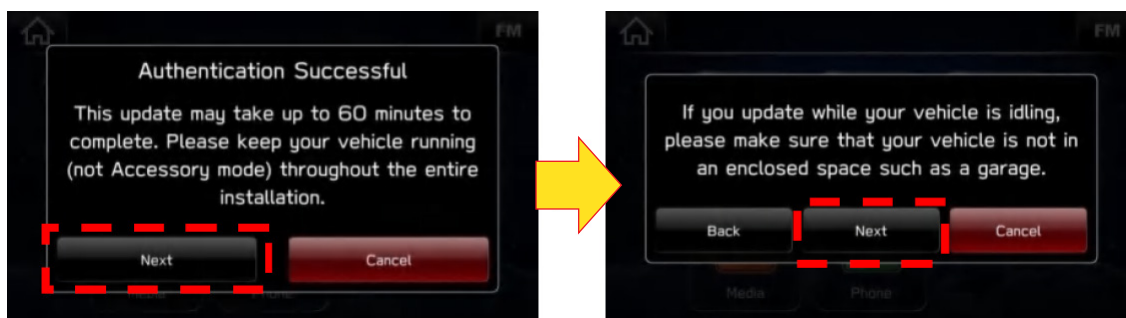
- After the unit “authenticates” the USB flash drive, press “Next” and after the second screen is displayed, press “Next” again.
