Reference Number:	N182167670	Release Date: Revision:	
Revision Description:	This bulletin has been revised to includ discard all copies of bulletin 18195.	le a copy of the customer no	otification letter. Please

Model Year		Model Year			
Make	Model	From	То	RPO	Description		
Chevrolet	Corvette	2019	2019	ZR1	Performance Package - Special Coupe

Condition	General Motors has decided that a defect which relates to motor vehicle safety exists in certain 2019 model-year Chevrolet Corvette ZR1 vehicles. In these vehicles, if the sensing and diagnostic module (SDM) is exposed to extremely hard braking and sustained acceleration events under certain track conditions, the SDM may enter a fault state and will not return to normal operation until battery power is removed from the system. In this faulted state, the SDM will not provide crash sensing or deploy air bags in the event of a crash.
Correction	Dealers will reprogram the SDM with updated software.

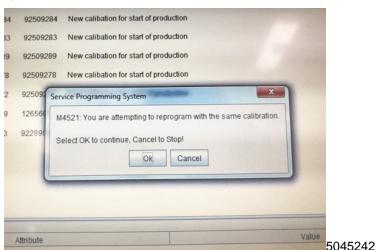
Note: If the Same Calibration/Software Warning is noted on the SPS controller screen, select "OK" and continue programming.
