TO: Mercedes-Benz Dealer Principals, General Managers, Sales Managers, Service Managers, Parts Managers	FROM: Gregory Gunther, Department Manager, Vehicle Compliance and Analysis, Engineering Services
RE: <b>Recall Campaign Launch Notification – 2019030017 Takata PG5 DRIVER and PASSENGER AIRBAG Zone A</b> Certain MY11 W204 (C-Class), MY12 X204 (GLK-Class), and MY 2011-2015 SLS Coupes and Roadsters vehicles	DATE: March 26, 2019

SUBJECT: **Model 204, X204 and 197**  
**Model Years 2011 – 2015**  
**Replace Driver-Side and Front Passenger-side Airbag**

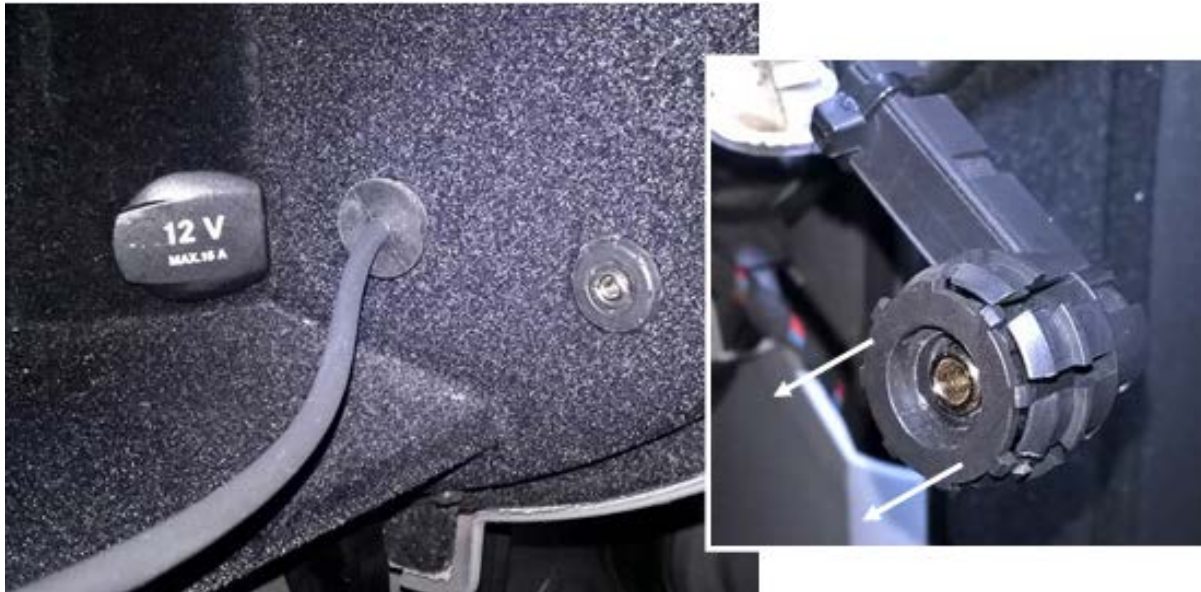
Figure 3

**i** Release inner retaining ring (**figure 3**) at the AUX connection towards the inside. The connection can then be removed from the glove box housing.

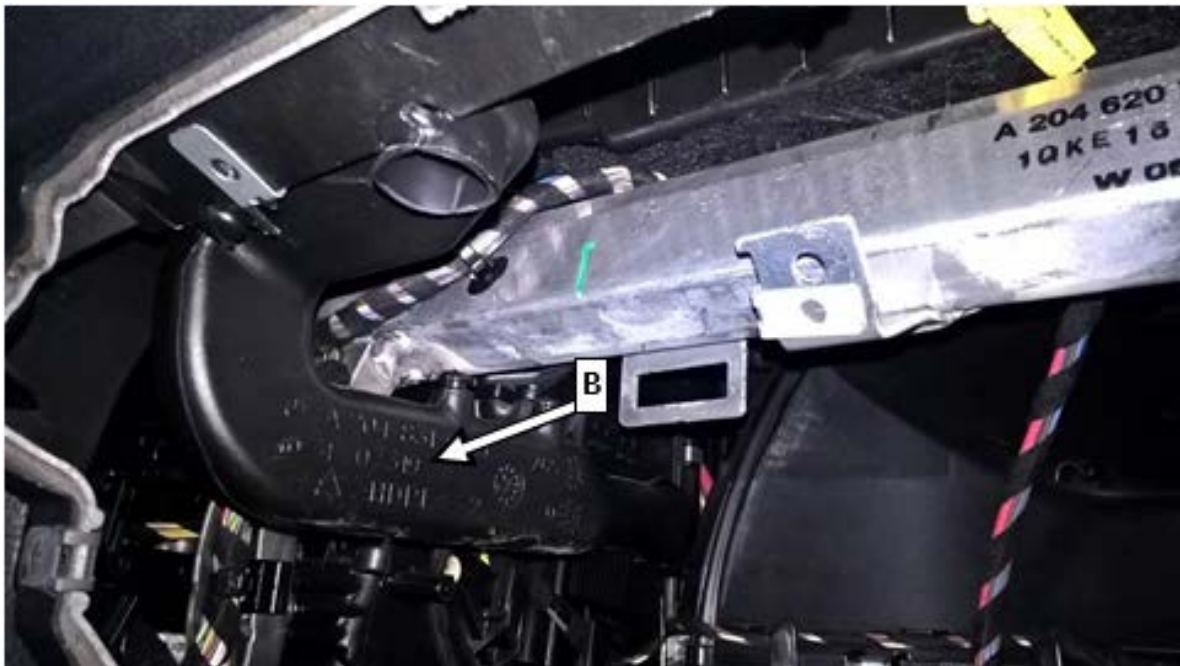
Figure 5

5. Remove air duct (**B**, figure 5) above the glove compartment.

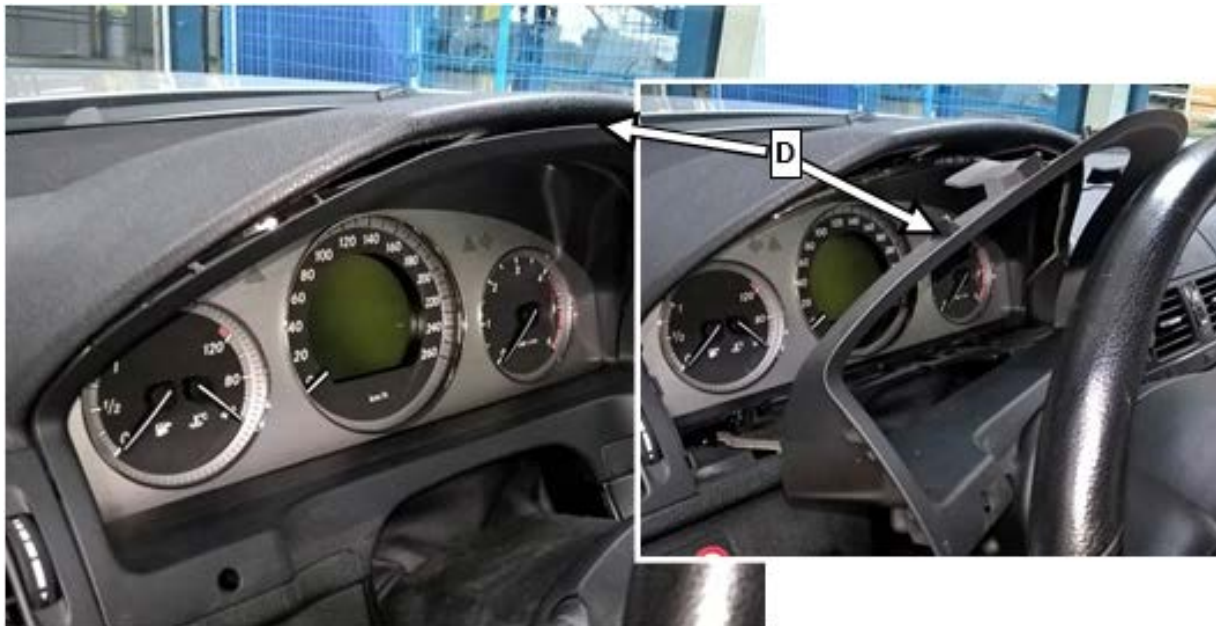
Figure 7

7. Remove center console (**AR68.20-P-2000CW**).
8. Remove automatic climate control and operating unit.
  - i For basic data of model 204, see **AR83.40-P-6350CW**
9. Remove trim (**D, figure 7**) around the instrument cluster.
  - i For basic data of model 204, see **AR54.30-P-6015CW**.

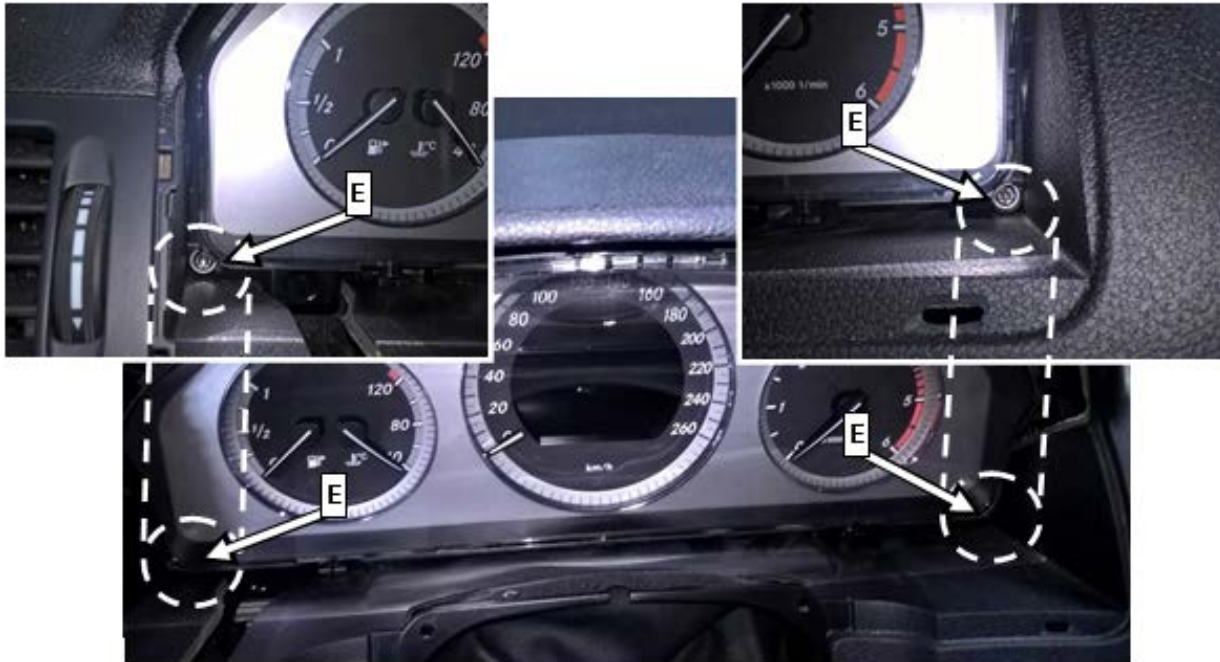
**Figure 8**

10. Remove the two bottom threaded connections (**E, figure 8**) of the instrument cluster.

**i** These screws are simultaneously fasteners for the instrument panel.

**i** The upper two screws do not need to be removed.

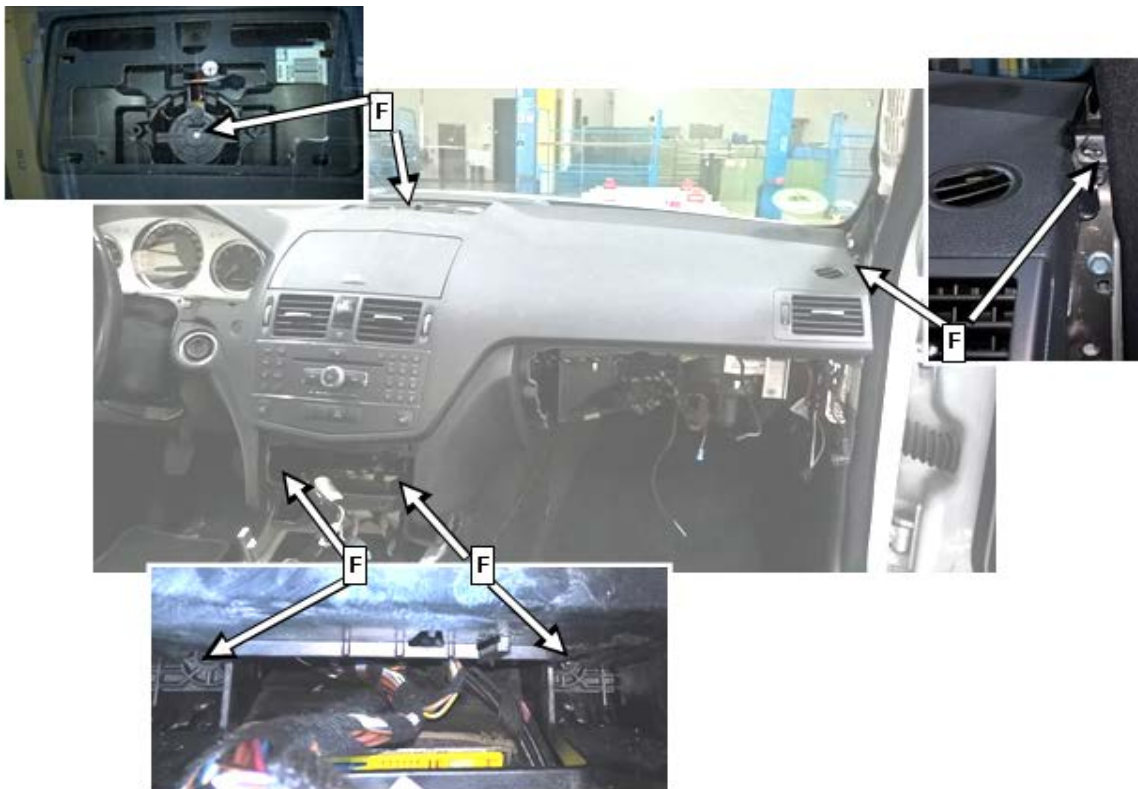
**Figure 9**

11. Remove four screws (**F, figure 9**) for fastening the instrument panel

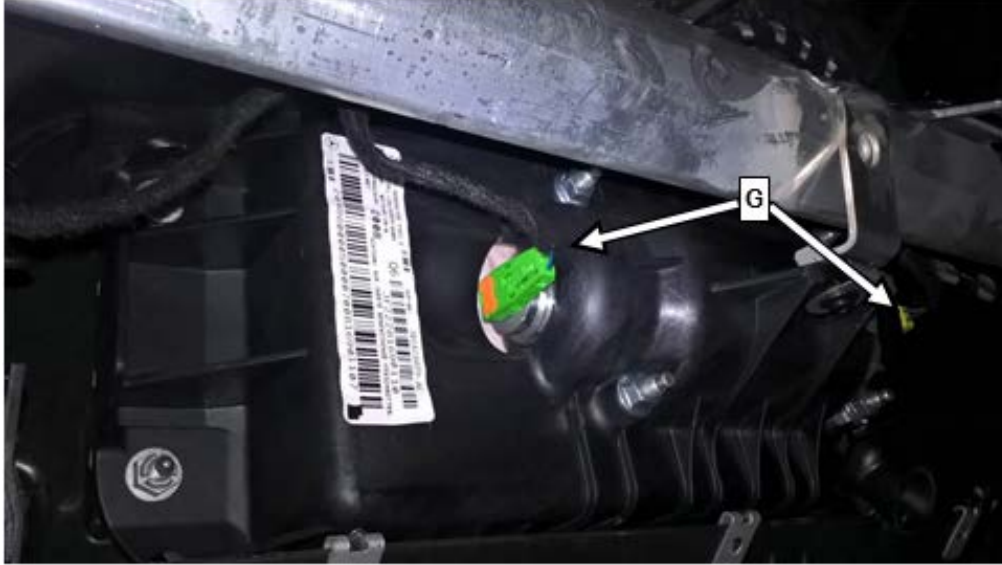
Figure 10

12. Disconnect electrical contacts (**G**, **figure 10**) at the front passenger airbag.

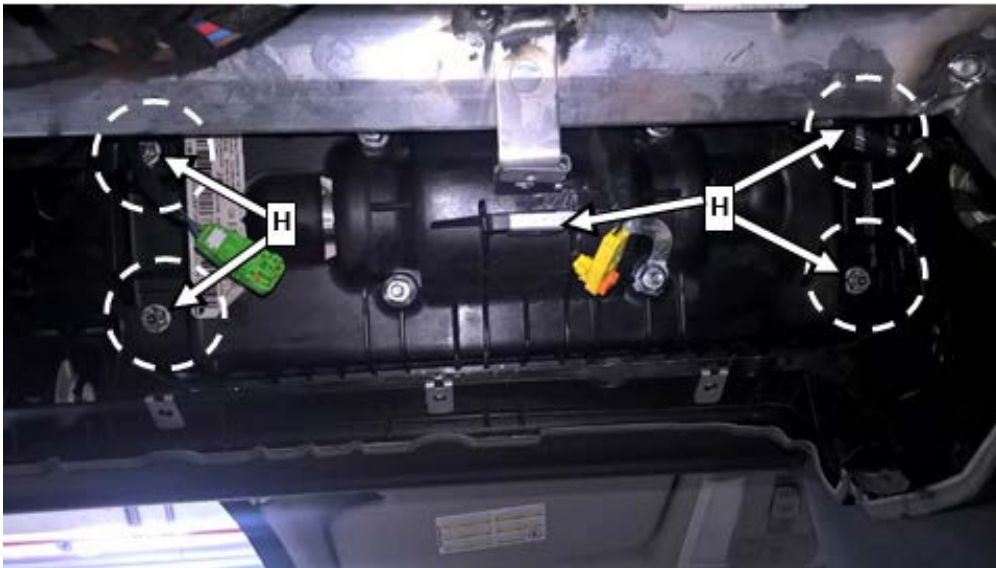
Figure 11

13. Remove lock nuts (**H**, **figure 11**) for the front the passenger airbag.

**i** Lock nuts should only be replaced if they are damaged. For more info see: **AH00.00-N-0001-01A / Modification notes 27.10.2016**

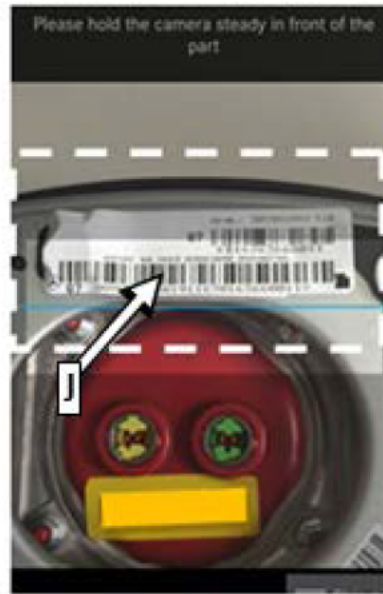
Figure 14

- Ensure that the lower barcode (J, figure 14) is scanned.
- All required data can also be read off and entered manually.

- Ensure that the lower barcode (J, figure 14) is scanned.
- All required data can also be read off and entered manually.

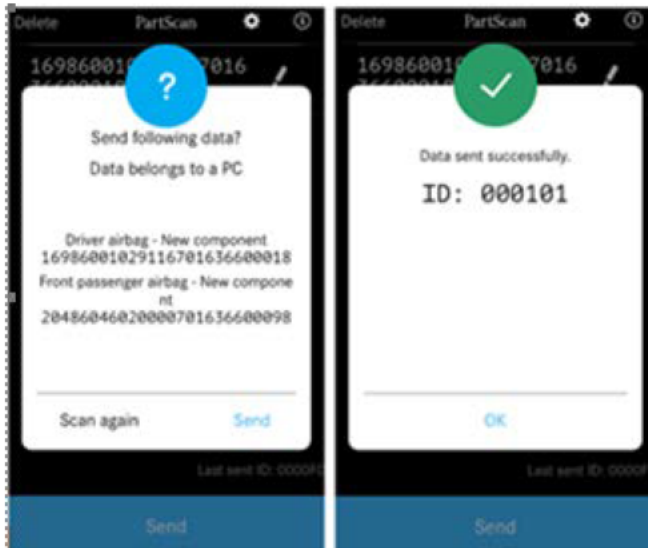
Figure 15

19. Create a scan ID via the "Send" button (figure 15).

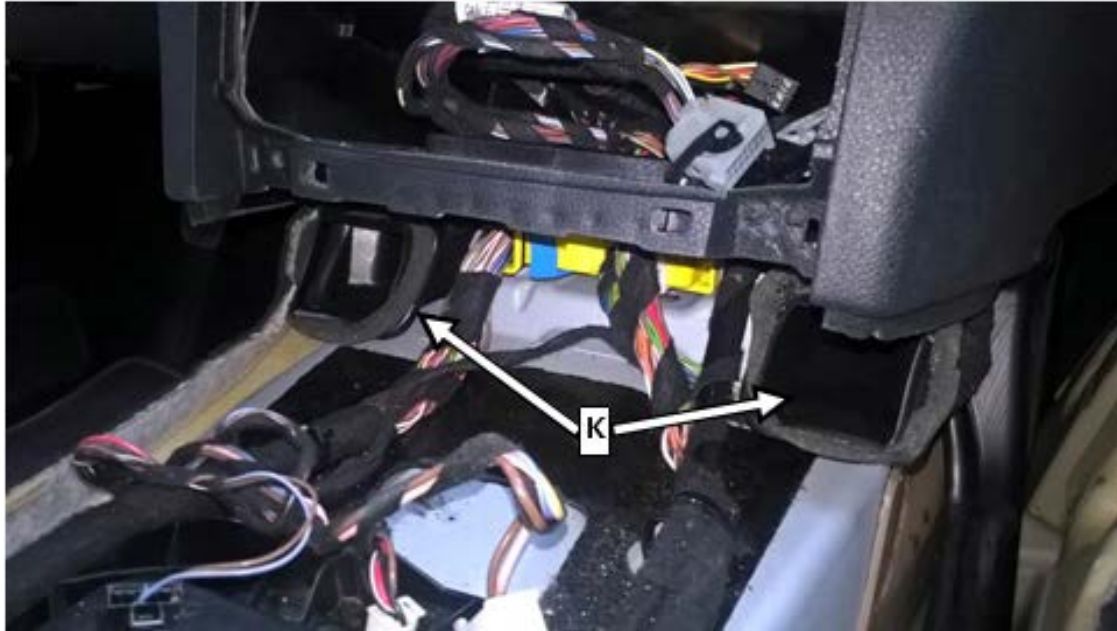
Figure 17

22. Place instrument panel back into position and install the air ducts (**K**, **figure 17**) correctly.

**i** The air ducts are pulled out when the instrument panel is raised.

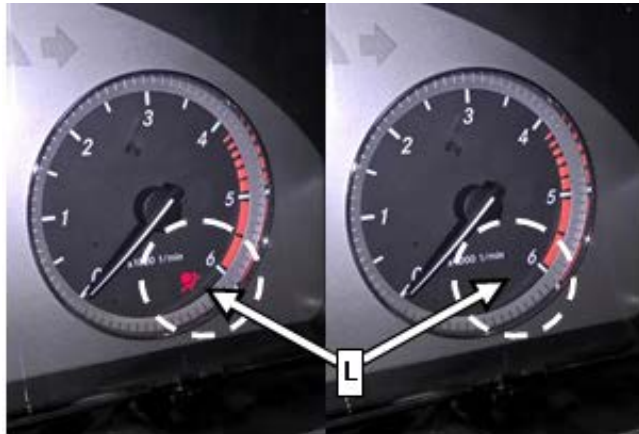
Figure 18

25. Turn the transmitter key in the electronic ignition lock to **position 1** and check whether the airbag indicator lamp (**L**, **figure 18 or 19**) correctly switches off after a few seconds.

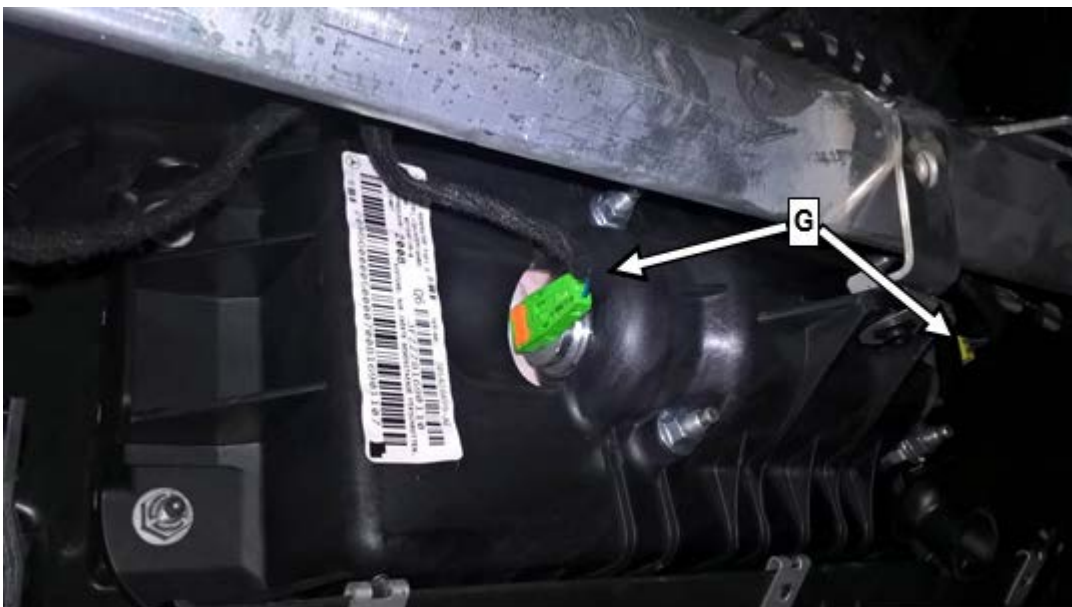
**Figure 2**

5. Disconnect electrical contacts (**G, figure 2**) at the front passenger airbag.

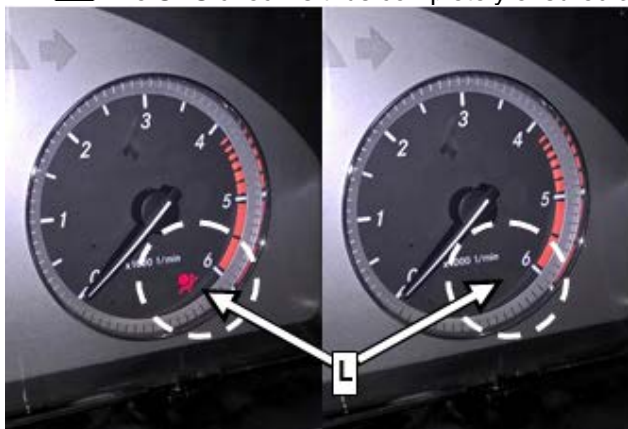
Figure 6

14. Turn the transmitter key in the electronic ignition lock to **position 1** and check whether the airbag indicator lamp (**L**, **figure 6 or 7**) correctly switches off after a few seconds.

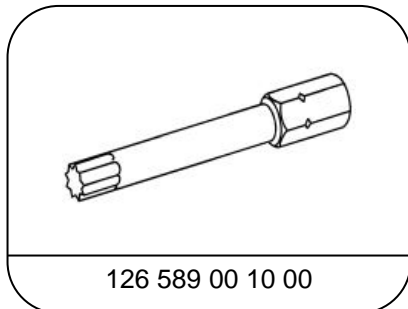
Screwdriver bit

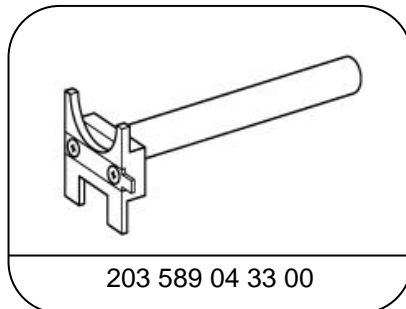
Removal lever

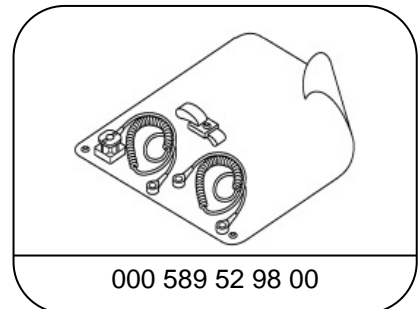
Electro Static Discharge (ESD) kit (or locally sourced equivalent)

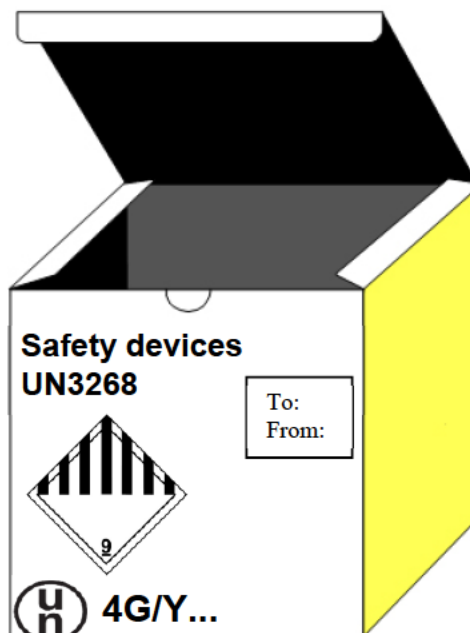
- Note:** The Packing Group and the EX# are no longer required to be printed on the HAZMAT bill of lading.
- Package example:**

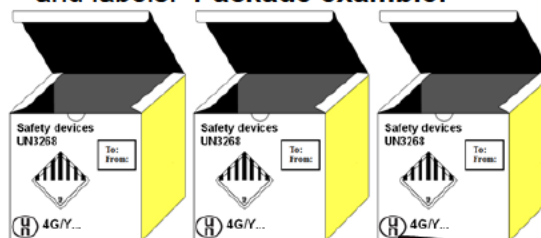
- Package each airbag in a separate UN spec box prepared with the labels/markings described above.
- Place each individual airbag box inside a larger non-UN spec box to keep the shipment together.
- This larger box is called an "OVERPACK."

- The OVERPACK must have the identical markings and label as the boxes contained inside.
- The OVERPACK must have the "OVERPACK" statement on the same face as the hazard markings and labels. **Package example:**
