Safety Recall Campaign
SC-84

Safety Recall Campaign Front Passenger Seat Occupant Classification System Campaign 4014

Affected Models: Certain 2006 - 2013 Suzuki Grand Vitara (JB627 / JB632W / JB424W)

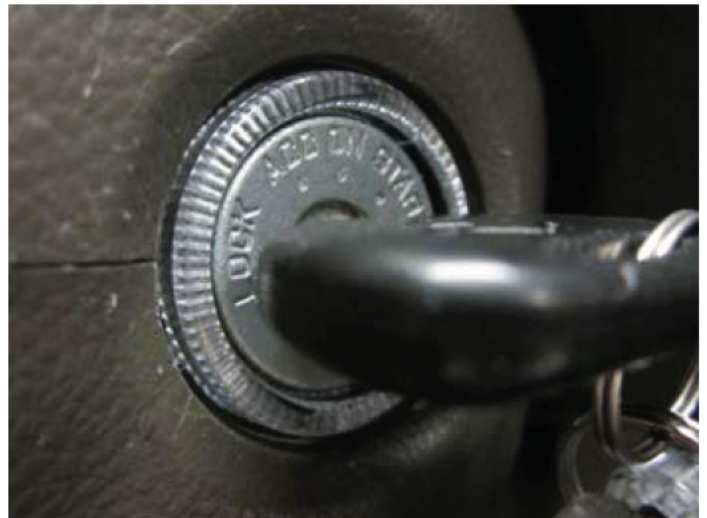
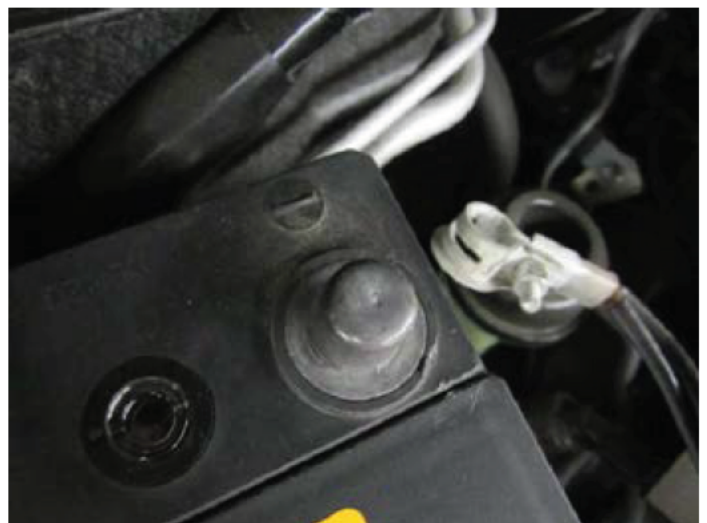
1. Record the radio presets then turn the ignition switch to the LOCK position and remove the key.
2. Disconnect the battery negative (-) cable and wait at least 90 seconds before proceeding.

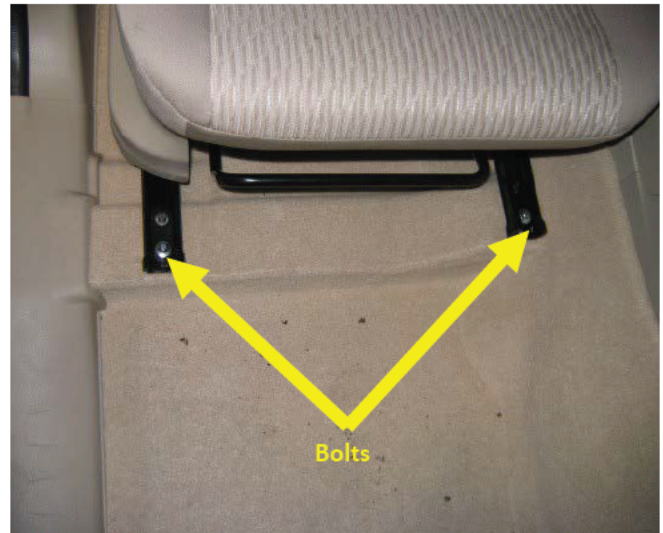
3. Remove the four seat track mounting bolts (2 front, 2 rear) securing the seat to the floor.

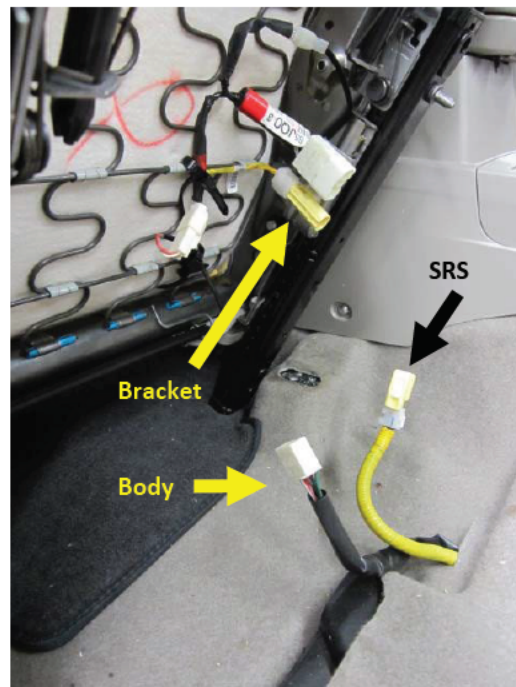
4. Under the seat, locate the body and SRS harnesses that are routed through from the carpet near the ventilation duct. Disconnect the connectors at the sub-harness bracket, then remove the seat from the vehicle.

The figure provided here is for component location identification only. Be careful not to move the seat in such a way as to damage the harnesses.

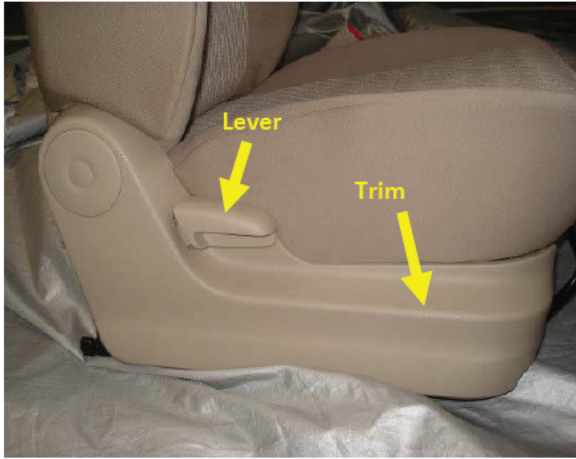
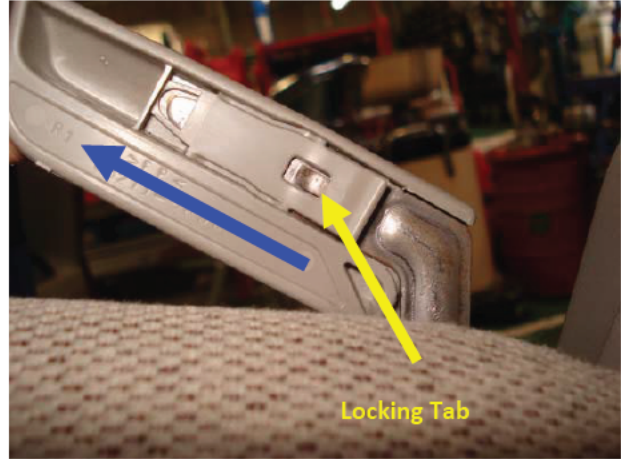
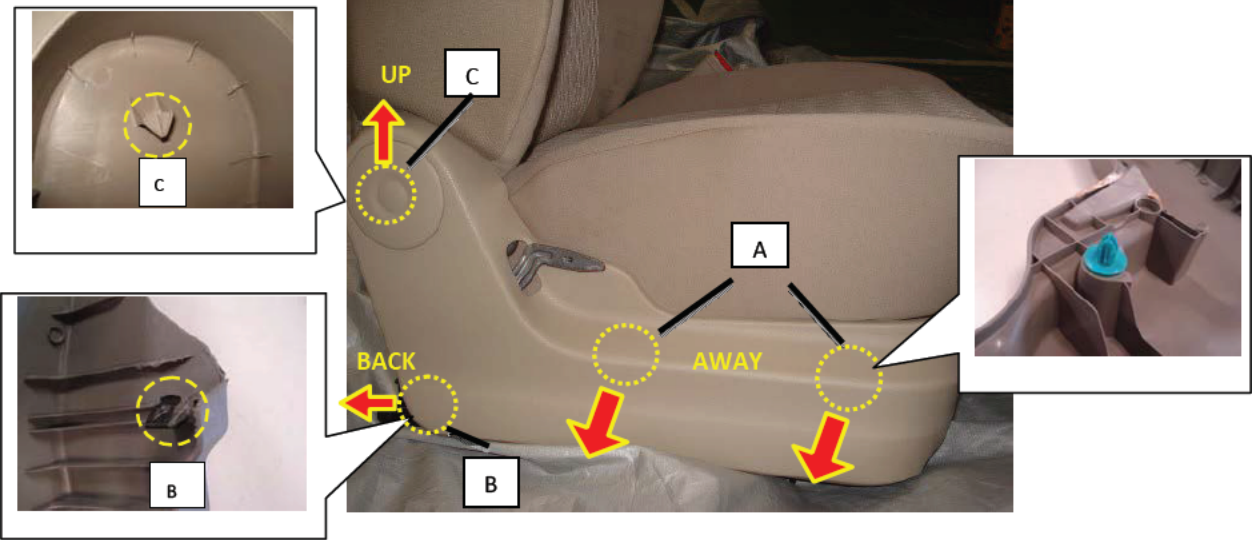
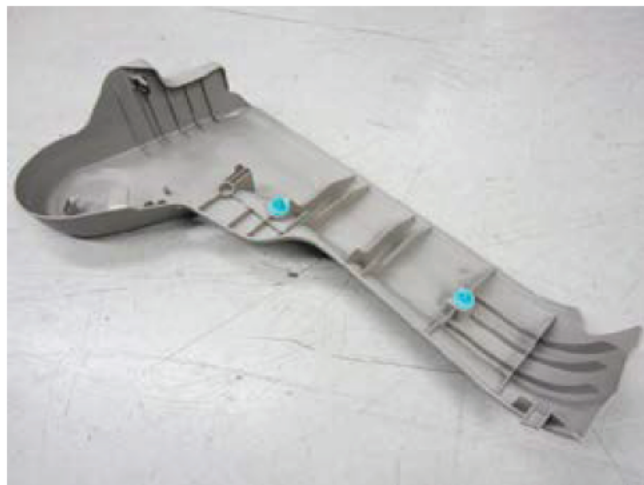
5. Remove the plastic handle from the seat retractor lever, then remove the right side plastic trim.
- a. Disengage the locking tab behind the lever and remove the plastic handle from the seat retractor lever on the right side of the seat by sliding the lever cover from the lever.
 - b. Remove the right side plastic trim. Take note of fastening points A, B and C.

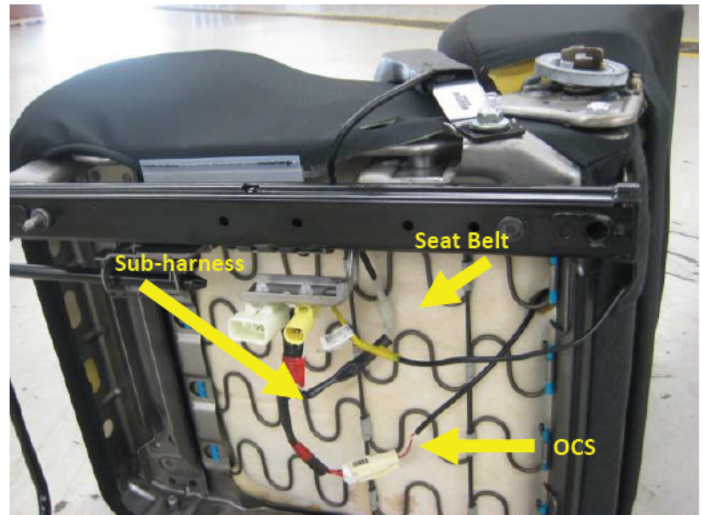
7. Remove and set aside the tie-straps fastening the harnesses to the seat cushion spring(s) for reuse.
8. Disconnect the seat belt harness connector from the sub-harness.
9. Disconnect the OCS harness connector from the sub-harness.
10. Disconnect the seat heater harness connector (if equipped) from the sub-harness.

6. Before disconnecting any connectors or releasing the harness tie-straps, position the seat for access to the seat bottom and record the layout of each harness (OCS, side air bag, seat belt, and heater if equipped), and mark the tie-strap locations at the seat cushion spring(s).

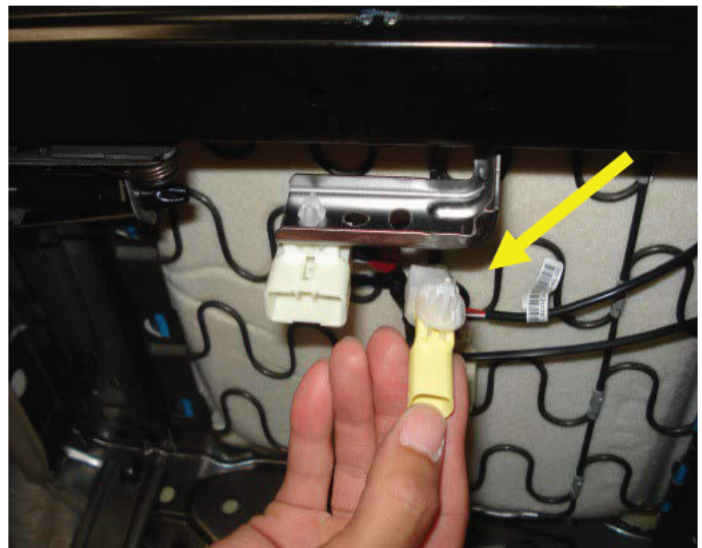
11. Disconnect the side air bag harness connector from the sub-harness bracket.

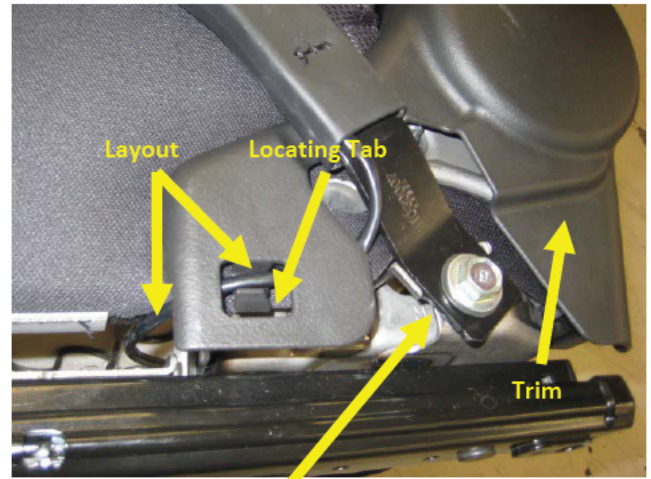
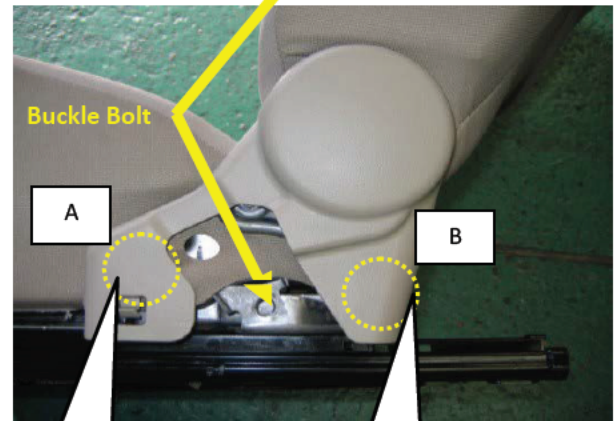
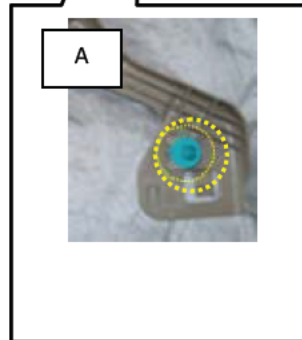
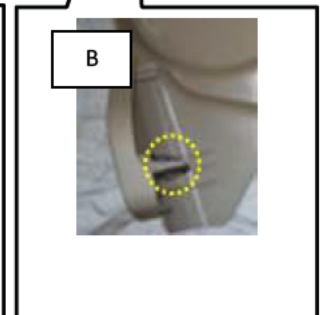
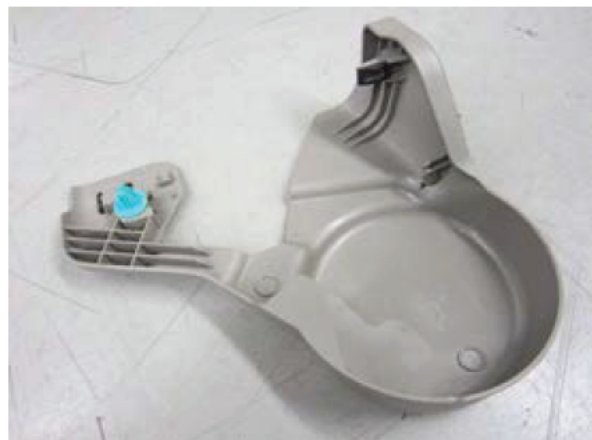
12. To help during reassembly, record the seat belt buckle wire harness layout at the harness locating tab of the left side plastic trim, and between the seat track and cushion.
13. Remove the seat belt buckle and the left side plastic trim. Take note of trim fastening points A and B.

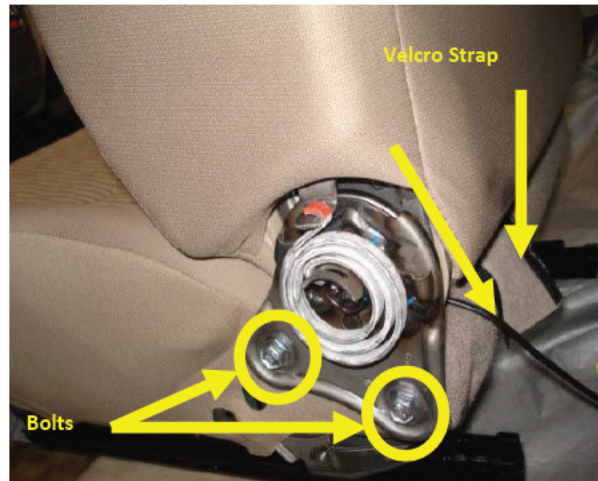
14. Record the position of the Velcro strap and the layout of the side air bag harness, then lift the strap to release the SRS harness from the lower seat cushion.
15. Remove the four bolts (two on each side) holding the seat back assembly to the seat cushion assembly, then separate the two assemblies from each other.

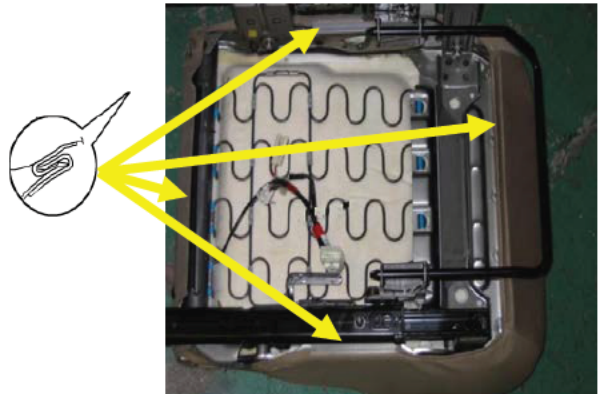
16. Release all four retaining strips of the seat bottom fabric/leather from the seat frame.

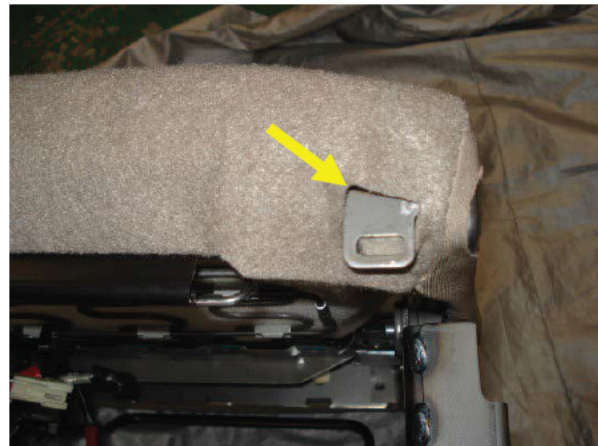
17. Release the trim sub-assembly from the two rear side cover fitting stays located on the rearward side of the seat frame.

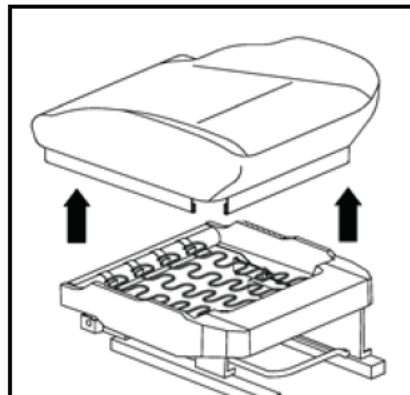
18. Remove the trim sub-assembly from the seat frame.

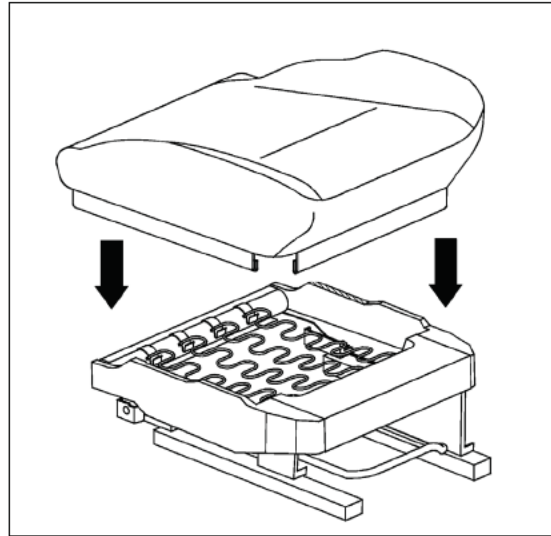
1. Install the new trim sub-assembly to the seat frame.

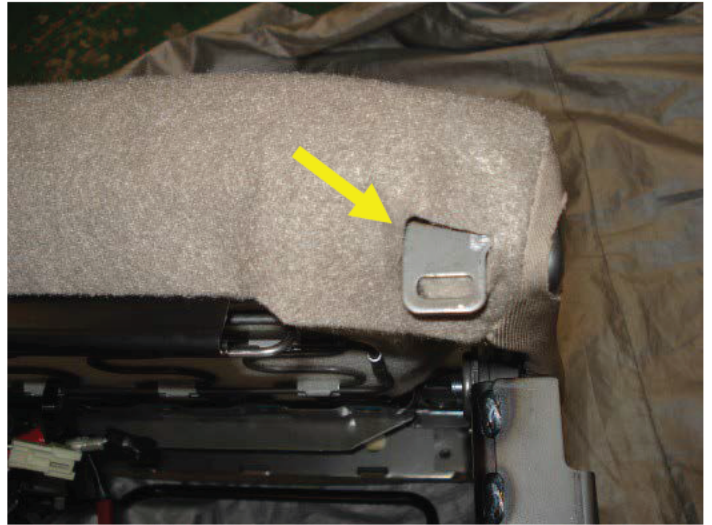
2. Fasten the trim sub-assembly at the two rear side cover fitting stays located on the rearward side of the seat frame.

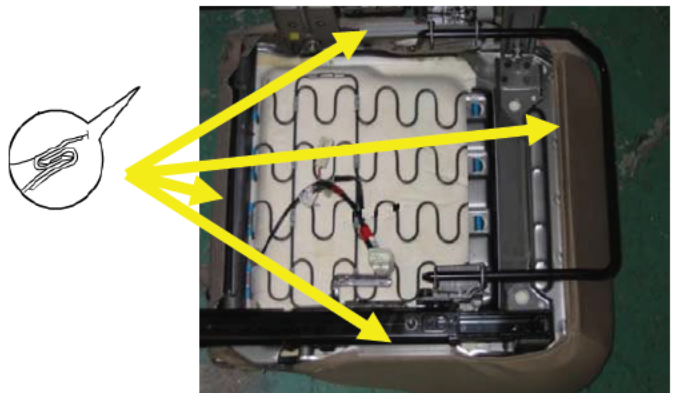
3. Secure all four retaining strips of the seat bottom fabric/leather to the seat frame.

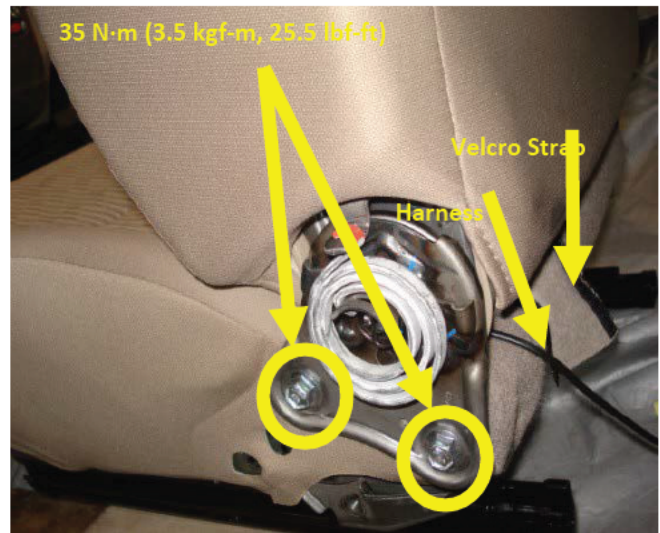
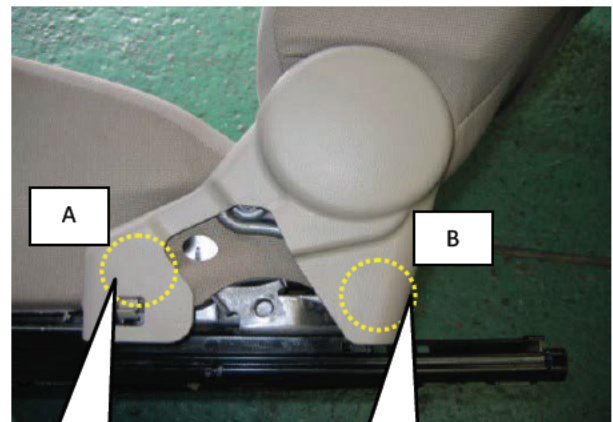
4. Install the four bolts (2 on each side) holding the seat back assembly to the seat cushion assembly.

Torque: 35 N•m (3.5 kgf-m, 25.5 lbf-ft)

5. Position the side air bag harness following the original layout and secure the Velcro strap.

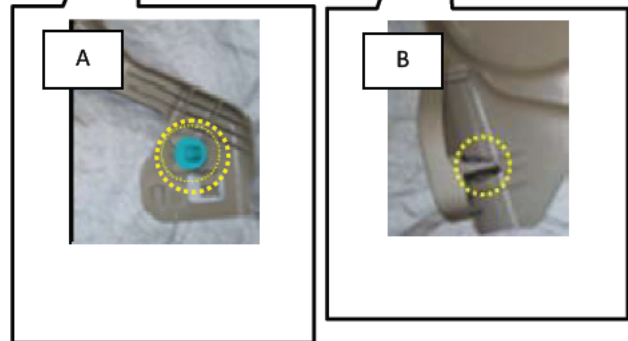
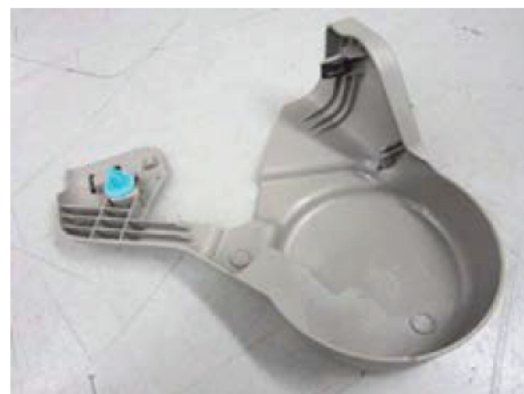
6. Install the left side plastic trim.

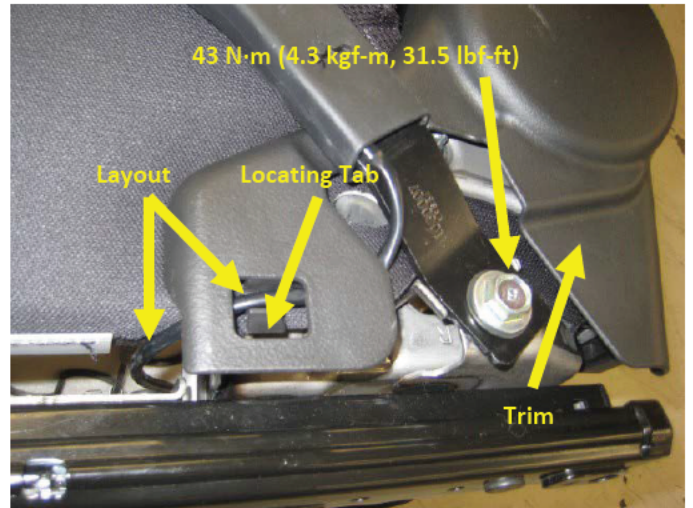
7. Install the seat belt buckle.

Torque: 43 N•m (4.3 kgf-m, 31.5 lbf-ft)

8. Position the seat belt buckle wire harness following the original layout.

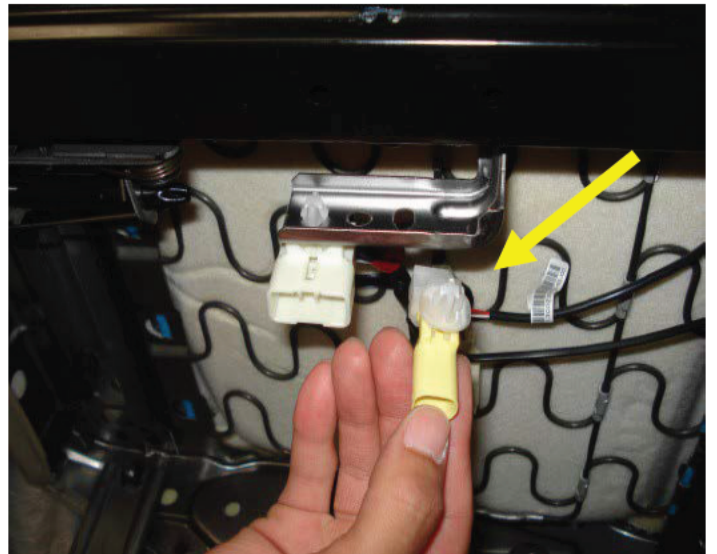
9. Connect the side air bag harness connector to the sub-harness bracket.

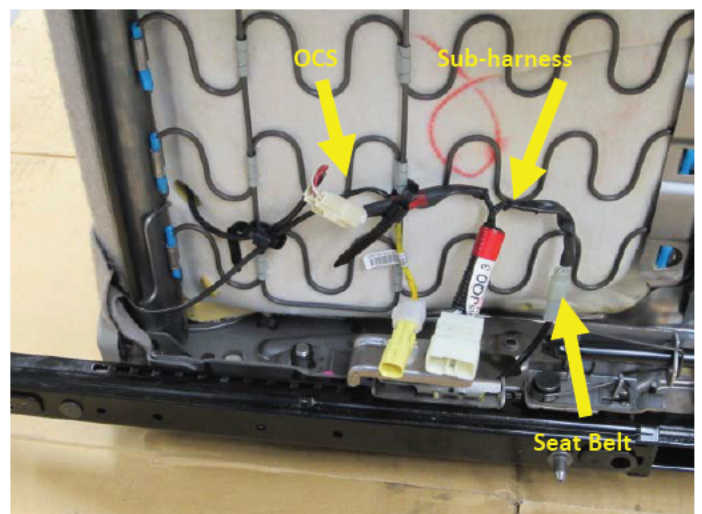
10. Position the seat heater harness (if equipped) following the original layout and connect the connector at the sub-harness.

11. Position the OCS harness following the original layout and connect the connector to the sub-harness.

12. Position the seat belt harness following the original layout and connect the connector to the sub-harness.

13. Install the tie-straps to the original location(s) on the seat cushion spring(s) and secure the harnesses following the original layout.

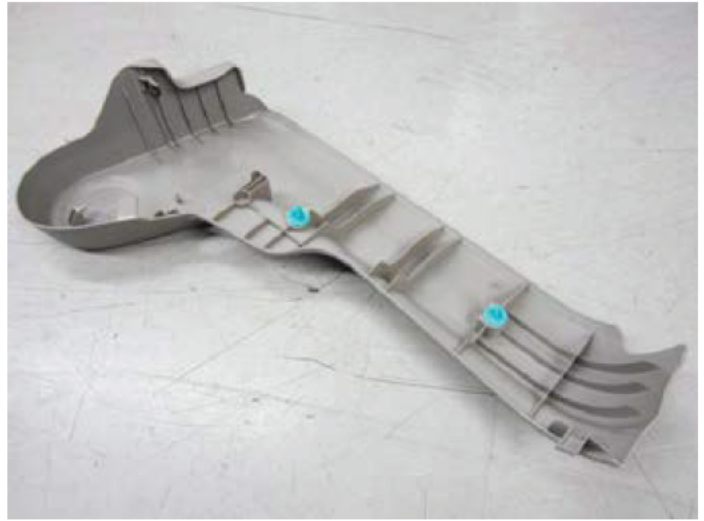
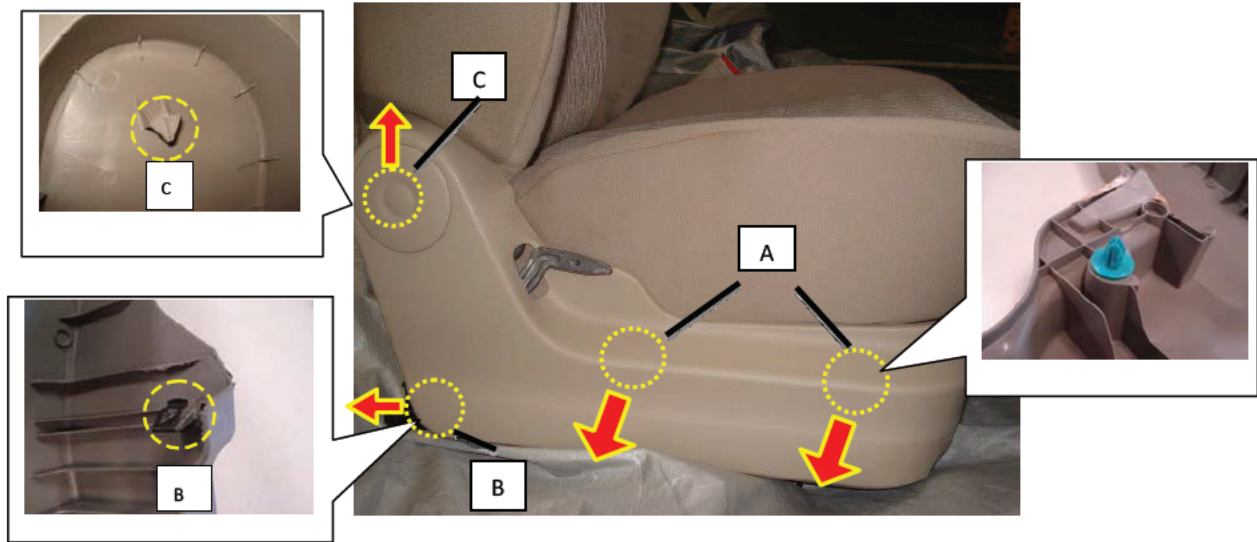
14. Install the right side plastic trim.

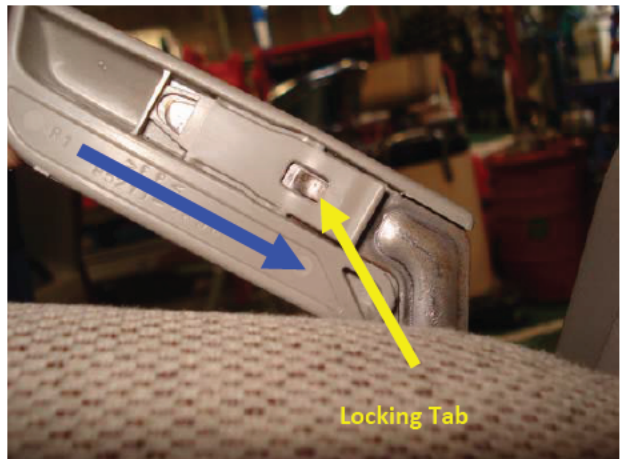
15. Install the plastic handle to the seat retractor lever.

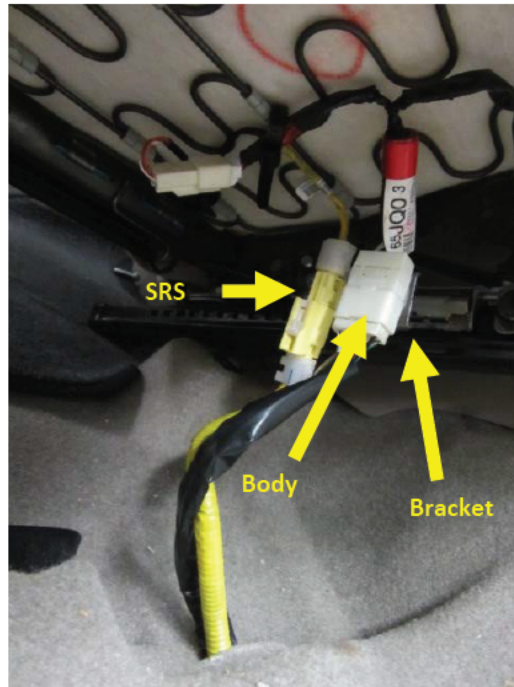
16. Set the seat in the vehicle and connect the body and SRS harness connectors to the connections at the sub-harness bracket.

The figure provided here is for component location identification only. Be careful not to move the seat in such a way as to damage the harnesses.

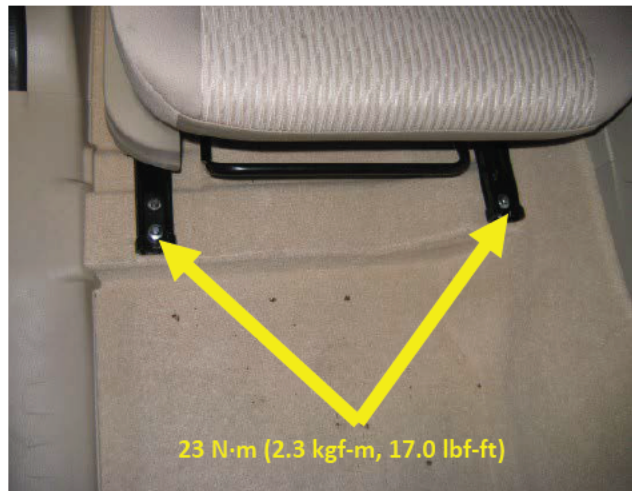
17. Install the four seat track mounting bolts (2 front, 2 rear) securing the seat to the floor.

Torque: 23 N•m (2.3 kgf-m, 17.0 lbf-ft)

18. Move the passenger seat completely back and forth to confirm the seat moves smoothly and is unobstructed.

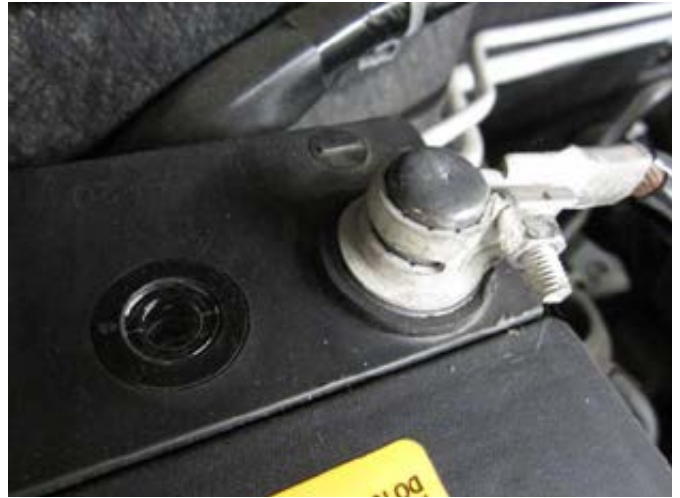
19. Connect the battery negative (-) cable and enter the vehicle owner's radio presets previously recorded.

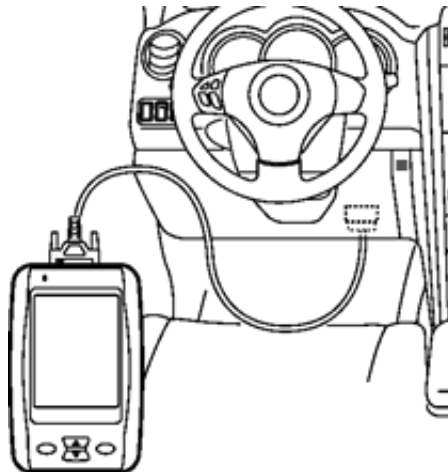
20. Without a passenger in the right front passenger seat, connect the SDT to the Data Link Connector (DLC) and clear all DTC codes.

- a. There are no DTC codes present.
- b. The AIR BAG warning light flashes six times, then turns **OFF** during the system check when the ignition switch is turned to the **ON** position.
- c. The Passenger Seat Belt Reminder light does not illuminate when turning the ignition switch to the **ON** position.
