Safety Recall Campaign
SC-85

Safety Recall Campaign Front Passenger Seat Occupant Classification System Campaign 4015

Affected Models: Certain 2010 - 2013 Kizashi

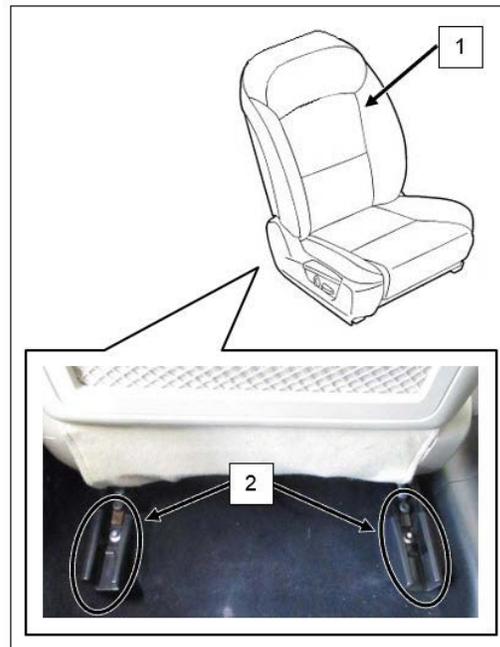
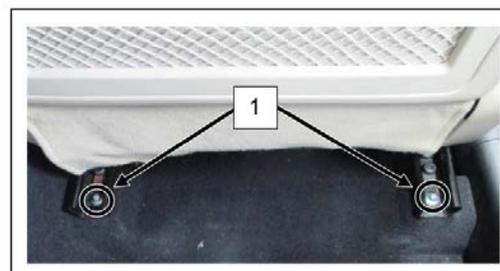
1. Record the radio presets then turn the ignition switch to the LOCK position and remove the key.
2. Make a note of the customer's seat position.
3. Disconnect the battery negative (–) cable and wait at least 90 seconds before proceeding.
4. Position the front wheels to be pointing straight ahead.
5. Position the passenger seat back so it is vertical.
6. Slide the seat assembly forward (1) and remove the lower rail end covers (2).
7. Remove lower rail bolts (1).

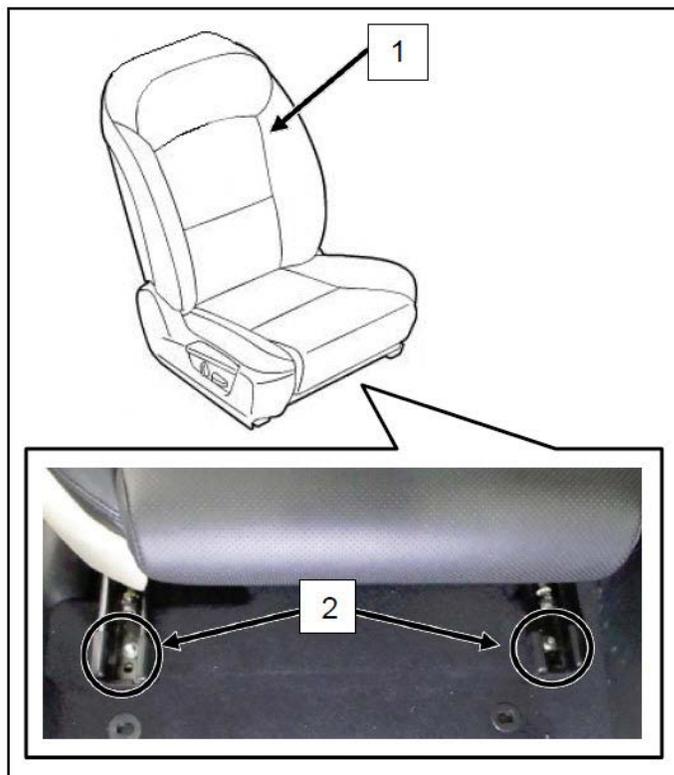
8. Slide the passenger seat assembly (1) backward and remove the lower rail front end covers (2).

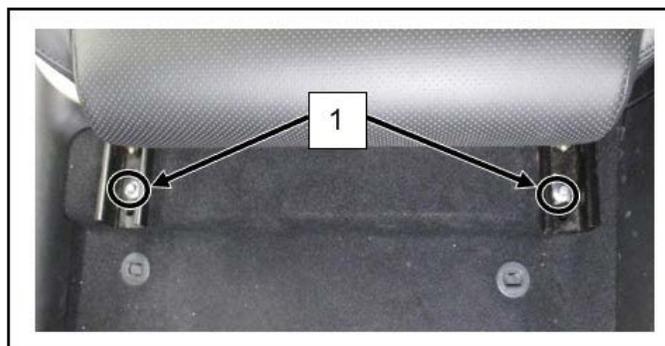
9. Remove the lower rail bolts (1).

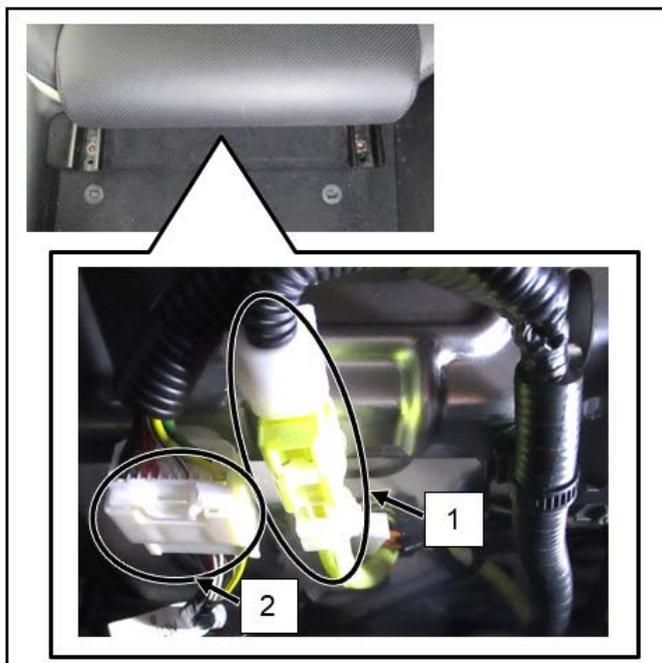
11. Disconnect the side air bag harness connector (1) and seat sensor harness connector (2) from the floor harness.

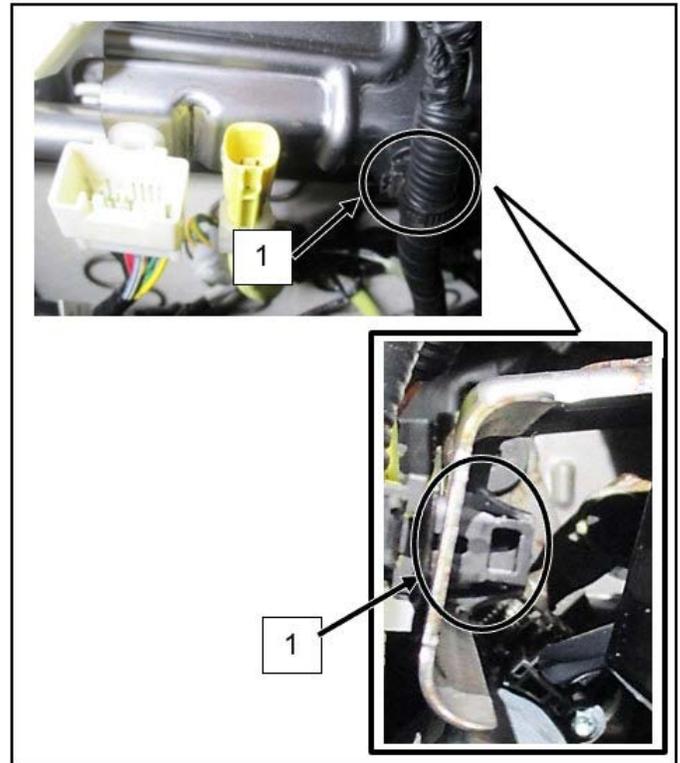
12. Remove the floor harness clamp (1) from the cushion frame assembly.

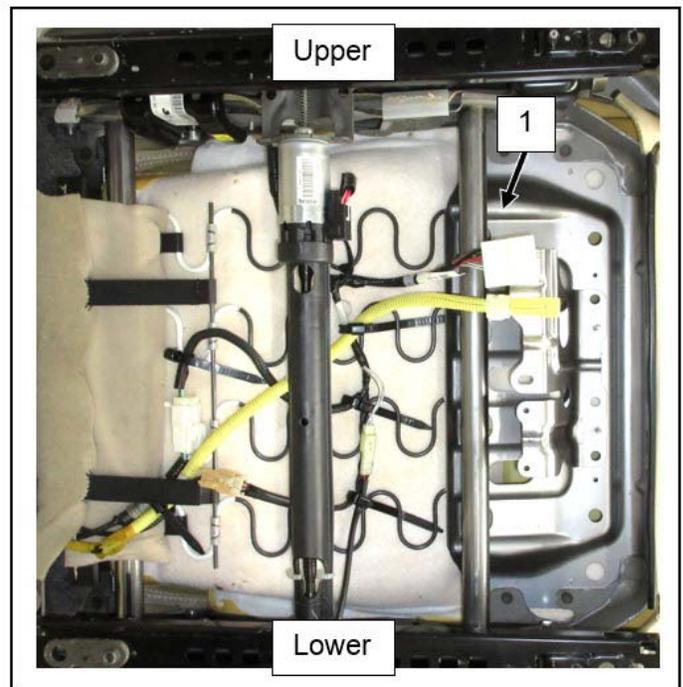
13. Dismount the passenger seat assembly (1) from the vehicle, and place the passenger seat assembly (1) in the position as shown.

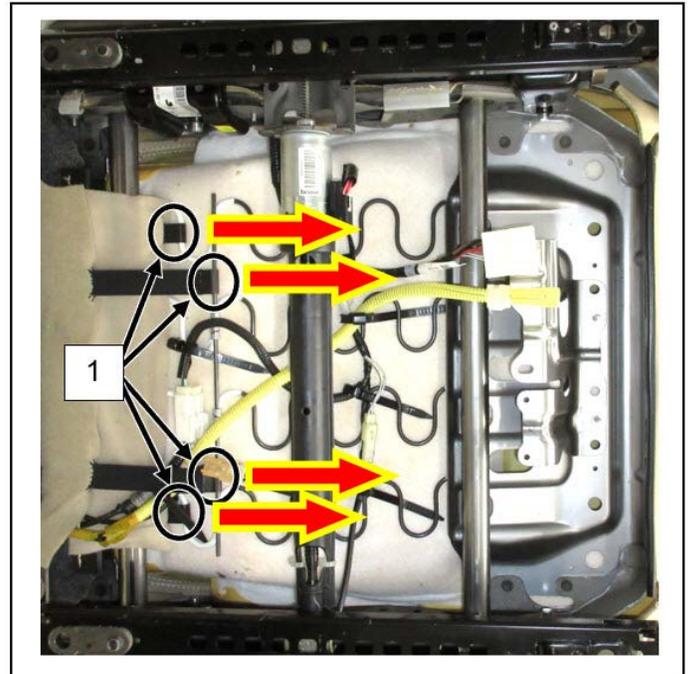
14. Pull the hooks (1) of the cushion trim sub-assembly in the direction of the arrows as shown and remove them from the from the cushion frame assembly.

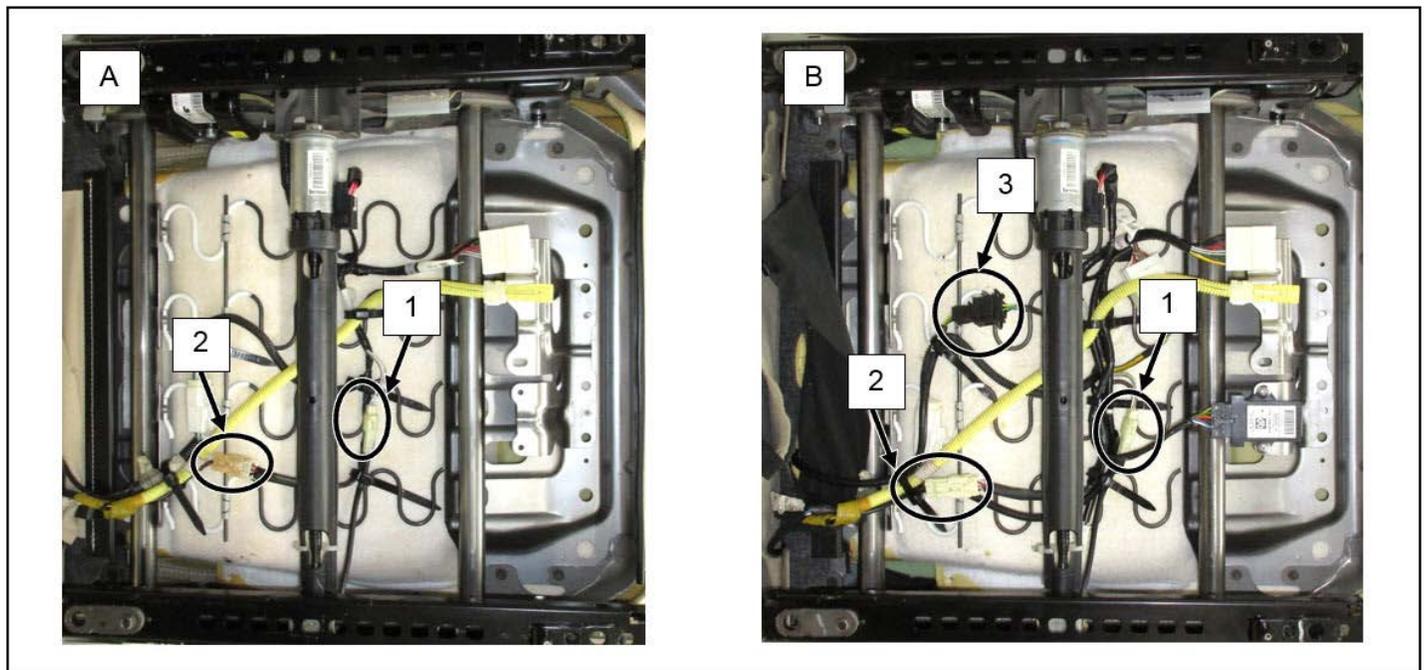
15. Disconnect the seat belt harness connector (1), OCS harness connector (2), and seat heater harness connector (3) (for vehicles equipped with a seat heater).

A. Without seat heater

B. With seat heater

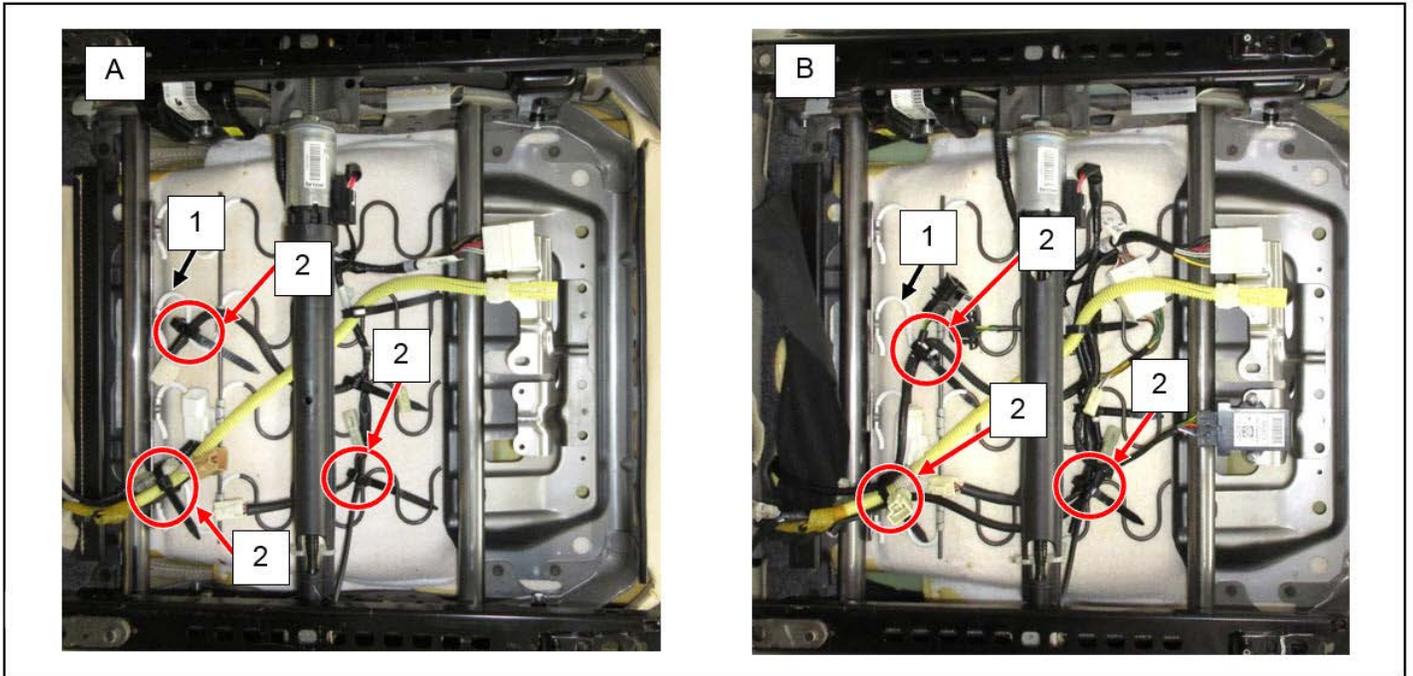
16. Mark the seat cushion springs (1) and each harness that is bundled with ties (2) on the locations where they are attached. Then detach the ties (2).

A. Without seat heater

B. With seat heater

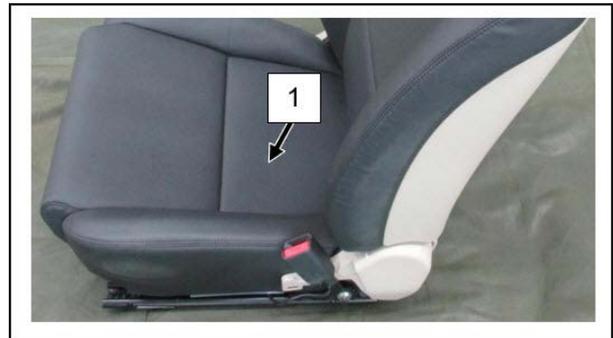
17. Place the passenger seat assembly (1) in the position as shown.

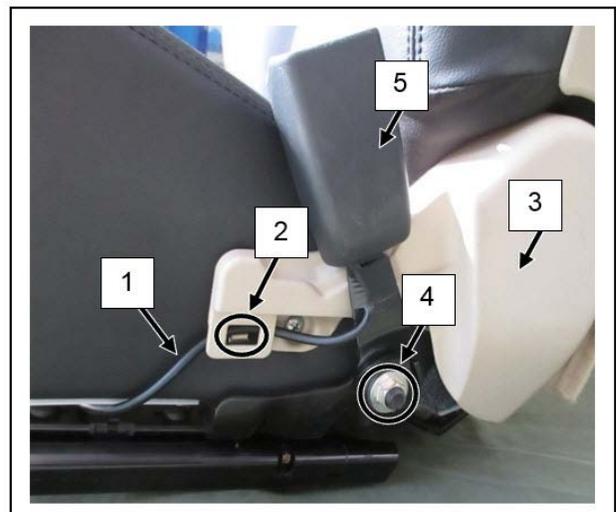
18. After detaching the seat belt harness (1) from the crow (2) of the reclining inside cover (3), remove the bolt (4) and seat belt buckle (5).

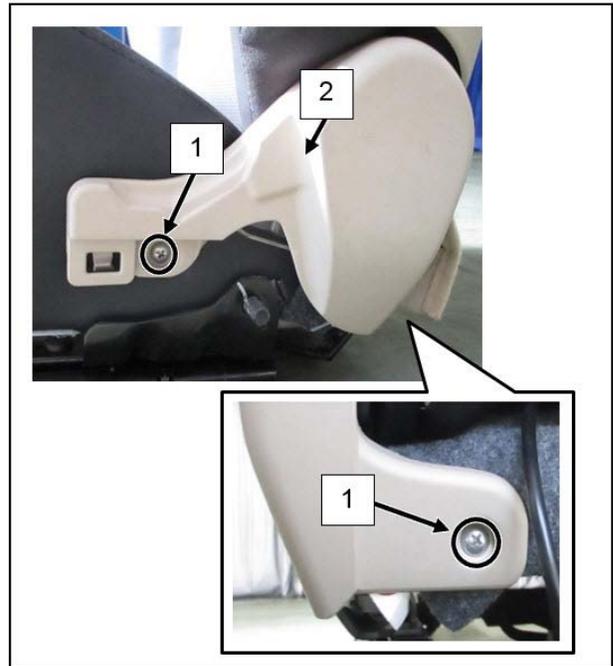
19. Remove the screws (1) from the reclining inside cover (2).

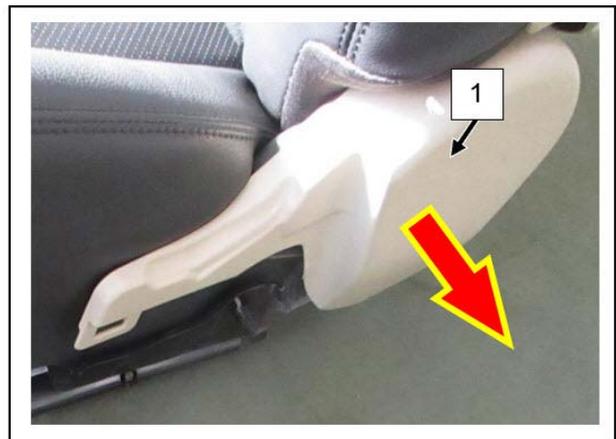
20. Remove the reclining inside cover (1) in the direction of the arrow as shown.

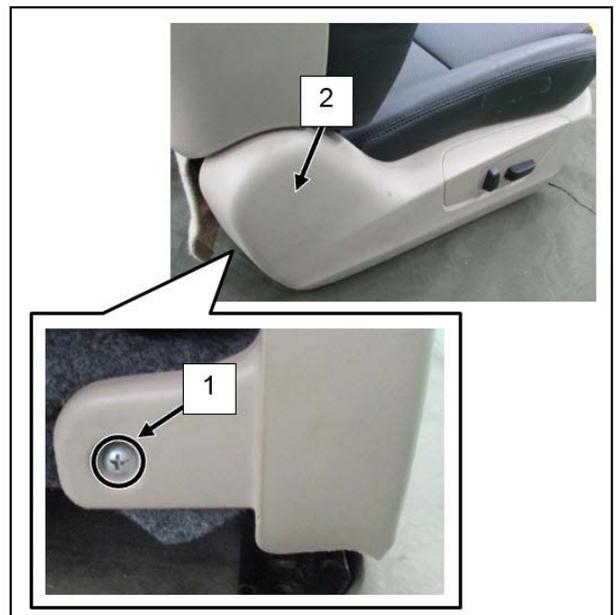
21. Remove the screw (1) from the reclining outside cover (2).

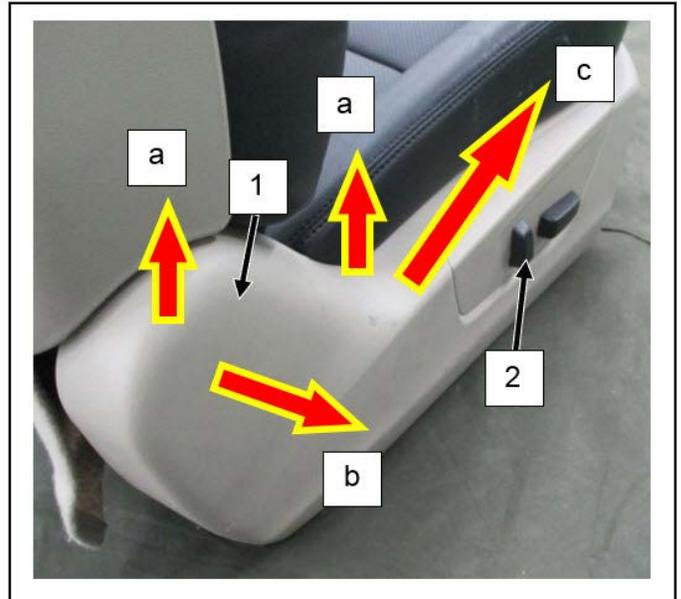
22. Remove the reclining outside cover (1) in the direction of the arrows as shown in alphabetical order (a – c).

The power seat switch (2) is connected to a harness. If the reclining outside cover (1) is removed to aggressively, the harness may be damaged.

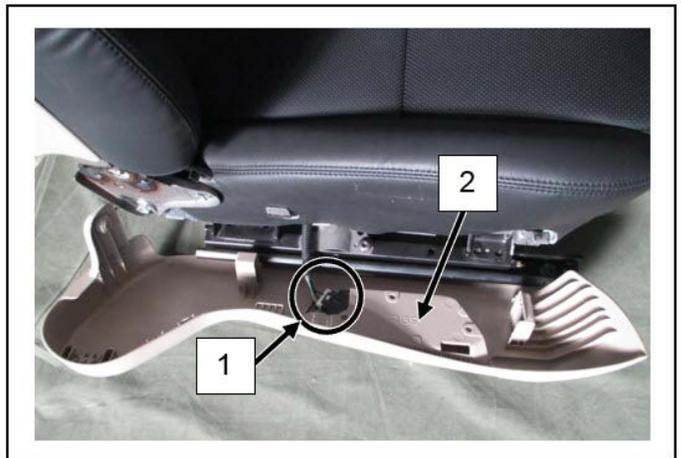
23. Disconnect the harness connector (1) from the reclining outside cover (2).

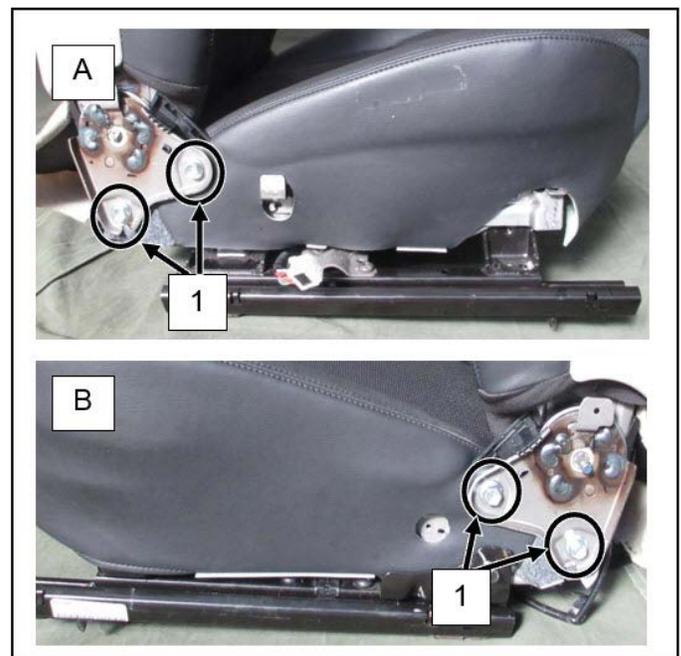
24. Remove the seat back mounting bolts (1).

- A. Outside
- B. Inside

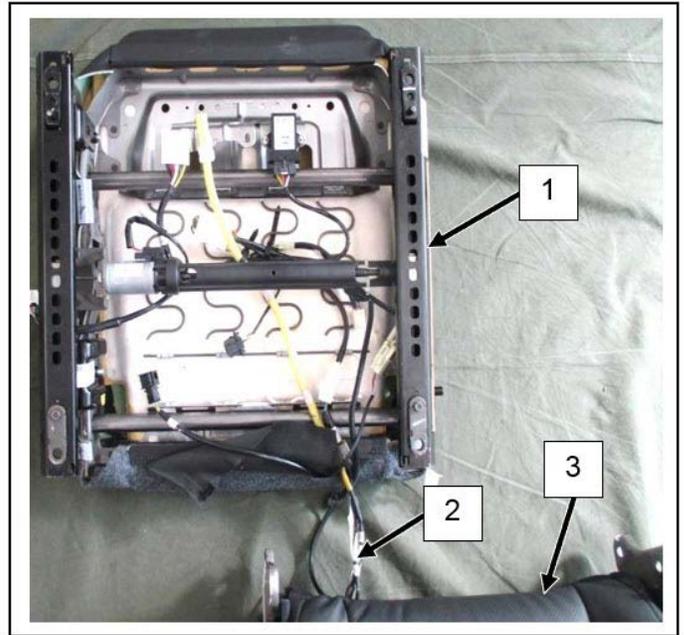
25. Place the cushion assembly (1) in the position as shown without disconnecting the harness (2) between the cushion assembly (1) and the seat back assembly (3).

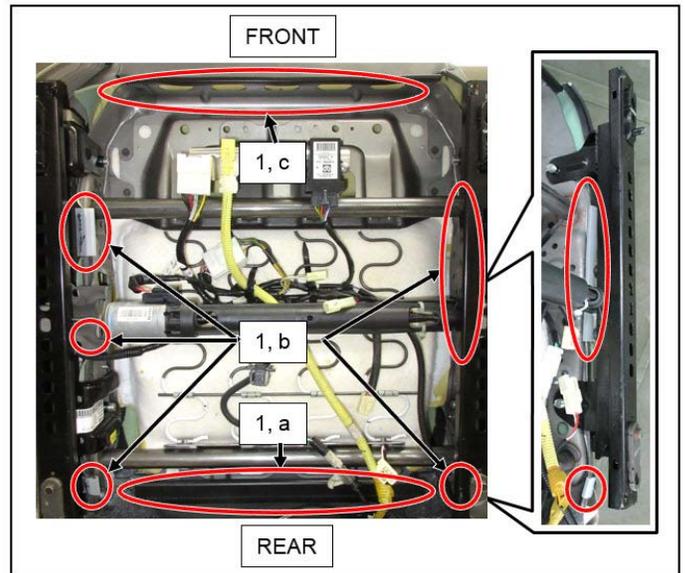
26. Remove the cushion trim sub-assembly hooks (1) from the seat frame in alphabetical order (a – c).

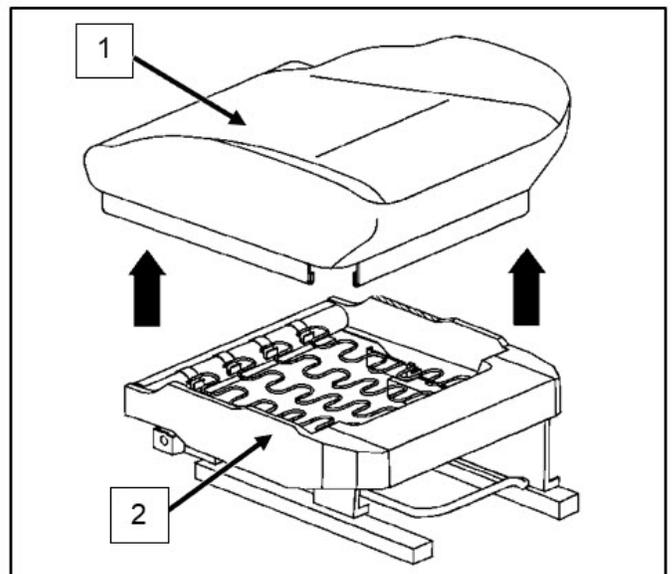
27. Remove the cushion trim sub-assembly (1) from the cushion frame assembly (2).

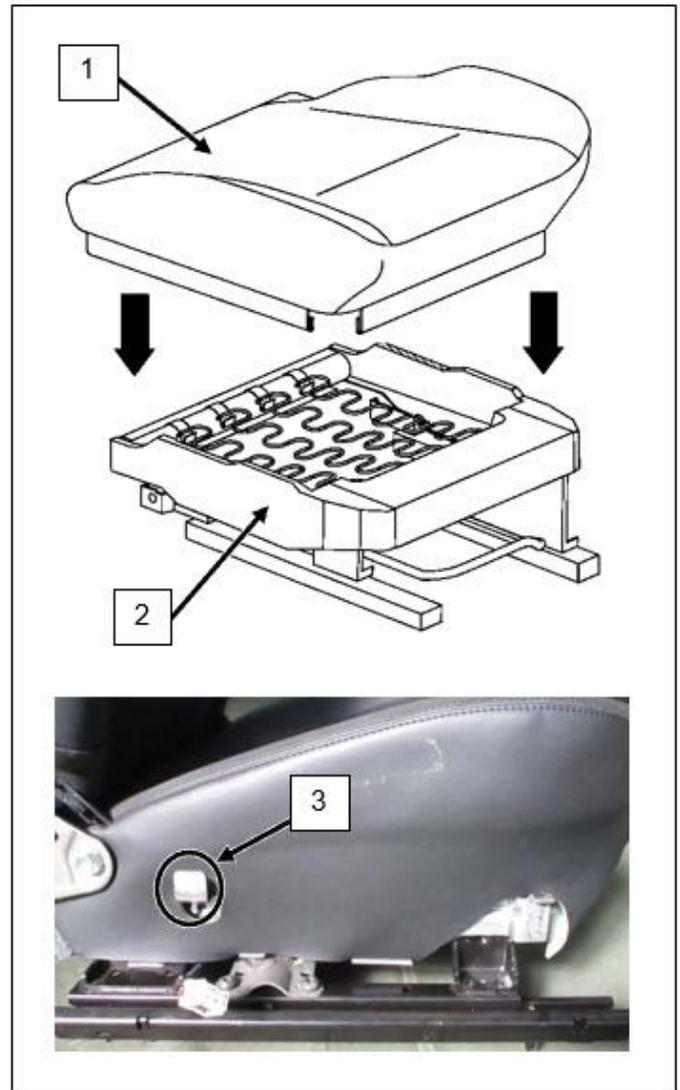
1. Install the new cushion trim sub-assembly (1) onto the cushion frame assembly (2).

2. Pass the hook (3) of the cushion frame assembly (2) through hole of the cushion trim sub-assembly (1).

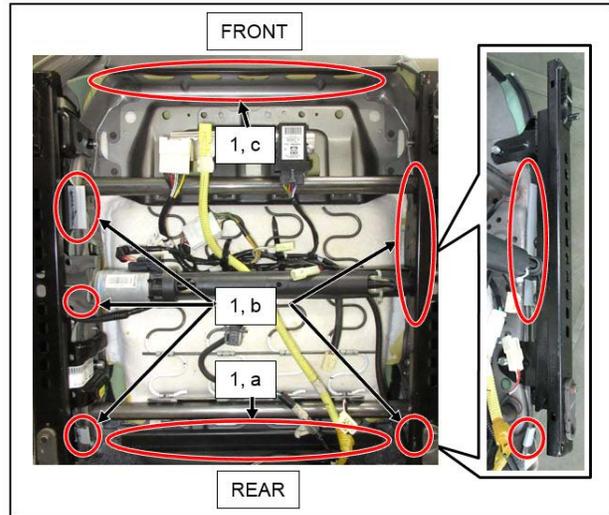
3. Connect the hooks (1) of the cushion trim sub-assembly to the cushion frame assembly in alphabetical order (a – c).

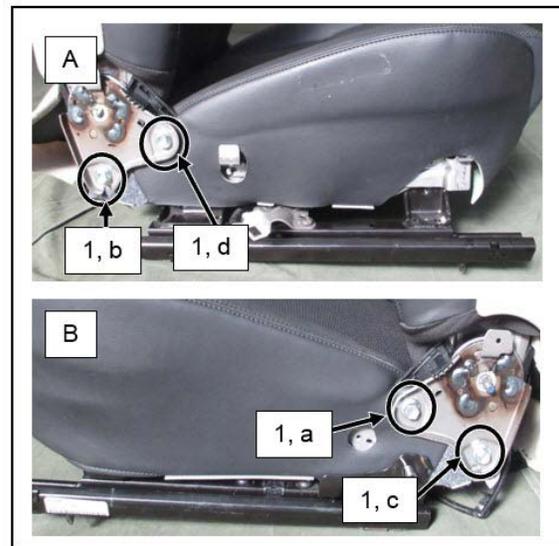
4. Tighten the seat back mounting bolts (1) to the specified torque in alphabetical order (a – d).

- A. Outside
- B. Inside

35 N•m (3.5 kgf-m, 25.5 lbf-ft)

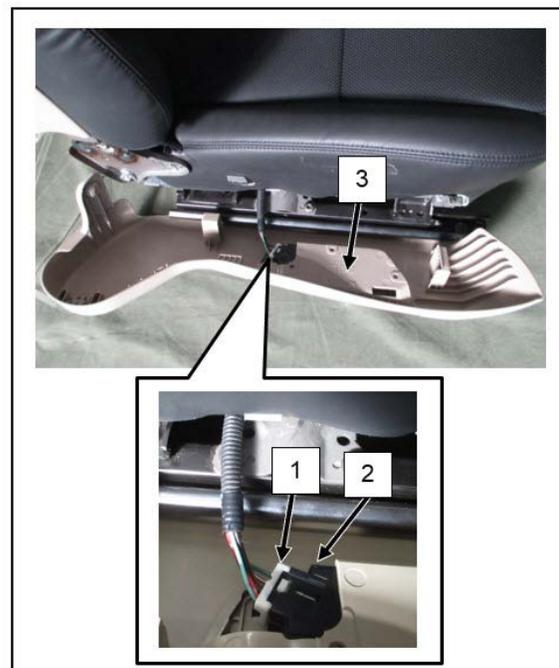
5. Connect the harness connector (1) to the power seat switch (2) of the reclining outside cover (3).

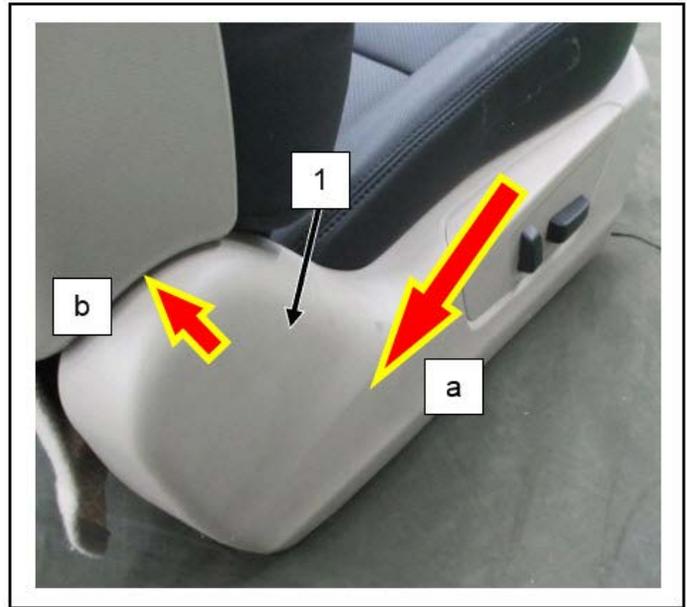
6. Install the reclining outside cover (1) in the direction of the arrows in alphabetical order (a – b).

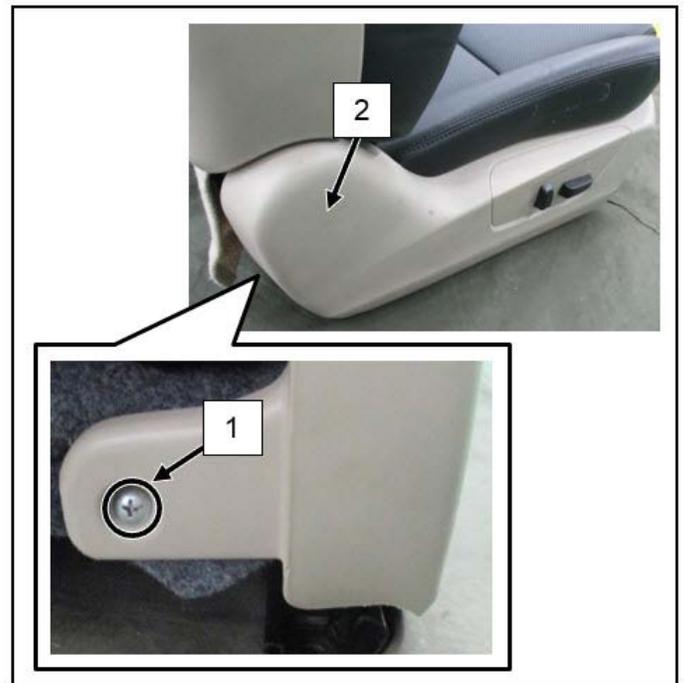
7. Tighten the screw (1) of the reclining outside cover (2).

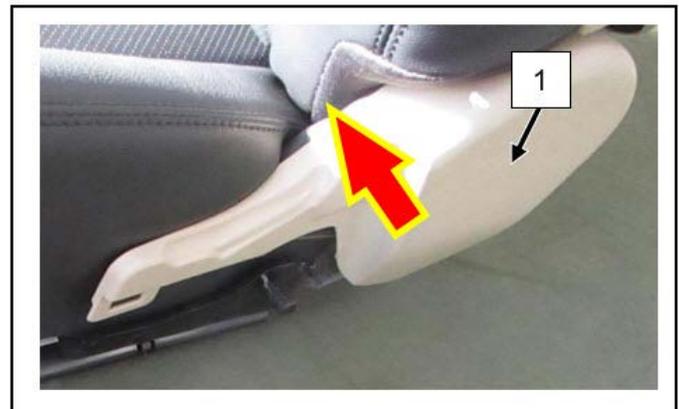
8. Install the reclining inside cover (1) in the direction of the arrow.

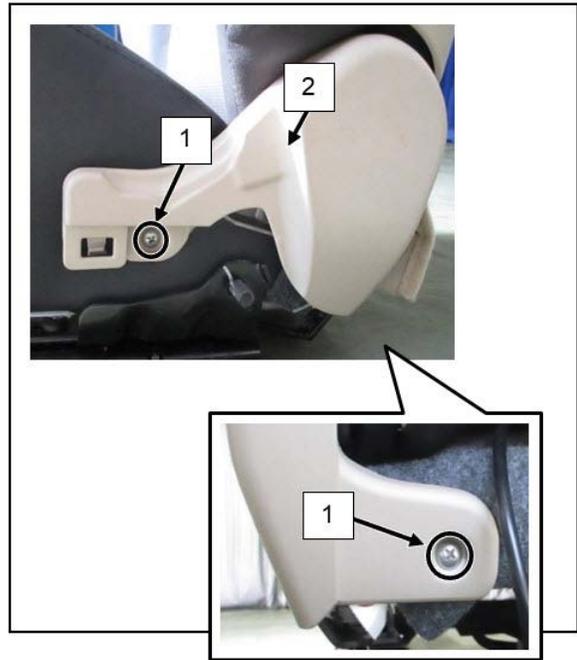
9. Tighten the screws (1) of the reclining inside cover (2).

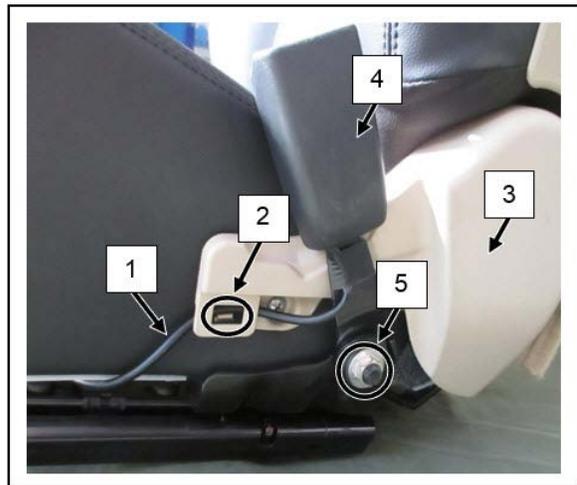
10. After attaching the seat belt harness (1) to the crow (2) of the reclining inside cover (3), install the seat belt buckle (4), and tighten the bolt (5) to the specified torque.

Tightening Torque
43 N•m (4.3 kgf-m , 32.0 lbf-ft)

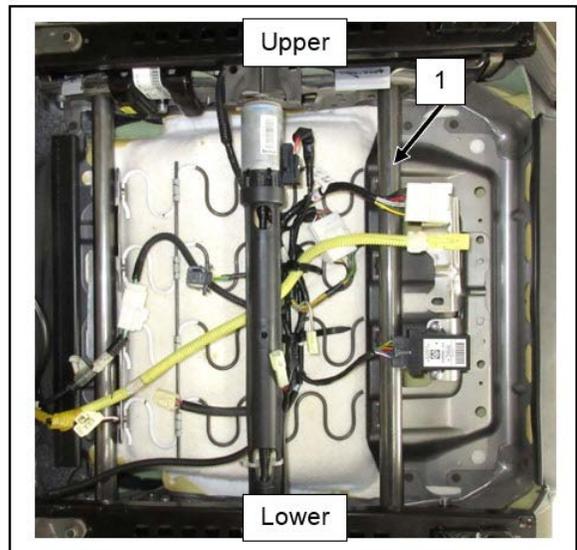
11. Place the passenger seat assembly (1) in the position as shown.

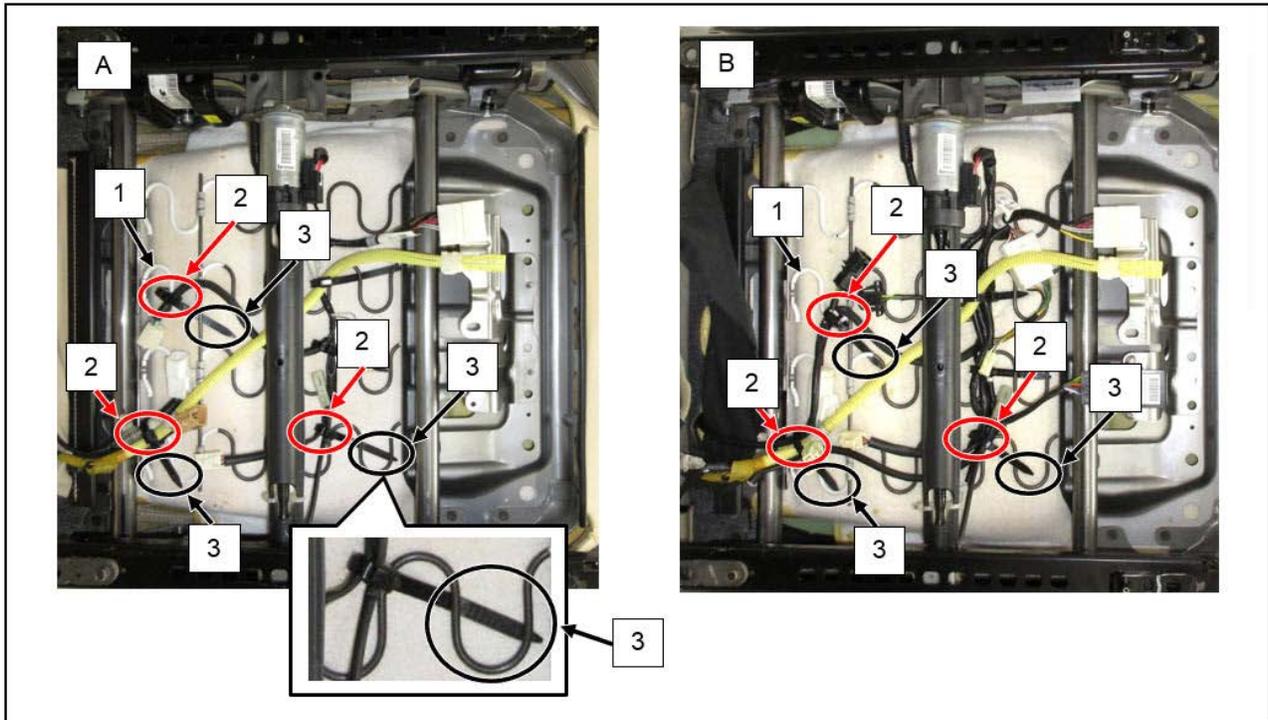
12. Align each mark on the seat cushion springs (1) with the mark on each harness (2). Then insert the rest of the ties (3) between the seat cushion spring and the seat cushion.

A. Without seat heater

B. With seat heater

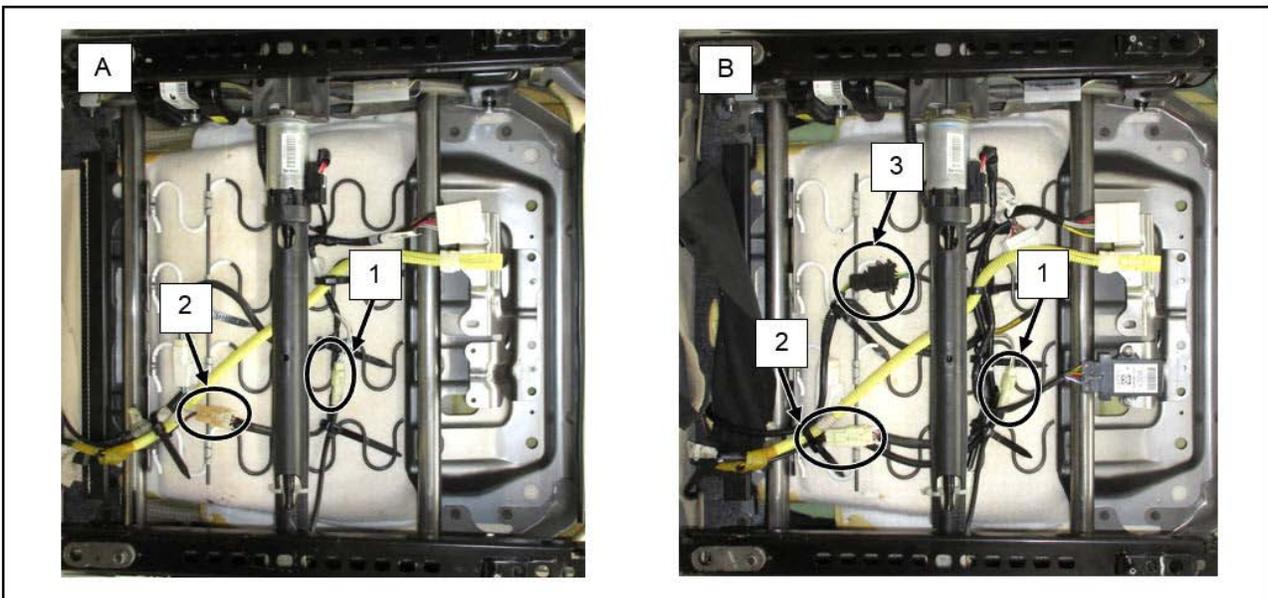
13. Connect the seat belt harness connector (1), OCS harness connector (2), and seat heater harness connector (3) (only for vehicles equipped with a seat heater) to the seat sensor harness.

A. Without seat heater

B. With seat heater

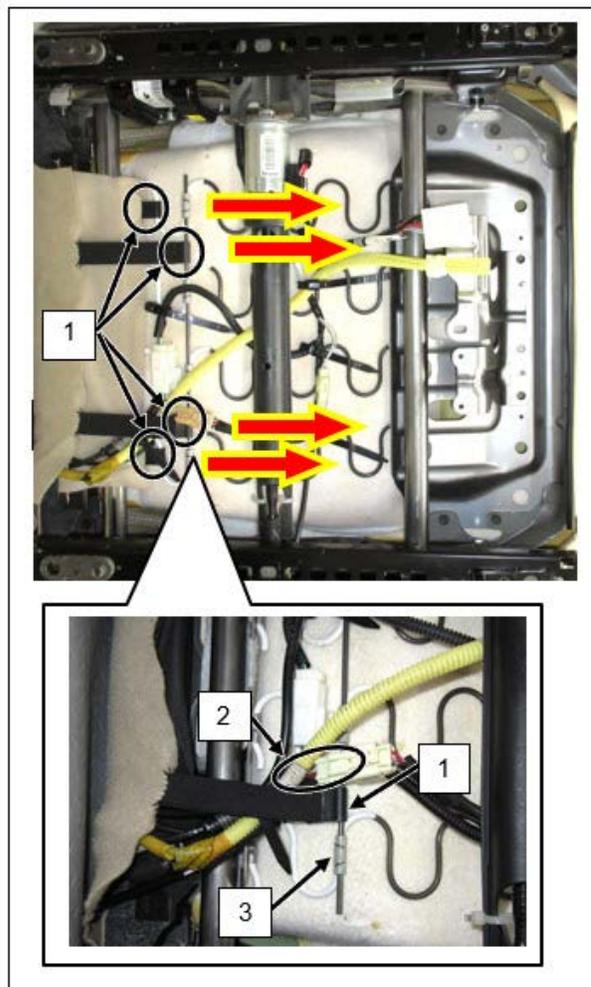
14. Pull the hooks (1) of the cushion trim sub-assembly in the direction of the arrows, and connect the hooks (1) of the cushion trim sub-assembly to the cushion frame assembly.

The OCS harness (2) can be damaged if it comes in contact with the edge of the clasp (3).

To prevent this, hang the hook (1) in the space between the OCS harness (2) and the clasp (3).

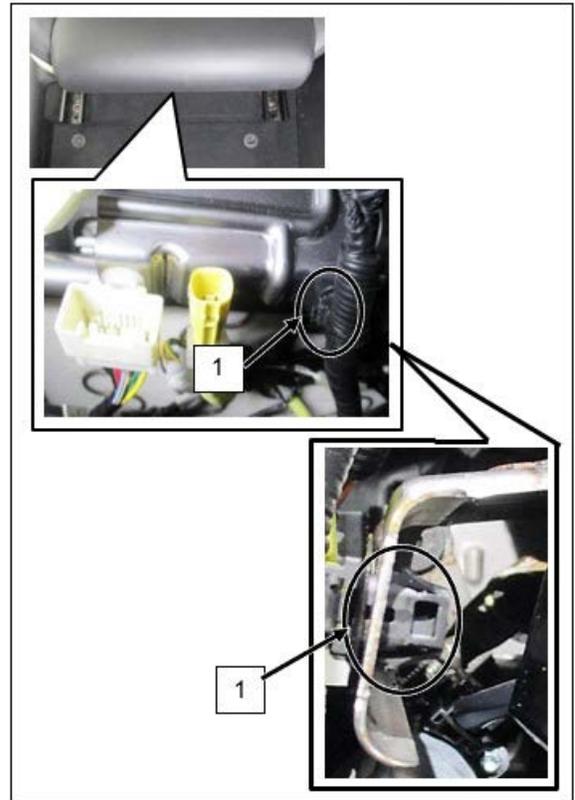
16. Install the floor harness clamp (1) to the cushion frame assembly.

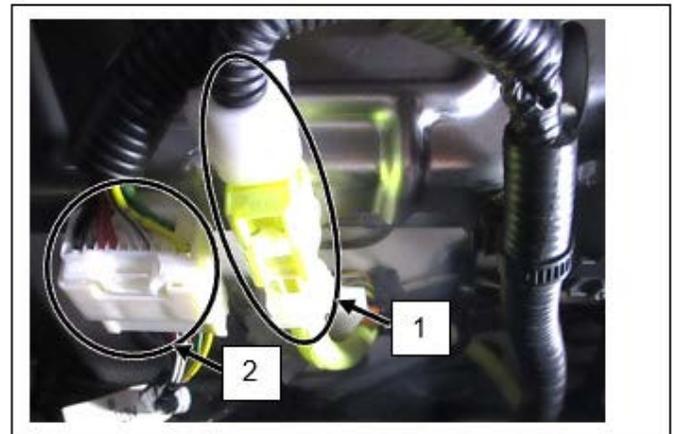
17. Connect the side air bag harness connector (1) and seat sensor harness connector (2) to the floor harness.

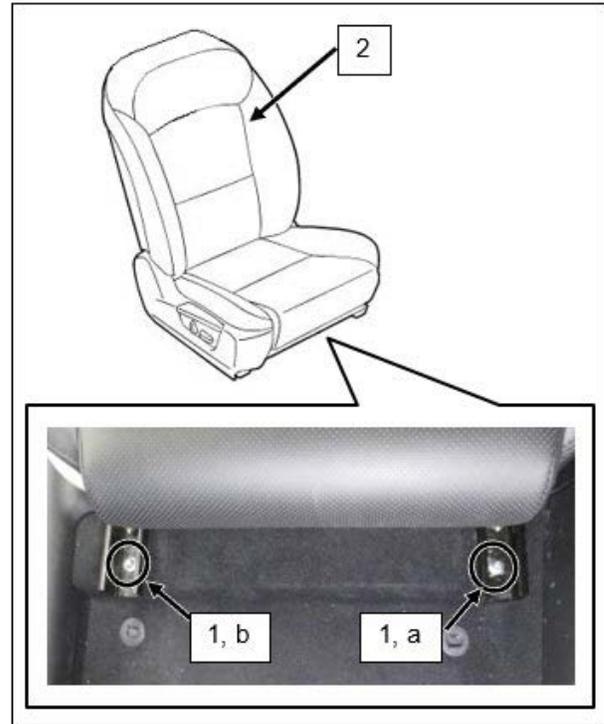
19. Tighten lower rail bolts (1) of passenger seat assembly (2) to specified torque in alphabetical order (a – b).

Tightening Torque
23 N•m (2.3 kgf-m, 17.0 lbf-ft)

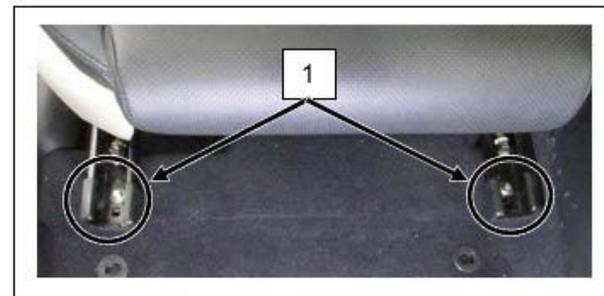
20. Install the lower rail front end covers (1).

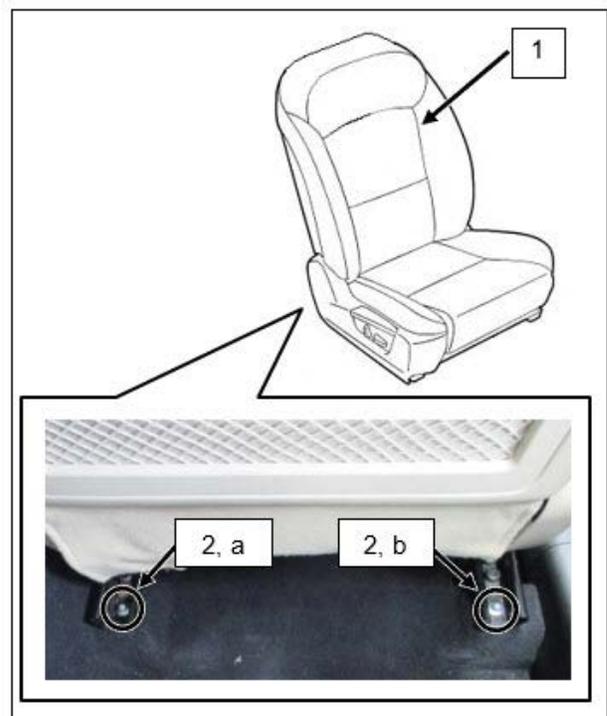
21. Slide the passenger seat assembly (1) forward and tighten the lower rail bolts (2) to the specified torque in alphabetical order (a – b).

Tightening Torque
23 N•m (2.3 kgf-m, 17.0 lbf-ft)

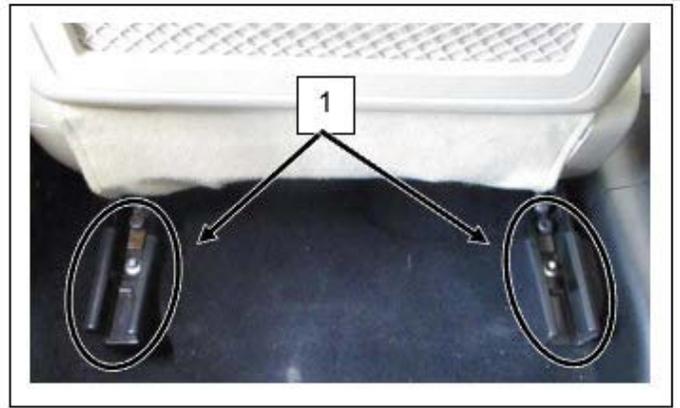
- 22. Install the lower rail rear end covers (1).
- 23. Install the passenger seat assembly head rest.
- 24. Move the passenger seat assembly back and forth to check that it moves smoothly.

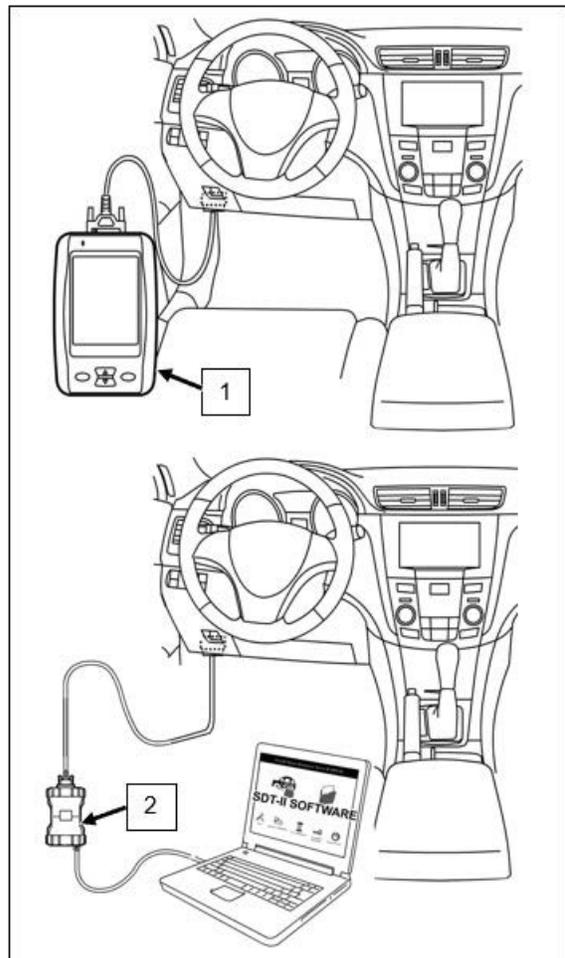
- 25. Connect Suzuki SDT (1) or SDT-II (2) to Data Link Connector (DLC).
- 26. Check if a DTC is detected using Suzuki SDT (1) or SDT-II (2).

If a DTC is detected, clear the DTC.

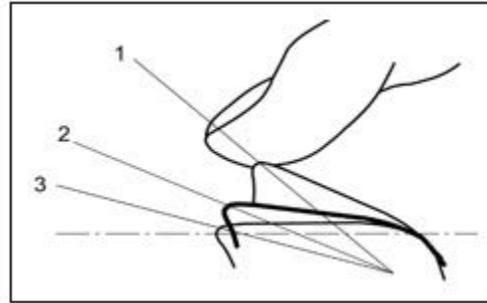
27. Conduct an initialization/reset for the front door power windows.

- a) Press down and hold the power window switch until the window is fully open, and continue to hold it down for at least 2 seconds.
- b) Pull up the power window switch into the AUTO position until the window is fully closed, and continue to hold it up for at least 2 seconds.

- 1. Auto UP
- 2. Manual UP
- 3. OFF
