SUBJECT: NEW VEHICLE DEMONSTRATION / DELIVERY HOLD – Safety Recall 19S20
Certain 2009-2016 Econoline Ambulance and School Bus Vehicles - Equipped with a 5.4L Engine and 5R110W Transmission
Coast Clutch Cylinder and One-Way Clutch Replacement

**CERTAIN 2009-2016 ECONOLINE AMBULANCE AND SCHOOL BUS
 VEHICLES — EQUIPPED WITH A 5.4L ENGINE AND 5R110W TRANSMISSION
 COAST CLUTCH CYLINDER AND ONE-WAY CLUTCH REPLACEMENT**

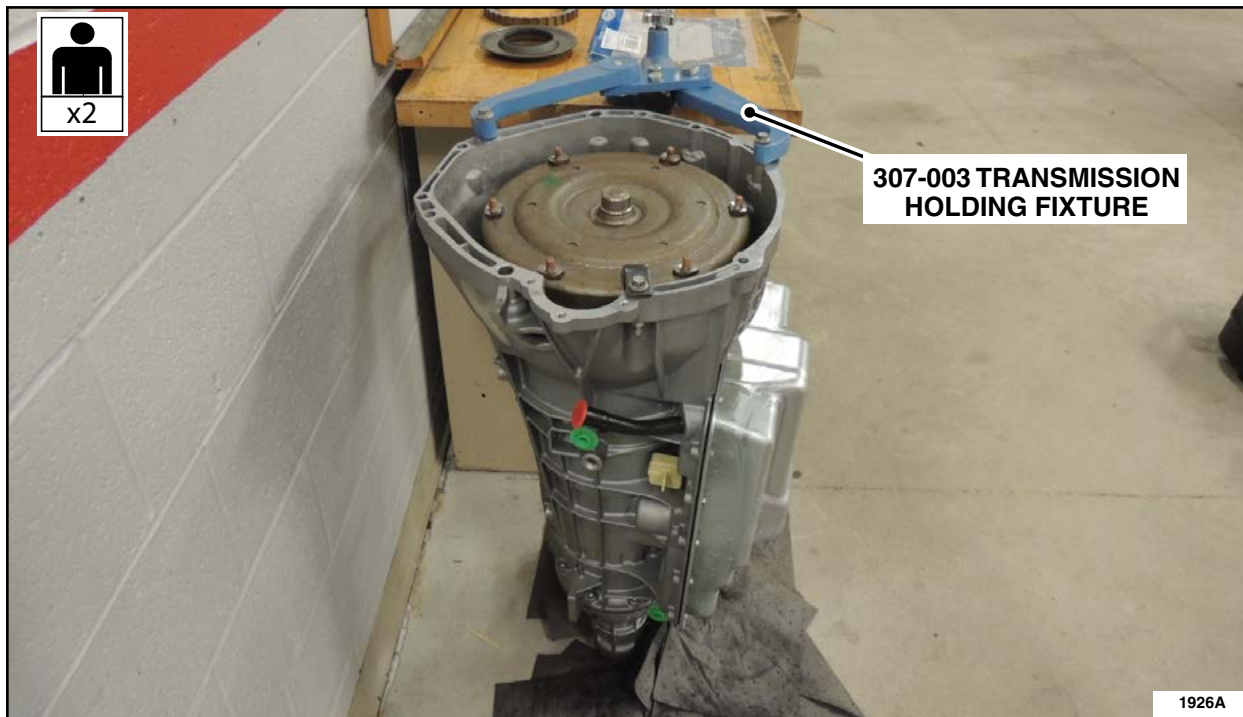
FIGURE 1

2. Mount the transmission on the bench using a suitable stand or transmission holding fixture such as 307-003 as shown. See Figure 1.

NOTE: Transmission shown is similar but may not be an exact representation of the assembly in question.

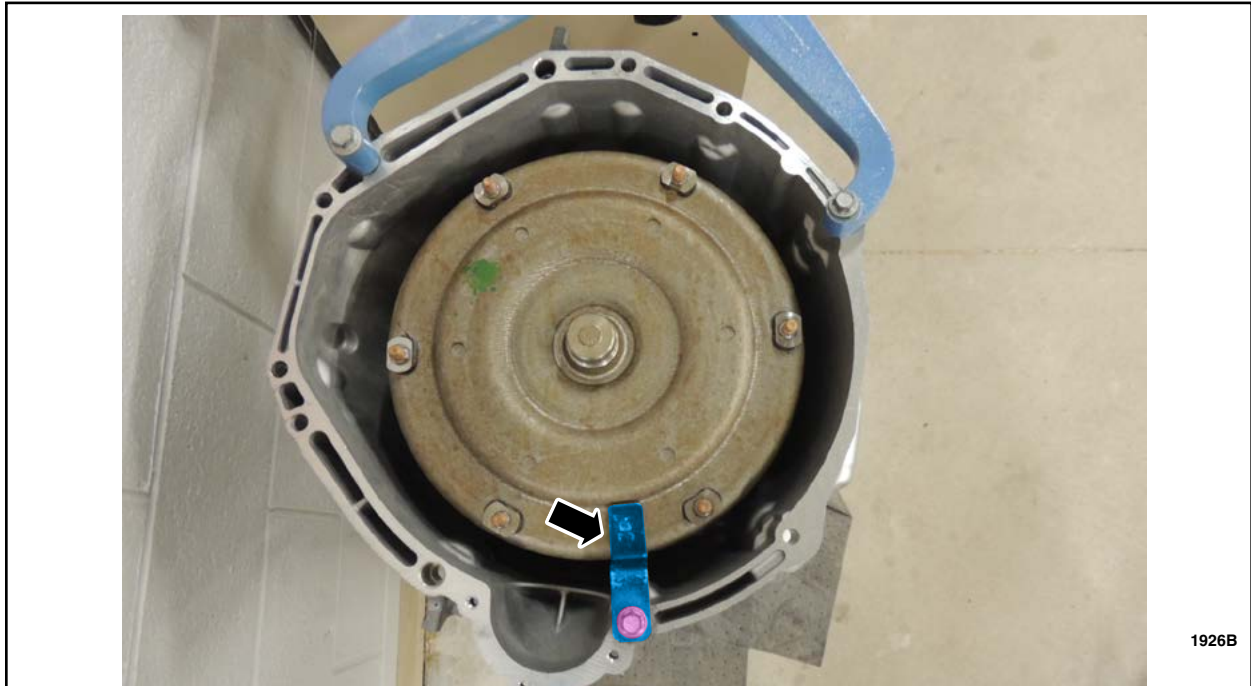
FIGURE 2

3. Remove the Torque Converter Retainer (307-346). See Figure 2.

51. Install the Torque Converter Retainer (307-346) to hold the torque converter in place when installing the transmission. See Figure 2.

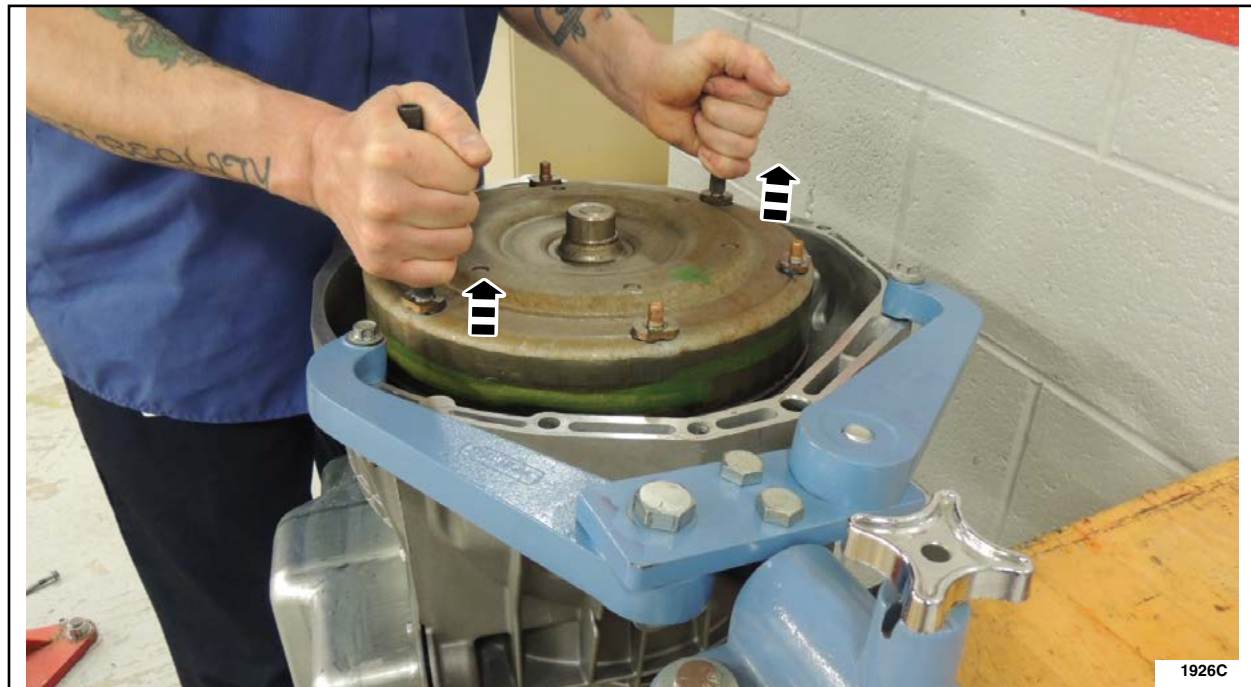
FIGURE 3

4. Using the Torque Converter Handles (307-091), remove the torque converter. See Figure 3.

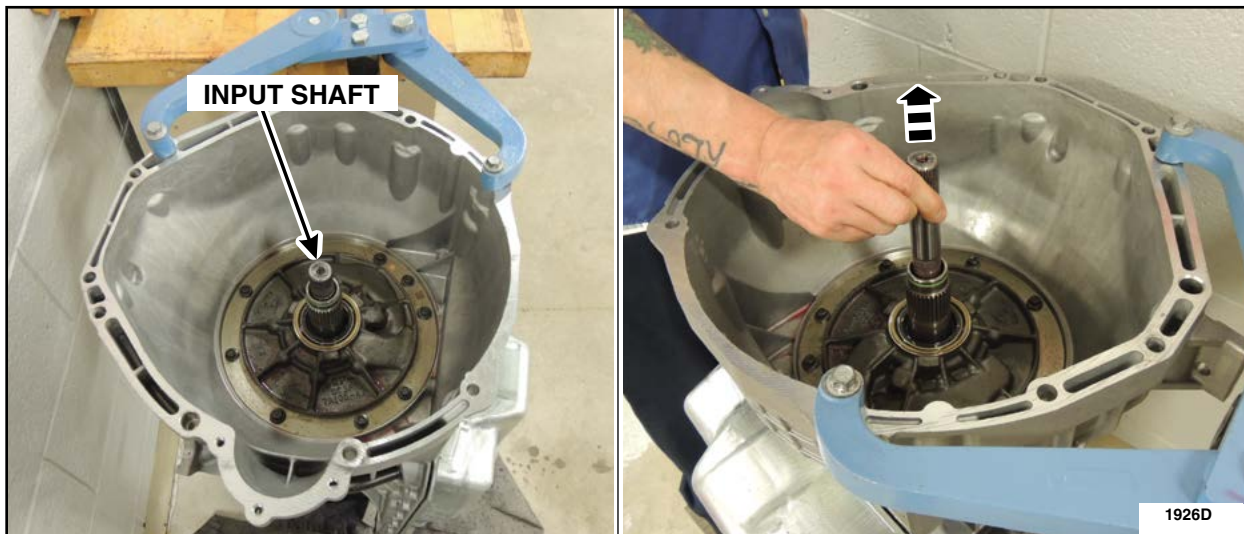
FIGURE 4

5. Remove the input shaft by lifting the input shaft up and out of the transmission. See Figure 4.

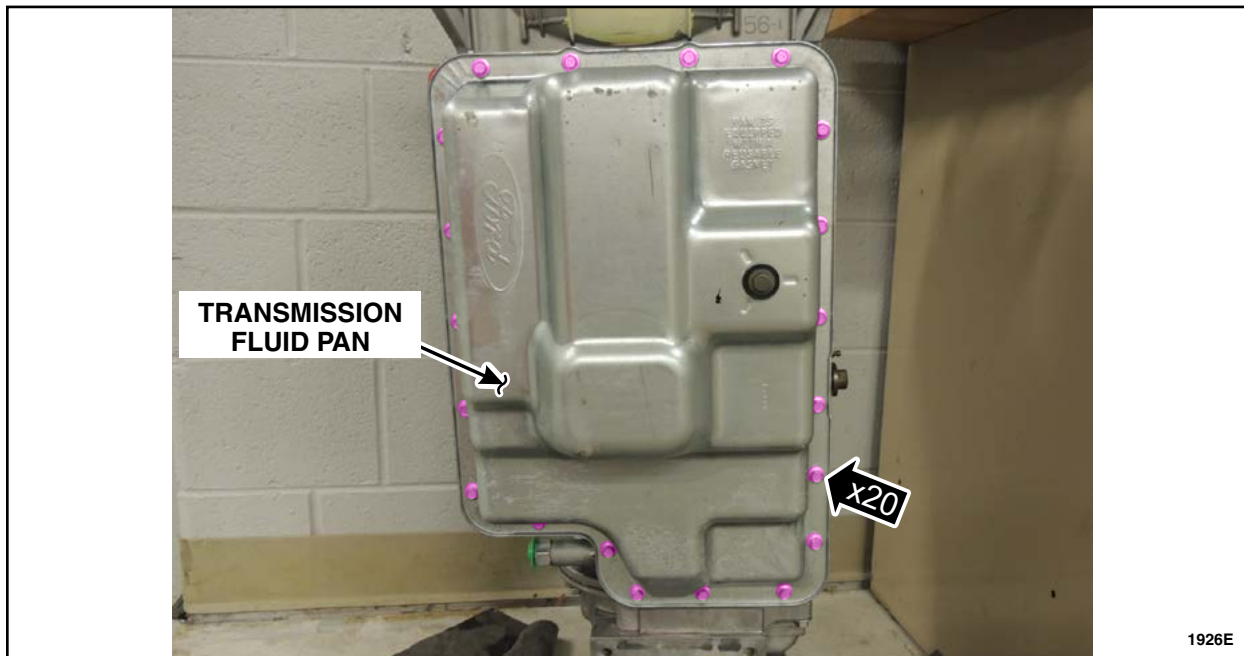
FIGURE 5

6. Remove the transmission fluid pan and gasket. See Figure 5.

NOTE: Do not discard the transmission fluid pan gasket unless damaged. This is a reusable transmission fluid pan gasket.

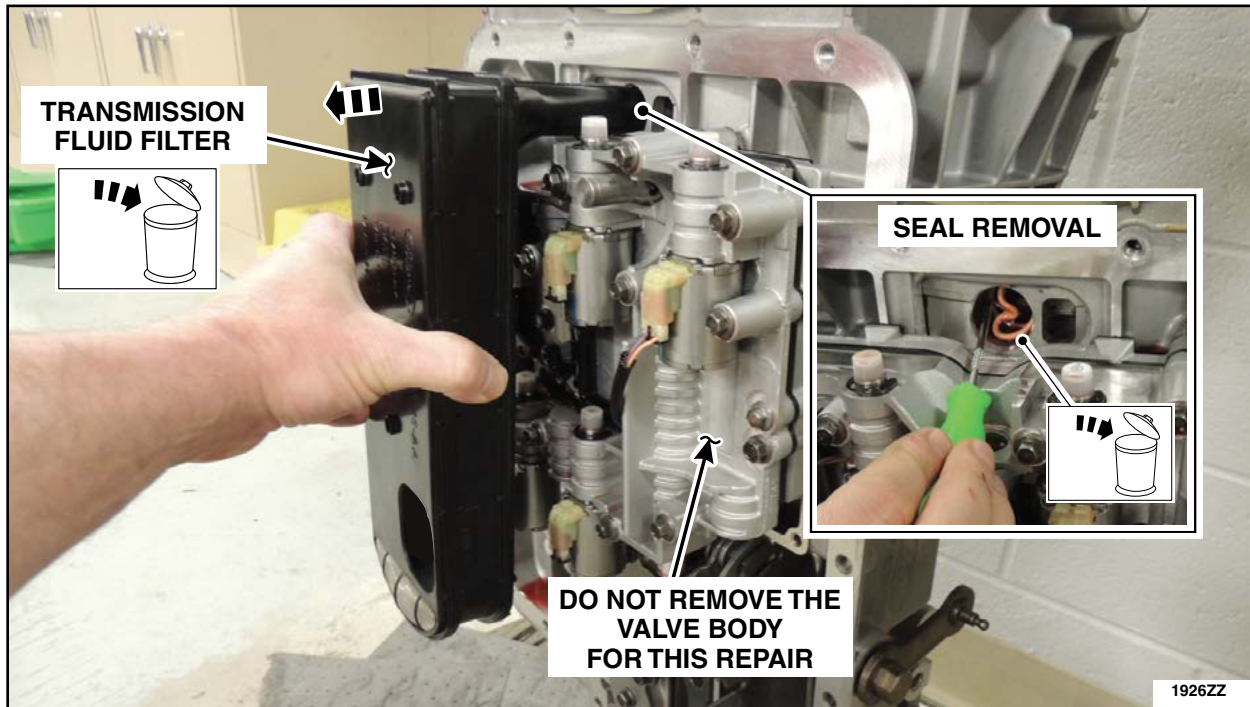
FIGURE 6

7. Remove and discard the transmission fluid filter and seal assembly. Use a right angle pick to extract the seal. See Figure 6.

NOTICE: Carefully remove the transmission fluid filter seal. Damage to the seal bore will cause transmission failure.

NOTE: Prior to installing the transmission fluid filter, make sure that the old seal is not stuck in the case. See Figure 6.

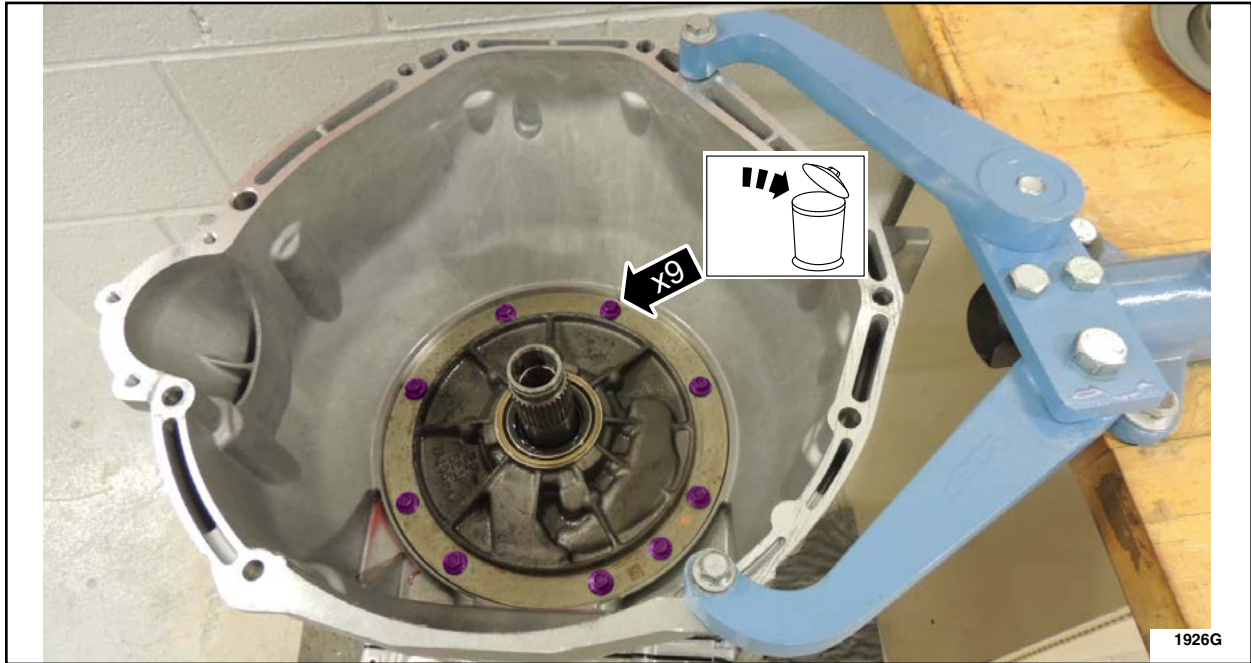
FIGURE 7

8. Remove and discard the nine front pump bolts. See Figure 7.

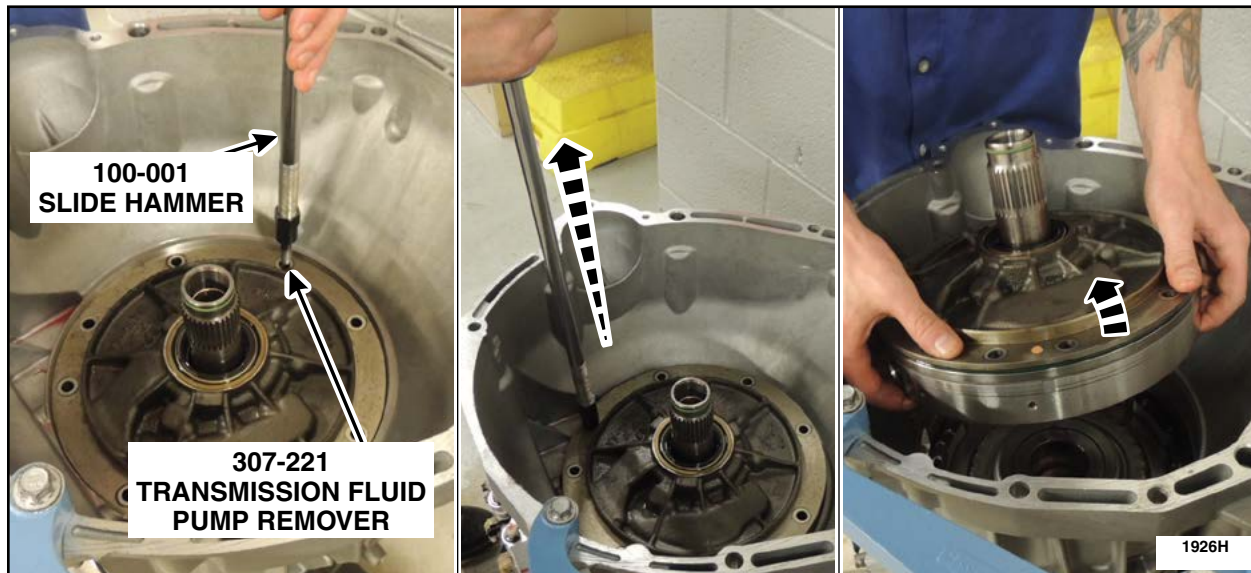
FIGURE 8

9. Remove the front pump using the Transmission Fluid Pump Remover (307-221) attached to a Slide Hammer (100-001). See Figure 8.

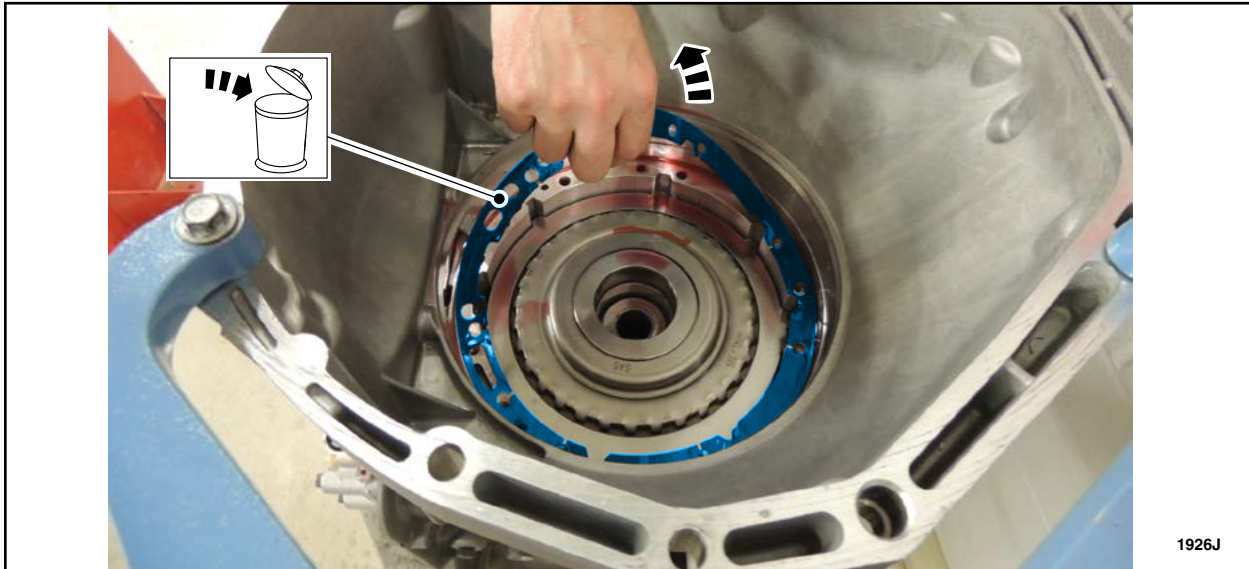
FIGURE 9

10. Remove and discard the front pump gasket. See Figure 9.

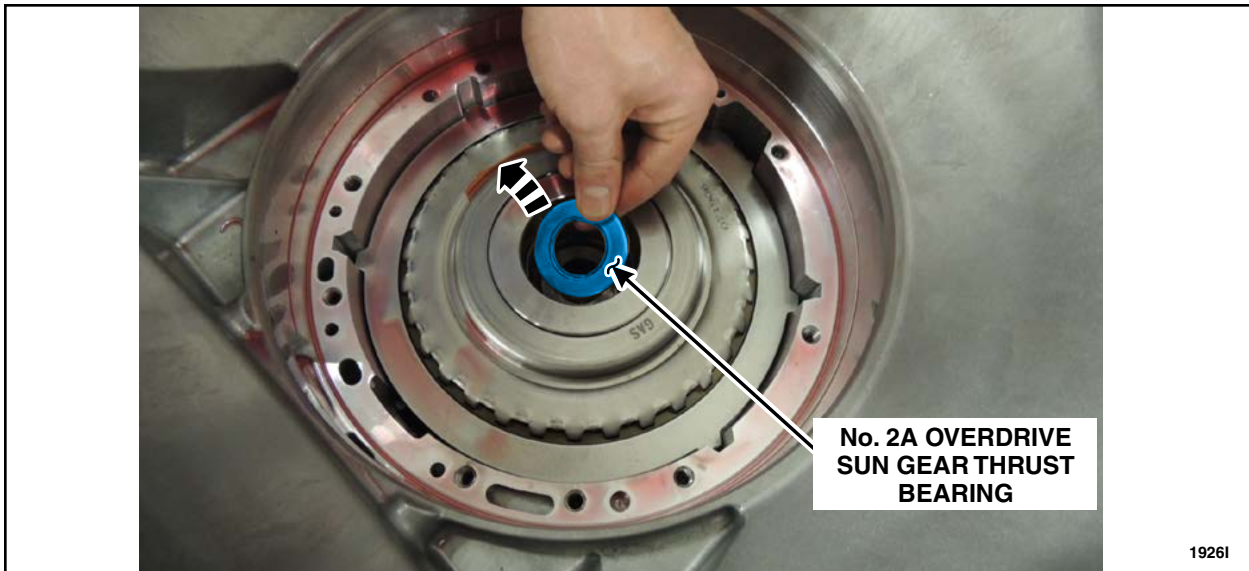
FIGURE 10

11. Remove the No. 2A overdrive sun gear thrust bearing. See Figure 10.

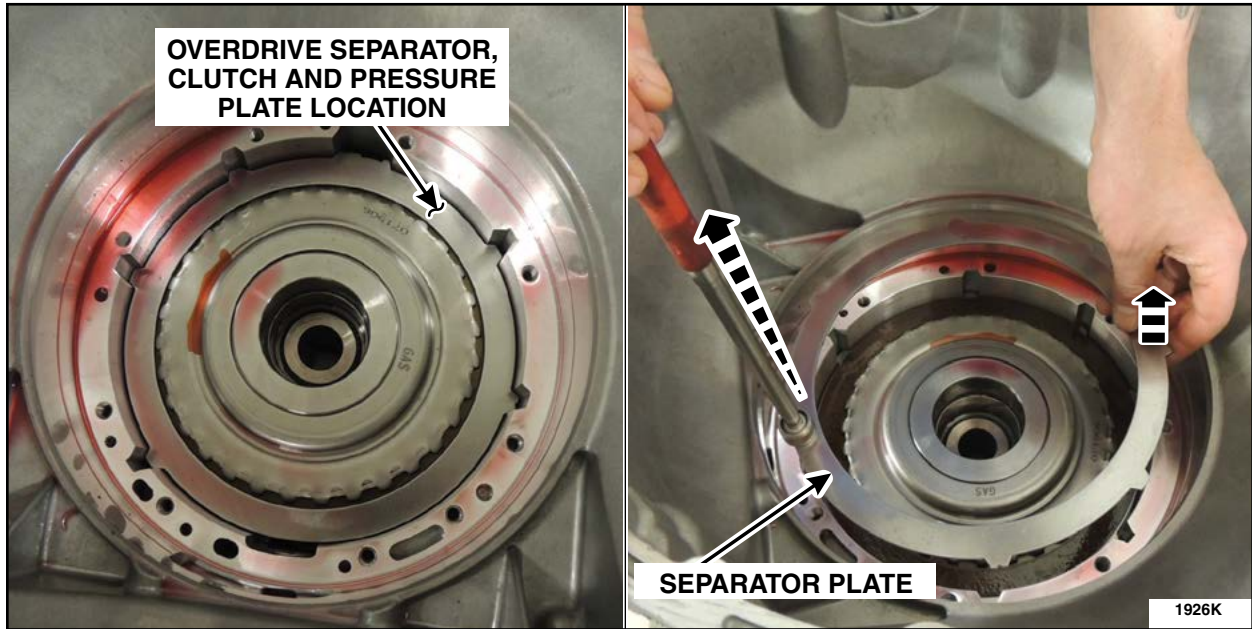
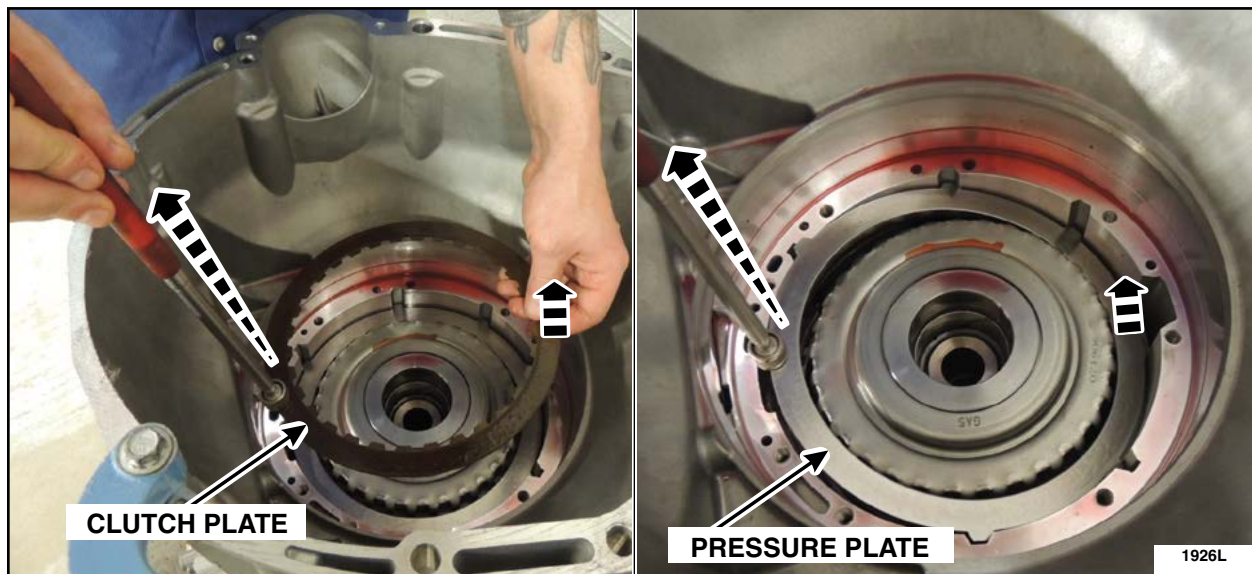
12. Remove the overdrive separator plates, clutch plates and overdrive pressure plate.
See Figures 11 and 12.

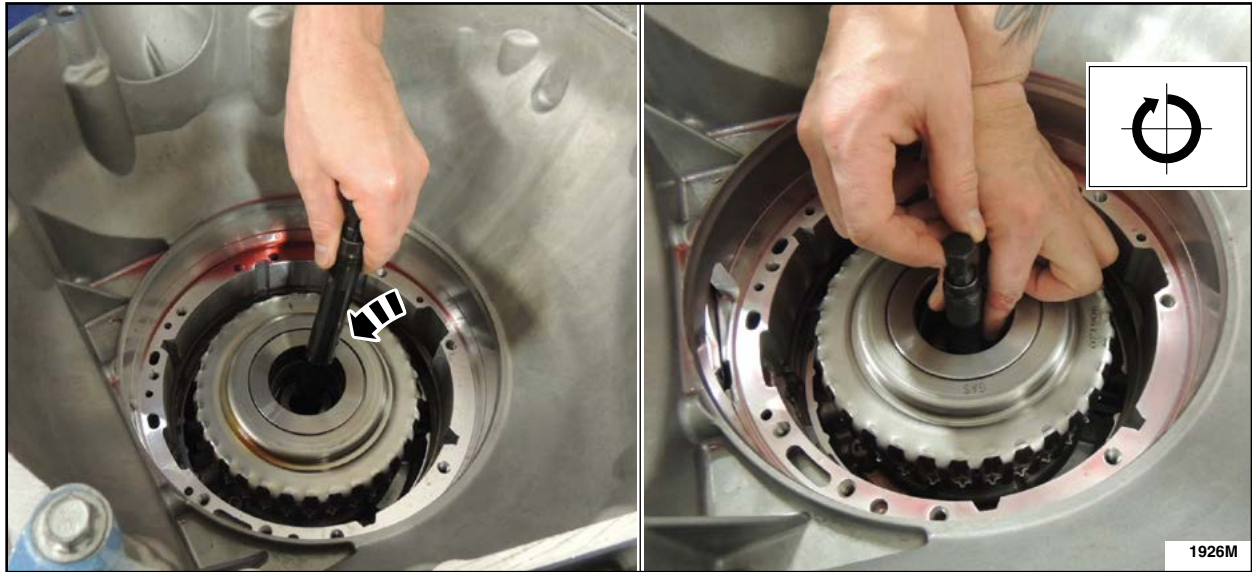
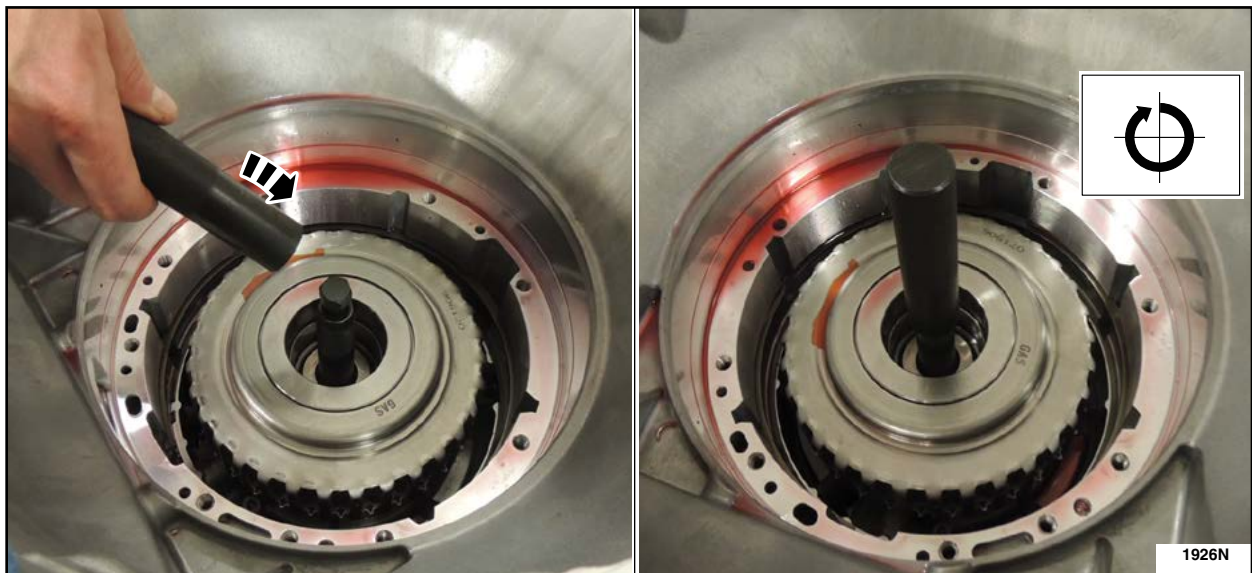
13. Install the Clutch Loading Fixture and Handle (307-S383), onto the coast clutch assembly.
See Figures 13 and 14.

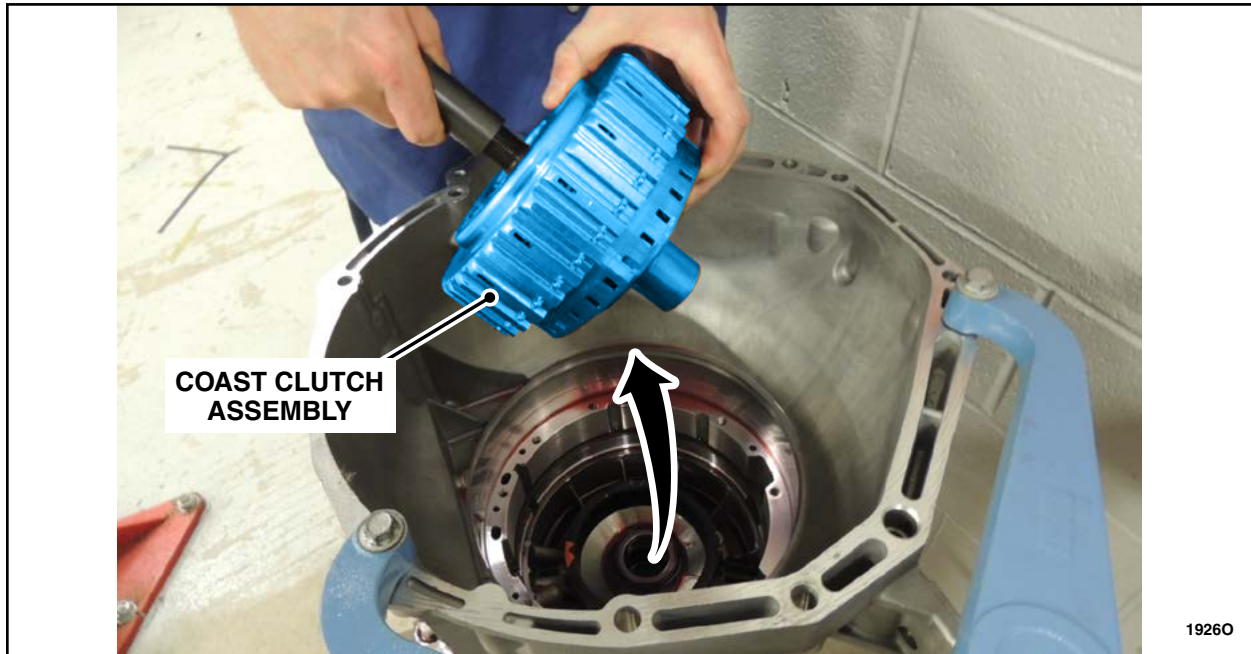
FIGURE 15

14. Remove the coast clutch assembly from the transmission then remove the Clutch Loading Fixture from the coast clutch assembly. See Figure 15.

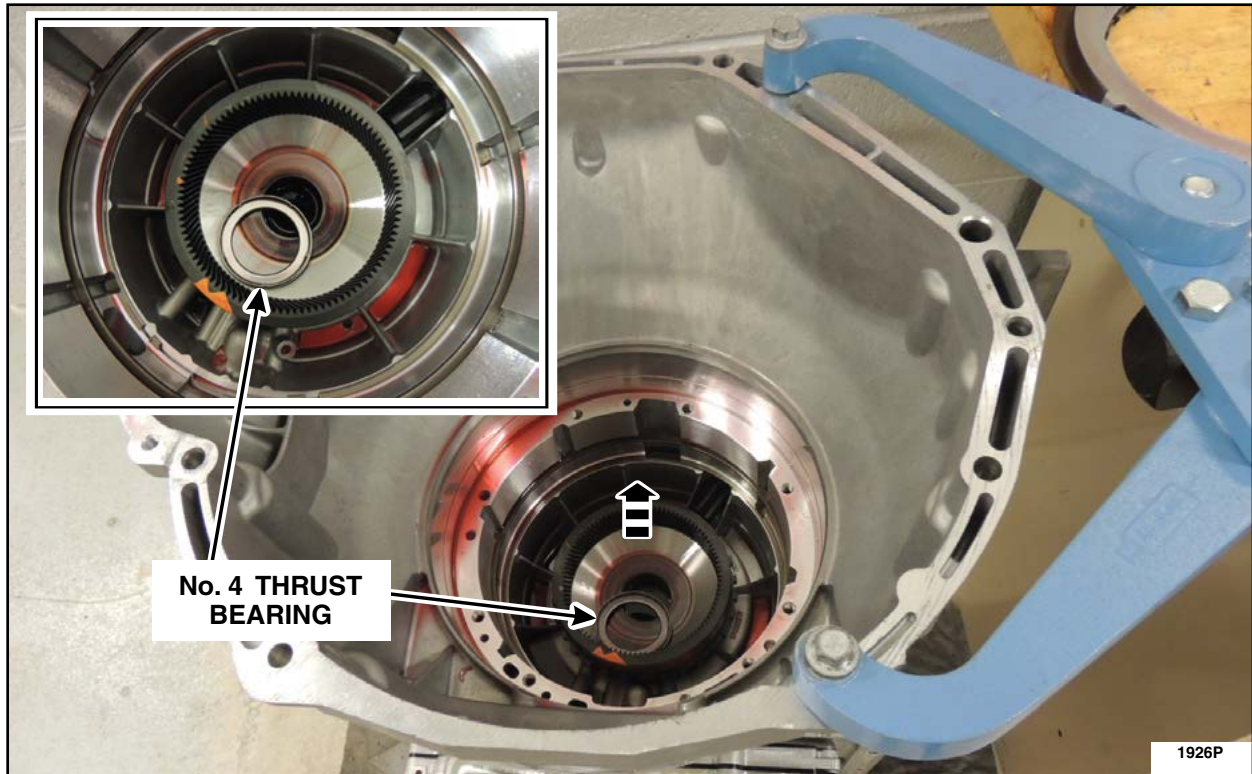
FIGURE 16

15. Remove the No. 4 thrust bearing. See Figure 16.

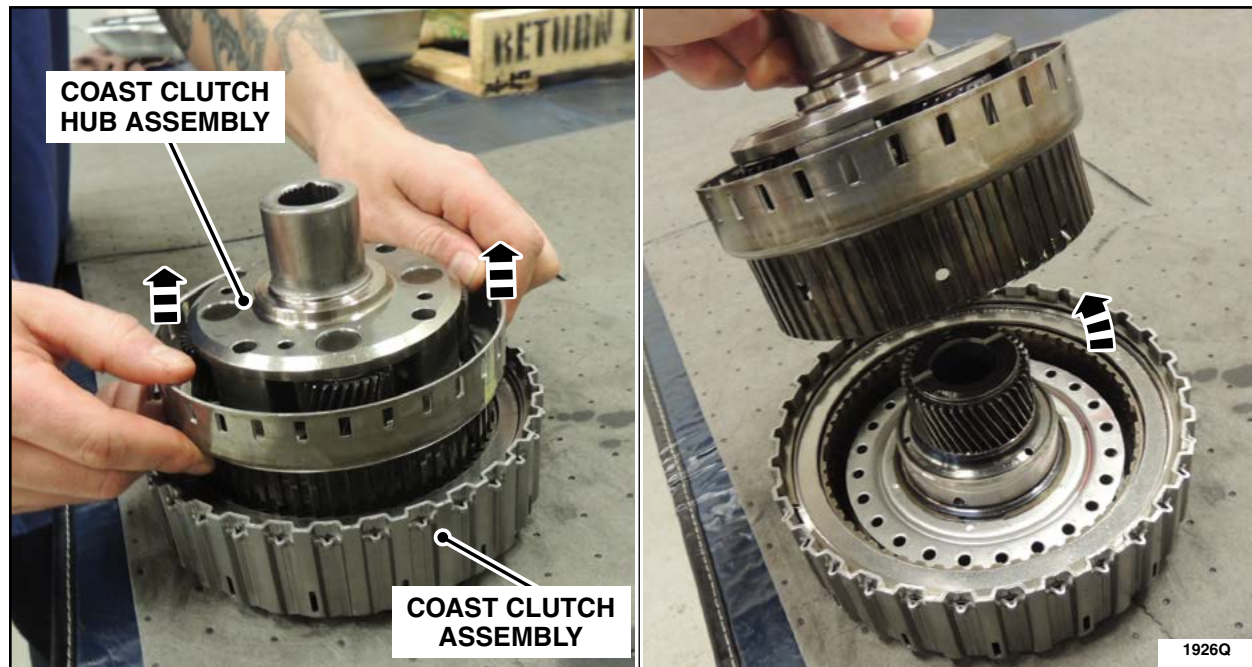
FIGURE 17

16. Separate the coast clutch hub assembly from the coast clutch assembly and set the coast clutch hub assembly aside to be reinstalled later in this procedure. See Figure 17.

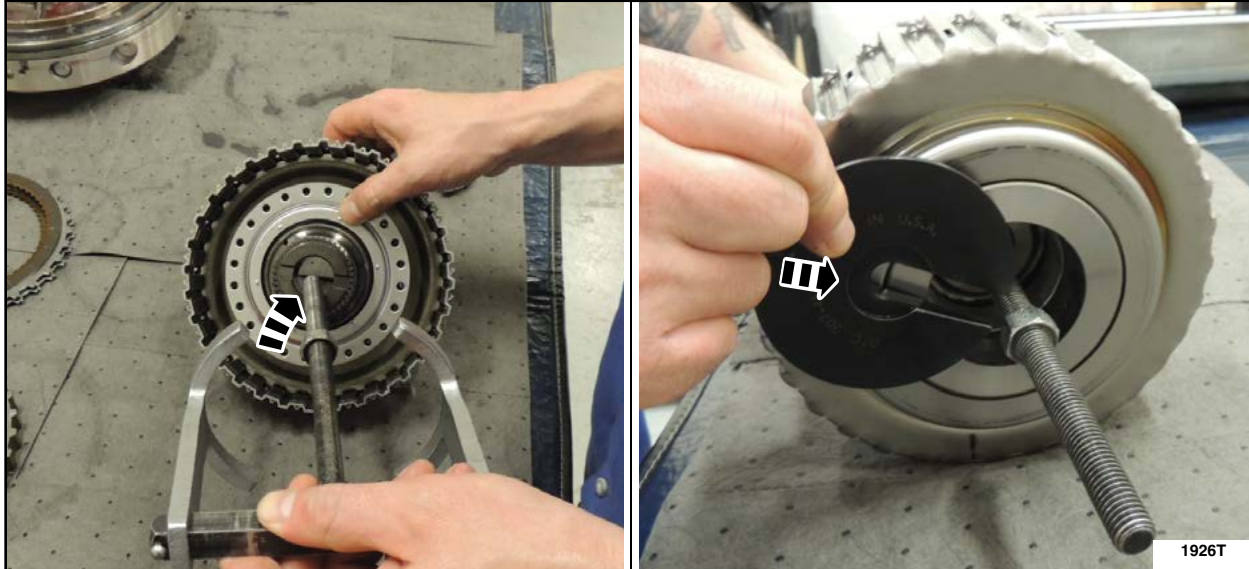
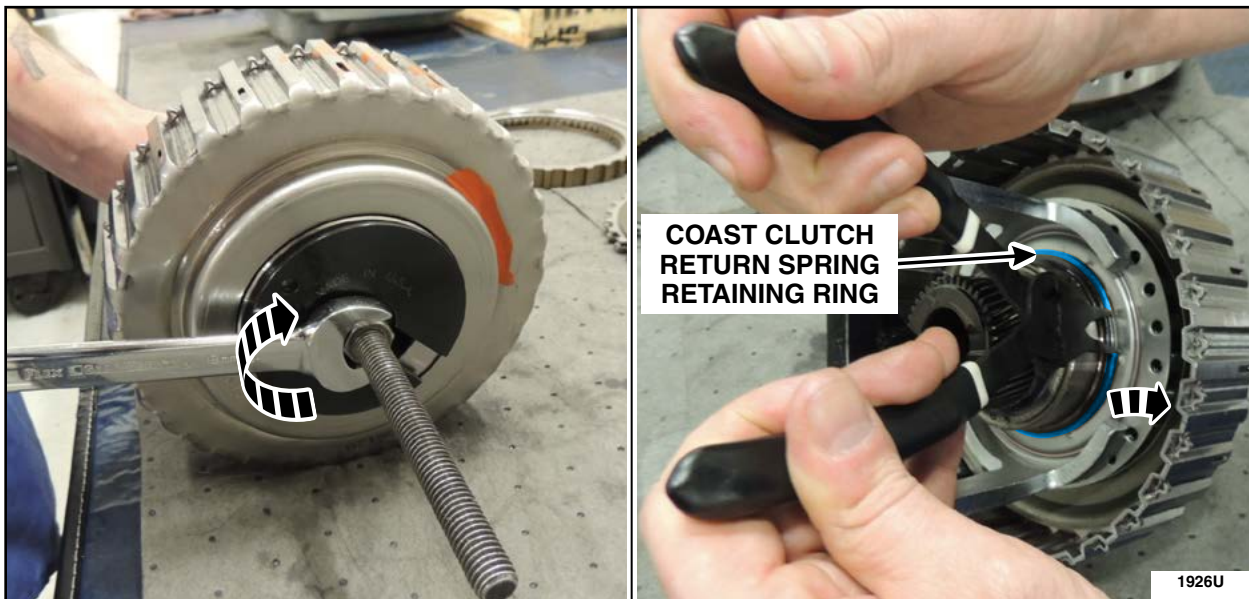
19. Using the Clutch Spring Compressor Aligner (307-455) and Clutch Spring Compressor (307-015), remove the coast clutch return spring retaining ring. See Figures 20 and 21.

NOTICE: Do not over compress the return spring or damage to the spring will occur.

24. Install the coast clutch return spring into the *new* coast clutch cylinder assembly. Using the Clutch Spring Compressor Aligner (307-455) and Clutch Spring Compressor (307-015), install the coast clutch return spring retaining ring. Refer to Figures 20, 21 and 22.

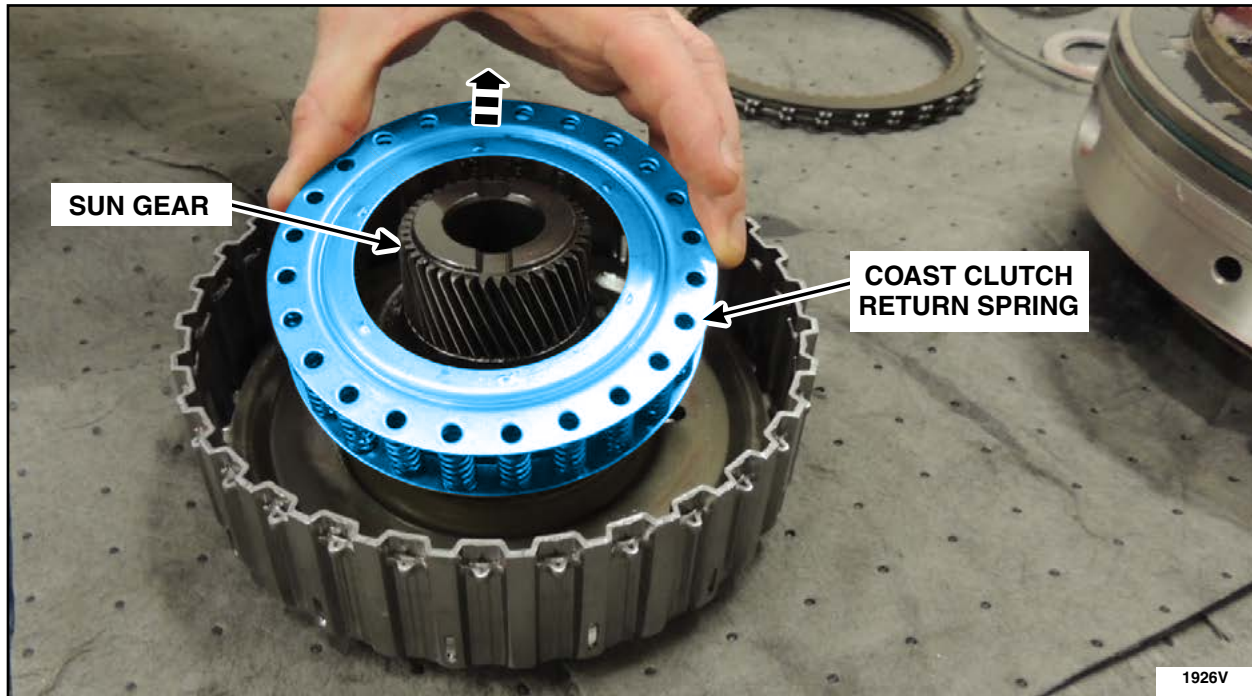
FIGURE 22

20. Remove the Clutch Spring Compressor Aligner and Clutch Spring Compressor, then remove the coast clutch return spring. See Figure 22.

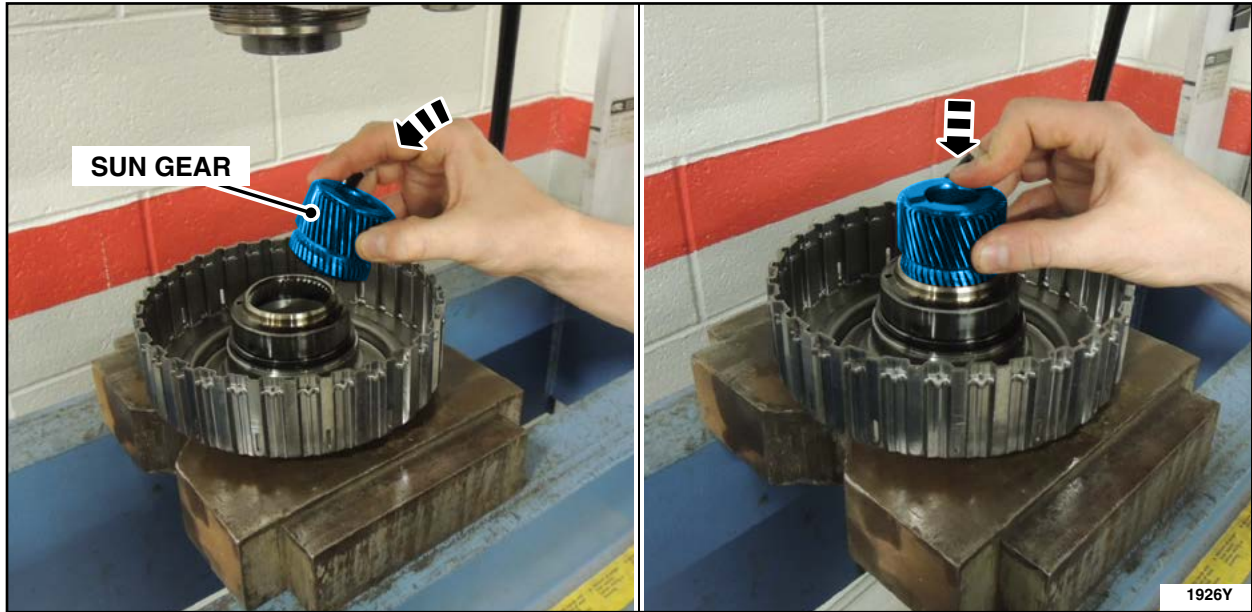
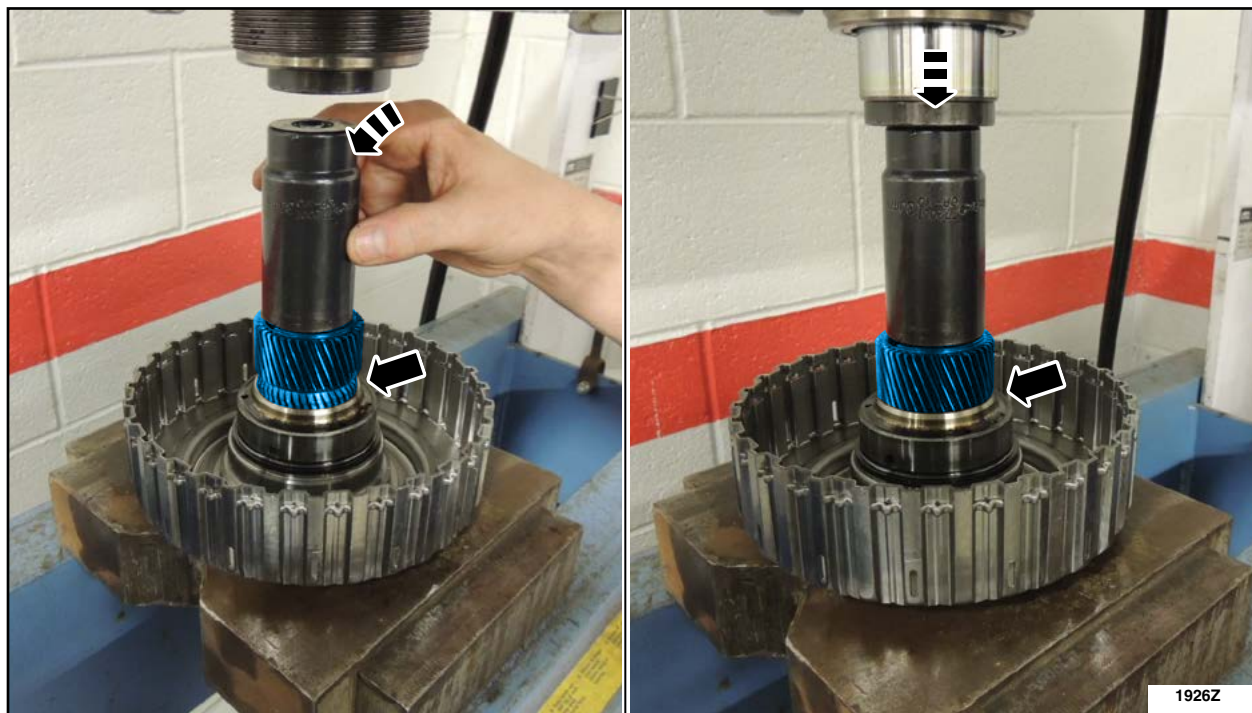
22. Install the original sun gear onto the *new* coast clutch cylinder assembly. See Figures 25 and 26.

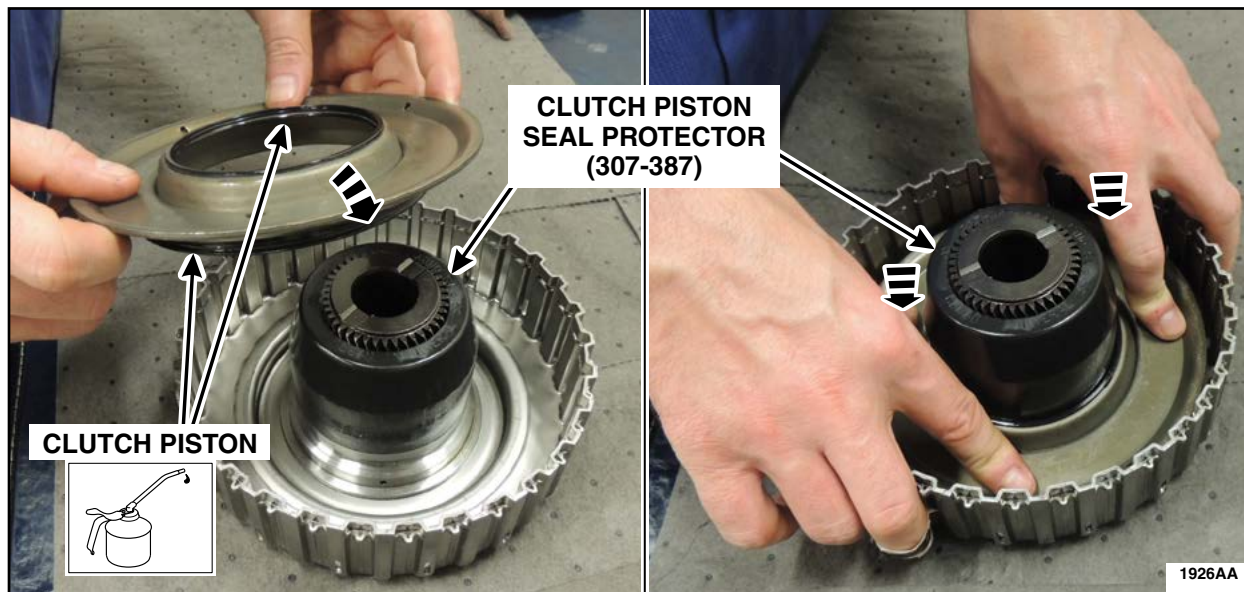
FIGURE 27

23. Lube the inner and outer coast clutch piston seals with automatic transmission fluid and install the *new* piston into the *new* coast clutch cylinder using the Clutch Piston Seal Protector (307-387). See Figure 27.

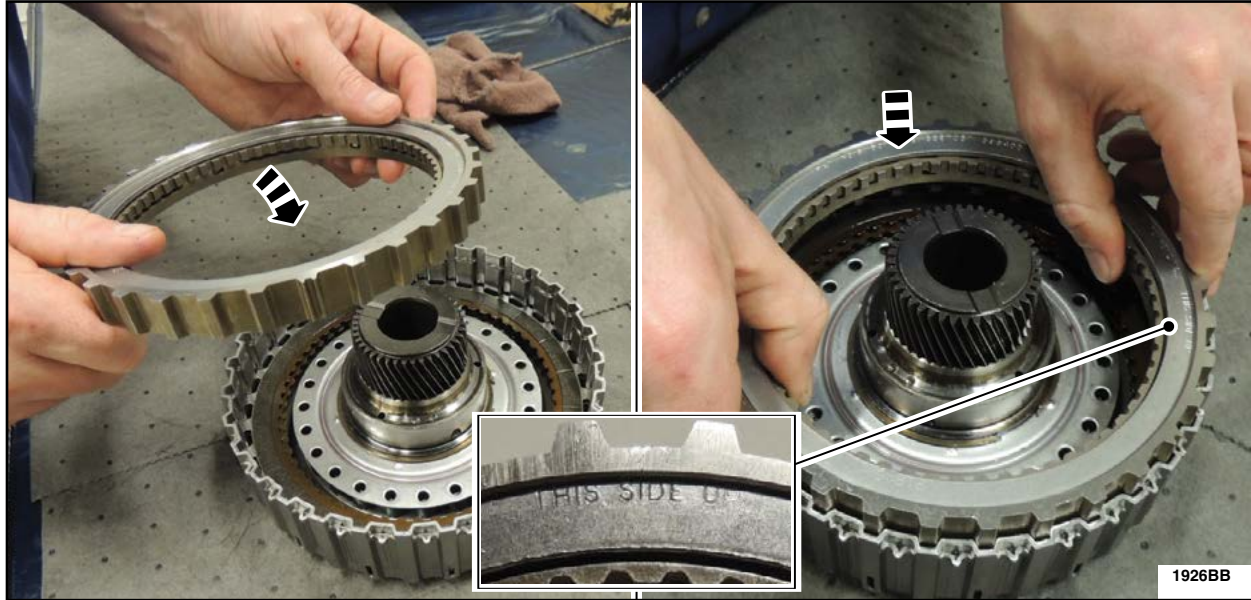
FIGURE 28a

25. Install the *new* coast clutch pressure plate OWC assembly and the clutch plates starting with the externally splined steel clutch plate. See Figures 19, 28a and 28b.

NOTE: When installing the *new* coast clutch pressure plate OWC, the words "THIS SIDE UP" should be visible.

Item	Description
1	Steel clutch plates (externally splined)
2	Friction clutch plates (internally splined)
3	Mechanical diode (One-Way Clutch (OWC))

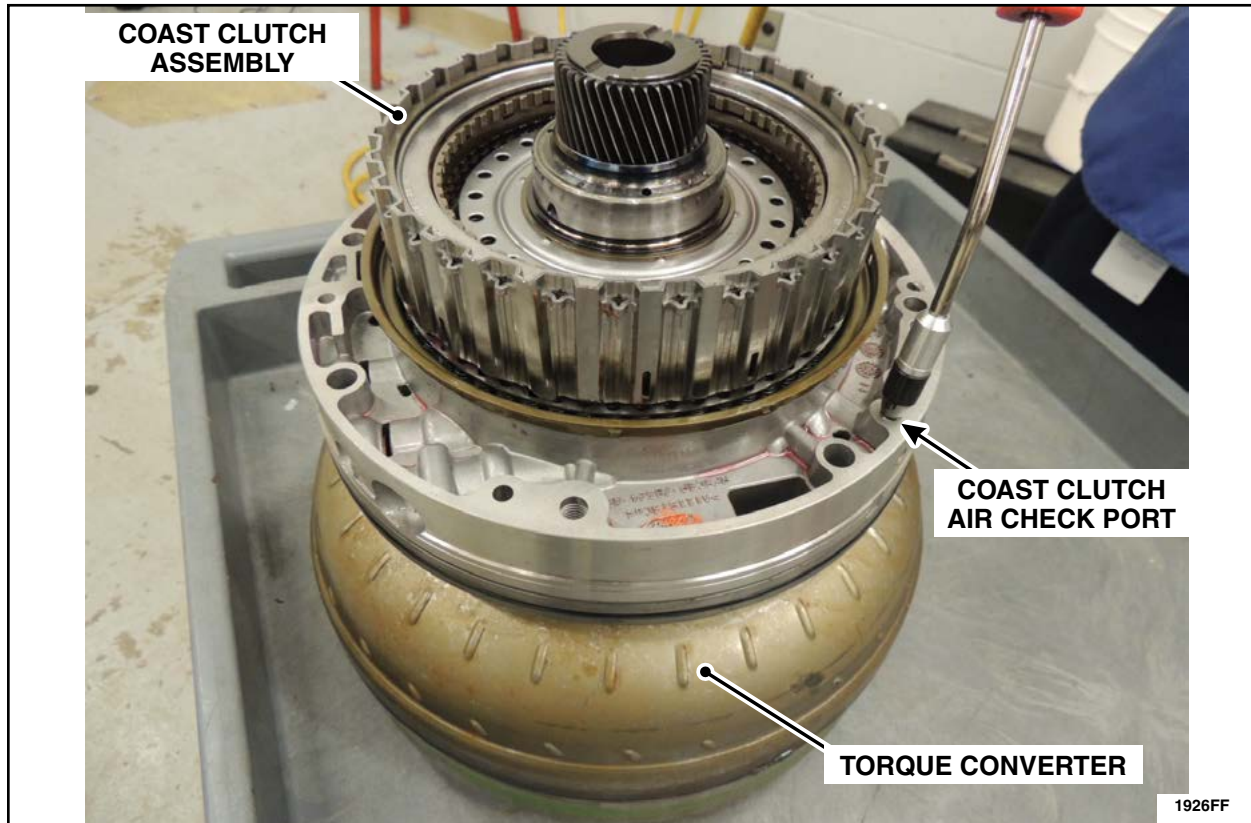
FIGURE 29

27. Air check the coast clutch assembly by stacking the torque converter, transmission fluid front pump and the coast clutch assembly as shown in Figure 29. Using a rubber tipped blow gun, apply 20 psi (138 kPa) of air to the coast clutch assembly test port on the transmission fluid front pump as shown in Figure 29. Unstack the transmission fluid front pump and the coast clutch assembly from the torque converter.

⚠ WARNING: Only use short bursts of air, not to exceed 20 psi (138 kPa), when testing the coast clutch assembly. Failure to follow this instruction may result in component damage and/or serious personnel injury.

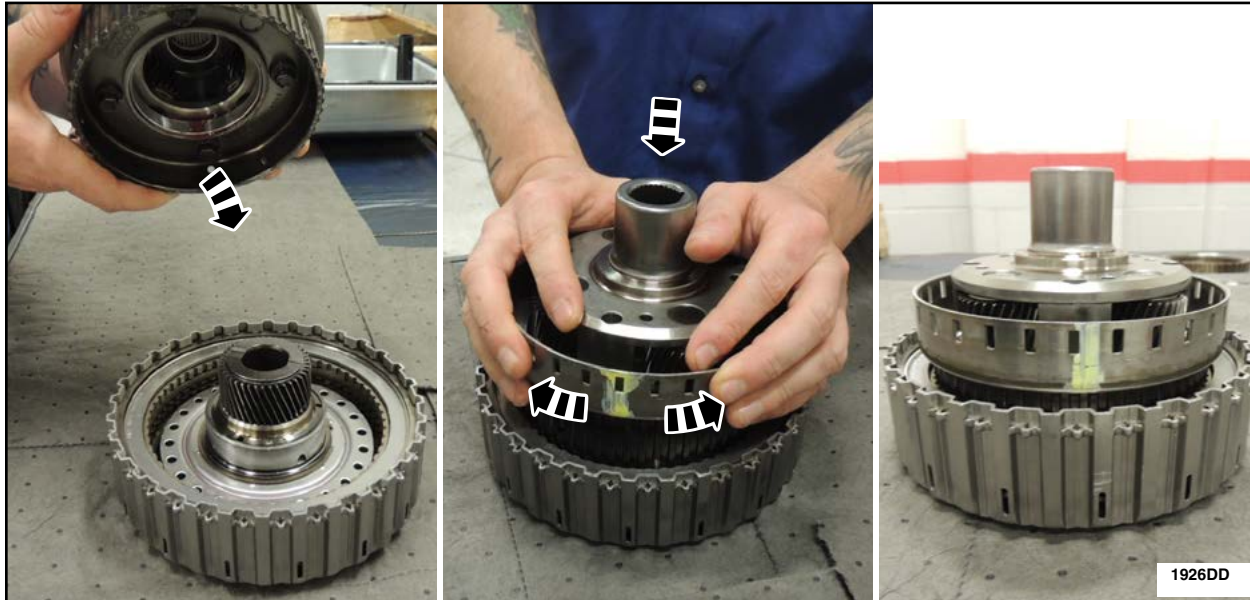
FIGURE 30

28. Install the coast clutch hub assembly into the coast clutch cylinder assembly. See Figure 30.

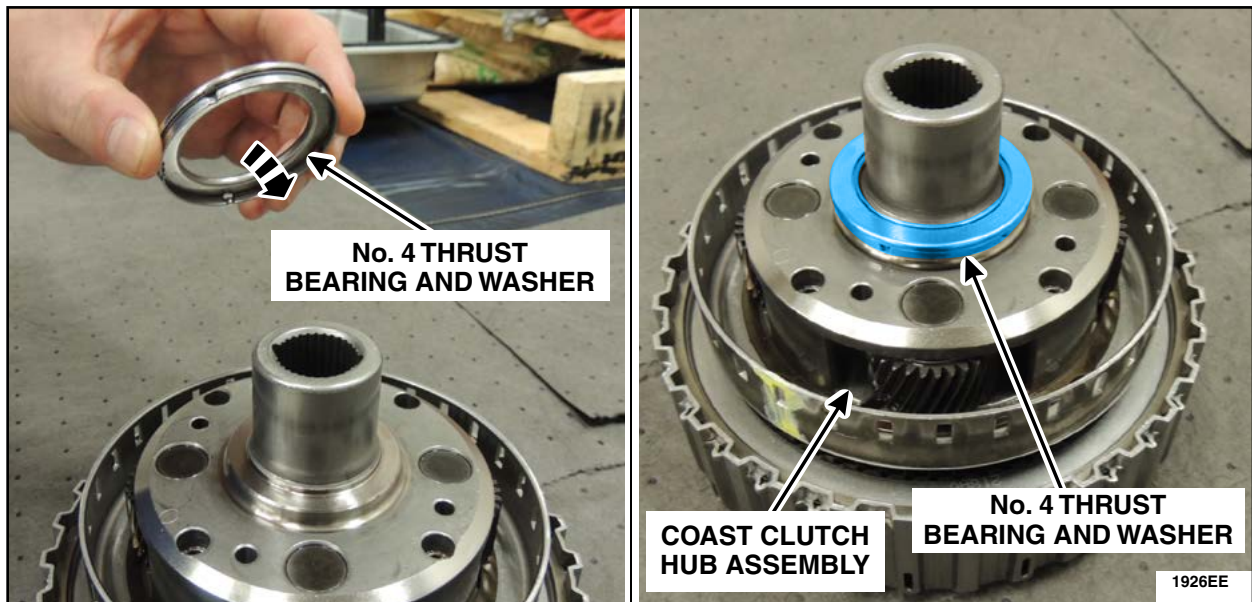
FIGURE 31

29. Install the No. 4 thrust bearing and washer onto the coast clutch hub assembly. See Figure 31.
