SUBJECT: NEW VEHICLE DEMONSTRATION / DELIVERY HOLD – Safety Recall 19S20
Certain 2009-2016 Econoline Ambulance and School Bus Vehicles - Equipped with a 5.4L Engine and 5R110W Transmission
Coast Clutch Cylinder and One-Way Clutch Replacement

**CERTAIN 2009-2016 ECONOLINE AMBULANCE AND SCHOOL BUS
 VEHICLES — EQUIPPED WITH A 5.4L ENGINE AND 5R110W TRANSMISSION
 COAST CLUTCH CYLINDER AND ONE-WAY CLUTCH REPLACEMENT**

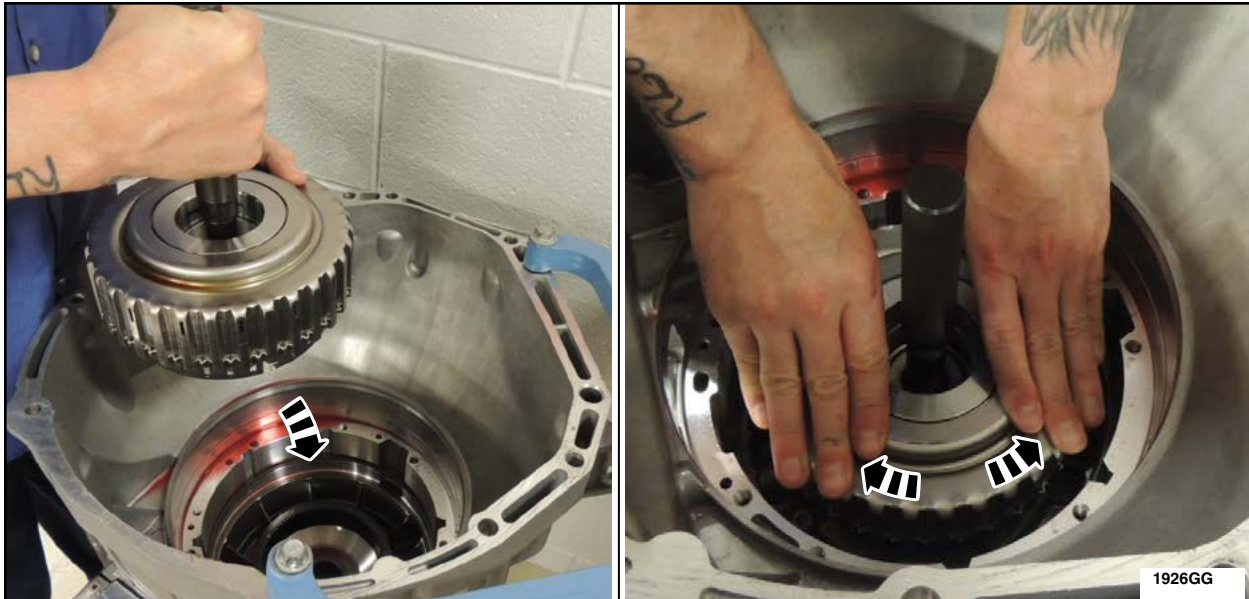
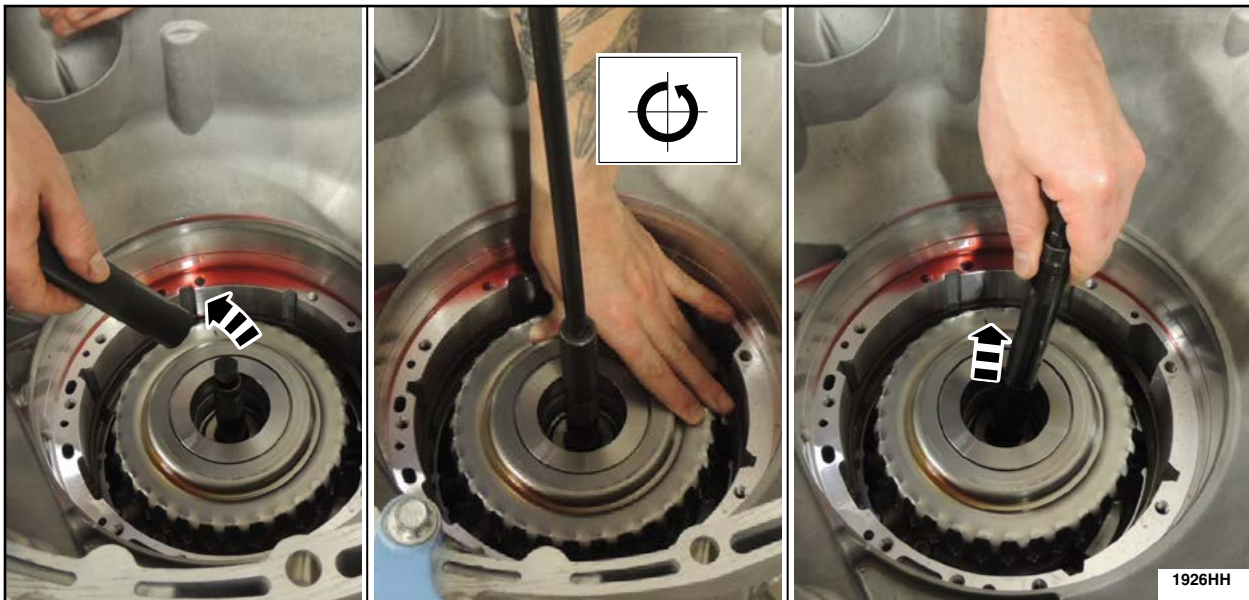
30. Using the Clutch Loading Fixture (307-S383), install the coast clutch assembly.
See Figures 32 and 33.

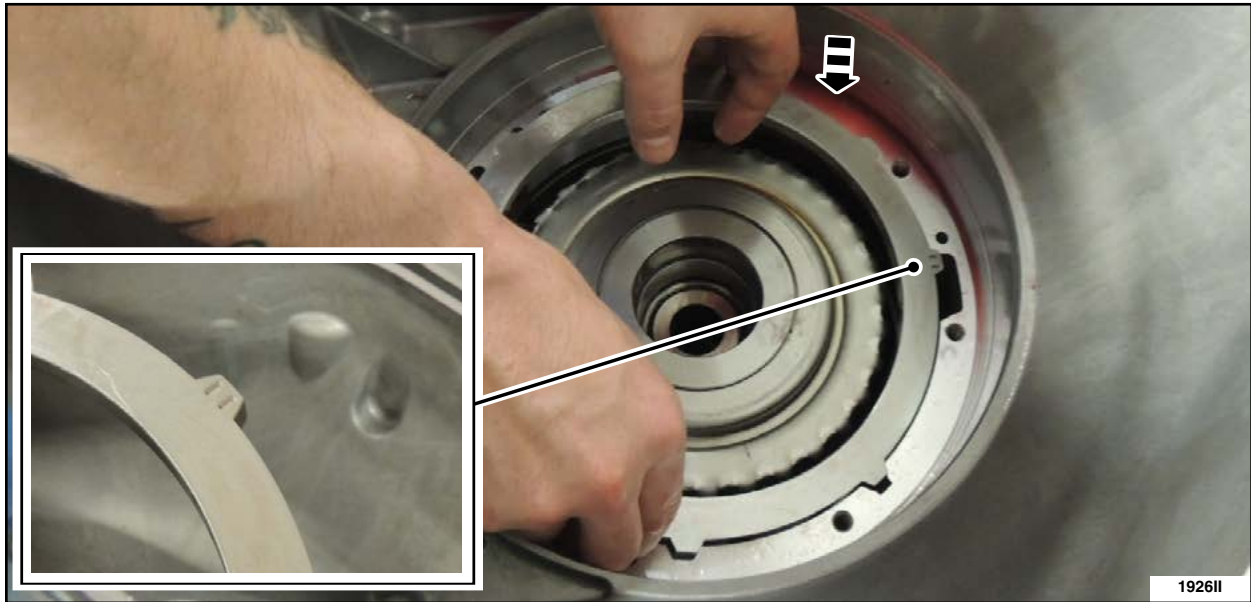
FIGURE 34

31. Install the overdrive pressure plate with the notches facing up. See Figure 34.

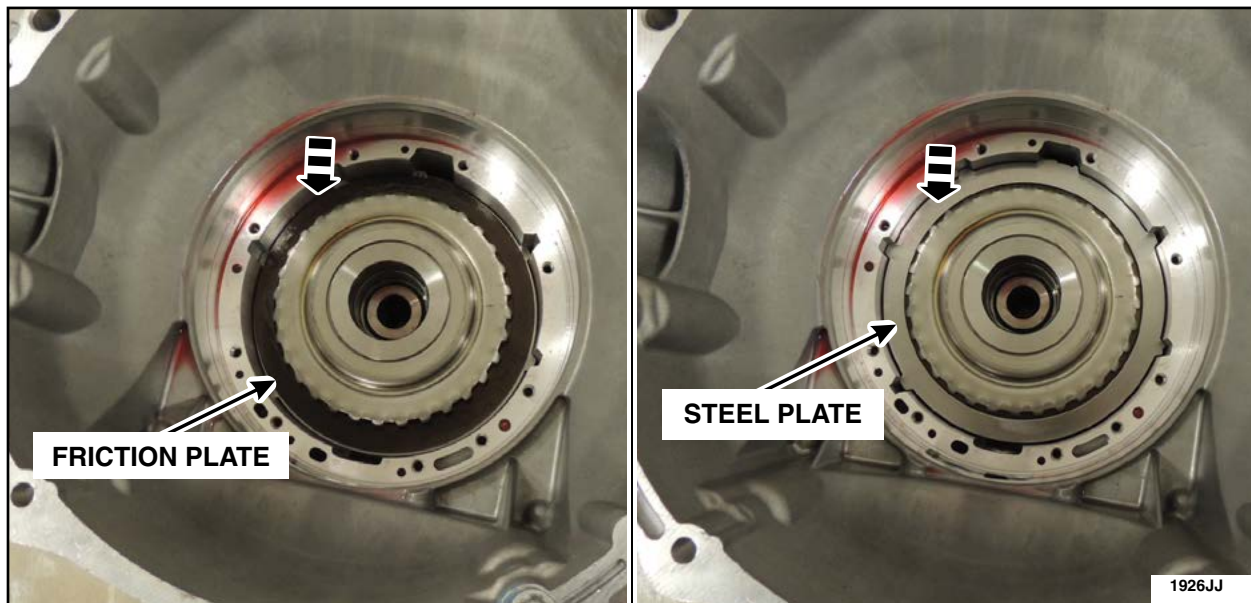
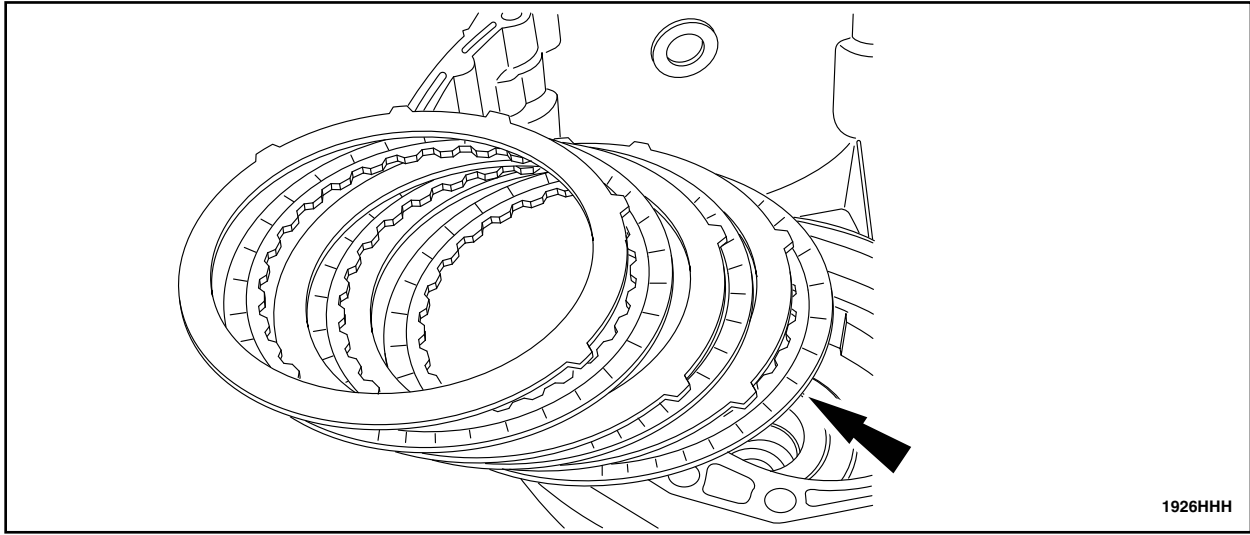
32. Install the overdrive clutch plates. Start with the friction plate, alternating with a steel plate. See Figure 35a and 35b.

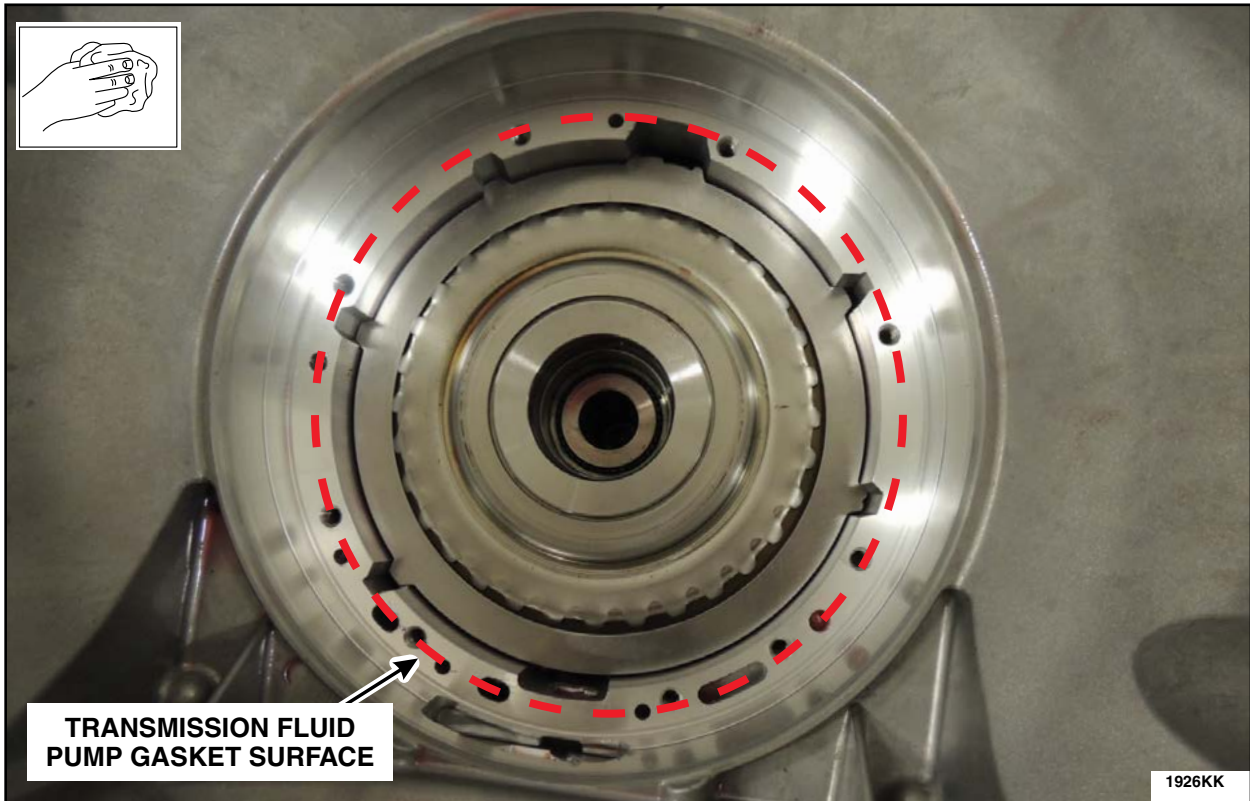
FIGURE 36

33. Clean any residual transmission fluid from the transmission front pump gasket surface and from the transmission fluid front pump retainer holes. See Figure 36.

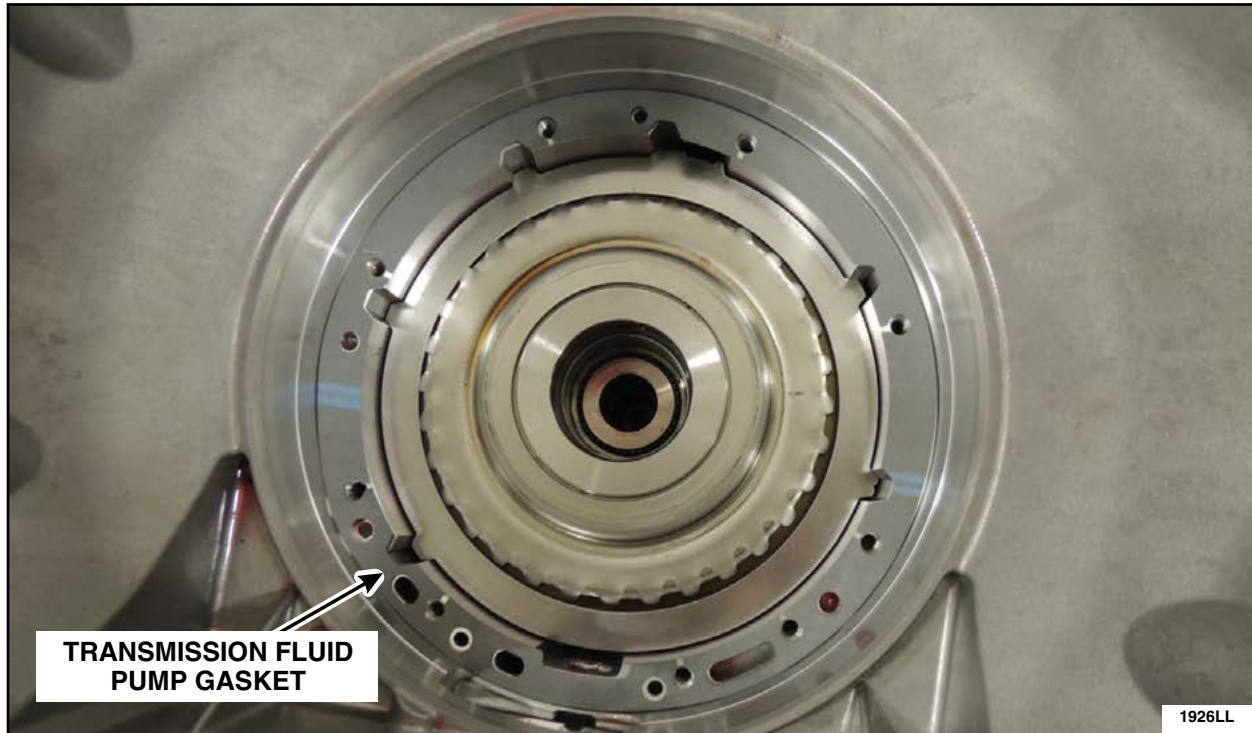
FIGURE 37

34. Install a *new* transmission front pump gasket. See Figure 37.

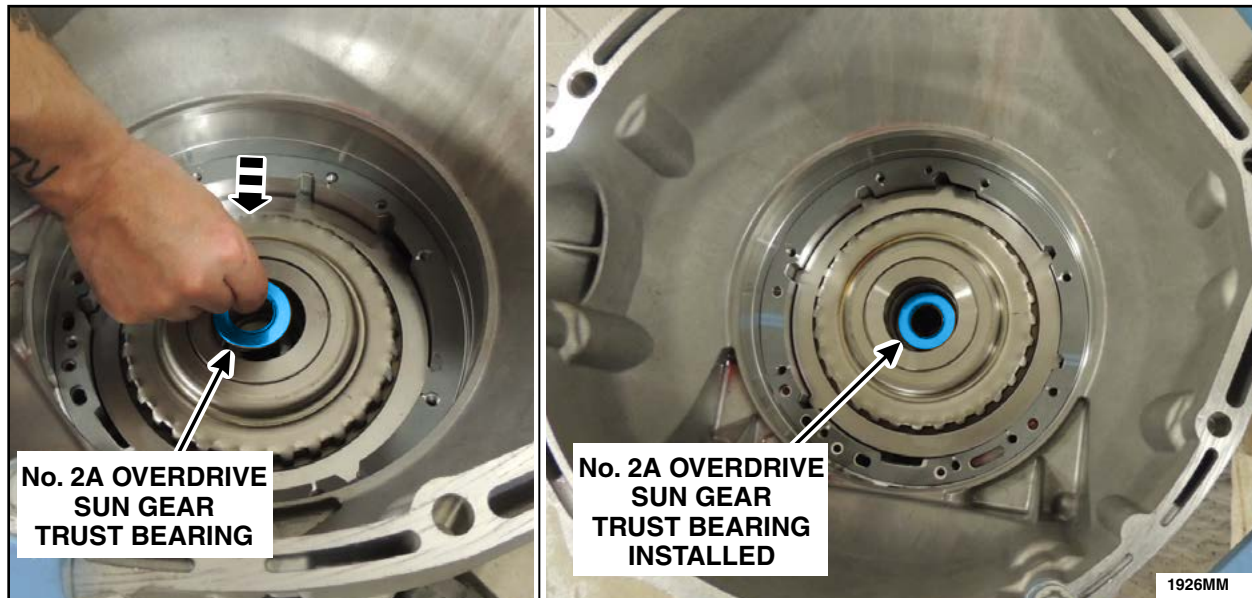
FIGURE 38

35. Install the No. 2A overdrive sun gear thrust bearing. See Figure 38.

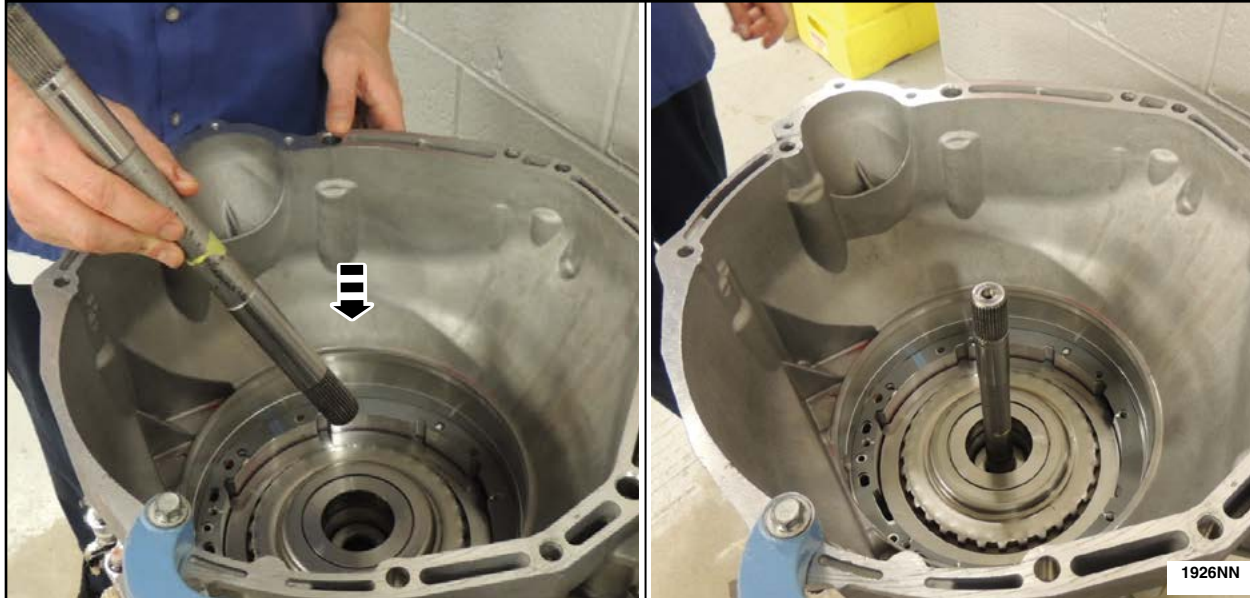
FIGURE 39

36. Install the input shaft into the case. See Figure 39.

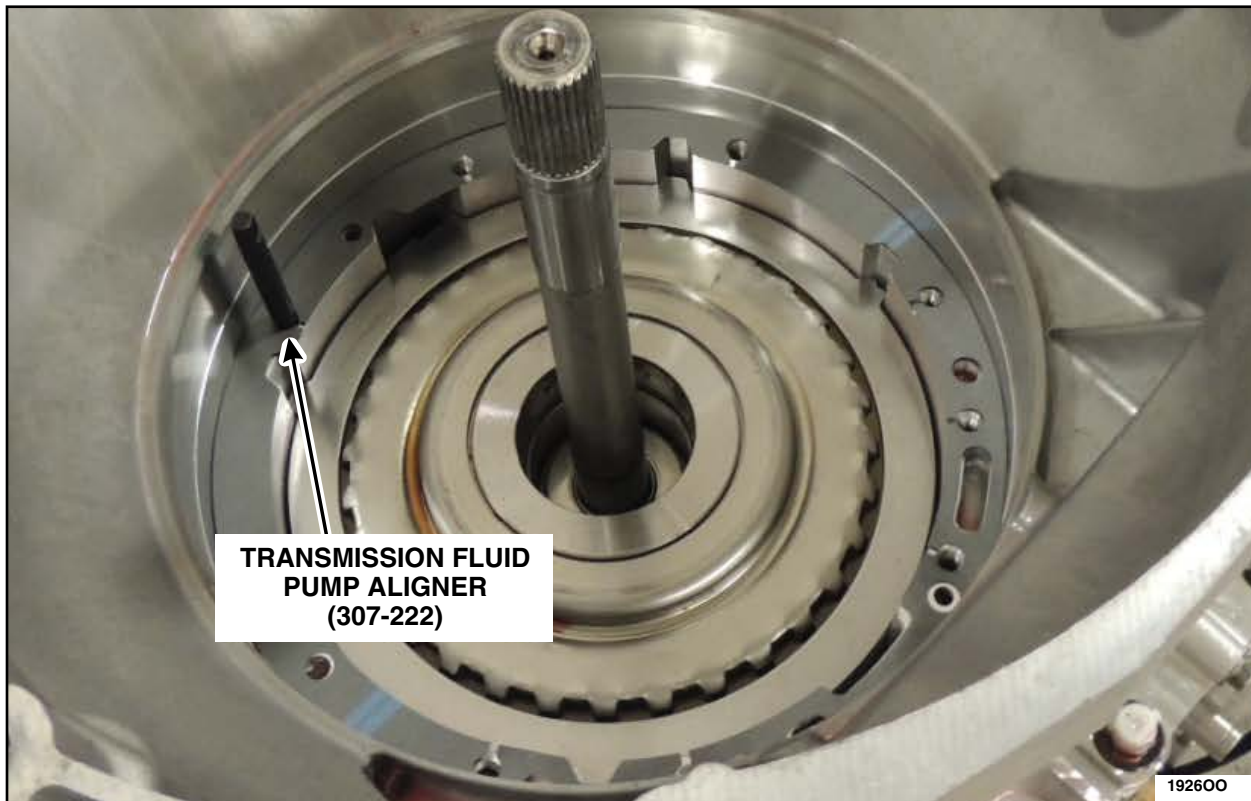
FIGURE 40

37. Install the Transmission Fluid Pump Aligner (307-222) into the case in order to achieve front pump-to-case alignment. See Figure 40.

NOTE: The Transmission Fluid Pump Aligner is used in a case hole located at either the 5 o'clock or 11 o'clock positions.

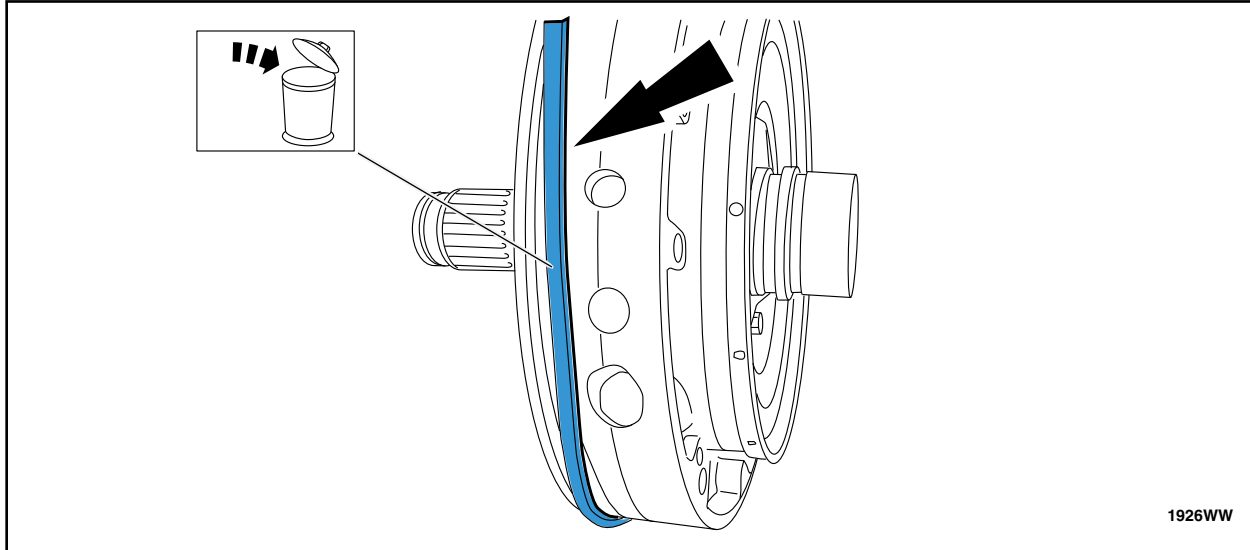
FIGURE 41

38. Remove and discard the front pump outer diameter square-cut pump seal. See Figure 41.

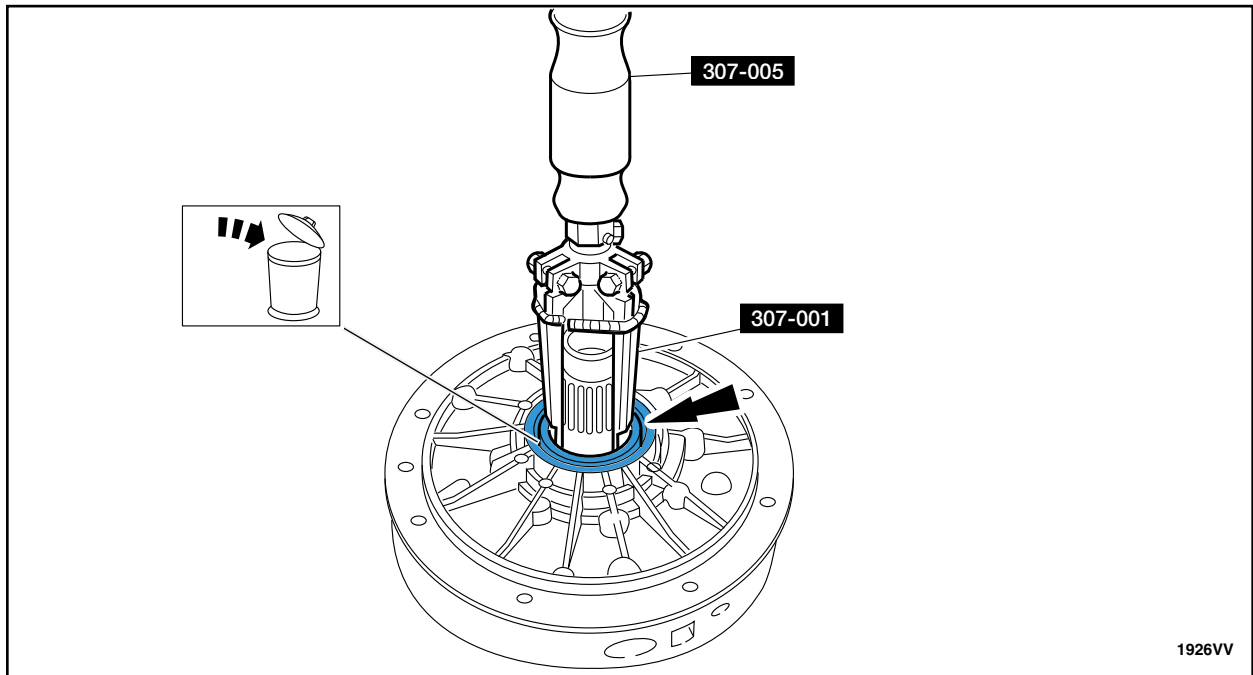
FIGURE 42

39. Using the Bushing Remover (307-001) and Slide Hammer (307-005), remove and discard the front pump fluid seal. See Figure 42.

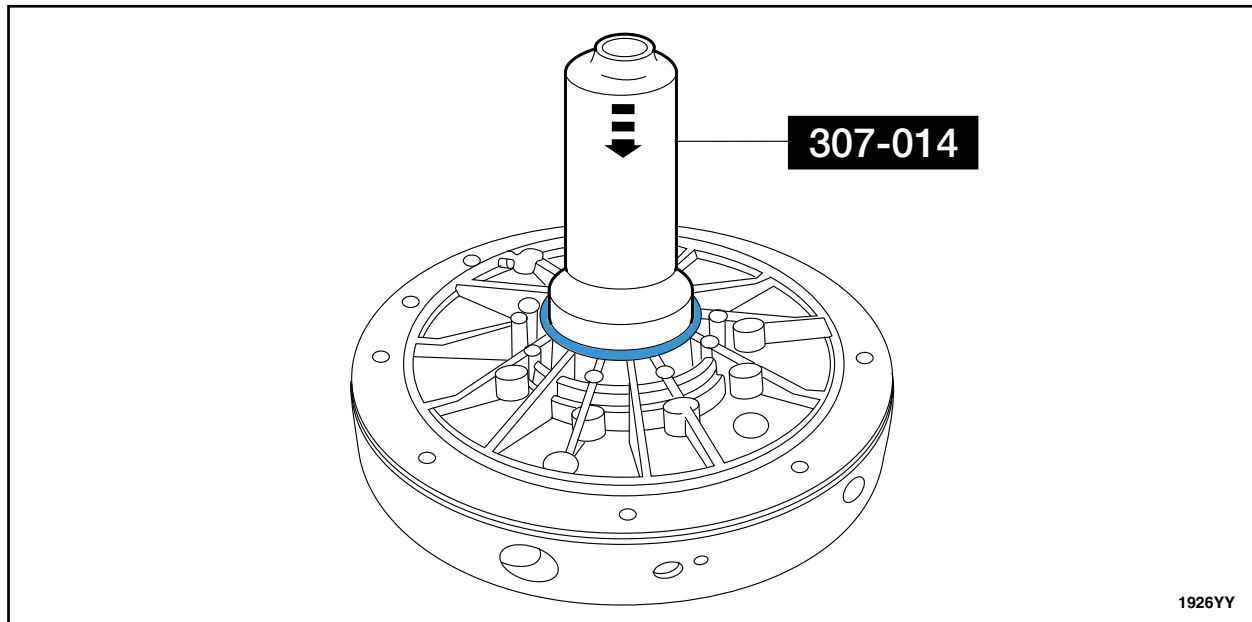
FIGURE 43

40. Using the Front Pump Fluid Seal Installer (307-014), install a *new* front pump fluid seal.
See Figure 43.

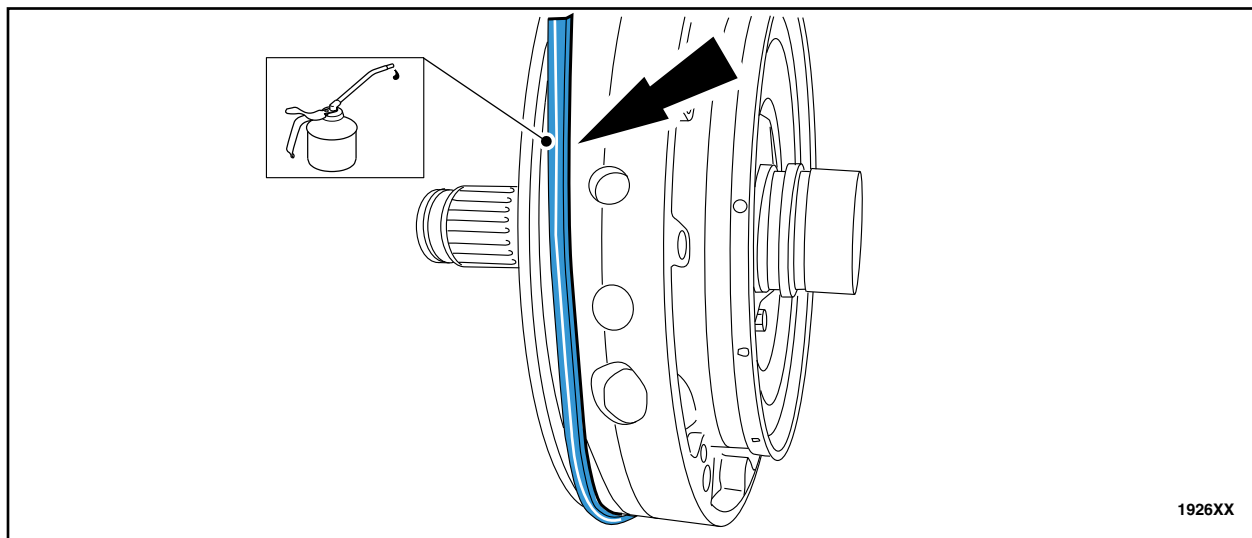
FIGURE 44

41. Coat the *new* front pump outer diameter square-cut seal with transmission fluid and install it with the white stripe facing out. See Figure 44.

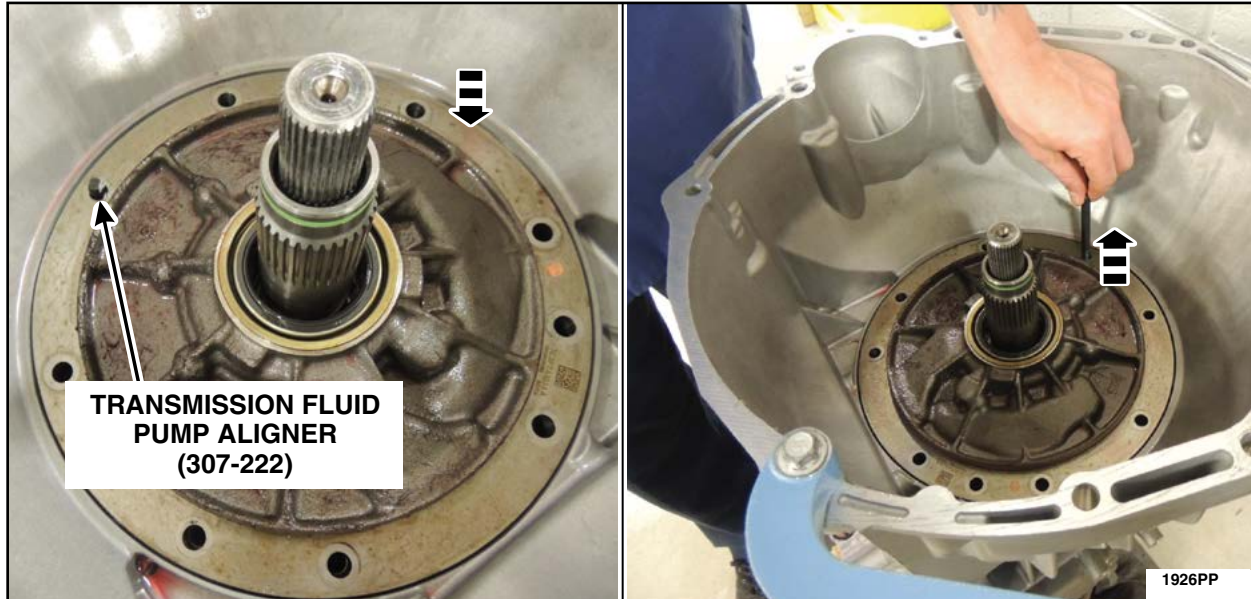
FIGURE 45

43. Using the Transmission Fluid Pump Aligner (307-222), install the front pump assembly with the transmission in a vertical position to avoid damage to the pump stator support Teflon® seals and then remove the Transmission Fluid Pump Aligner. See Figure 45.

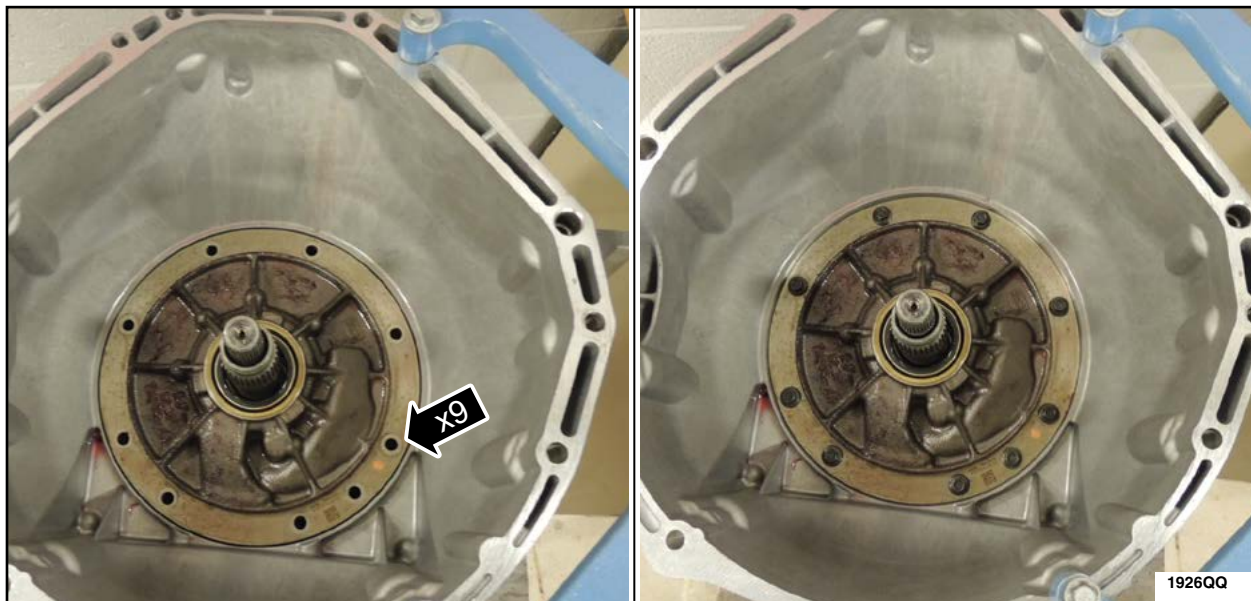
FIGURE 46

44. Install nine *new* front pump body-to-case retaining bolts. See Figure 46.

- Torque to 20 lb-ft (27 Nm).

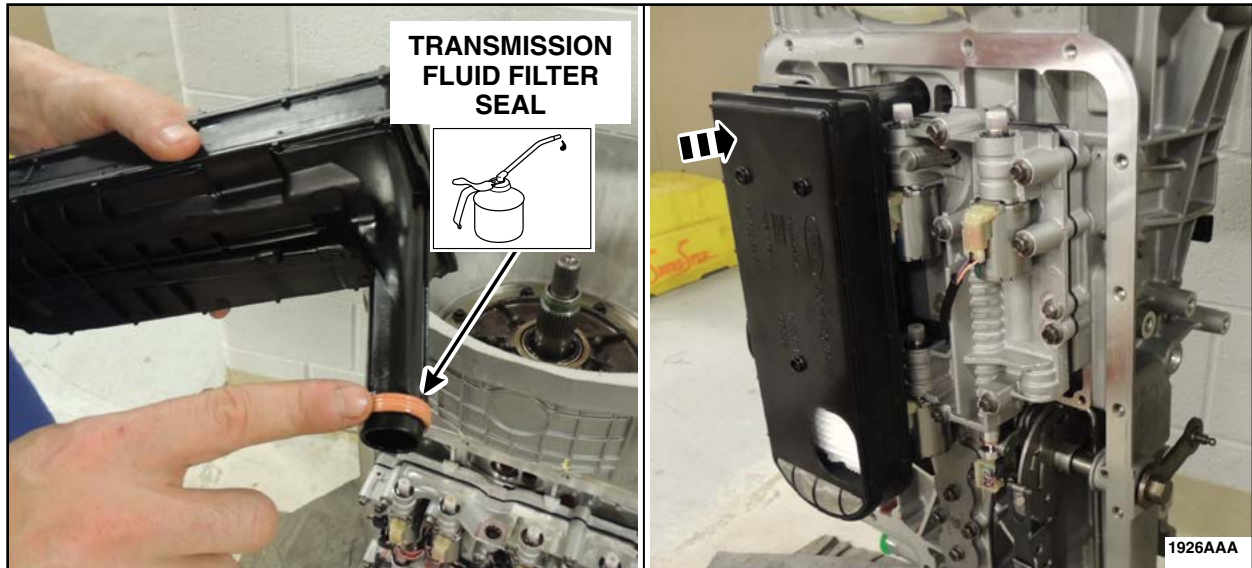
FIGURE 47

45. Lubricate the *new* transmission fluid filter seal with automatic transmission fluid and install a *new* transmission fluid filter. See Figure 47.

NOTE: Prior to installing the transmission fluid filter, make sure that the old seal is not stuck in the case. See Figure 6.

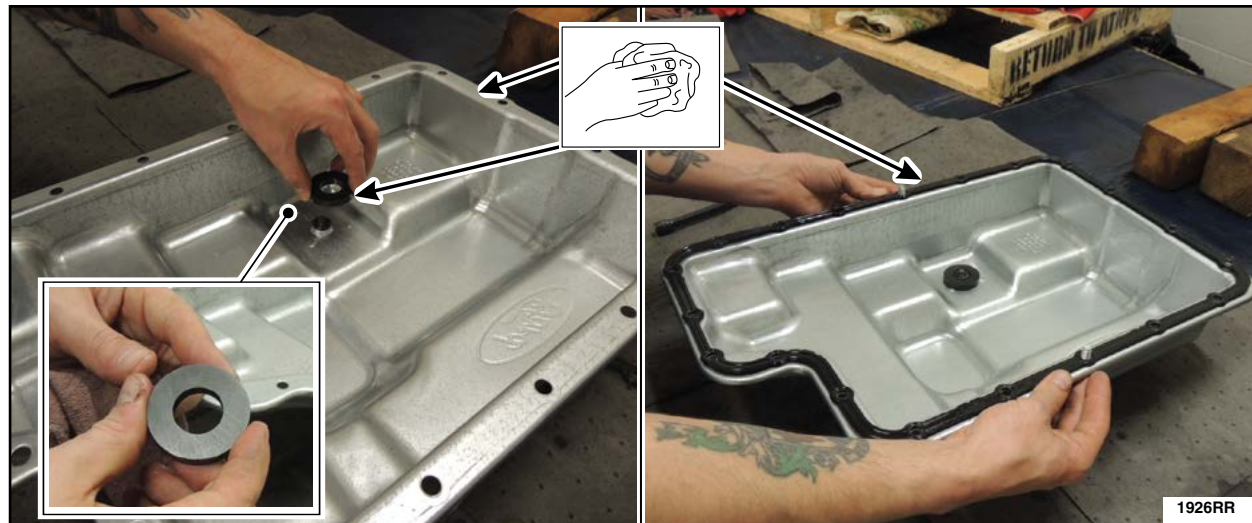
FIGURE 48

46. Clean the transmission fluid pan, magnet and the gasket mounting surface. Position the magnet over the dimple in the transmission fluid pan and position the transmission fluid pan gasket onto the transmission fluid pan. See Figure 48.

NOTE: Reuse the transmission fluid pan gasket unless it is damaged.

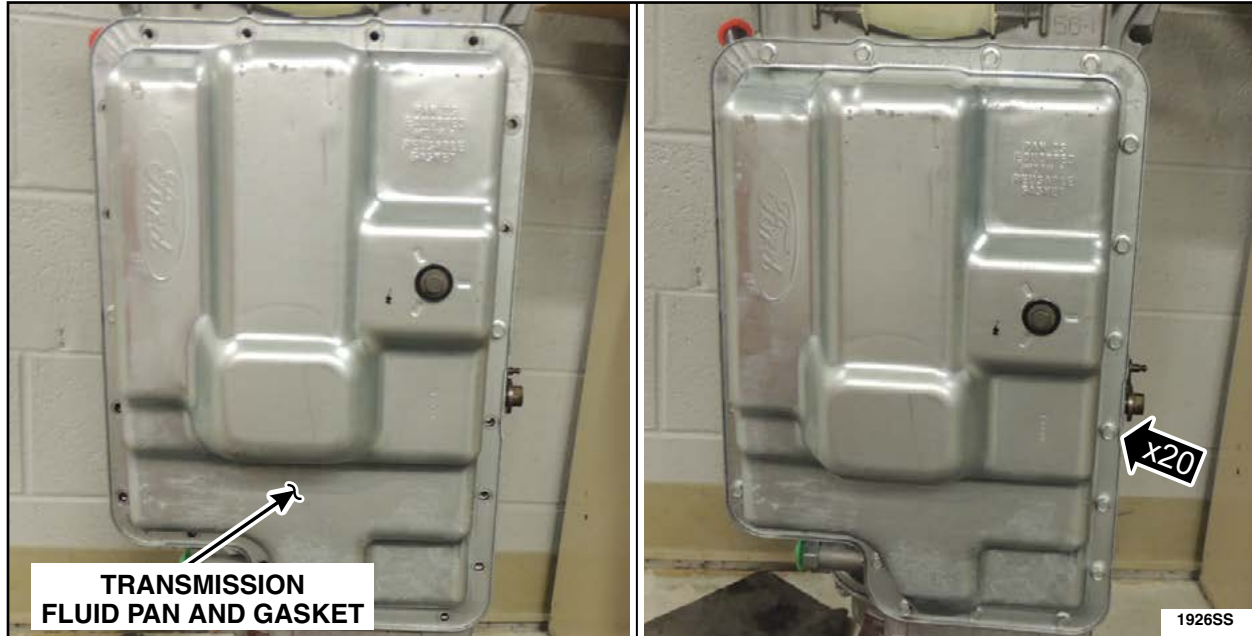
FIGURE 49

47. Install the transmission fluid pan and gasket. See Figure 49.

- Torque to 177 lb-in (20 Nm).

NOTE: Tighten all the transmission fluid pan bolts in a crisscross pattern.

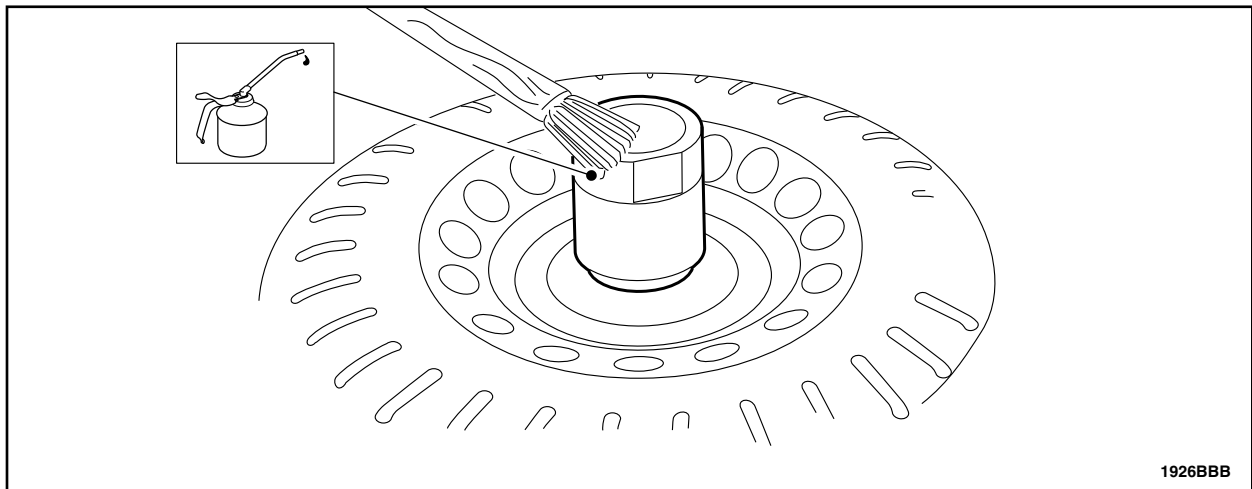
FIGURE 50

48. Lubricate the converter hub with automatic transmission fluid. See Figure 50.

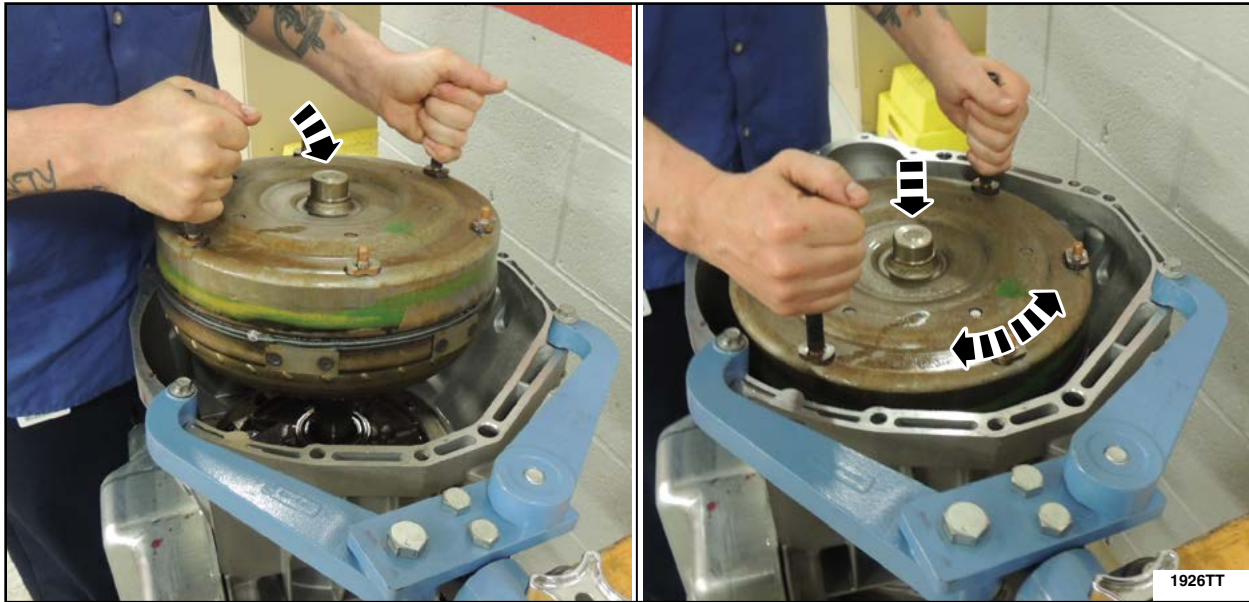
FIGURE 51

NOTICE: Use care when installing the torque converter to avoid damage to the front pump stator support seal.

NOTICE: Make sure the converter hub is fully engaged in the front pump support and the gear rotates freely. Do not damage the hub seal.

49. Using the Torque Converter Handles (307-091), install the torque converter. Push and rotate the converter onto the front pump assembly until it bottoms out. See Figure 51.

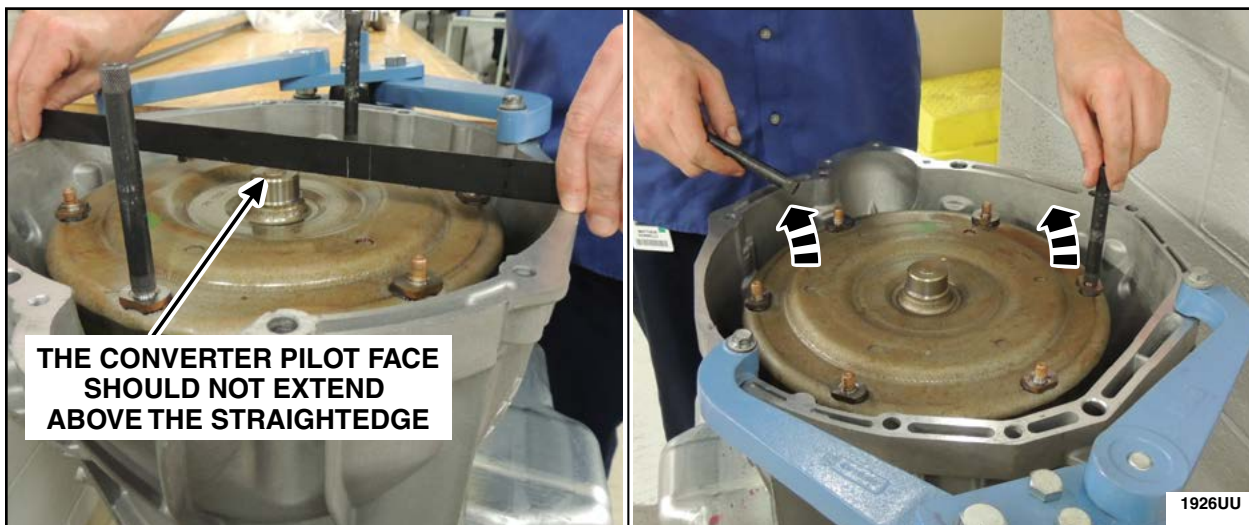
FIGURE 52

50. Check the seating of the torque converter. See Figure 52.

- a. Place the straightedge across the converter housing.
- b. Make sure there is a gap between the converter pilot face and the straightedge.
- c. Remove the Torque Converter Handles.
