**SUBJECT:** **NEW VEHICLE DEMONSTRATION / DELIVERY HOLD - Safety Recall 19S48**  
Certain 2017-2019 Model Year F-250-F-450 Vehicles  
Unintended Tailgate Opening

**SERVICE ACTION**

### SERVICE PROCEDURE

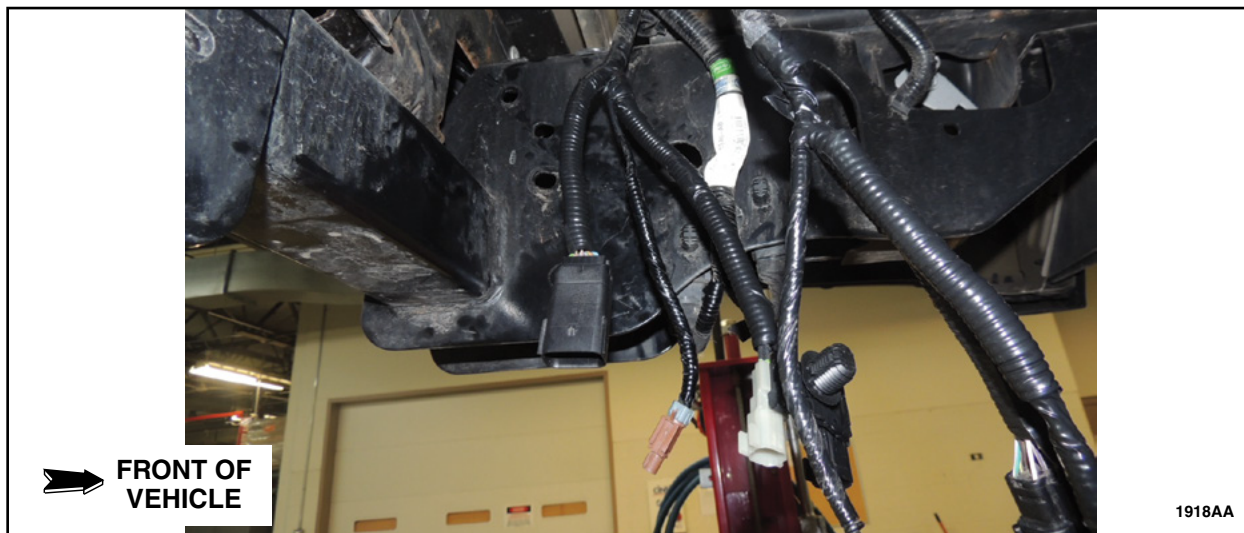
FIGURE 24

27. Cut to fit the *new* convolute and properly recover the wiring and secure using electrical tape. See Figure 24.
