David J. Johnson
Director
Service Engineering Operations
Ford Customer Service Division

SUBJECT: Safety Recall 19S54 – Supplement #3
Certain 2006-2010 Model Year Fusion/Milan/MKZ/Zephyr Vehicles Equipped with Anti-Lock Brake Systems
DOT 3 Brake Fluid and Anti-Lock Brake System Function

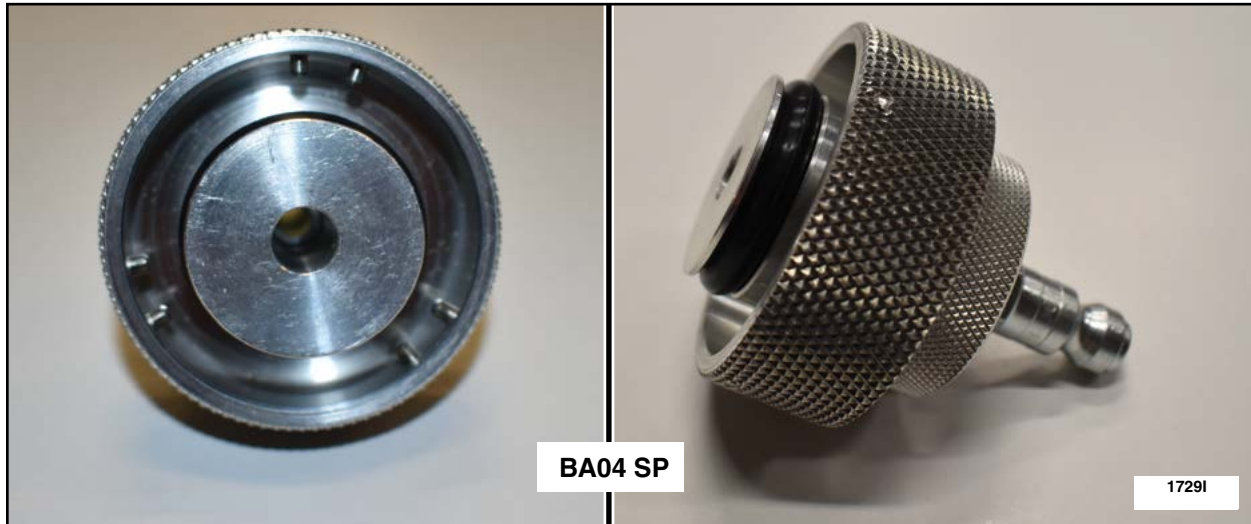
FIGURE 22

NOTE: When using a suitable Brake/Clutch System Pressure Bleeder/Filler ensure that you are using the correct adapter cap. The cap should fit tight/snug on the brake master cylinder reservoir. To ensure a proper fit to the brake master cylinder while using the power bleeder, it is recommend to use adapter 199-40100045 available through Rotunda or adapter BA04 SP available through NORCO INDUSTRIES®. The cap can be manually adjusted and tightened by moving the bands of the cap with your hands to further ensure a proper fit. See Figure 22.
