PRODUCT CAMPAIGN BULLETIN

**APPLICABILITY:** 2010-2014 model year Legacy NUMBERS: TKA-19 2010-2014 model year Outback **TKB-19** 2010-2013 model year Forester **TKC-19** 2010-2014 model year Tribeca **DATE:** 01/14/19 2010-2011 model year Impreza NHTSA ID: 19V-TBD 2010-2014 model year WRX and STI 19V-TBD **SUBJECT:** Takata Front Passenger Airbag Inflator Replacement 19V-TBD (2019 Calendar year expansion)

#### \*SERVICE PROCEDURE FOR 2010-14MY LEGACY / OUTBACK MODELS\* Inflator Kit Part Number: 98279AJ02A Replacement Airbag Module Assembly Part Number: 98279AJ06A

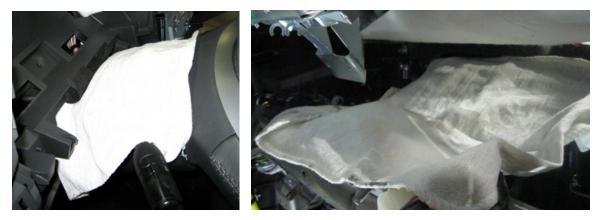
• **IMPORTANT:** Always cover the steering column cover to protect it along with the top of the HVAC blower case to keep out any removed hardware (e.g. airbag module retaining bolts) with clean shop cloth.

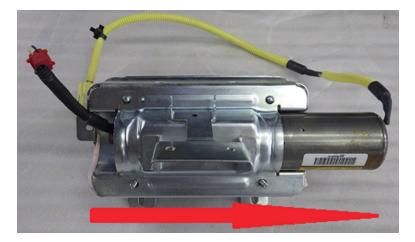
**STEP 8-** With the self-locking nuts and stopper plate removed, slide the original inflator out of the mounting bracket. Place the removed original air bag inflator back into the "cradle" of the Kit Box.

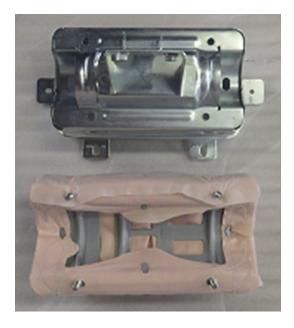
**STEP 10- CAREFULLY** remove the airbag from the mounting bracket (case).
