Safety Recall Code: 69Y5

Driver Frontal Airbag Inflator (Takata)

Replace the driver frontal airbag inflator with a newly manufactured version.

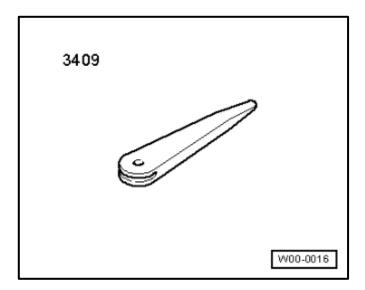
• Trim Removal Wedge – 3409 (or equivalent)

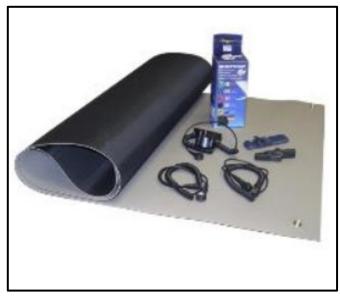
• ESD Worksurface - VAS 6613

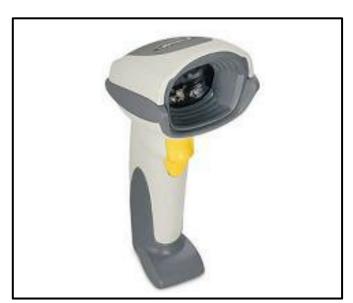
• Bar Code Scanner - VAS6161/1

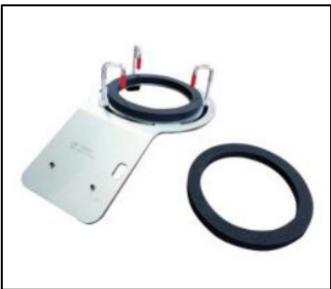
• Airbag Support - T10568

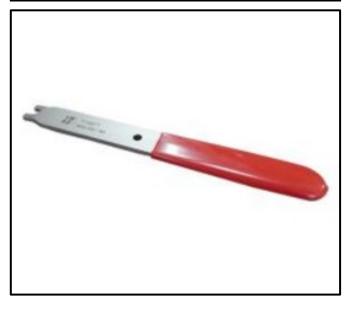
• Lever - T10571

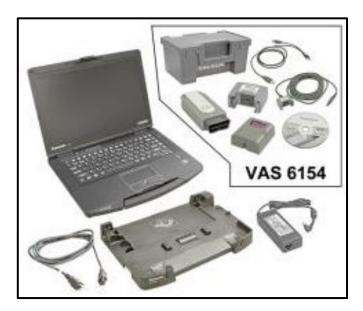
VAS6150D - Diagnostic Tester (or equivalent)

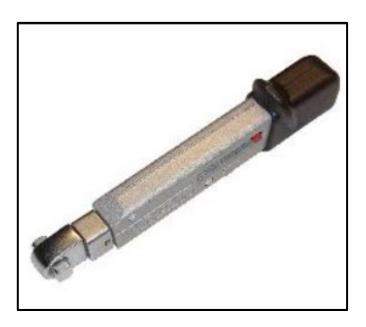
VAG1410 – Torque Wrench (or equivalent)

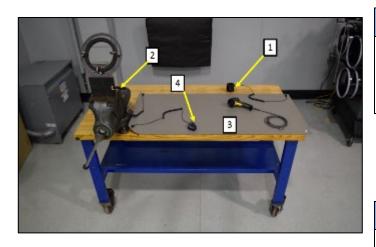
- Prior to beginning work, all parts and tools are to be placed on the ESD table mat.
- The workstation must be in the vicinity of the vehicle.
- Assemble ESD workplace -VAS 6613- <1, 2, 3,
- Plug ESD workplace into a wall socket using plug <1>.

- Clamp Airbag Support T10568 <2> into the vice.
- Connect crocodile clip <1> to airbag support <2> and ESD workplace -VAS 6613-.

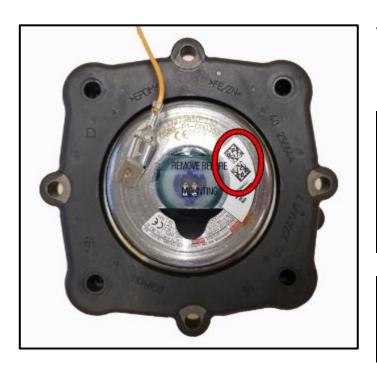
- Place the new inflator on the ESD mat.
- Scan the data matrix code of the new inflator at a distance of about 15 cm.

The photo is for reference only. The inflator that is installed may be either a single stage or dual stage inflator.

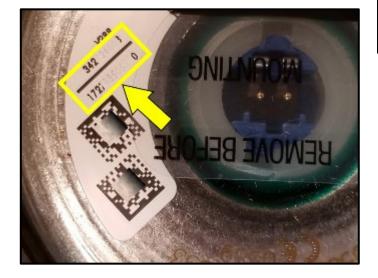
The data matrix code includes the values as shown.

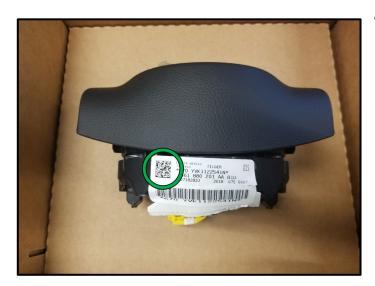
- Place the new airbag on the ESD mat.
- Scan the data matrix code <circle> of the new airbag at a distance of about 15 cm.

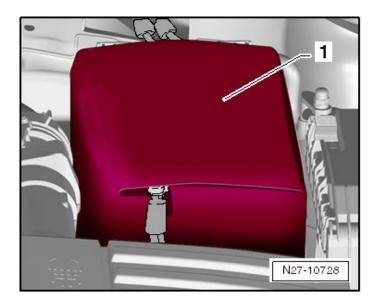
Battery in Engine Compartment:

- Open the battery protective covering <1>.
- Loosen the nut <1>.
- Remove and isolate the battery ground cable terminal from the battery terminal.

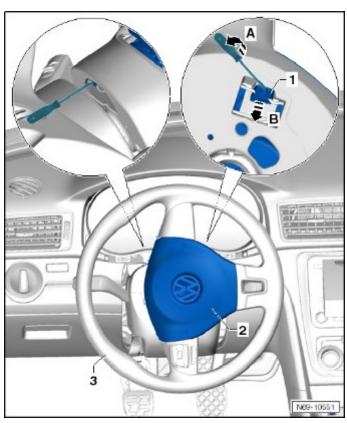
- Lower the steering wheel <3> as far as possible.
- Adjust steering wheel depth (reach) <3> so it is in the fully extended position.
- Turn the steering wheel <3> to the position illustrated.
- Insert a screwdriver all the way into the hole on the back of the steering wheel (approximately 8 mm).
- Turn the screwdriver toward the driver door <arrow A>. This will unlock the airbag unit <2> locking mechanism <1> in direction of <arrow>, on the right side of the steering wheel.
- Turn the steering wheel 180° and repeat the procedure on the opposite side.

The screwdriver previously mentioned should be about 175 mm long and have a blade width of 7 mm.

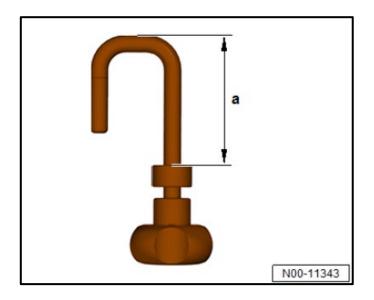
- The three spoke steering wheel has three mounting points.
- Tighten mounting by hand to prevent damage.
- Adjust three knurled nuts of securing hooks to <dimension a> 50mm.

- The three spoke steering wheel has three mounting points.
- Tighten mounting by hand to prevent damage.
- Adjust three knurled nuts of securing hooks to <dimension a> 50mm.

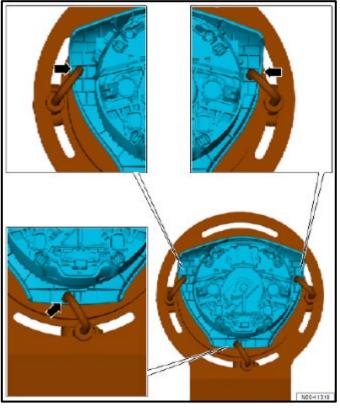
Clamp airbag centrally in airbag support. There are securing points on the sides <arrows>, parallel, opposite each other, and below.

The clamps must be placed in the positions shown <arrows> to prevent damage to the airbag. Damage to the airbag is not covered under this action.

The clamps must be placed in the positions shown <arrows> to prevent damage to the airbag. Damage to the airbag is not covered under this action.

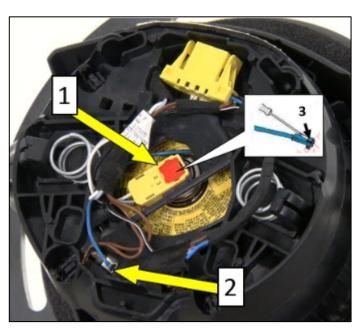
- Disengage connector lock <3> using a small flat bladed screwdriver.
- Remove connector <1> using needle nose pliers.

- Do not use a screwdriver to pry off connector
 <1> or damage to the connector could occur.
- Damage to the airbag connectors will not be covered under this action.
- Remove ground cable <2>.

The photo is for reference only. The inflator that is installed may be either a single stage or dual stage inflator.

- Do not use a screwdriver to pry off connector
 <1> or damage to the connector could occur.
- Damage to the airbag connectors will not be covered under this action.
- Remove ground cable <2>.

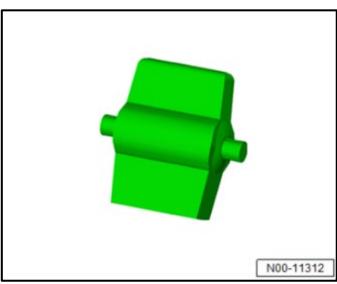
- The locking pins are to be reused.
- There may be instances in which short locking pins are fitted. These can be levered out with a small screwdriver.

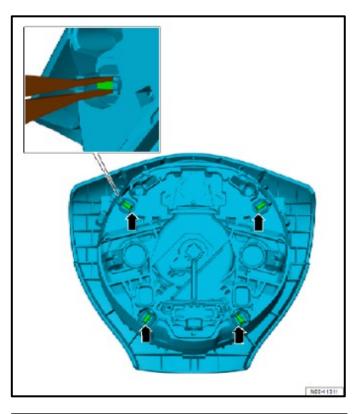
Remove locking pins <arrows> for horn ring with aid of longnose pliers.

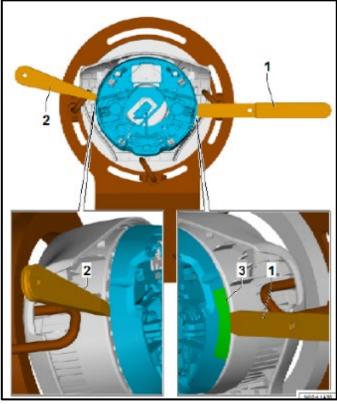
- Apply lever -T10571- <1> in shaded area <3>. At the same time, apply removal wedge -3409- on the other side <2> and lever off horn ring.
- · Repeat work steps on other side.

Use extreme care when removing the horn ring. If horn ring is damaged during removal, airbag replacement will be necessary. Replacement of the airbag due to damage during horn ring removal will not be covered under this action.

Use extreme care when removing the horn ring. If horn ring is damaged during remove, airbag replacement will be necessary. Replacement of the airbag due to damage during horn ring removal will not be covered under this action.

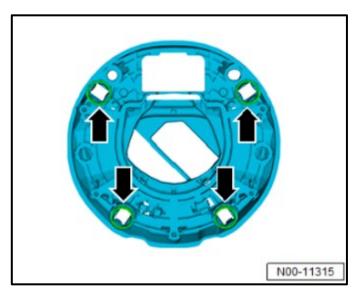
· Remove horn ring with springs <arrows>.

- When removing the horn ring, take care that the springs are not lost as they are not available sepereately.
- **ONE** replacement spring is included in the inflator kit in the event a spring is lost or damaged.
- If more than one spring is lost, replacement of the airbag is required. Replacement of the airbag is required if a spring is lost and is not covered under this action.

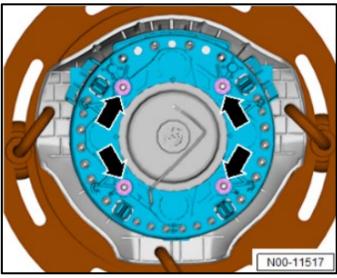
- Remove and discard nuts <arrows>.
- Remove cover for inflator.

The nuts are self-locking and must be replaced

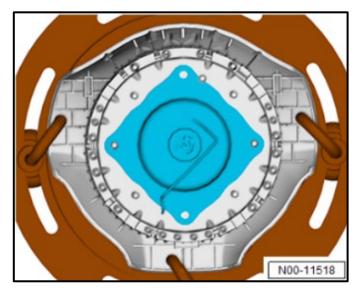
Remove the inflator and place in the original packaging.

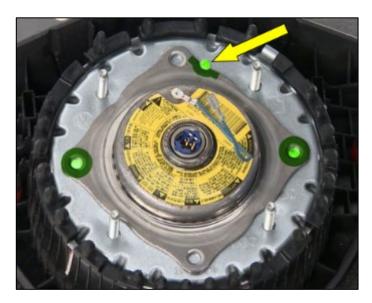
Insert the new inflator as shown. Note the recess <arrow>.

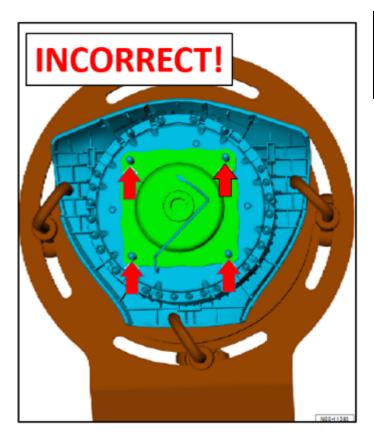
The photo is for reference only. The inflator that is installed may be either a single stage or dual stage inflator.

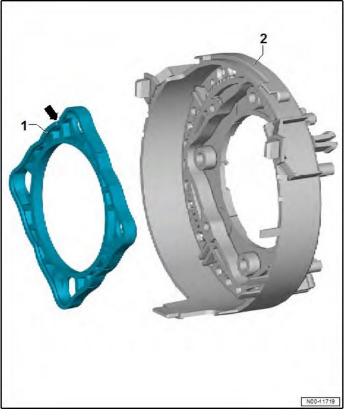
Note installation position:

The inflator must ${f NOT}$ be placed on the studs <arrows>.

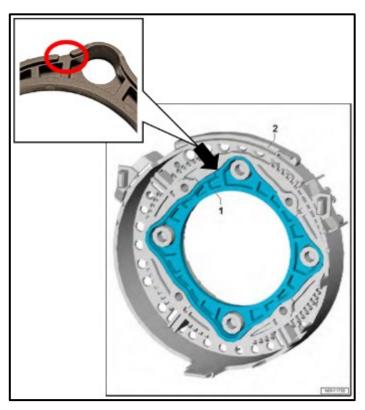
Included in the replacement parts kit is an insert ring <1>. This must be used when installing a new inflator and placed in the horn ring <2>.

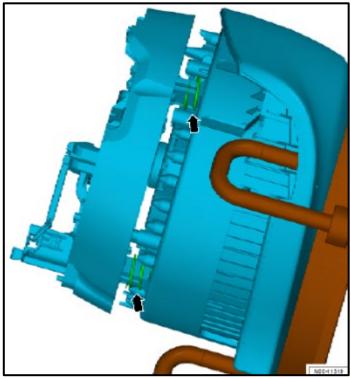
Fit springs <arrows> for horn ring again and allow to engage audibly.

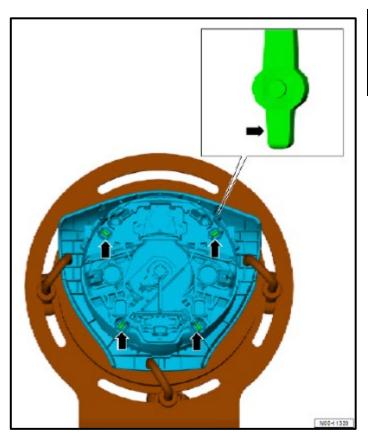
Position horn ring <arrows> with springs on securing clips and press firmly in place. Ensure that springs are seated correctly on both sides.

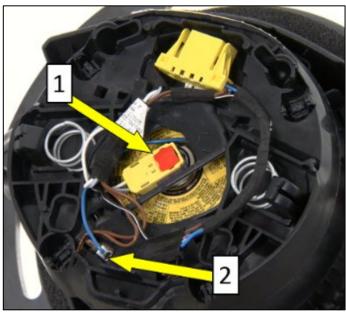
If a pin is damaged or has been lost, it can be replaced with a locking pin from the bag of spares included.

Using long-nose pliers, insert four locking pins in retaining lugs with narrow side facing downwards <arrow in magnification>. Pins must engage audibly.

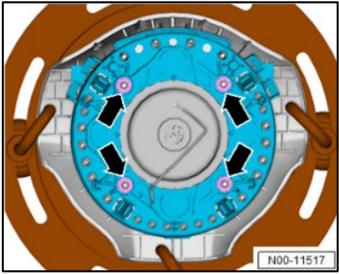
• Remove horn ring with springs <arrows>.

- When removing the horn ring, take care that the springs are not lost as they are not available sepereately.
- ONE replacement spring is included in the inflator kit in the event a spring is lost or damaged.
- If more than one spring is lost, replacement of the airbag is required. Replacement of the airbag is required if a spring is lost and is not covered under this action.

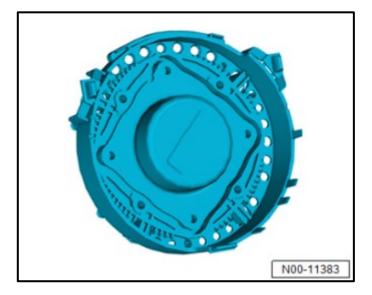
Remove and discard nuts <arrows>.

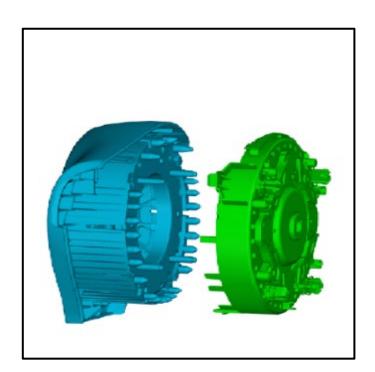
Remove the inflator and place in the original packaging.

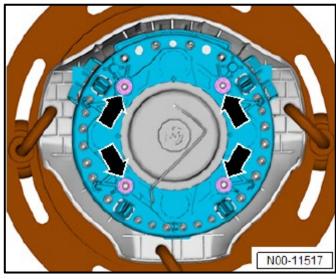
Set new inflator in installation position.

Criteria	Inflator Kit Part Number
T2	3C8898201C

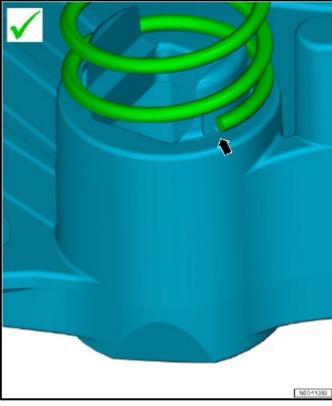
- If one of the springs is damaged or has been lost, it can be replaced with a spring from the bag of spares included.
- Note the examples shown for reference of proper spring seating.
- Spring seated incorrectly <arrow>.

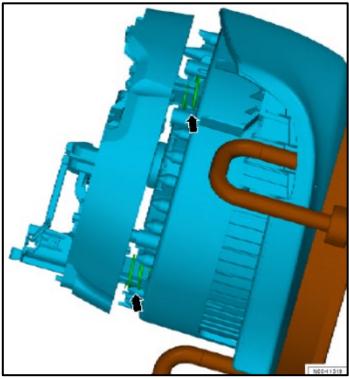
Fit springs <arrows> for horn ring again and allow to engage audibly.

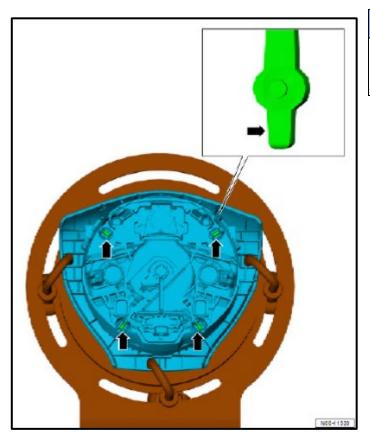
Position horn ring <arrows> with springs on securing clips and press firmly in place. Ensure that springs are seated correctly on both sides.

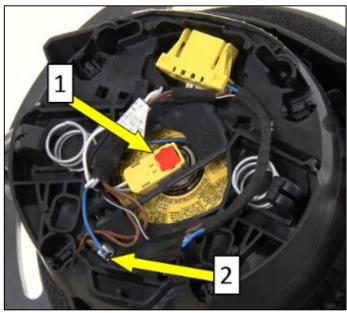
If a pin is damaged or has been lost, it can be replaced with a locking pin from the bag of spares included.

Using long-nose pliers, insert four locking pins in retaining lugs with narrow side facing downwards <arrow in magnification>. Pins must engage audibly.

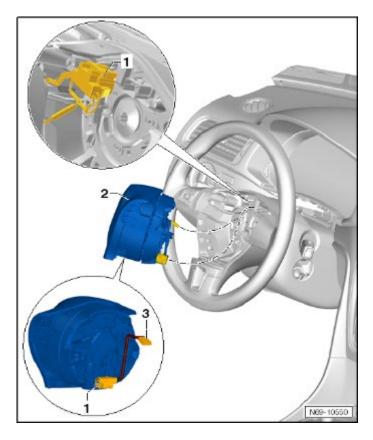
Vehicles with Critiera T3: Install a new driver airbag.

Criteria	Driver Airbag Part Number
Т3	561880201AA 81U

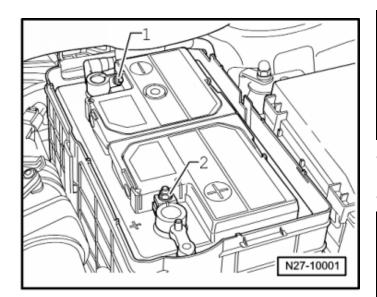
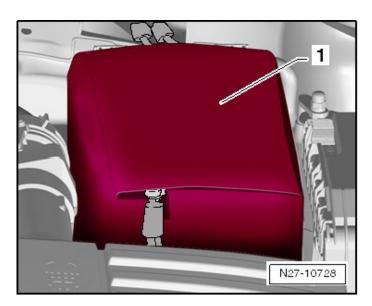
- Close the cover <1>.
- Cycle the ignition off and back on.
- Bring driver seat to an upright position.
- Store previously recorded radio presets (if necessary).
- Set clock to local time.
- Activate the power window regulator one-touch up/down function.
- Check the DTC memories of all the control units and erase under-voltage faults if necessary.
- After completing repairs, verify the horn is operational.
