Safety Recall Code: 69Y5

Subject	Driver Frontal Airbag Inflator (Takata)
Release Date	February, 26 2019
Affected Vehicles	U.S.A.: Certain 2015-2016 MY Volkswagen Eos, 2015-2017 MY Volkswagen CC & 2015 MY Volkswagen Passat equipped with a Takata driver frontal airbag
	CANADA: Certain 2015 MY Volkswagen Eos, 2015-2017 MY Volkswagen CC & 2015 MY Volkswagen Passat equipped with a Takata driver frontal airbag
	Check Campaigns/Actions screen in Elsa on the day of repair to verify that a VIN qualifies for repair under this action. Elsa is the <u>only</u> valid campaign inquiry & verification source.
	 ✓ Campaign status must show "open." ✓ If Elsa shows other open action(s), inform your customer so that the work can also be completed at the same time the vehicle is in the workshop for this campaign.
Problem Description	The driver airbag may explode in a crash with airbag deployment. Sharp metal fragments can hit people and cause serious injury or death.

Corrective Action	Replace the driver frontal airbag inflator with a newly manufactured version.
Parts Information	Parts will be allocated weekly. Please email <u>VWoAPartsSpecialists@vw.com</u> with VIN if you do not have the proper part(

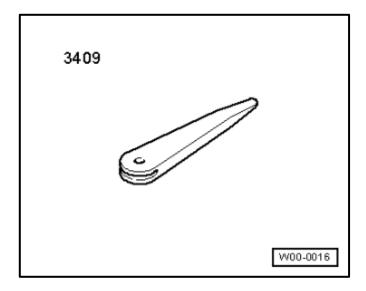
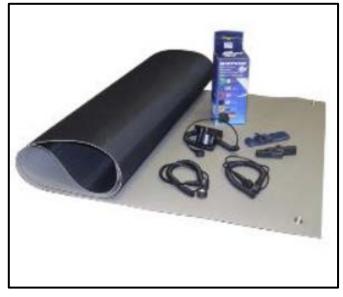
• Trim Removal Wedge - 3409 (or equivalent)

• ESD Worksurface - VAS 6613

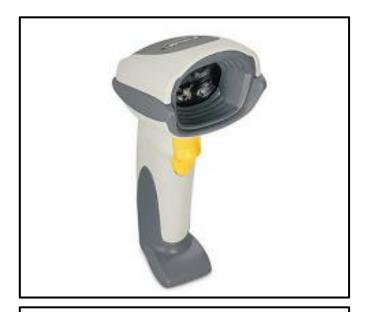
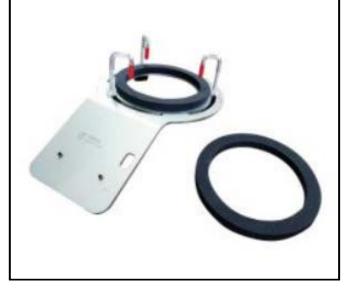
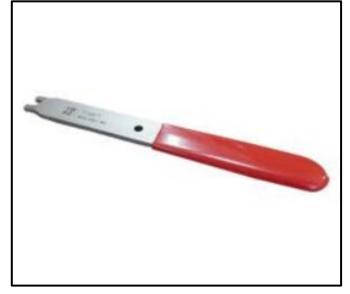
Bar Code Scanner – VAS6161/1

• Airbag Support - T10568

• Lever - T10571

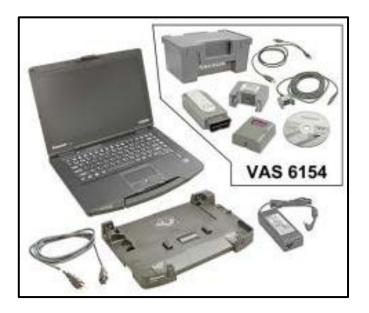
VAS6150D - Diagnostic Tester (or equivalent)

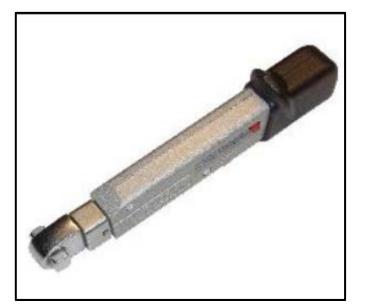
VAG1410 – Torque Wrench (or equivalent)

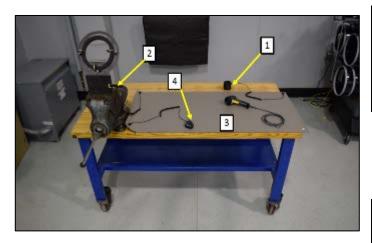
- Prior to beginning work, all parts and tools are to be placed on the ESD table mat.
- The workstation must be in the vicinity of the vehicle.
- Assemble ESD workplace -VAS 6613- <1, 2, 3, • and 4>.
- Plug ESD workplace into a wall socket using plug • <1>.

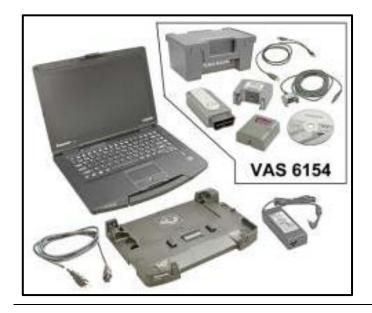
- Ensure ODIS is updated to the latest version. •
- Connect vehicle diagnostic tester to the diagnostic • head using the USB cable.
- Select Start Diagnosis function and identify • vehicle.
- After identification of control units, Guided Fault • Finding is started automatically.
- Follow the instructions on screen. •

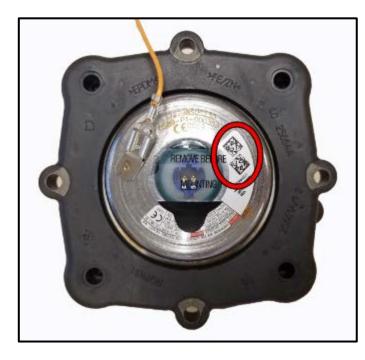
- Place the new inflator on the ESD mat. •
- Scan the data matrix code of the new inflator at a distance of about 15 cm.

The photo is for reference only. The inflator that is installed may be either a single stage or dual stage inflator.

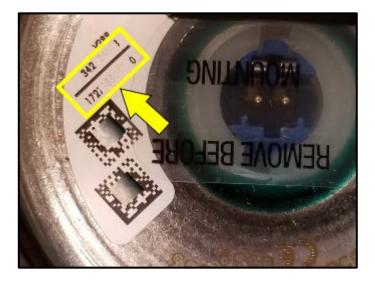
The data matrix code includes the values as shown.

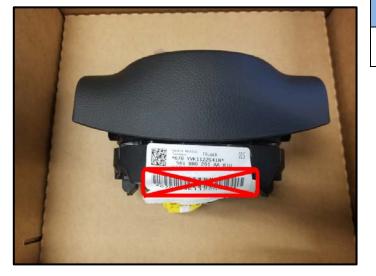
- Place the new airbag on the ESD mat. •
- Scan the data matrix code <circle> of the new • airbag at a distance of about 15 cm.

Scanning the bar code on the new airbag will result in an "implausible barcode" message.

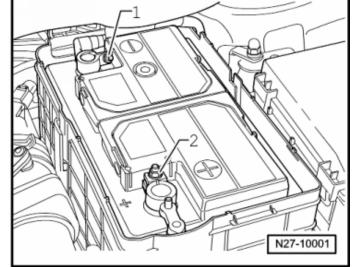
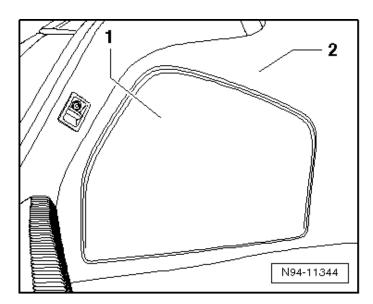
- Open the battery protective covering <1>.
- Loosen the nut <1>.
- Remove and isolate the battery ground cable terminal from the battery terminal.

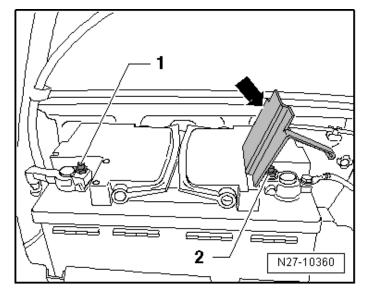
- Loosen the nut <1>.
- Remove and isolate the battery ground cable • terminal from the battery terminal.

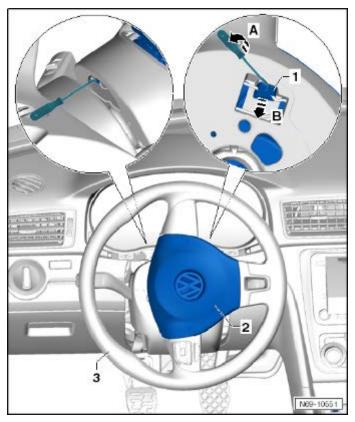
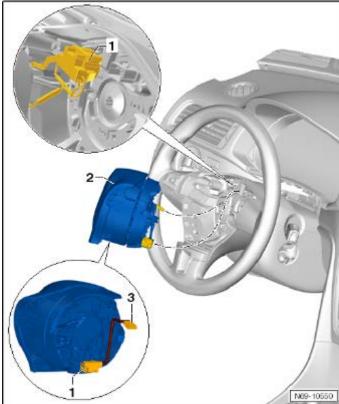
- Lower the steering wheel <3> as far as possible.
- Adjust steering wheel depth (reach) <3> so it is in the fully extended position.
- Turn the steering wheel <3> to the position illustrated.
- Insert a screwdriver all the way into the hole on the back of the steering wheel (approximately 8 mm).
- Turn the screwdriver toward the driver door <arrow A>. This will unlock the airbag unit <2> locking mechanism <1> in direction of <arrow>, on the right side of the steering wheel.
- Turn the steering wheel 180° and repeat the procedure on the opposite side.

The screwdriver previously mentioned should be about 175 mm long and have a blade width of 7 mm.

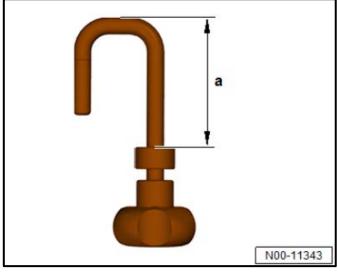
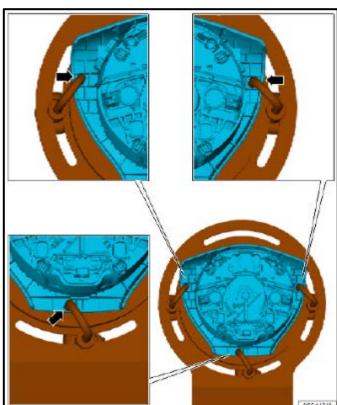
- The three spoke steering wheel has three • mounting points.
- Tighten mounting by hand to prevent damage.
- Adjust three knurled nuts of securing hooks to <dimension a> 50mm.

The clamps must be placed in the positions shown <arrows> to prevent damage to the airbag. Damage to the airbag is not covered under this action.

- The three spoke steering wheel has three mounting points.
- Tighten mounting by hand to prevent damage.
- Adjust three knurled nuts of securing hooks to <dimension a> 50mm.

The clamps must be placed in the positions shown <arrows> to prevent damage to the airbag. Damage to the airbag is not covered under this action.

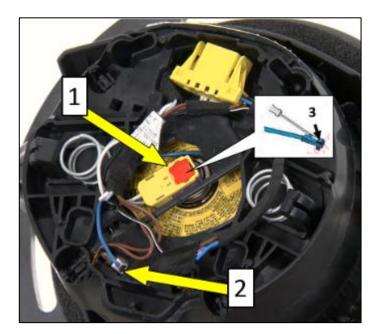
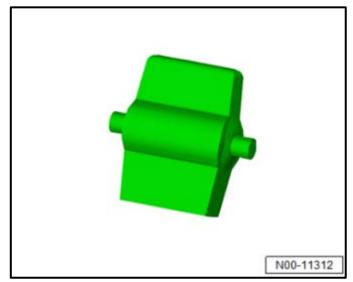
- Disengage connector lock <3> using a small flat bladed screwdriver.
- Remove connector <1> using needle nose pliers. •

- Do not use a screwdriver to pry off connector • <1> or damage to the connector could occur.
- Damage to the airbag connectors will not be covered under this action.
- Remove ground cable <2>.

- Do not use a screwdriver to pry off connector • <1> or damage to the connector could occur.
- Damage to the airbag connectors will not be covered under this action.
- Remove ground cable <2>.

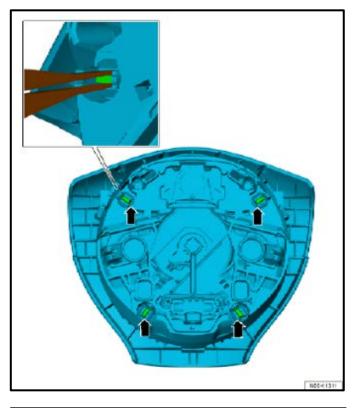
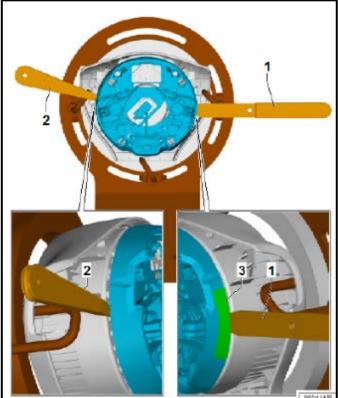
- The locking pins are to be reused. •
- There may be instances in which short locking • pins are fitted. These can be levered out with a small screwdriver.

Remove locking pins <arrows> for horn ring with aid of longnose pliers.

- Apply lever -T10571- <1> in shaded area <3>. At • the same time, apply removal wedge -3409- on the other side <2> and lever off horn ring.
- Repeat work steps on other side.

Use extreme care when removing the horn ring. If horn ring is damaged during removal, airbag replacement will be necessary. Replacement of the airbag due to damage during horn ring removal will not be covered under this action.

Use extreme care when removing the horn ring. If horn ring is damaged during remove, airbag replacement will be necessary. Replacement of the airbag due to damage during horn ring removal will not be covered under this action.

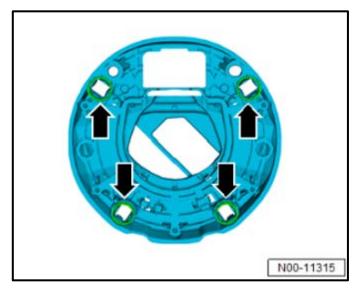
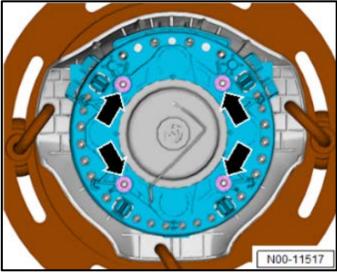
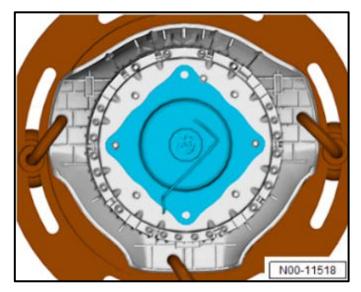
Remove horn ring with springs <arrows>.

- When removing the horn ring, take care that the springs are not lost as they are not available sepereately.
- **ONE** replacement spring is included in the inflator kit in the event a spring is lost or damaged.
- If more than one spring is lost, replacement of the airbag is required. Replacement of the airbag is required if a spring is lost and is not covered under this action.
- Remove and discard nuts <arrows>.
- Remove cover for inflator.

Remove the inflator and place in the original packaging.

- When removing the horn ring, take care that the • springs are not lost as they are not available sepereately.
- **ONE** replacement spring is included in the inflator kit in the event a spring is lost or damaged.
- If more than one spring is lost, replacement of the airbag is required. Replacement of the airbag is required if a spring is lost and is not covered under this action.
- Remove and discard nuts <arrows>.

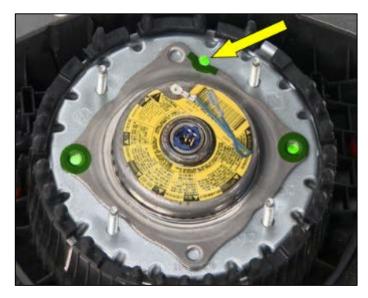
Insert the new inflator as shown. Note the recess <arrow>.

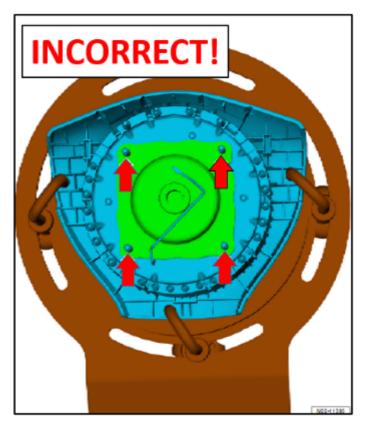
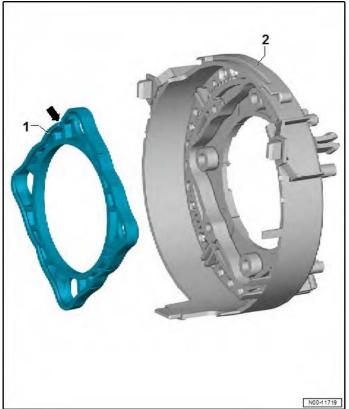
Note installation position:

The inflator must NOT be placed on the studs <arrows>.

Included in the replacement parts kit is an insert ٠ ring <1>. This must be used when installing a new inflator and placed in the horn ring <2>.

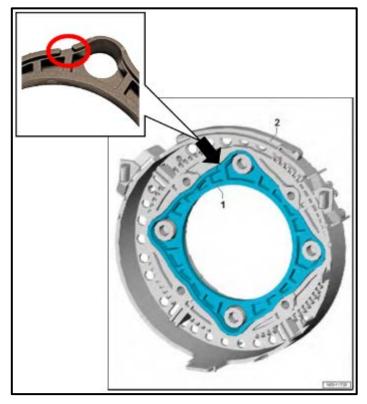
Fit insert ring <1> into horn ring <2>. The notch • (circle) in the insert ring must be at top <arrow> when doing this.

- It should be possible to fit the insert ring from the • replacement parts kit with ease.
- It is essential to adhere to the installation position.
- The notch must be at the top <arrow>.

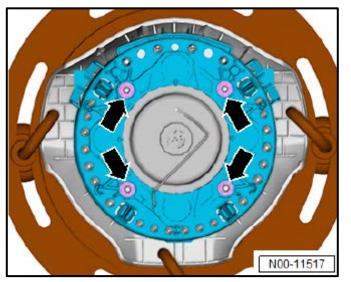
The nuts are self-locking and must be replaced

Fit cover for inflator and tighten 4 nuts <arrows> • to 5 Nm ± 0.4 Nm.

The nuts are self-locking and must be replaced

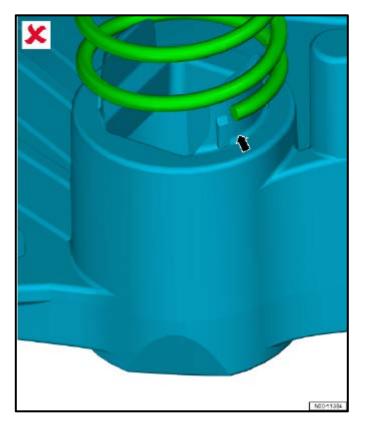
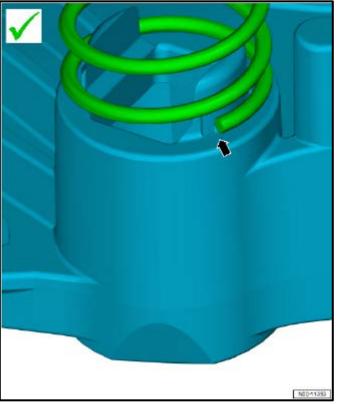
- If one of the springs is damaged or has been lost, • it can be replaced with a spring from the bag of spares included.
- Note the examples shown for reference of proper spring seating.
- Spring seated incorrectly <arrow>. •

Spring seated correctly <arrow>.

- If one of the springs is damaged or has been lost, • it can be replaced with a spring from the bag of spares included.
- Note the examples shown for reference of proper spring seating.
- Spring seated incorrectly <arrow>. •

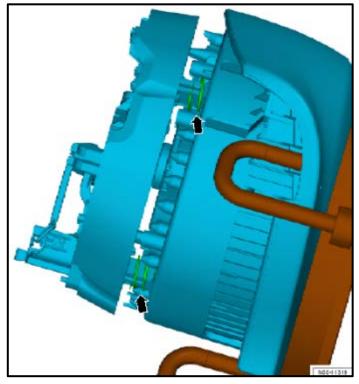
Fit springs <arrows> for horn ring again and allow to engage audibly.

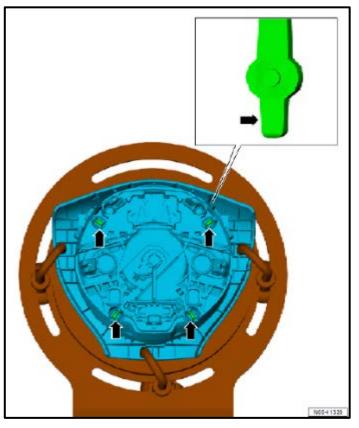
Position horn ring <arrows> with springs on • securing clips and press firmly in place. Ensure that springs are seated correctly on both sides.

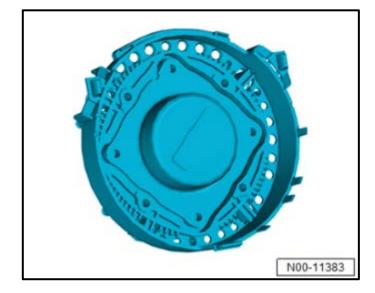
Remove horn ring with springs <arrows>.

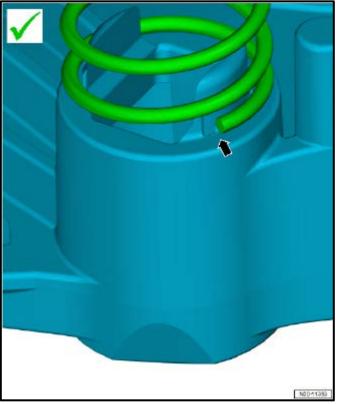
Spring seated correctly <arrow>.

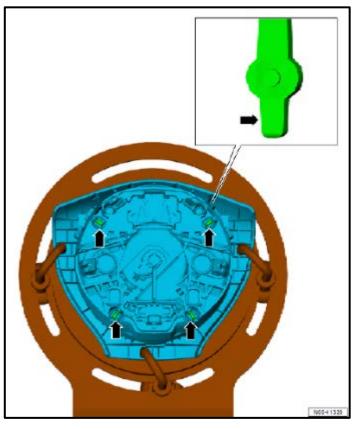
Position horn ring <arrows> with springs on • securing clips and press firmly in place. Ensure that springs are seated correctly on both sides.

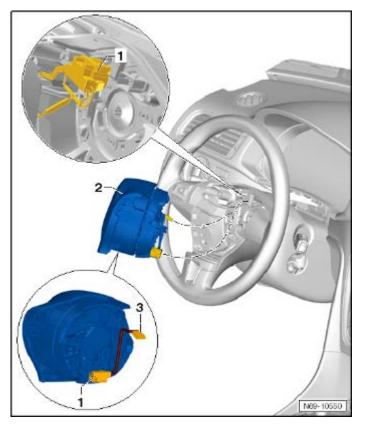
- The battery must be disconnected before • installing the airbag back into the vehicle.
- Before handling pyrotechnic components (for example, disconnecting the connector), the person handling it must "discharge static electricity". This can be done by touching the door striker, for example.
- Connect the connector <1>. The connector must click into place during this.
- Press the connector lock on the connector <1>. •
- Connect the connector <3> (if equipped).
- Insert the airbag unit <2> into the steering wheel but do not press on it.

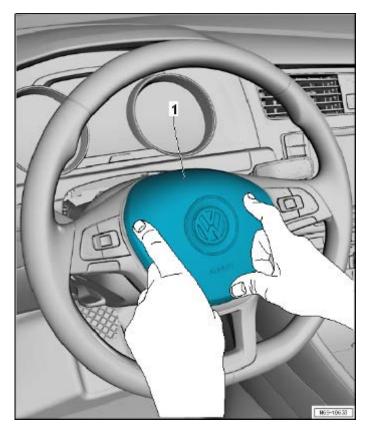
- Press on the edge of the airbag unit <1> with both • hands until it locks into place.
- Gently pull on the airbag unit to make sure the • airbag unit is secured correctly at all three attachment points in the steering wheel.

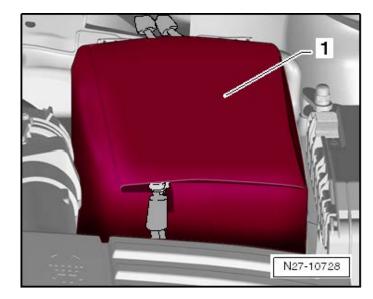
- Close the cover <1>.
- Cycle the ignition off and back on.
- Bring driver seat to an upright position.
- Store previously recorded radio presets (if necessary).
- Set clock to local time.
- Activate the power window regulator one-touch up/down function.
- Check the DTC memories of all the control units and erase under-voltage faults if necessary.
- After completing repairs, verify the horn is operational.

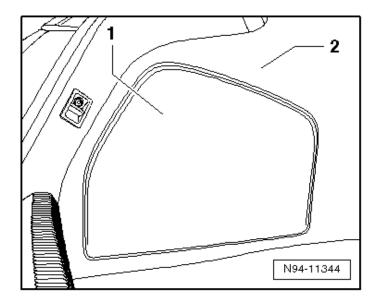
- Install the service cover <1> on the side trim panel <2>.
- Cycle the ignition off and back on. •
- Bring driver seat to an upright position. •
- Store previously recorded radio presets (if . necessary).
- Set clock to local time. •
- Activate the power window regulator one-touch • up/down function.
- Check the DTC memories of all the control units and erase under-voltage faults if necessary.
- After completing repairs, verify the horn is operational.
