SIB 65 01 19

## RECALL CAMPAIGN 19V-016: DRIVERS FRONT AIR BAG MODULE E84(X1)

E-Series	Model Description	Production Date
E84	X1 Sports Activity Vehicle	from October 1, 2014 through June 30, 2015

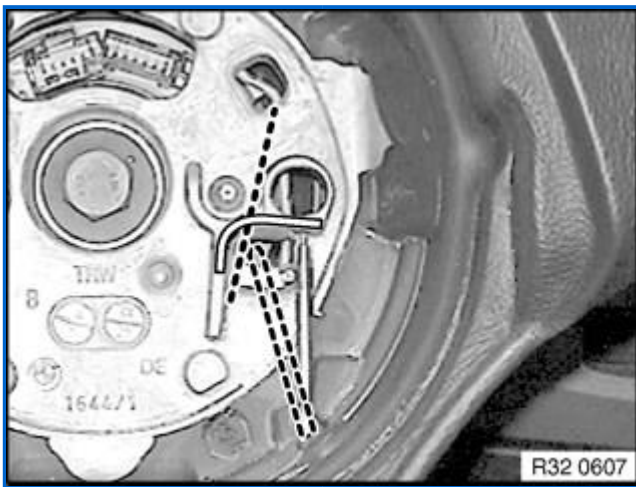
Insert Torx screwdriver (T20) roughly straight from below into opening on reverse side of steering wheel up to stop (approx. 5.5 cm). Swing Torx screwdriver (T20) with handle sideways until airbag unit is unlocked.

Repeat procedure on other side.

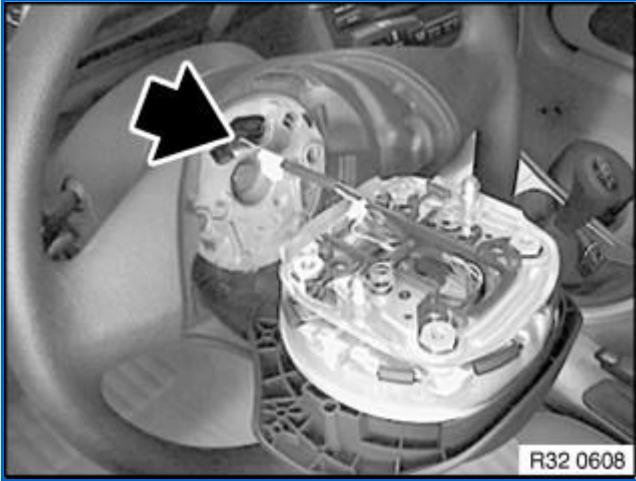
Tilt airbag unit towards rear.

Disconnect plug connection and remove airbag unit.

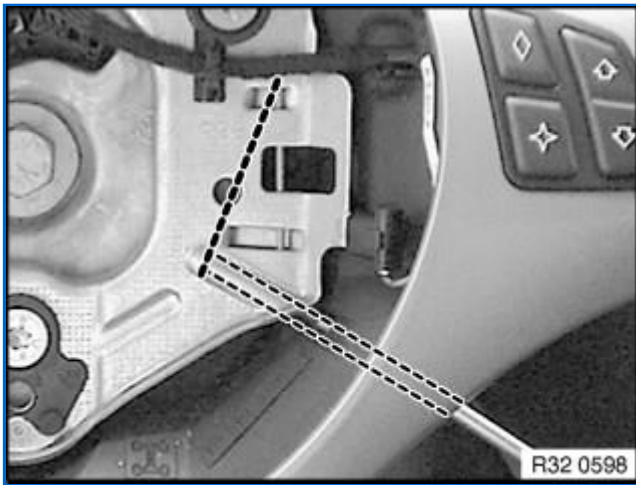
Insert Torx screwdriver (T25) at an angle into concealed opening on reverse side of steering wheel until a spring resistance is felt (approx. 1.5 cm).

Increase pressure on spring leg (concealed) using Torx screwdriver (T25) until airbag unit is unlocked.

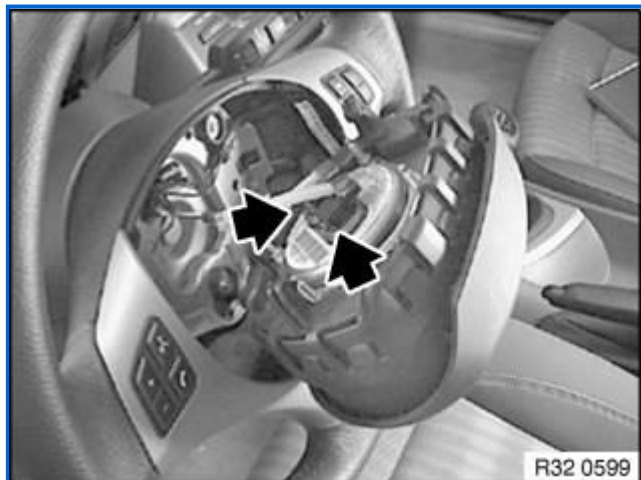
Tilt airbag unit forwards.

Disconnect plug connections and remove  
airbag
