Compliance Recall

Code: 90L8

Subject	Brake System Software – Instrument Cluster Warning Noncompliance
Release Date	March 07, 2019
Affected Vehicles	U.S.A. & CANADA: Certain 2019 MY Volkswagen Beetle & Beetle Convertible <i>Check Campaigns/Actions screen in Elsa on the day of repair to verify that a VIN qualifies for repair under this action. Elsa is the <u>only</u> valid campaign inquiry & verification source.</i> <ul style="list-style-type: none">✓ Campaign status must show "open."✓ If Elsa shows other open action(s), inform your customer so that the work can also be completed at the same time the vehicle is in the workshop for this campaign.
Problem Description	When the ESP or ABS control unit detects a failure in the brake system regarding the brake force distribution EBV, no visual warning is displayed in the instrument cluster. Because the driver will not see a warning in the instrument cluster when the malfunction occurs, there is a risk of losing control of the car during emergency braking. This may lead to a crash without warning.

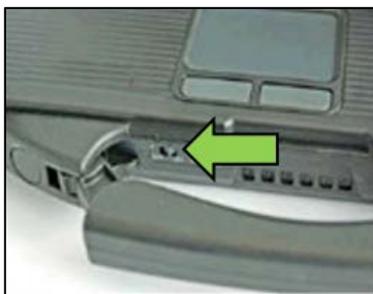
VAS 6150 & VAS 6150A
(Front panel behind handle)

- ✓ **The Bluetooth function of the scan tool is physically switched off <see pictures below>.**

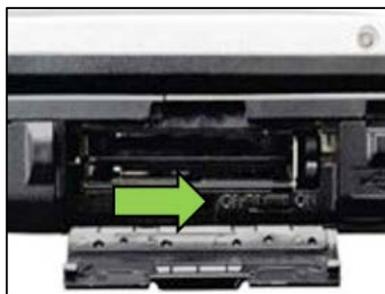
VAS 6150B
(Right side behind WIRELESS door)

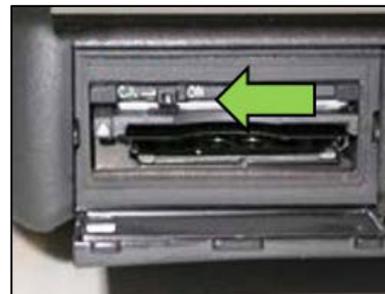
VAS 6150C/D
(Left side behind SC/EX door)

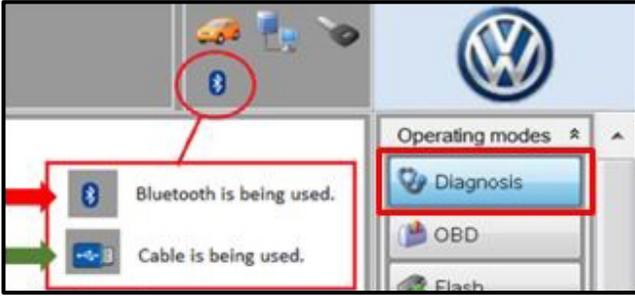
- Confirm that scan tool is communicating with the diagnostic head by USB <Green Arrow>.
 - If the Bluetooth symbol is shown <Red Arrow> then disconnect the diagnostic head from the vehicle and reconnect the USB cable to the diagnostic head and then reattach to the vehicle.
- Upon ODIS startup, verify the “Diagnosis” operating mode is selected <as shown>.

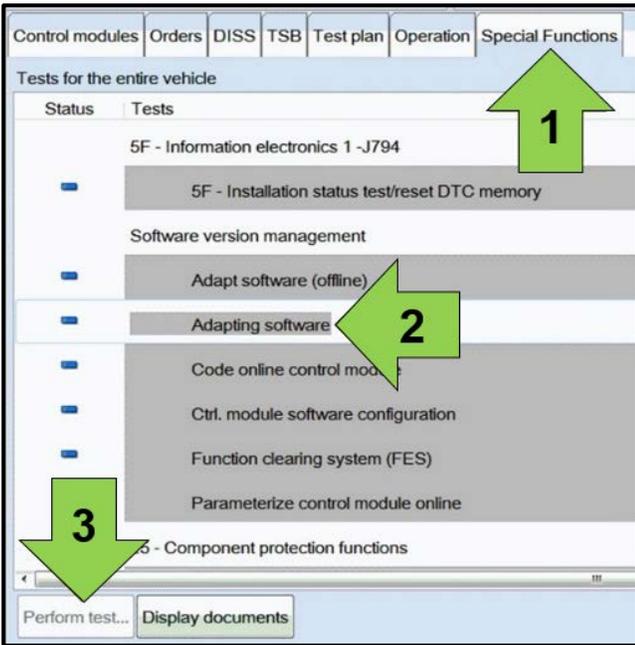
- Once the GFF scan is complete, select “Special functions” <arrow 1>, then “Adapting software” <arrow 2>, then select “Perform test” <arrow 3>.

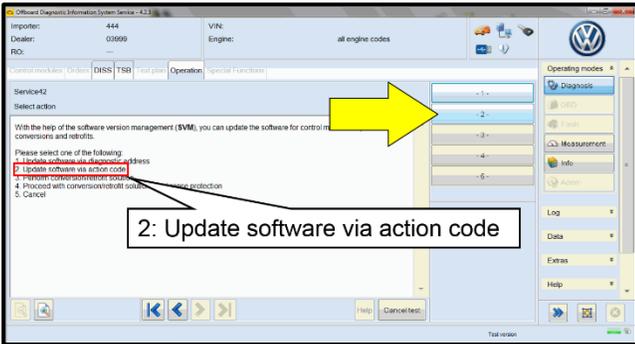
- Select option 2 to “Update software via action code”.

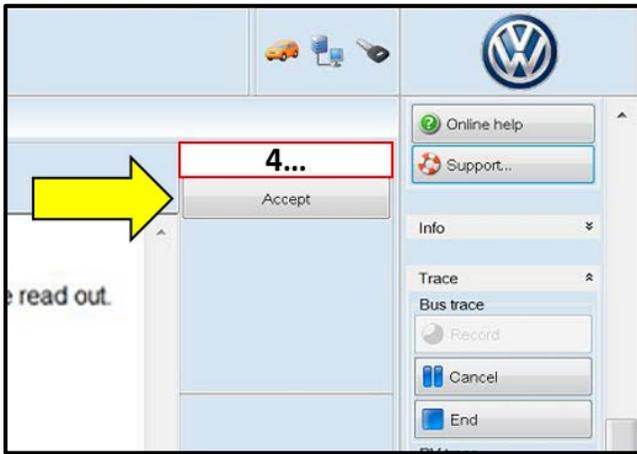
- Enter the corrective action code (SVM code) as listed below.

SVM code
42C2

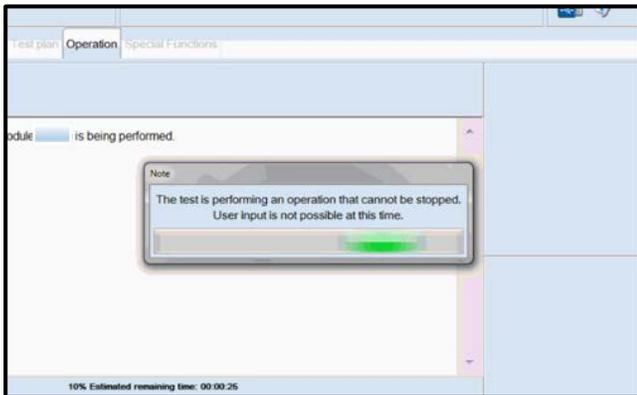
- Select “Accept” <arrow> and follow the on screen prompts.
- During the flash, this screen appears when each of the following operations are performed:
 - Flashing

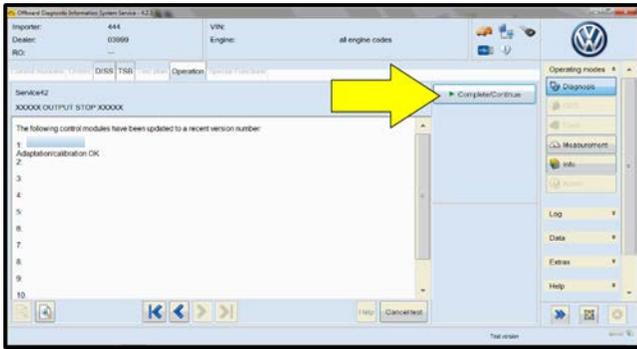
- Select Complete/Continue <arrow> after each operation is completed.

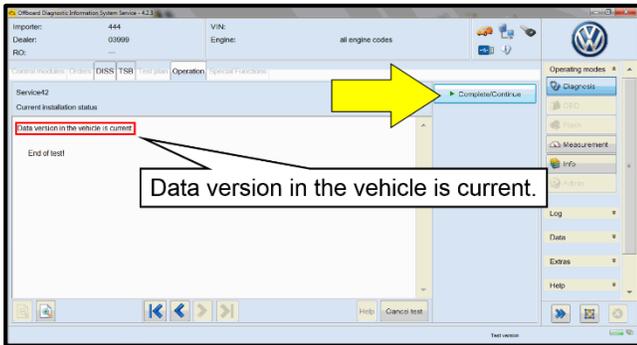
- When the SVM update is complete a confirmation message may be displayed <as shown>.
- Select "Complete/Continue" <arrow>.

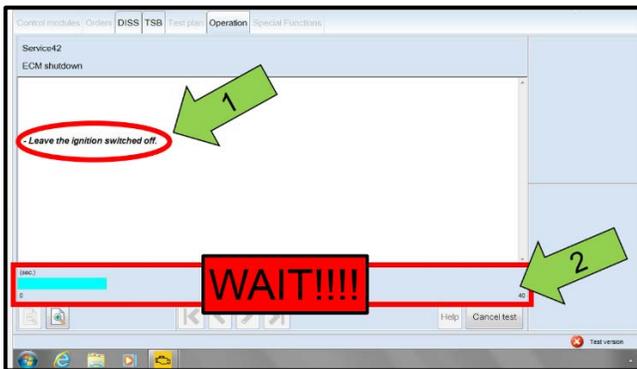
- It is **IMPERATIVE** that **ALL** of the ignition cycle on/off delay requests are fulfilled in their entirety during this flash process <arrow 1>.
- Failing to wait for the ignition on/off timing cycle to complete (progress bar and countdown timer <arrow 2>) before cycling the ignition on/off **MAY** damage a control module.
- Damage to control modules as a result of failing to wait the specified time displayed by the progress bar and countdown timer <arrow 2> are **NOT** covered under this action.

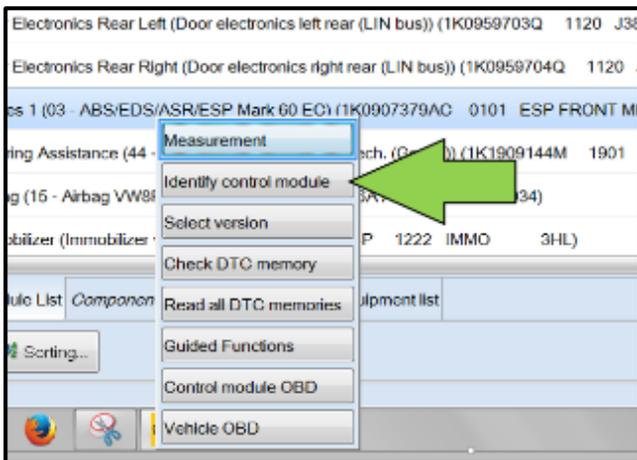
- After the software update is completed and before sending the GFF Log Online:
 - Select the "Control Module" tab.
 - Scroll down and right click on the module that was updated (**0017**).
 - Select "Identify Control Module" <arrow>.

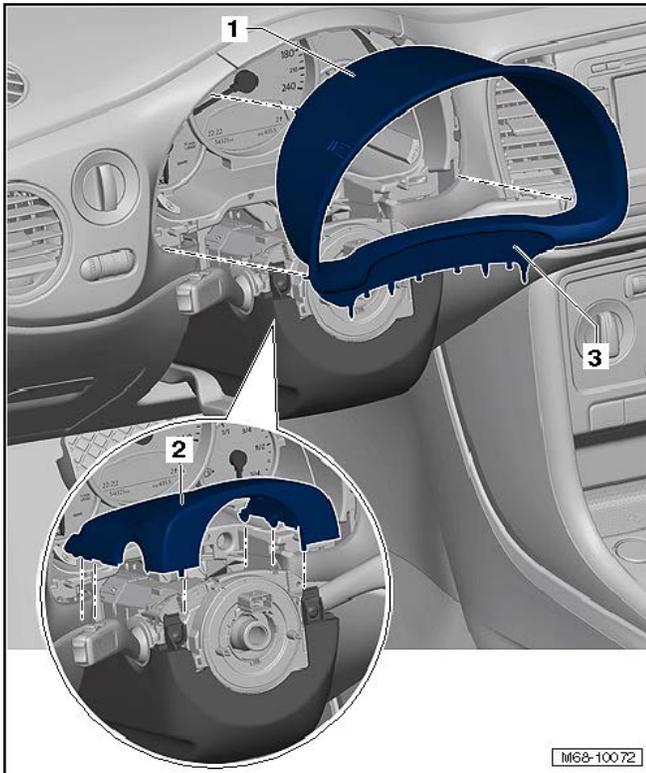
- Turn off the ignition and all electrical equipment and remove the ignition key.
- Move the steering wheel to the lowest position.
- Adjust the steering wheel depth (reach) so it is in the fully extended position.
- Loosen the gap cover <3> from the mounts on the upper steering column trim panel <2> using the Trim Removal Wedge -3409-. It is not necessary to remove the complete steering column trim.
- Remove the instrument cluster trim panel <1> from the instrument panel.

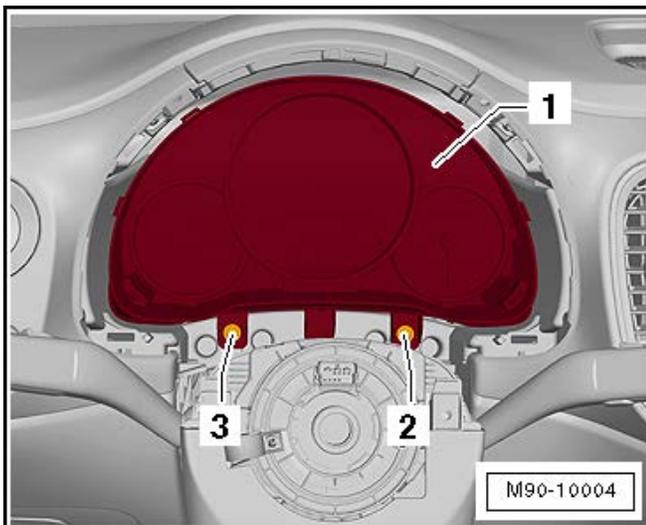
- Remove the bolts <2 and 3>.
- Pull the instrument cluster <1> back out of the instrument panel while being careful of the connected wires.

- Install the new instrument cluster in reverse order of removal and tighten the bolts <2 and 3> to 2 Nm.

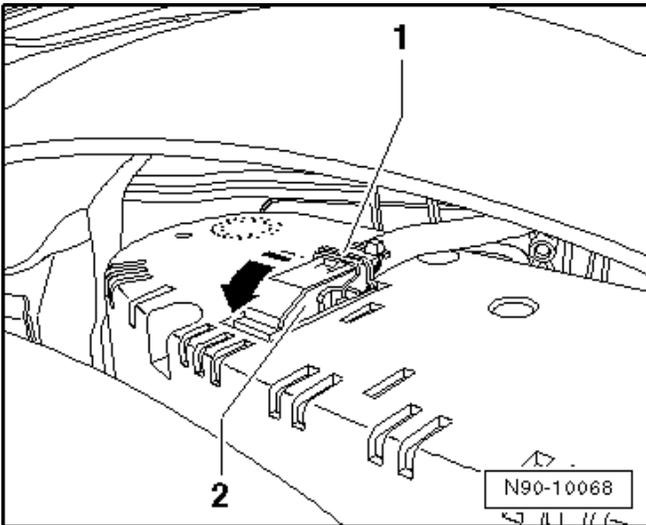
- Move the securing bracket <1> in the direction of the <arrow> and remove the connector <2>.
- Remove the instrument cluster from the vehicle.
- Connect the new instrument cluster to the connector <2> and close the securing bracket <1>.
