AKA0 - Re-programming Instrument Cluster and Various Other Control Units (Stop Delivery/Recall Campaign)

Model Year: **As of 2018 up to 2019**

Model Line: **Cayenne (9YA)**

Subject: **Instrument cluster and various other control units**

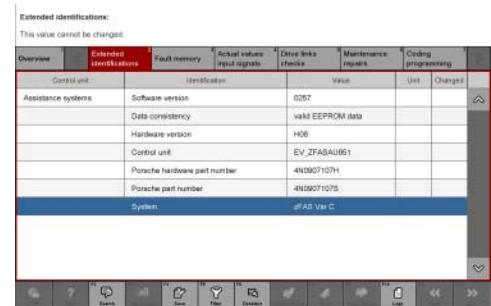
Assistance system variant

- 1.1 Select the **Assistance systems** control unit in the control unit selection screen ('Overview' menu) and confirm your selection by pressing •F12" ('Next').
- 1.2 Once the control unit for assistance systems has been found and is displayed in the 'Overview', select the '**Extended identifications**' menu.
- 1.3 Read out the value in the 'Identification' column under 'System' and **write it down** ⇒ *Assistance system variant*.

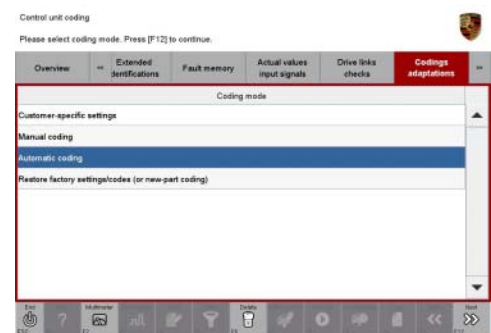
Automatic coding

It may not always be possible to code the control unit for Tire Pressure Monitoring (TPM). This will also be indicated as 'not carried successfully' by an X in the 'Status' box in the general overview following control unit coding.

If this is the case, the tire size must be set in the Vehicle menu.

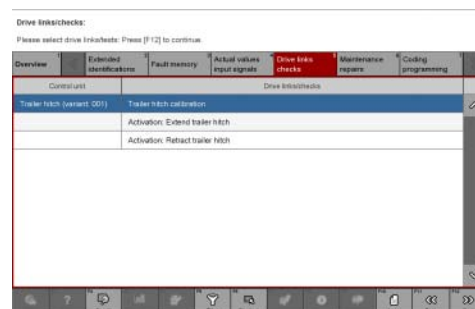
Trailer hitch calibration

- 4.4 Select the '**Trailer hitch calibration**' function and press •F12" ('Next') to confirm your selection ⇒ *Trailer hitch calibration*.
- 4.5 Confirm the displayed warning message with •F12" ('Next').
- 4.6 Carry out the '**Trailer hitch calibration**' function by pressing •F8" ('Start').
