August 2019
FL808A
NHTSA #19V-137

Subject: ICU3S Shift Position Display

Models Affected: Specific Freightliner Cascadia vehicles manufactured January 4, 2019, through January 26, 2019, and equipped with a DT12 automated manual transmission and ICU3S instrument cluster.

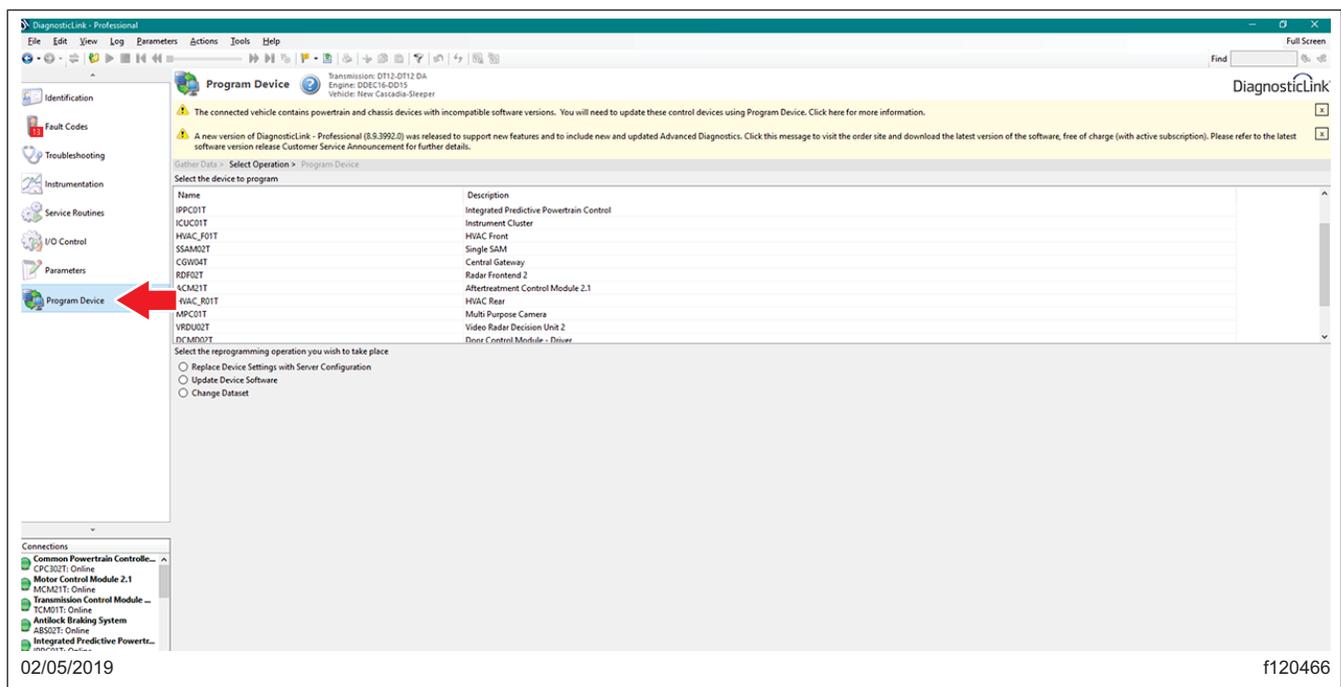
Fig. 1, Updating DiagnosticLink to the Latest Version

1. Check the base label (Form WAR259) for a completion sticker for FL808 (Form WAR260) indicating this work has been completed. The base label is usually located on the passenger-side door, about 12 inches (30 cm) below the door latch. If a completion sticker is present, no work is needed. If a completion sticker is not present, proceed to the next step.
2. Park the vehicle, shut down the engine, and apply the parking brakes.
3. Connect the vehicle to DiagnosticLink. Make sure that DiagnosticLink is updated to 8.10, or later. To update DiagnosticLink, select "Update" from the dropdown menu under "Tools." See [Fig. 1](#).

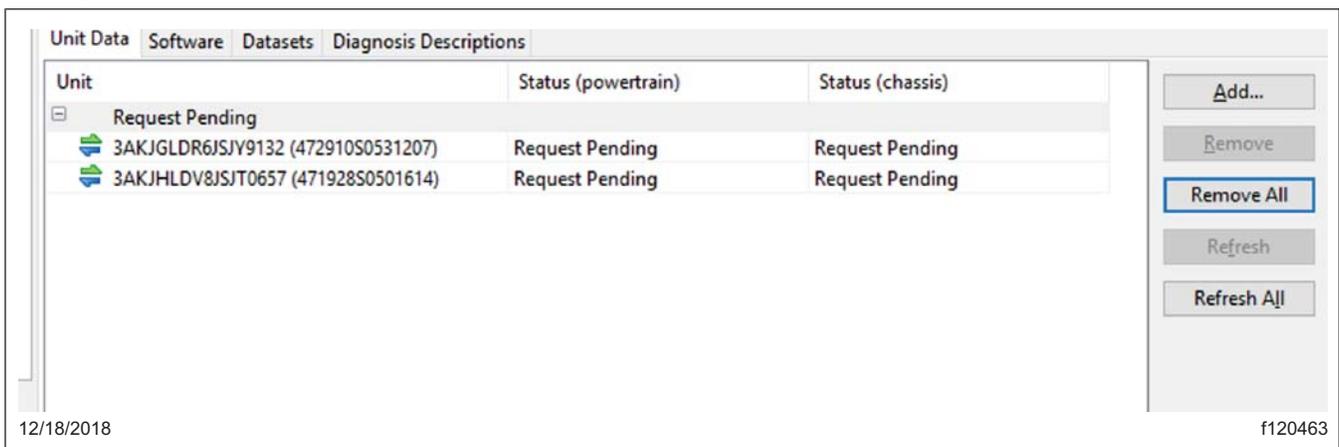
- Select "Program Device." If there are any items in the section "Request Pending" downloads, they should be removed. To remove them, select the "Request Pending" list item, then press the "Remove" button. See [Fig. 2](#).

Fig. 2, Removing Pending Requests

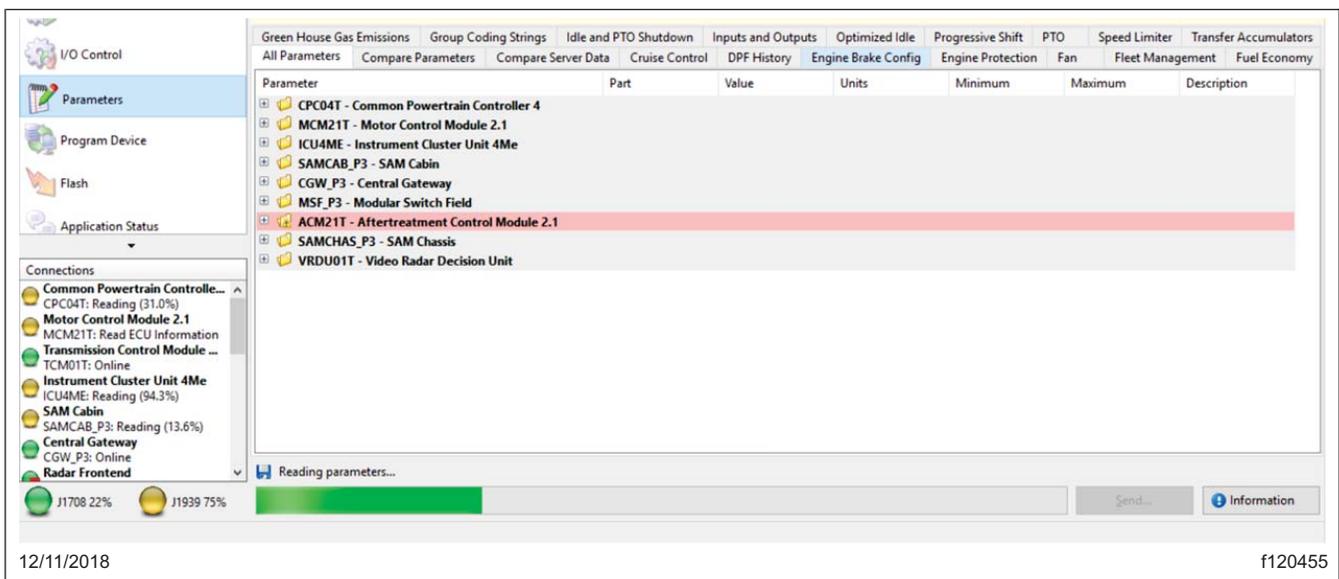
- Once all controllers are connected, read the vehicle parameters. See [Fig. 3](#).

Fig. 3, Reading Vehicle Parameters on DiagnosticLink

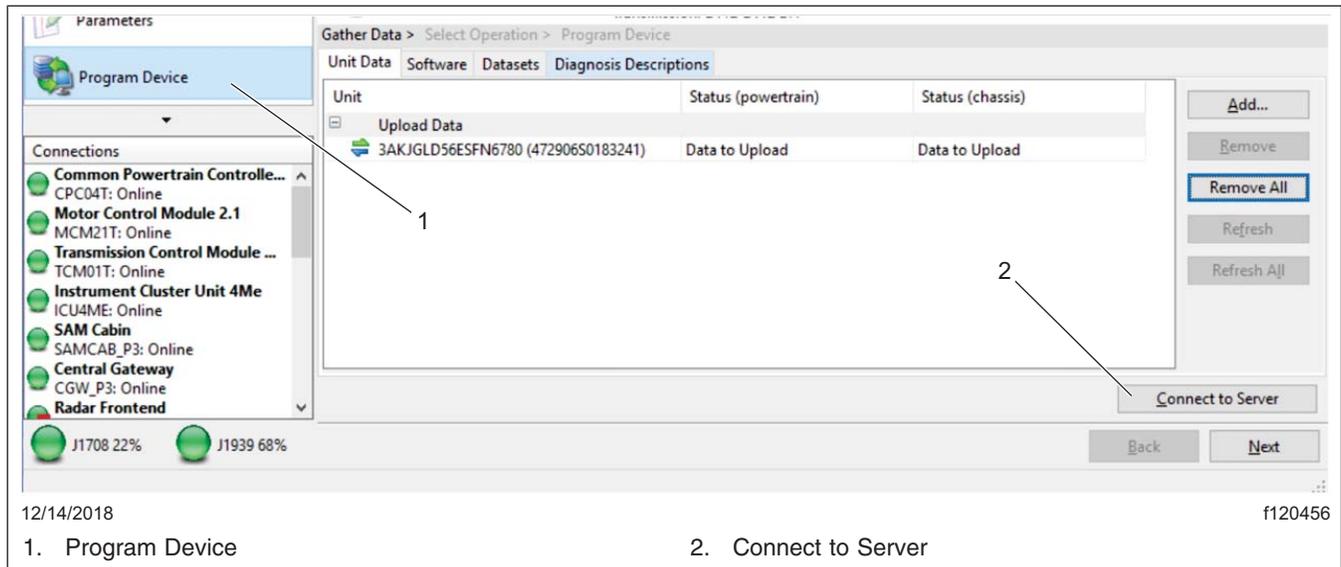
6. Select "Program Device." There should be data to upload. Click "Connect to Server" to upload vehicle parameters to the server. See **Fig. 4**.

Fig. 4, Uploading Vehicle Parameters

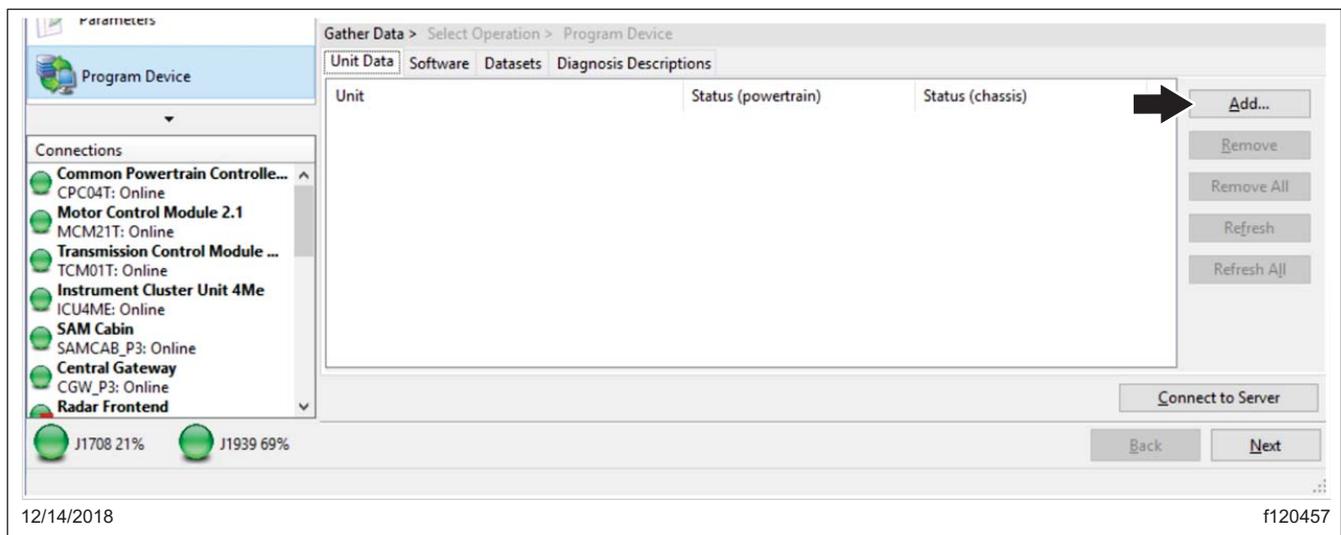
7. Click "Add" to add a download request for the vehicle. See **Fig. 5**.

Fig. 5, Adding the VIN to Download Updated Server Data

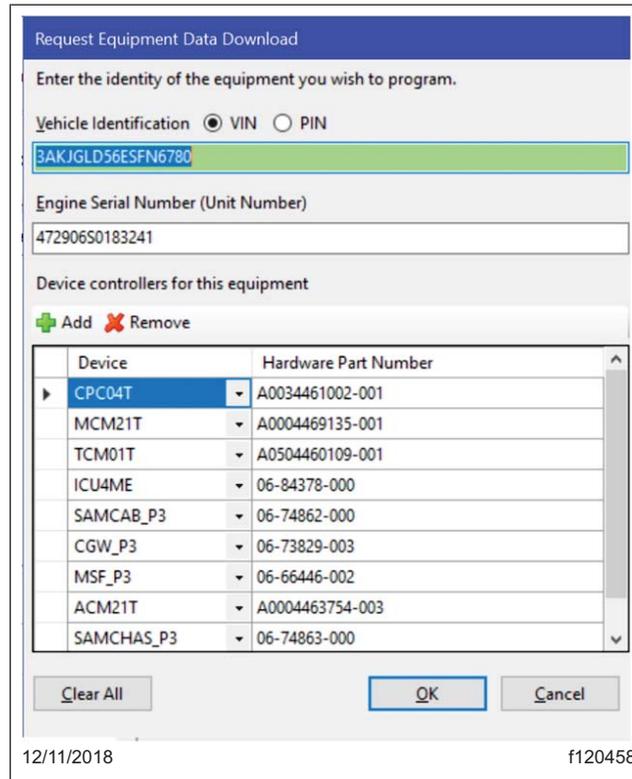
- Make sure the correct VIN and hardware is populated, then click OK. See Fig. 6.

Fig. 6, Verifying Correct VIN Hardware

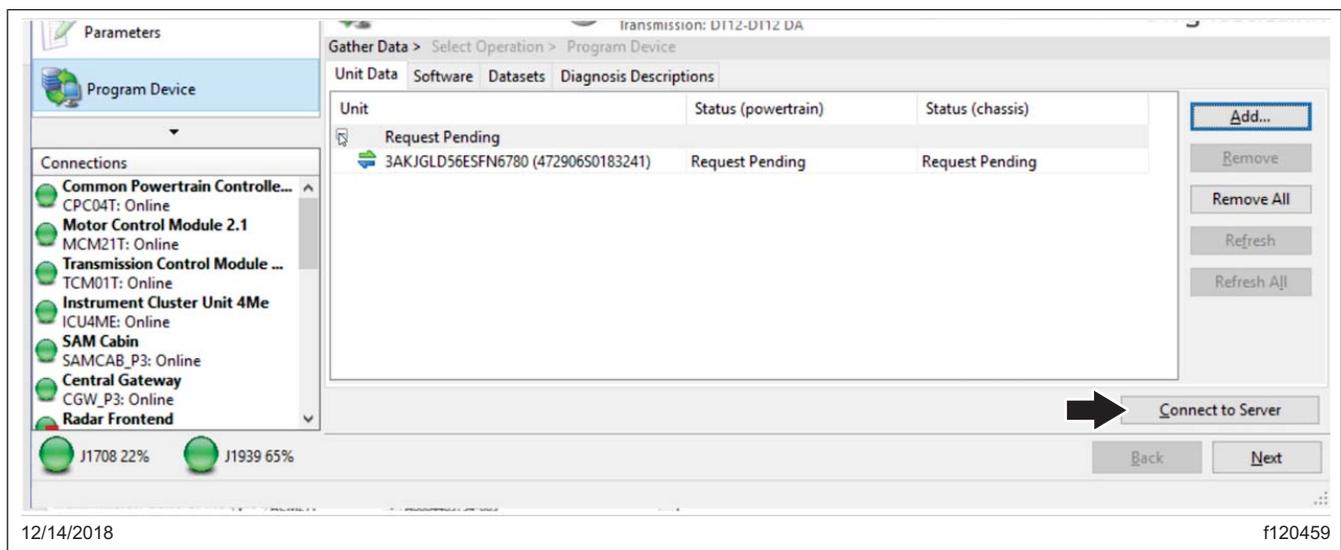
- There should be a request pending status for the VIN. Click "connect to server" to download the updated unit data. See Fig. 7. The server will provide any new software available on the server as well as updated parameter sets for the new software, adjusted for the parameter set that was just uploaded from the vehicle.

Fig. 7, Downloading Updated Unit Data

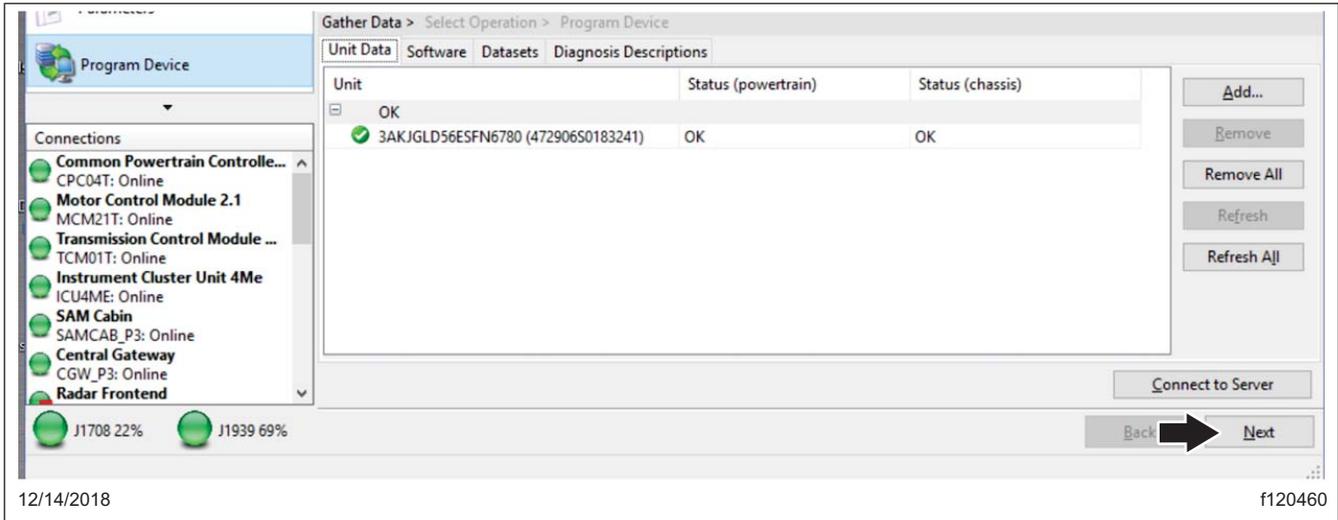
10. Once the data has been downloaded, click "Next." See [Fig. 8](#).

Fig. 8, Clicking Next

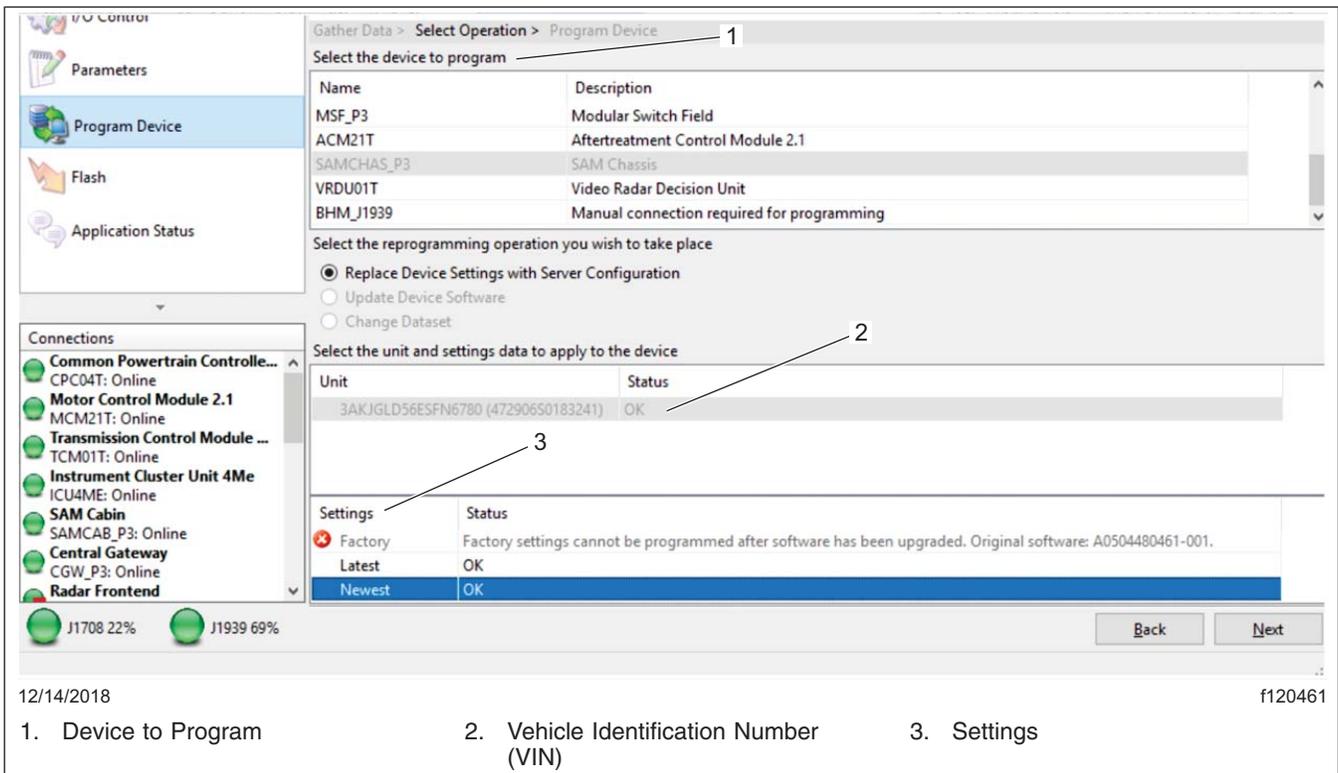
11. Select the CPC controller to program, select the VIN, and select "Latest." Click "Next." See [Fig. 9](#).

Fig. 9, Selecting "Latest" or "Newest" Software

NOTE: "Latest" is the last service record (may be older software) and "Newest" is the most up to date software available for the installed hardware. Both will have parameter sets that have been updated relative to the upload from the vehicle.

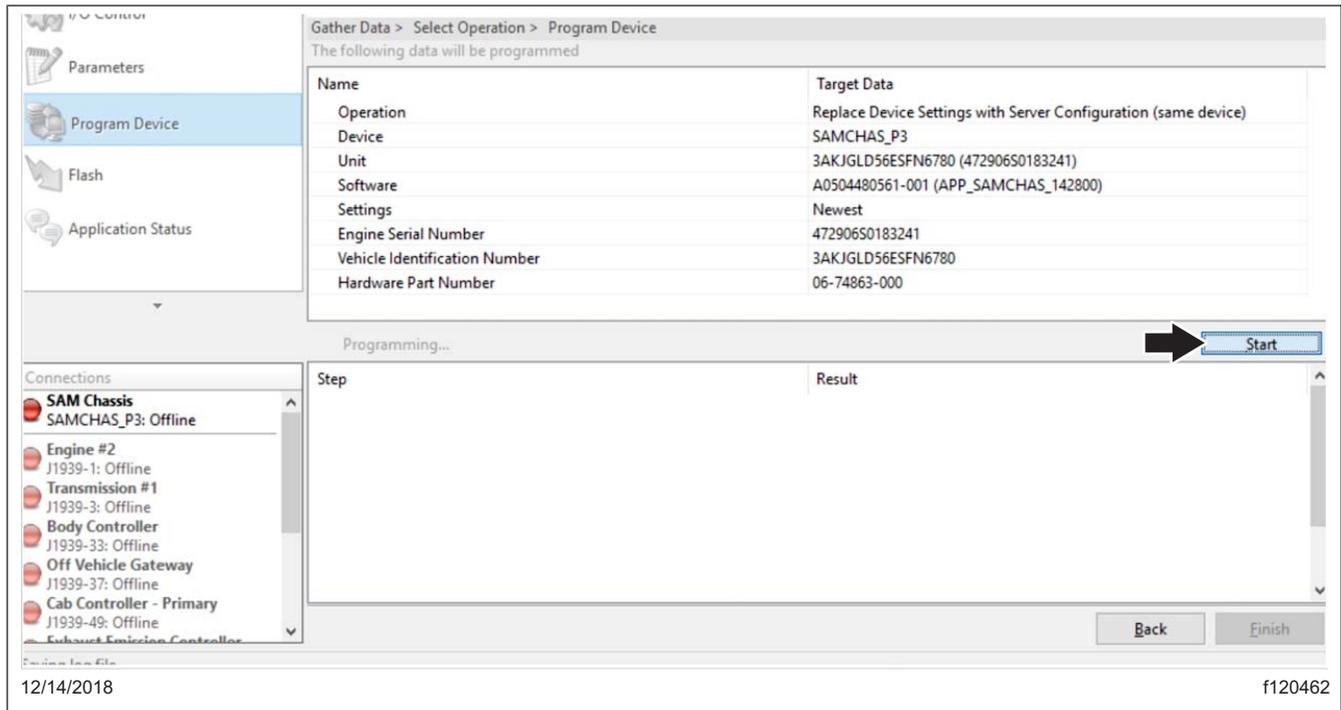
12. Review and verify the VIN and hardware part number. Click "Start" to program the controller. The software will be flashed and the new parameter set will be written to the controller on the vehicle. See [Fig. 10](#).

Fig. 10, Programming the Controller

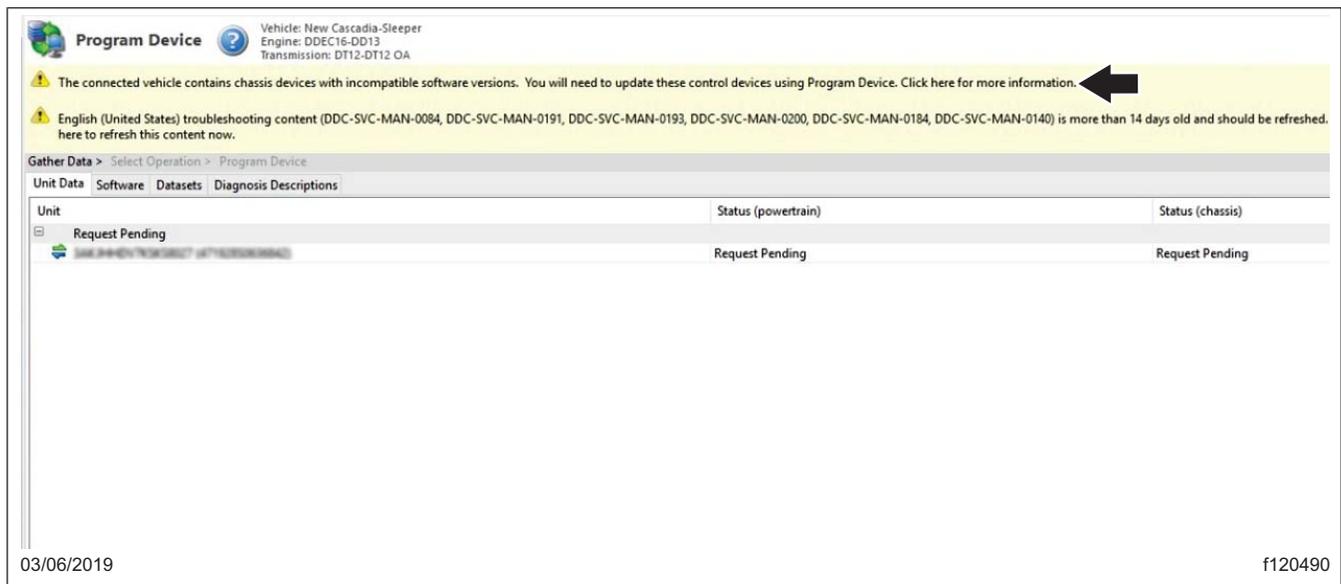
13. Click on the banner message. See [Fig. 11](#).

Fig. 11, Clicking on the Banner Message

IMPORTANT: After programming is complete, the following message may appear in DiagnosticLink: "The connected vehicle contains powertrain and Chassis devices with incompatible software versions, you will need to update these control devices using Program Device. Click here for more information." If this message is shown, continue with the next step. Otherwise, go to step 15.
