Dealer Service Instructions for:

Safety Recall V27 / NHTSA 19V-148

Adaptive Cruise Control

2017-2019 (GA) Alfa Romeo Giulia

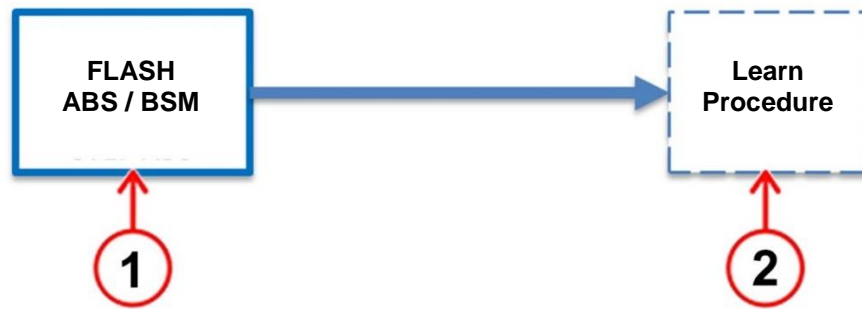
Figure 14 – ABS / BSM Software Reprogramming Sequence

NOTE: To update the ABS / BSM software to proper level, the procedure must be followed in the same sequence as listed below (Figure 14):

- **Step 1** –Flash ABS / BSM “**FINAL STEP**”.
- **Step 2** – Post reprogramming calibration procedure.

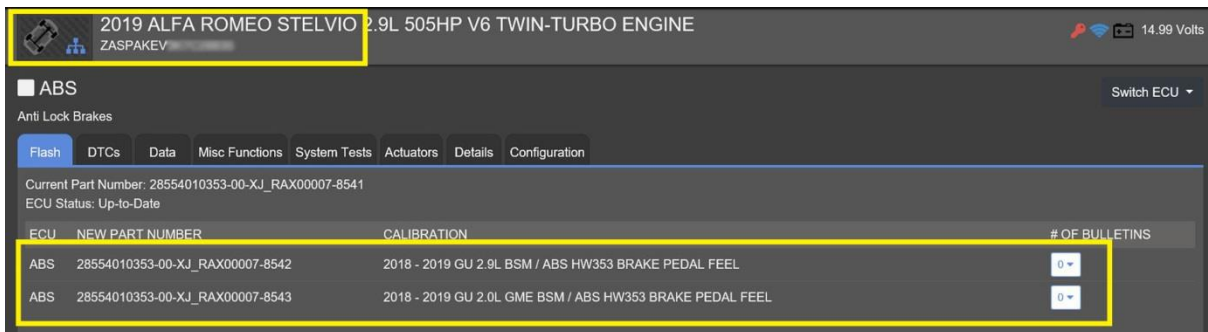
Figure 25 – Brake Pedal Feel Software

- 20. Select “**Flash ECU**” then follow the wiTECH screen instructions to complete the flash (Figure 25).

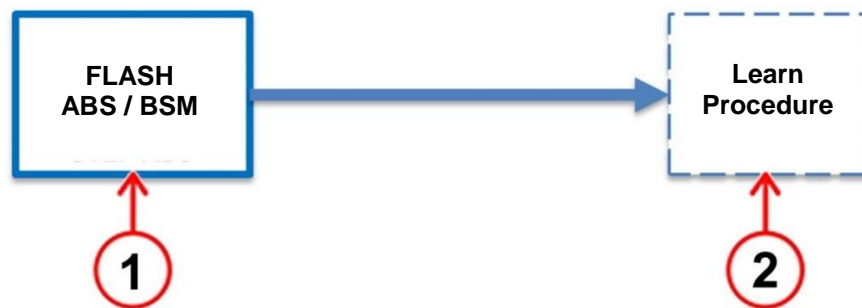
Figure 29 – ABS / BSM Software Reprogramming Sequence

NOTE: To update the ABS / BSM software (SW) to proper level, the procedure must be followed in the same sequence as listed below (Figure 29):

- **Step 1** – Flash ABS / BSM “**FINAL STEP**”.
- **Step 2** – Post reprogramming calibration procedure.
