# Safety Recall V27 / NHTSA 19V-148

## Adaptive Cruise Control

**2017-2019 (GA) Alfa Romeo Giulia**

**2018-2019 (GU) Alfa Romeo Stelvio**

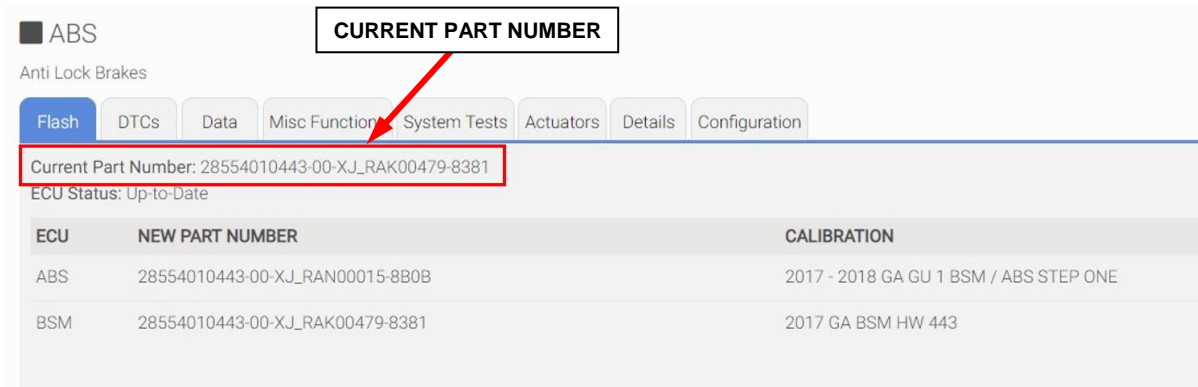
**Figure 1 – Example of ECU “Current Part Number”**

10. From the ABS “**Flash**” tab, record the “**Current Part Number**” (Figure 1) for the software currently installed in the Electronic Control Unit (ECU), then proceed to the table in (Figure 2) to determine which flash **Procedure A, B, C, D, E, F** is the appropriate starting point for the specific hardware and software combination currently installed in the vehicle.

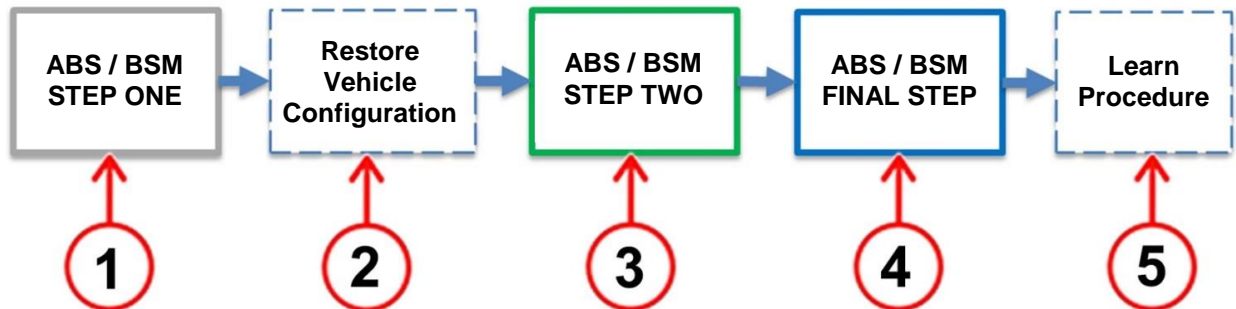
**Figure 3 – ABS/BSM Software Reprogramming Sequence**

**NOTE:** To update the ABS / BSM software to proper level, three separate software flashes are required. Complete all relevant procedures steps. The procedure must be followed in the same sequence as listed below (Figure 3):

- **Step 1** – First flash ABS / BSM – “**STEP ONE**”
- **Step 2** – “**Restore Vehicle Configuration**”
- **Step 3** – Second flash ABS / BSM – “**STEP TWO**”
- **Step 4** – Third flash ABS / BSM – “**FINAL STEP**”
- **Step 5** – Post reprogramming calibration - “**Learn Procedure**”

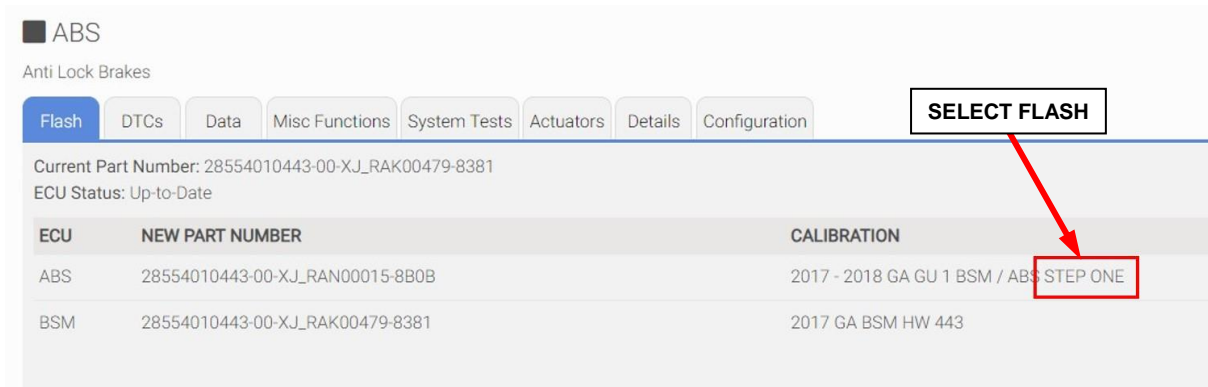
**Figure 4 – First Flash ABS / BSM “STEP ONE”**

11. From the ABS flash tab, select the ABS flash “STEP ONE” and proceed with the first reprogramming procedure (Figure 4).

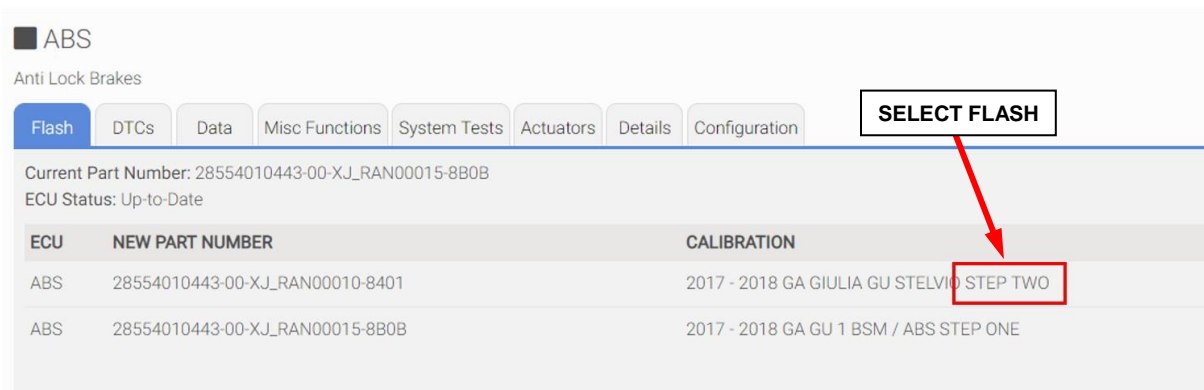
**Figure 6 – Second Flash ABS / BSM “STEP TWO”**

20. From the ABS “**Flash**” tab, select the ABS flash “**STEP TWO**” and proceed with the second reprogramming procedure (Figure 6).

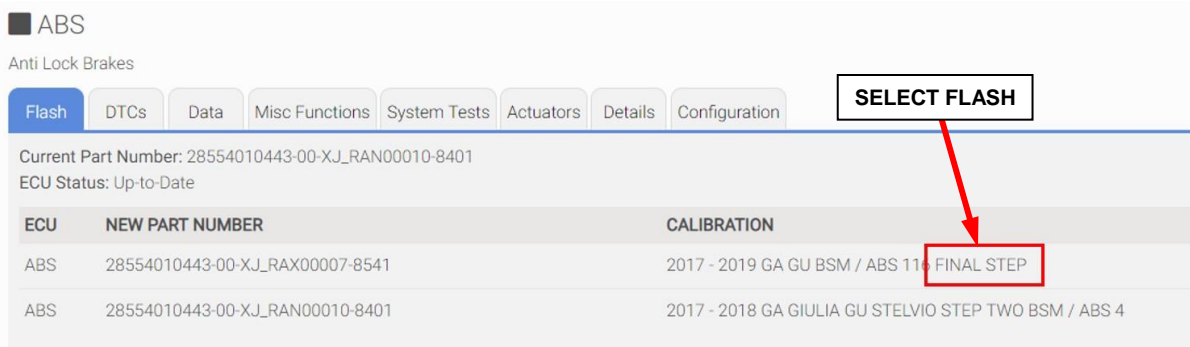
**Figure 8 – Third Flash ABS / BSM “FINAL STEP”**

26. From the ABS flash tab, select the ABS flash “**FINAL STEP**” and proceed with the third reprogramming procedure (Figure 8).

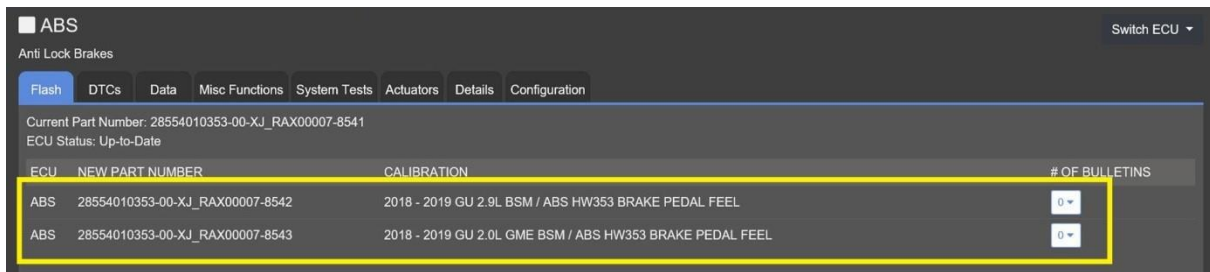
**Figure 10 – ABS/BSM Brake Pedal Feel Software Flash Files**

**The brake pedal feel software flash may be performed on all (GU) Stelvio vehicles and will modify brake pedal feel. However, this flash is NOT required for Procedure A of this recall and labor time to perform this flash will NOT be reimbursed (Figure 10):**

- “2018 - 2019 GU 2.9L BSM/ABS BRAKE PEDAL FEEL”
- “2018 - 2019 GU 2.0L GME BSM/ABS BRAKE PEDAL FEEL”

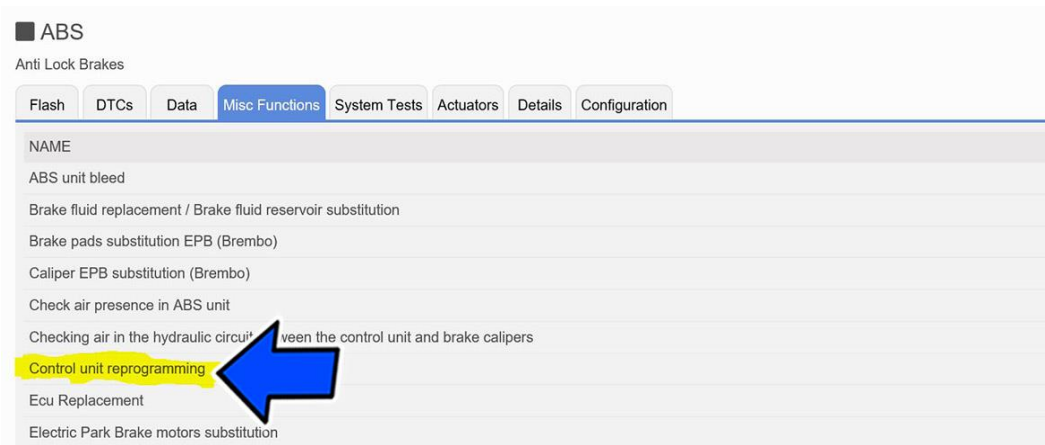
**Figure 11 - Control Unit Reprogramming**

- 32. From the ABS “Misc. Functions” tab, select and run the “Control Unit Reprogramming” routine (Figure 11).

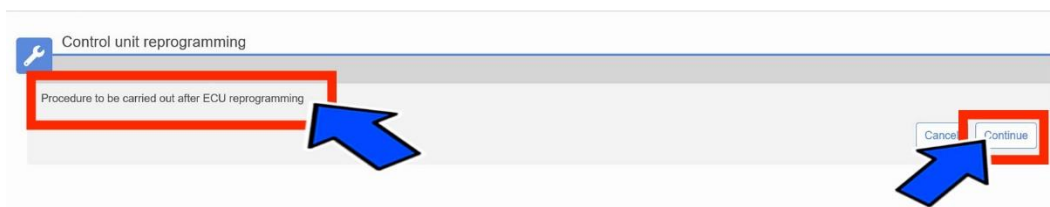
**Figure 12 - Procedure to be Carried Out After ECU Reprogramming**

- 33. Select “Procedure to be carried out after ECU reprogramming” and then click “Continue” (Figure 12).

**NOTE: If prompted with only the option to perform programming after a module replacement, complete all programming steps within that routine.**

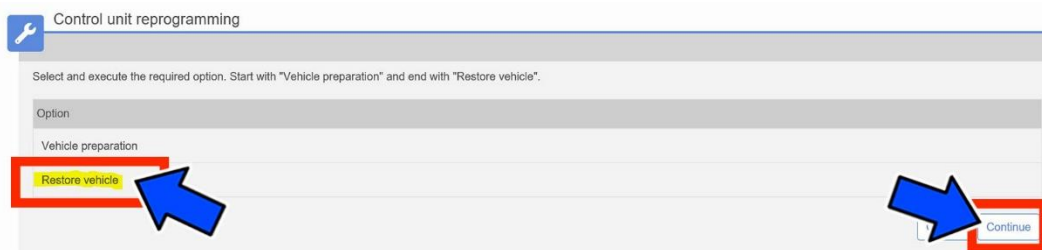
**Figure 13 - Restore Vehicle**

34. Select **“Restore Vehicle”** and then click **“Continue”** (Figure 13).

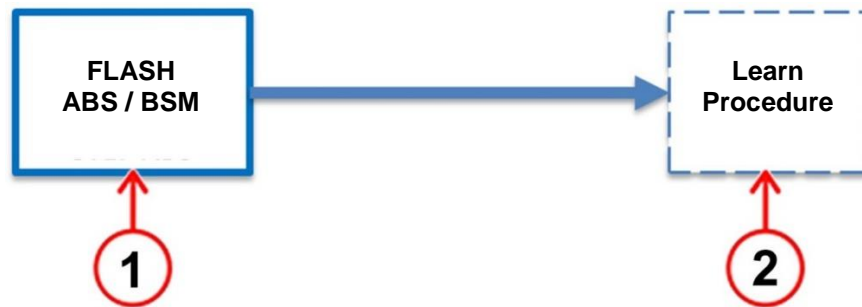
**Figure 14 – ABS / BSM Software Reprogramming Sequence**

**NOTE:** To update the ABS / BSM software to proper level, the procedure must be followed in the same sequence as listed below (Figure 14):

- **Step 1** –Flash ABS / BSM “FINAL STEP”.
- **Step 2** – Post reprogramming calibration procedure.

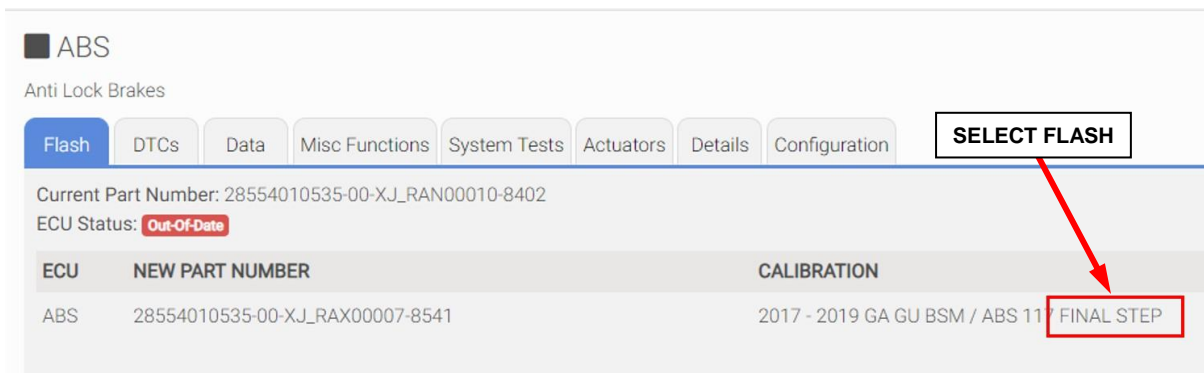
**Figure 15 – Flash ABS / BSM “FINAL STEP”**

11. From the ABS flash tab, select the ABS flash “FINAL STEP” and proceed with the reprogramming procedure (Figure 15).

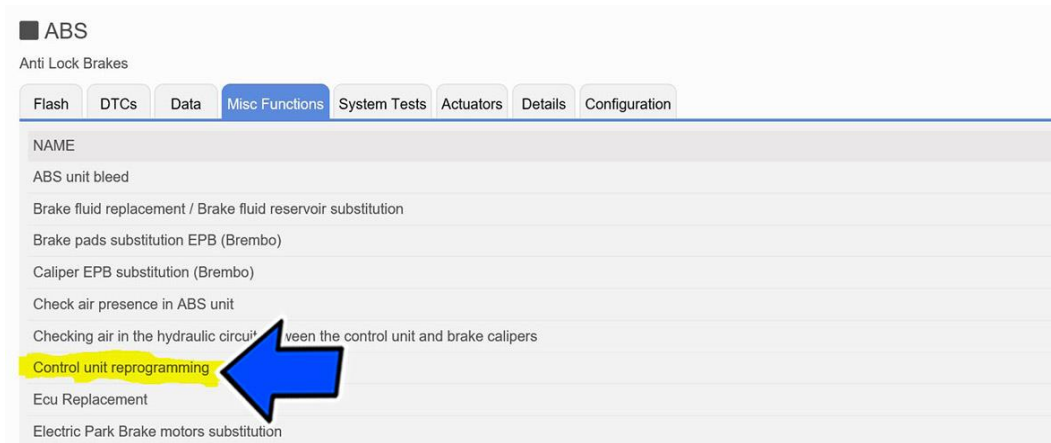
**Figure 18 - Control Unit Reprogramming**

- From the ABS “Misc. Functions” tab, select and run the “Control Unit Reprogramming” routine (Figure 18).

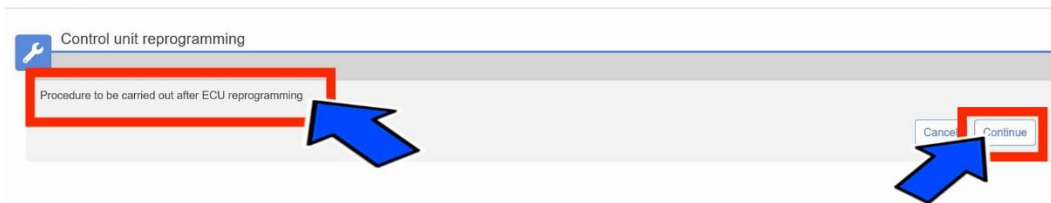
**Figure 19 - Procedure to be carried out after ECU reprogramming**

- Select “Procedure to be carried out after ECU reprogramming” and then click “Continue” (Figure 19).

**NOTE: If prompted with only the option to perform programming after a module replacement, complete all programming steps within that routine.**

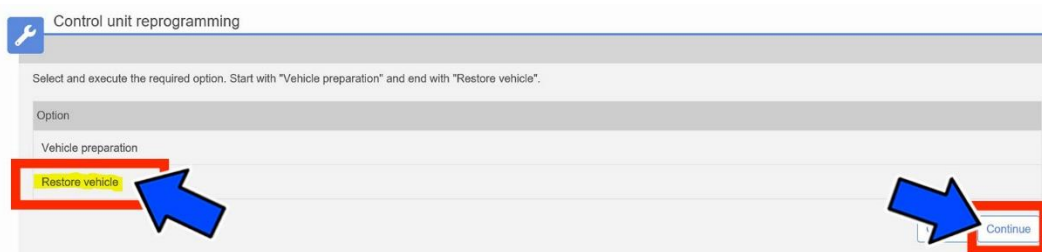
**Figure 20 - Restore Vehicle**

19. Select “**Restore Vehicle**” and then click “**Continue**” (Figure 20).

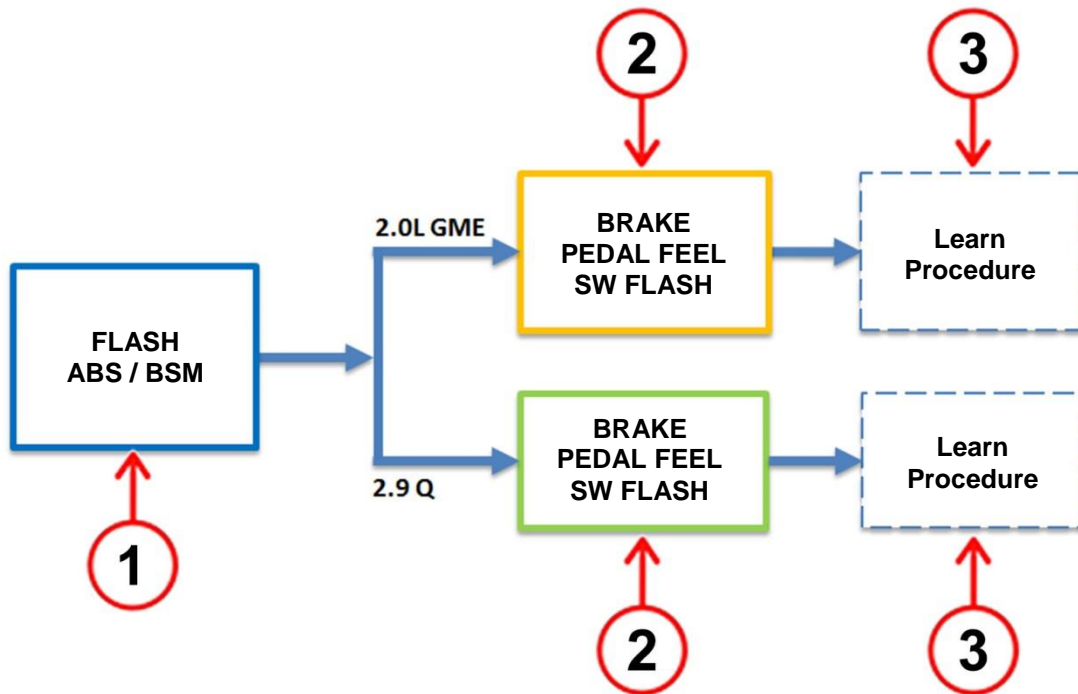
**Figure 21 – ABS / BSM Software Reprogramming Sequence**

**NOTE:** To update the ABS / BSM software (SW) to proper level, the procedure must be followed in the same sequence as listed below (Figure 21):

- **Step 1** – First flash ABS / BSM – “**FINAL STEP**”
- **Step 2** – Second flash “**BRAKE PEDAL FEEL**”
- **Step 3** – Post reprogramming calibration procedure

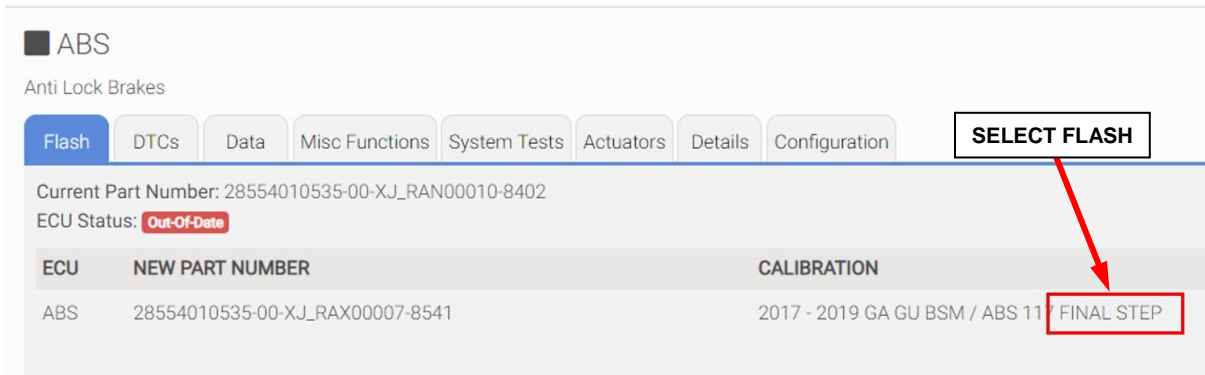
**Figure 22 – First Flash ABS / BSM - “FINAL STEP”**

11. From the ABS tab, select the ABS flash “**FINAL STEP**” and proceed with the reprogramming procedure (Figure 22).

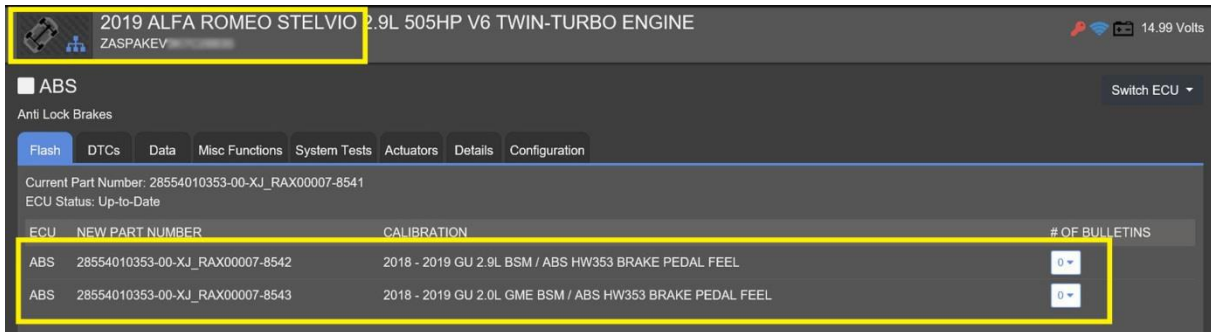
**Figure 25 – Brake Pedal Feel Software**

20. Select “**Flash ECU**” then follow the wiTECH screen instructions to complete the flash (Figure 25).

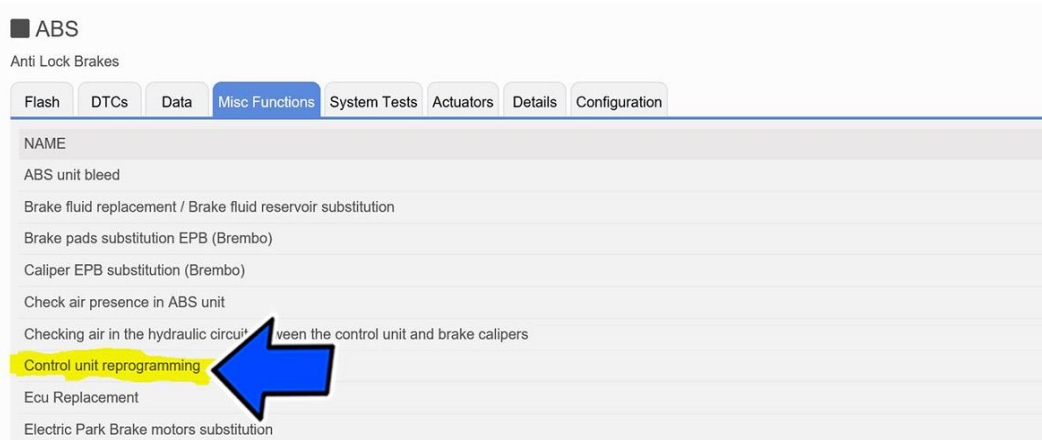
**Figure 26 - Control Unit Reprogramming**

- 21. From the ABS “Misc. Functions” tab, select and run the “Control Unit Reprogramming” routine (Figure 26).

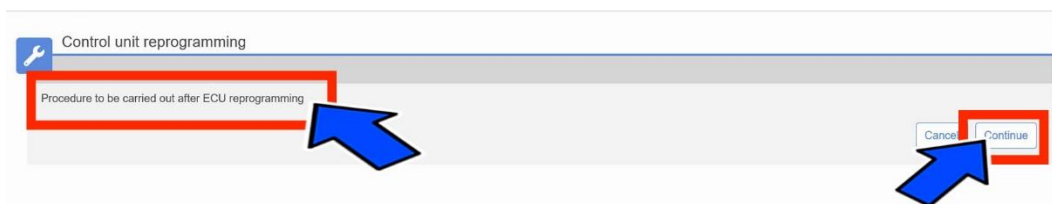
**Figure 27 - Procedure to be Carried Out After ECU Reprogramming**

- 22. Select “Procedure to be carried out after ECU reprogramming” and then click “Continue” (Figure 27).

**NOTE: If prompted with only the option to perform programming after a module replacement, complete all programming steps within that routine.**

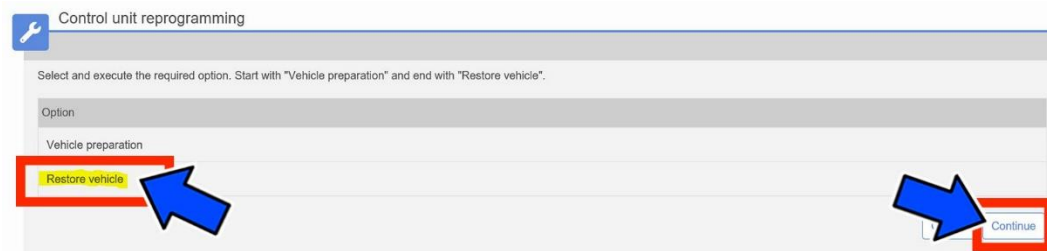
**Figure 28 - Restore Vehicle**

23. Select “**Restore Vehicle**” and then click “**Continue**” (Figure 28).

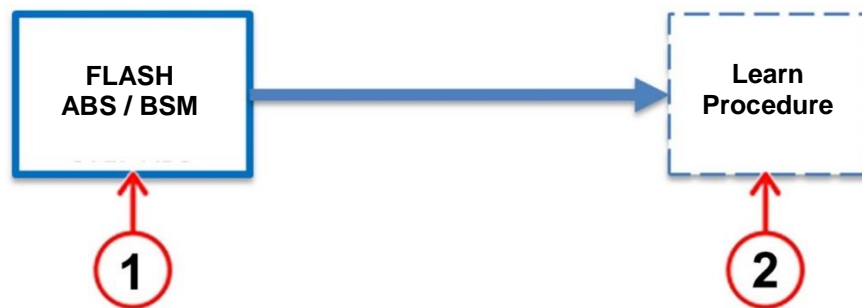
**Figure 29 – ABS / BSM Software Reprogramming Sequence**

**NOTE:** To update the ABS / BSM software (SW) to proper level, the procedure must be followed in the same sequence as listed below (Figure 29):

- **Step 1** – Flash ABS / BSM “**FINAL STEP**”.
- **Step 2** – Post reprogramming calibration procedure.

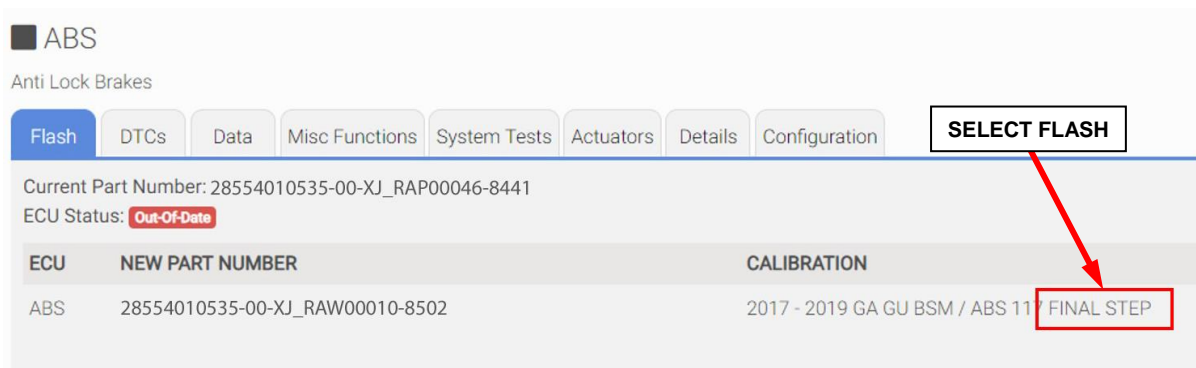
**Figure 30 – Flash ABS / BSM “FINAL STEP”**

11. From the ABS flash tab, select the ABS flash “**FINAL STEP**” and proceed with the reprogramming procedure (Figure 30).

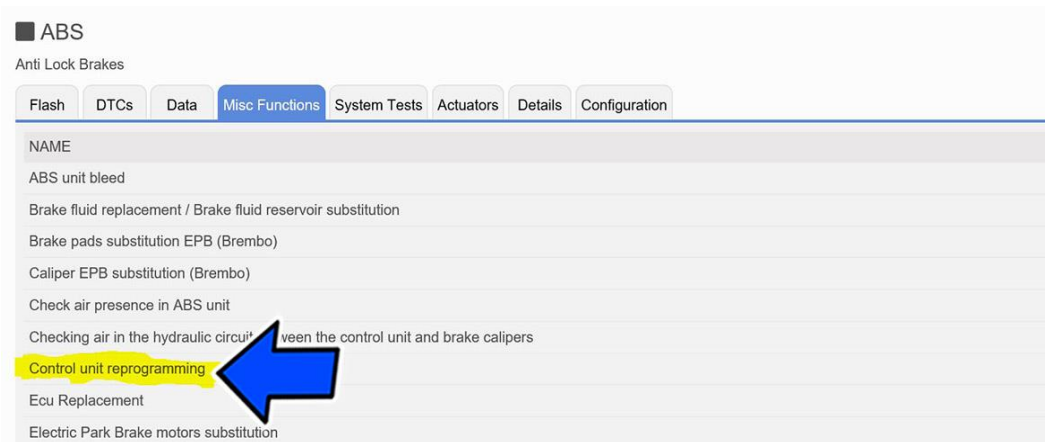
**Figure 32 - Control Unit Reprogramming**

- From the ABS “Misc. Functions” tab, select and run the “Control Unit Reprogramming” routine (Figure 32).

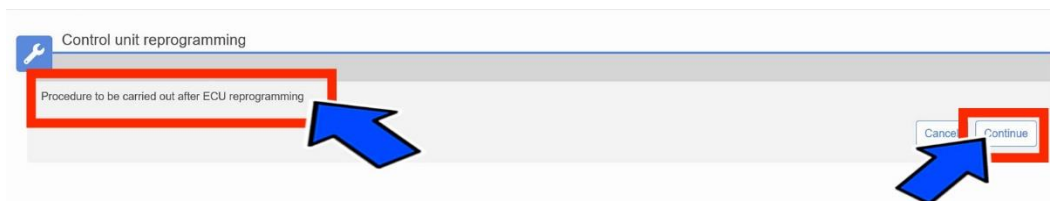
**Figure 33 - Procedure to be Carried Out After ECU Reprogramming**

- Select “Procedure to be Carried Out After ECU reprogramming” and then click “continue” (Figure 33).

**NOTE:** If prompted with only the option to perform programming after a module replacement, complete all programming steps within that routine.

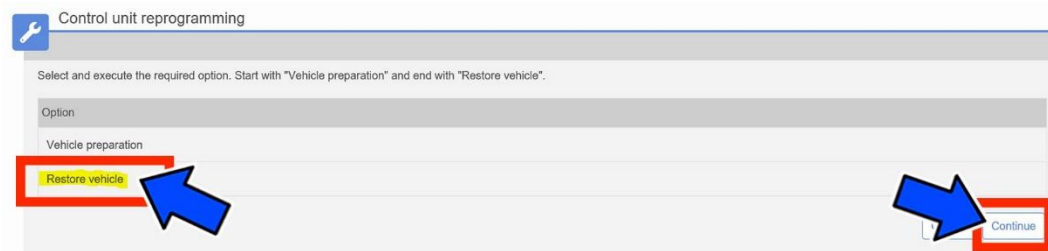
**Figure 34 - Restore Vehicle**

19. Select “**Restore Vehicle**” and then click “**Continue**” (Figure 34).

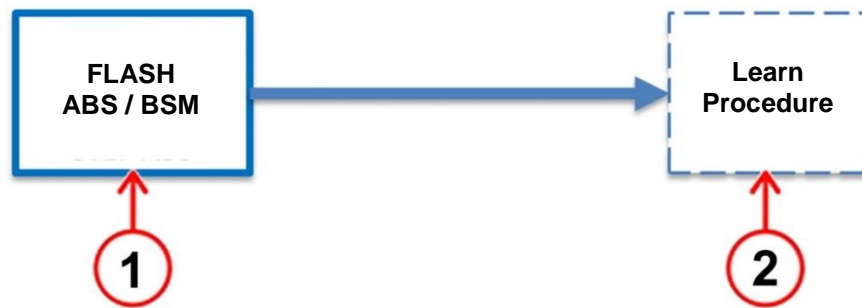
**Figure 35 - ABS/BSM Software Reprogramming Sequence**

**NOTE: The procedures must be followed in the same sequence as listed below (Figure 35):**

- **Step 1** – First flash “**2019 GA GU BSM/ABS HW 115 NAFTA**”
- **Step 2** – Post reprogramming calibration procedure.

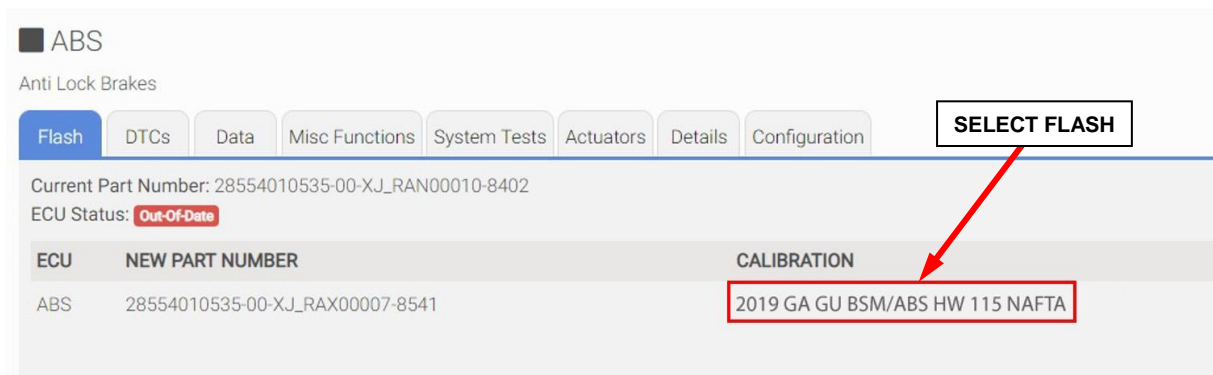
**Figure 36 – Flash ABS / BSM “2019 GA GU BSM/ABS HW 115 NAFTA”**

11. From the ABS flash tab, select the ABS flash “**2019 GA GU BSM/ABS HW 115 NAFTA**” and proceed with the reprogramming procedure (Figure 36).

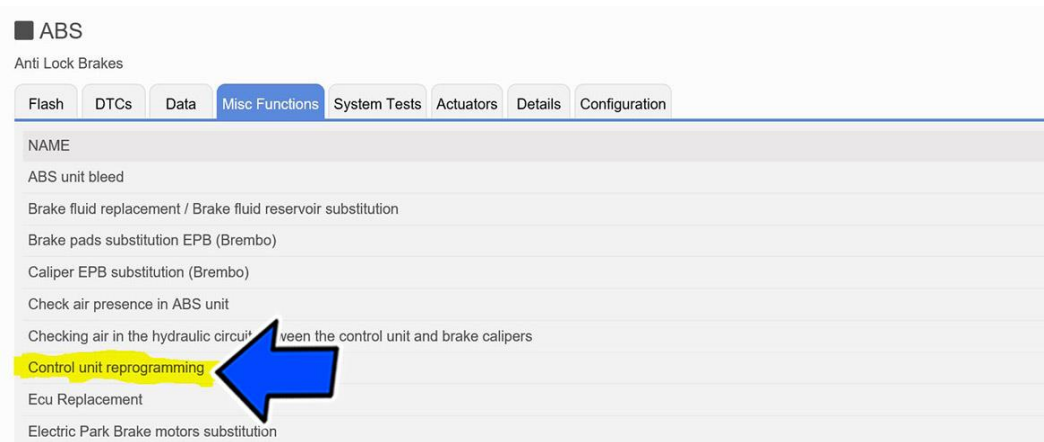
**Figure 38 - Control Unit Reprogramming**

- From the ABS “Misc. Functions” tab, select and run the “Control Unit Reprogramming” routine (Figure 38).

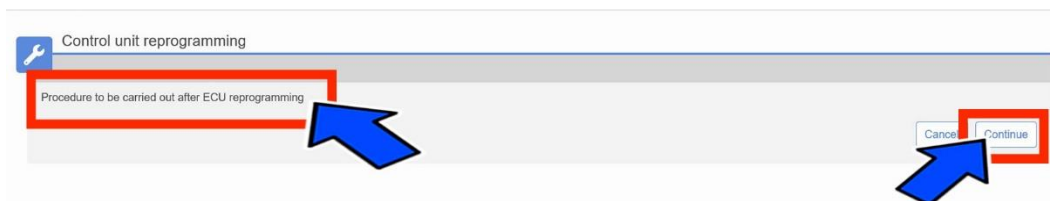
**Figure 39 - Procedure to be Carried Out After ECU Reprogramming**

- Select “Procedure to be carried out after ECU reprogramming” and then click “Continue” (Figure 39).

**NOTE: If prompted with only the option to perform programming after a module replacement, complete all programming steps within that routine.**

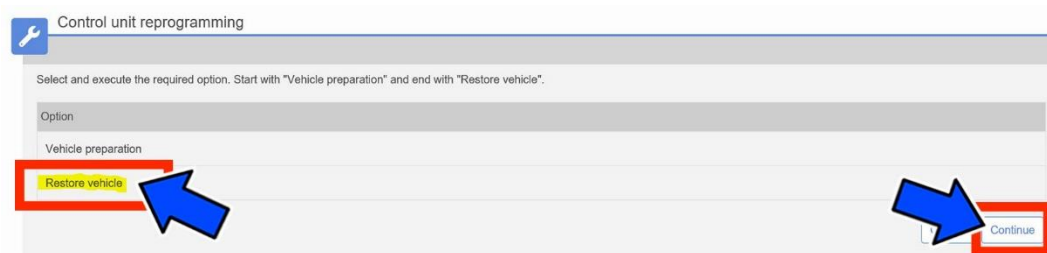
**Figure 40 - Restore Vehicle**

19. Select “**Restore Vehicle**” and then click “**Continue**” (Figure 40).
