September 2019
FL817AB
NHTSA #19V-443
Transport Canada #19-287

Subject: Meritor MX EVO 120 Front Drive Axles

Models Affected: Specific Model Years 2019-2020 Freightliner 108SD, and Business Class M2 vehicles manufactured December 20, 2018, through May 13, 2019, and equipped with certain Meritor MX 120 EVO Front Drive Steer axles.

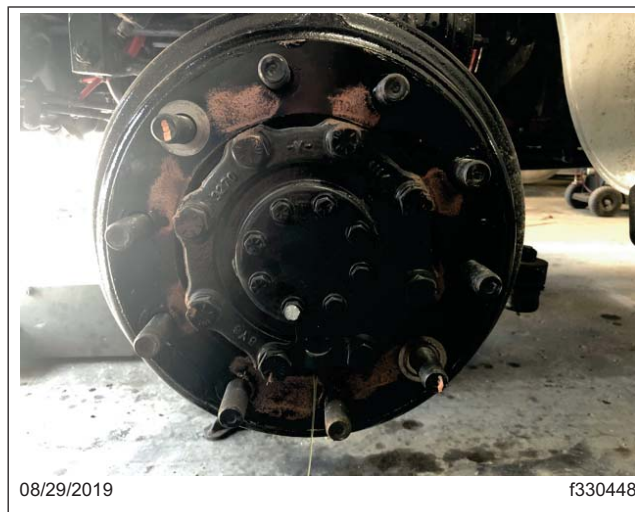
7. Remove the oil fill/drain plug. See [Fig. 1](#).

Fig. 1, Removed Oil Fill/Drain Plug

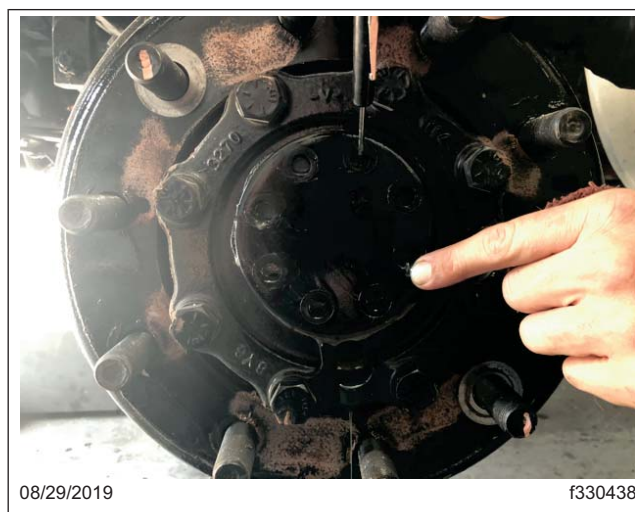
8. Remove the bolts and washer that connect the hub cover to the drive flange. See [Fig. 2](#).

Fig. 2, Removed Hub Cover Bolts

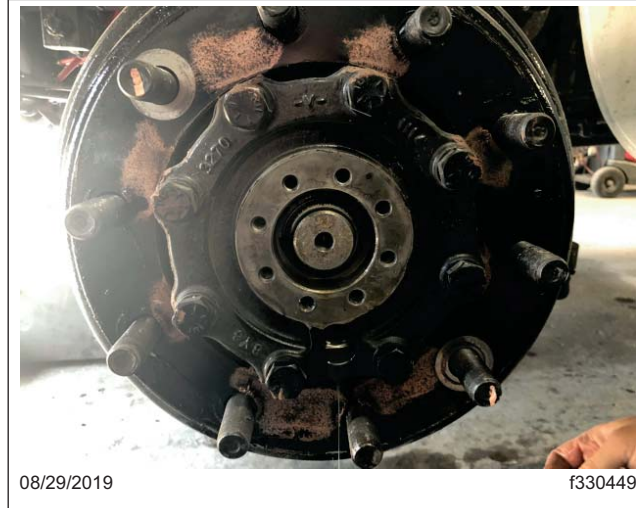
9. Remove the hub cover using a light hammer by gently tapping the axle. See [Fig. 3](#).

Fig. 3, Removed Hub Cover

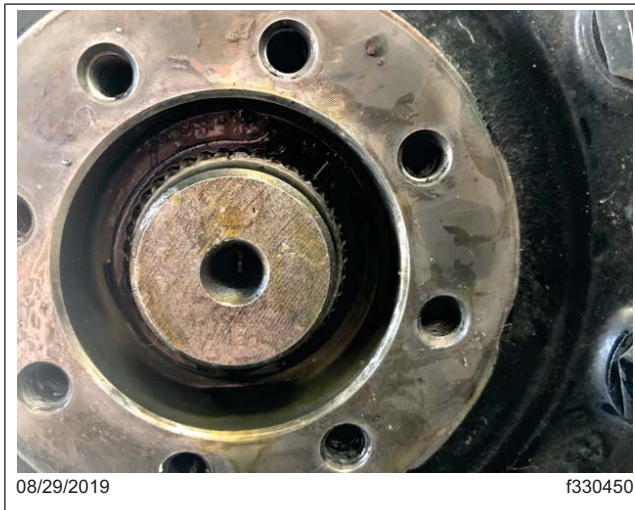
10. Remove the snap ring from the end of the axle shaft. See [Fig. 4](#). and [Fig. 5](#).

Fig. 4, Axle Shaft with Snap Ring

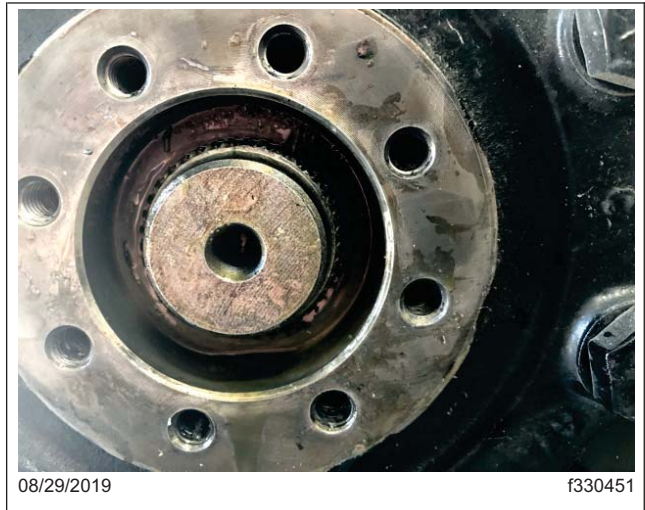
Fig. 5, Removed Snap Ring from Axle Shaft

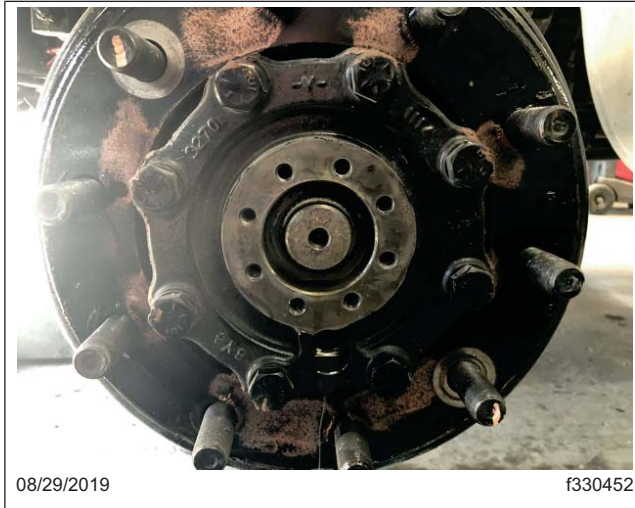
11. Remove the eight flange bolts that connect the drive flange to the wheel hub. See [Fig. 6.](#) and [Fig. 7.](#)

Fig. 6, Flange Bolts Connecting the Drive Flange to the Wheel Hub

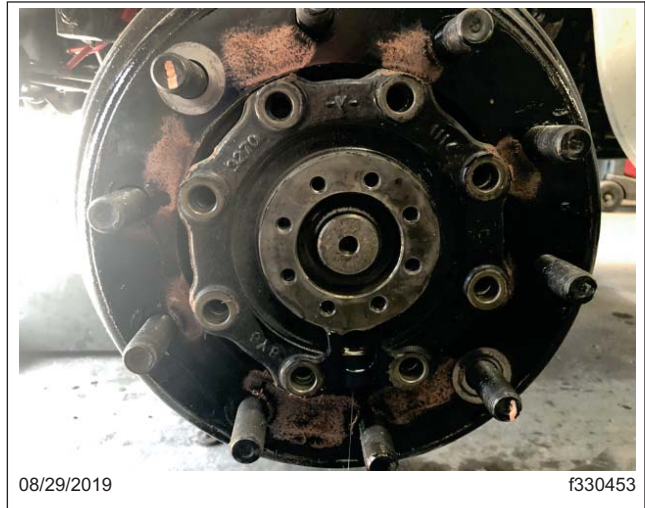
Fig. 7, Removed Flange Bolts that connect the Drive Flange to the Wheel Hub

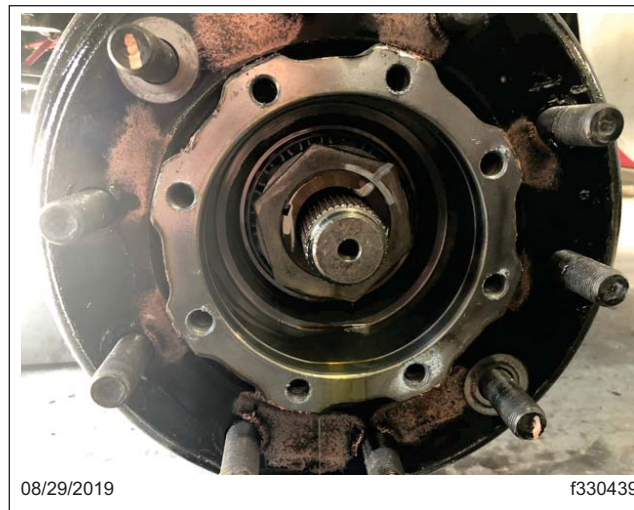
12. Remove the drive flange from the hub. If necessary, use a puller to remove the drive flange. See [Fig. 8.](#)

Fig. 8, Removed Drive Flange from the Hub

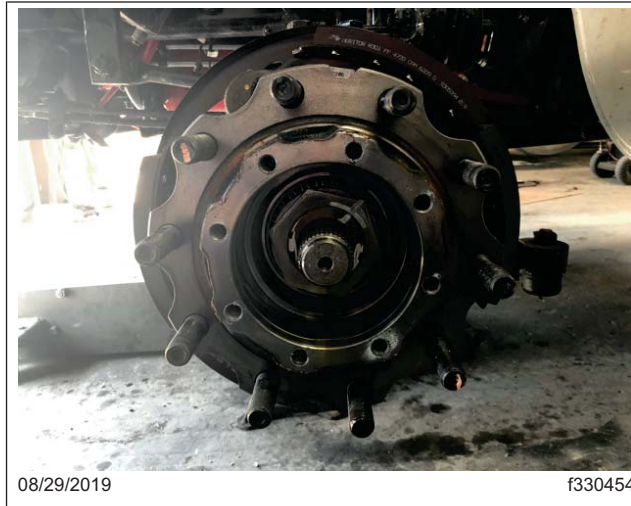
13. Remove the brake drum. See [Fig. 9](#).

Fig. 9, Removed Brake Drum

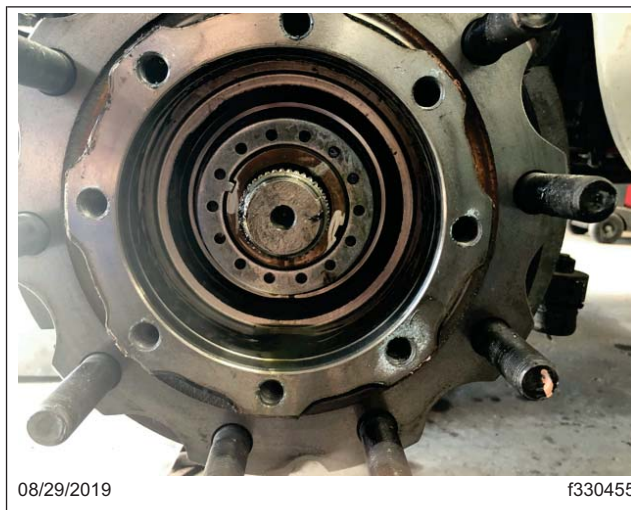
14. Remove the outer spindle nut. See [Fig. 10](#).

Fig. 10, Removed Outer Spindle Nut

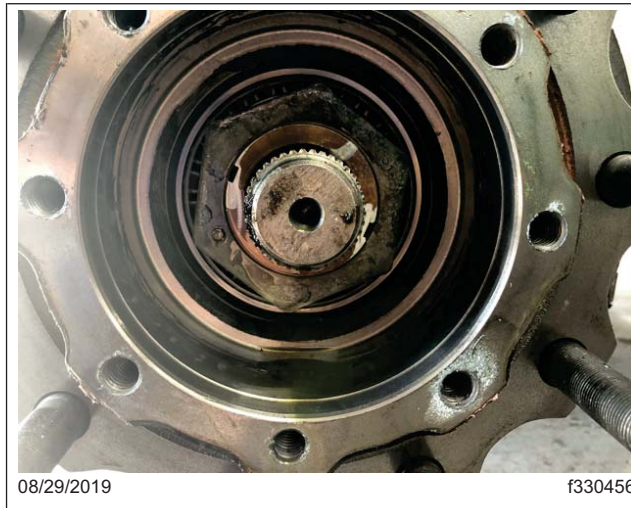
15. Remove the lock ring. See [Fig. 11](#).

Fig. 11, Removed Lock Ring

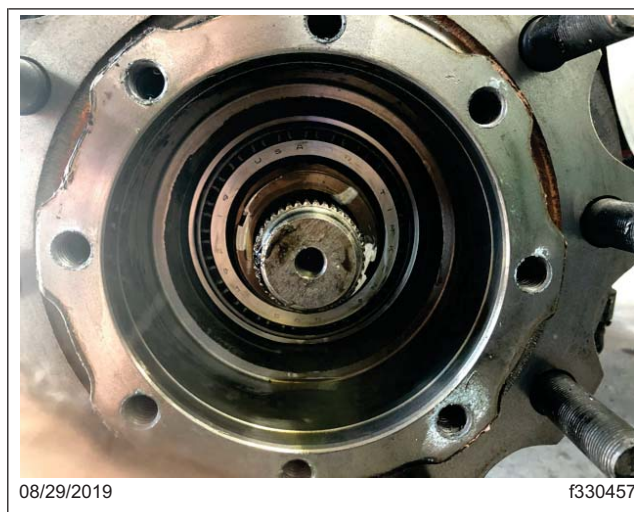
16. Remove the inner spindle nut. See [Fig. 12](#).

Fig. 12, Removed Inner Spindle Nut

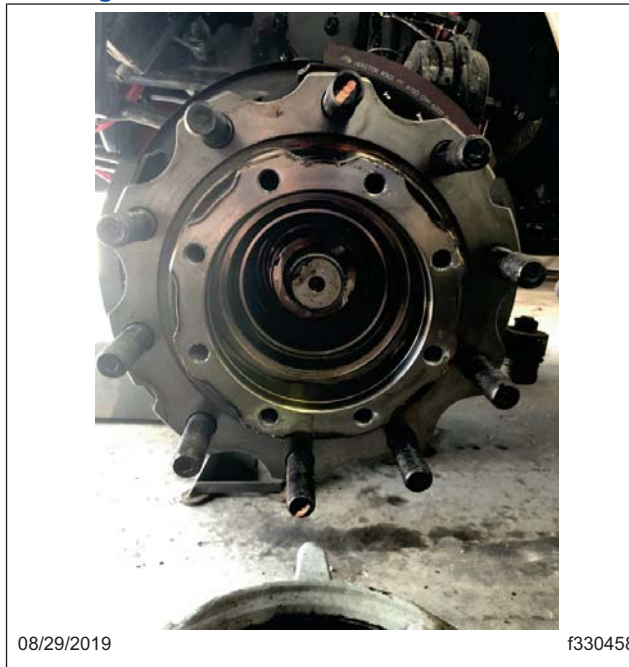
17. Remove the outer bearing. See [Fig. 13](#).

Fig. 13, Removed Outer Bearing

- Be careful not to let the outer wheel bearing drop from the axle spindle. Dropping the bearing can warp the cage or damage the rollers, ruining the bearing. Use care when working with the hubs. To prevent damage to the tone wheel, do not drop the hub, or lay it down in a way that would damage the tone wheel.
- Do not spin bearing rollers at any time. Dirt or grit can scratch the roller surface and cause rapid wear of the bearing assembly. Treat used bearings as carefully as new ones.

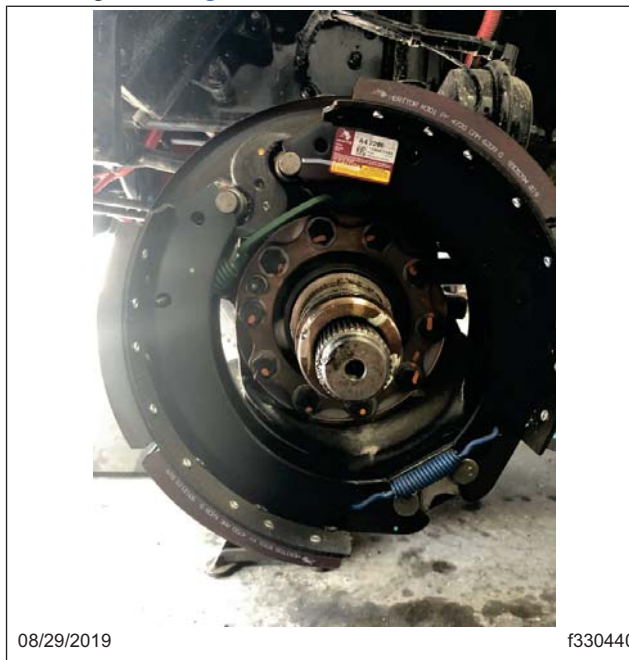
18. Remove the hub and inner bearing. See [Fig. 14](#).

Fig. 14, Removed Hub and Inner Bearing

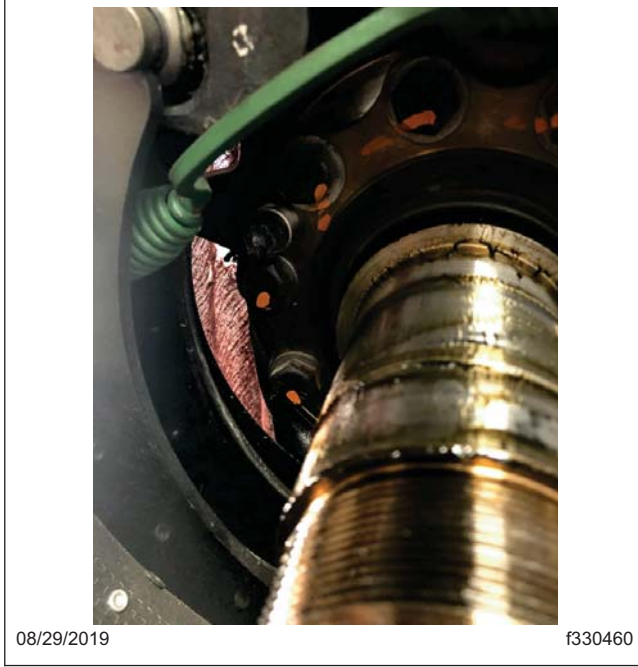
19. Remove the ABS sensor. See [Fig. 15](#), [Fig. 16](#), [Fig. 17](#) and [Fig. 18](#).

Fig. 15, Removal of ABS Sensor

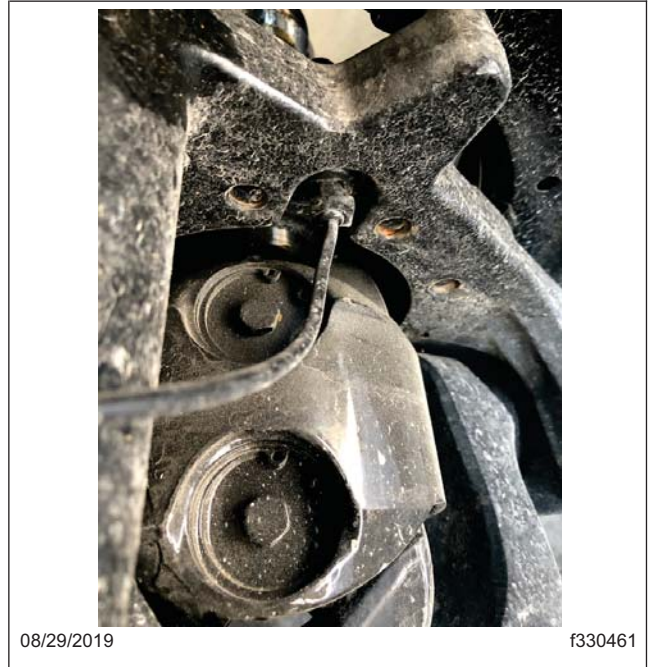
Fig. 16, Removal of ABS Sensor

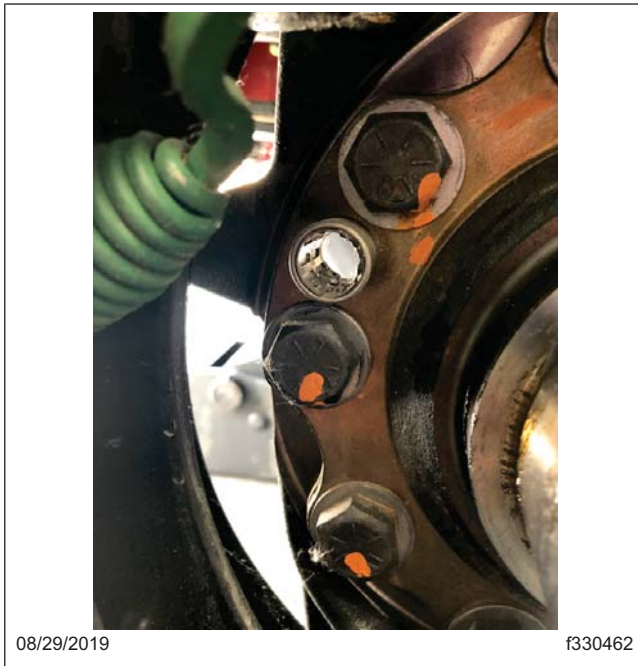
Fig. 17, Removal of ABS Sensor

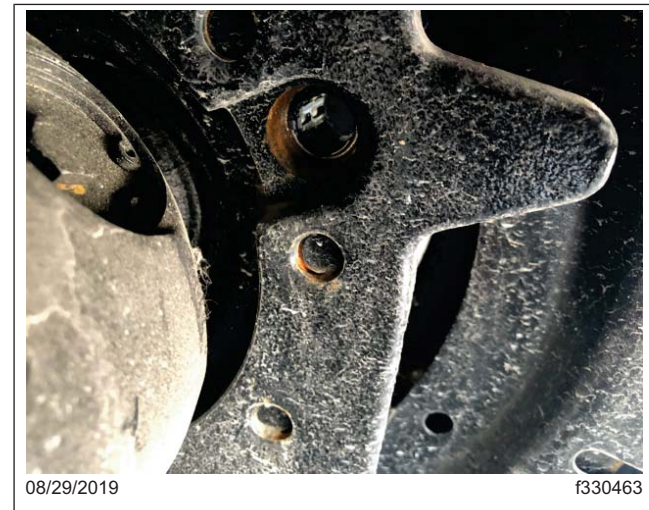
Fig. 18, Removed ABS Sensor

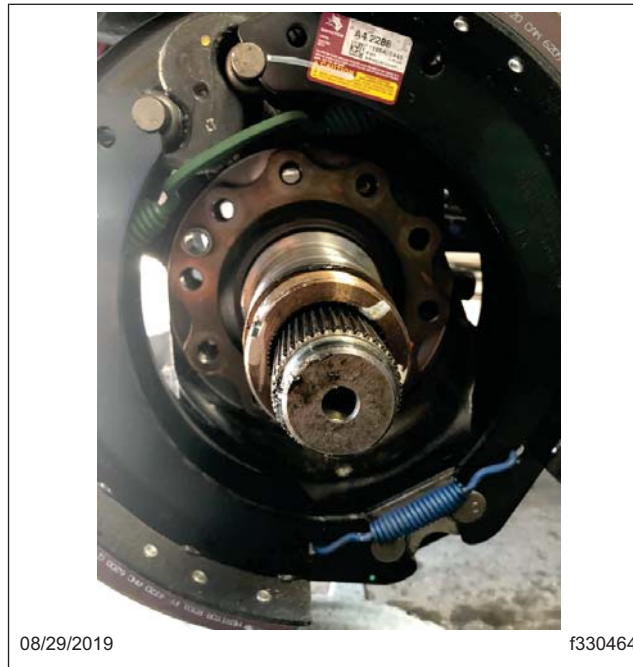
20. Remove ten spindle mounting flange bolts. See [Fig. 19](#).

Fig. 19, Removed Mounting Flange Bolt

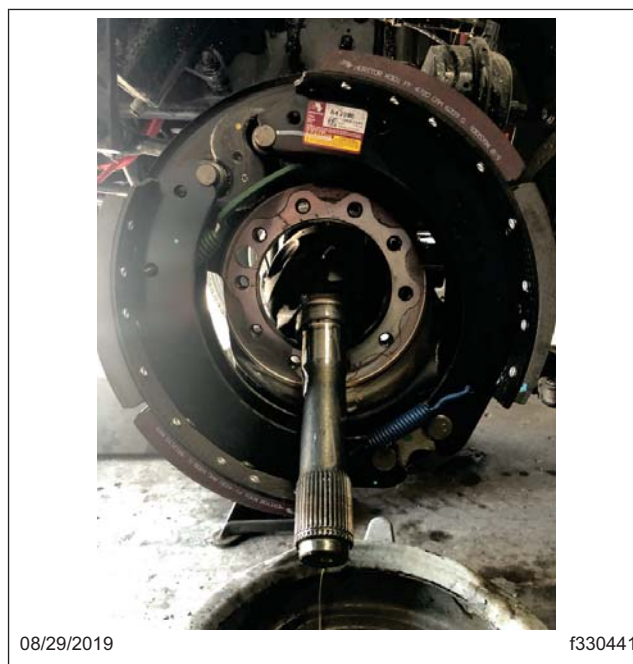
21. Remove the spindle from the assembly. See [Fig. 20](#).

Fig. 20, Removed Spindle from the Assembly

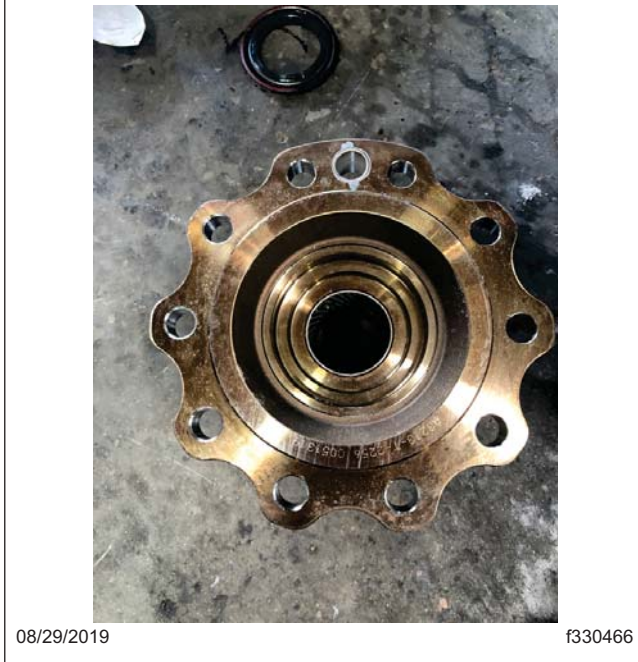
22. Install the spindle seal. See [Fig. 21.](#) and [Fig. 22.](#)

Fig. 21, Installing Spindle Seal

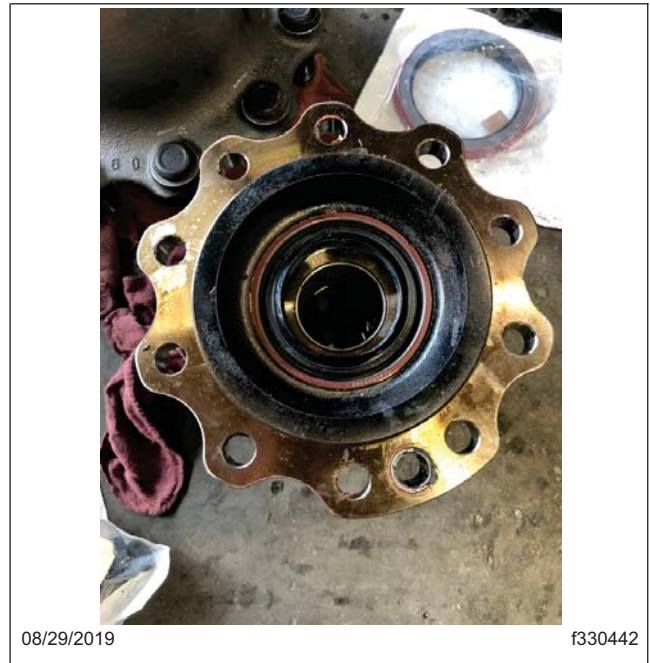
Fig. 22, Installed Spindle Seal

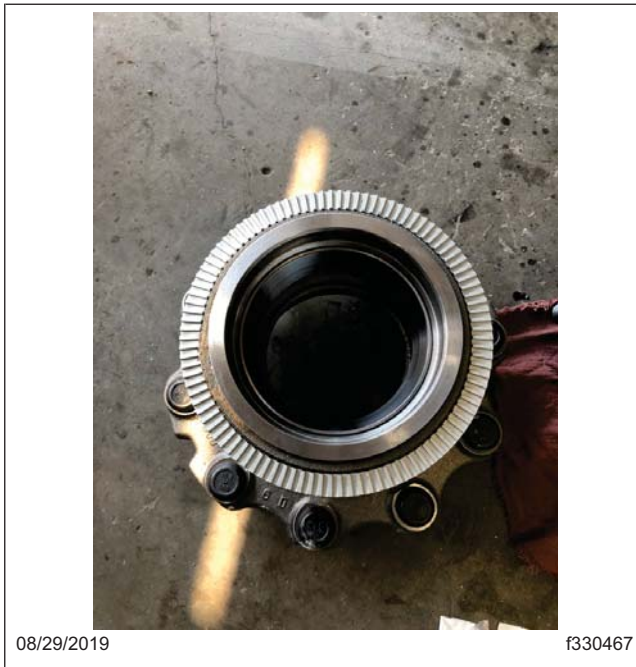
23. Lubricate the new inner wheel bearing from the parts kit by dipping it in oil and slowly working the rollers in oil. See [Fig. 23](#), and [Fig. 24](#).

Fig. 23, Lubricating the New Inner Wheel Bearing

Ensure that both bearing assemblies are coated with fresh oil. Use only fresh oil on the bearing assemblies; old oil could be contaminated with dirt or water (both are corrosives) and could cause damage to both wheel bearing assemblies and the wheel hub.

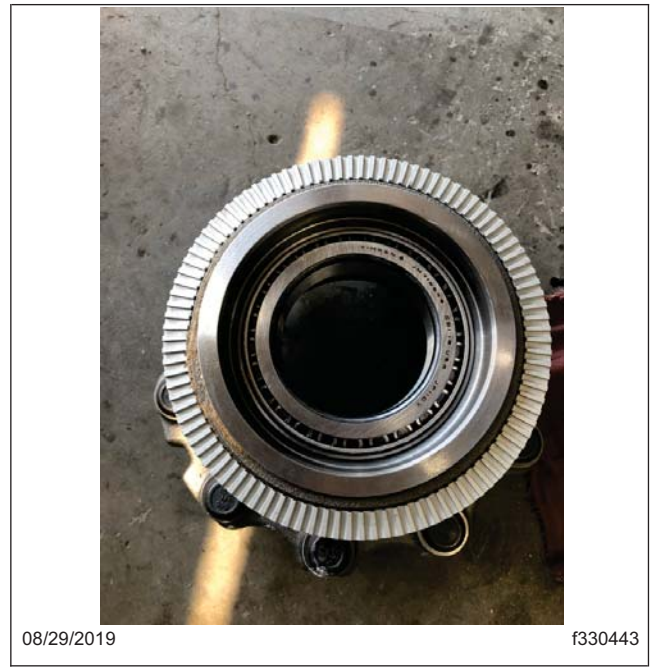
Fig. 24, Lubricated New Inner Wheel Bearing

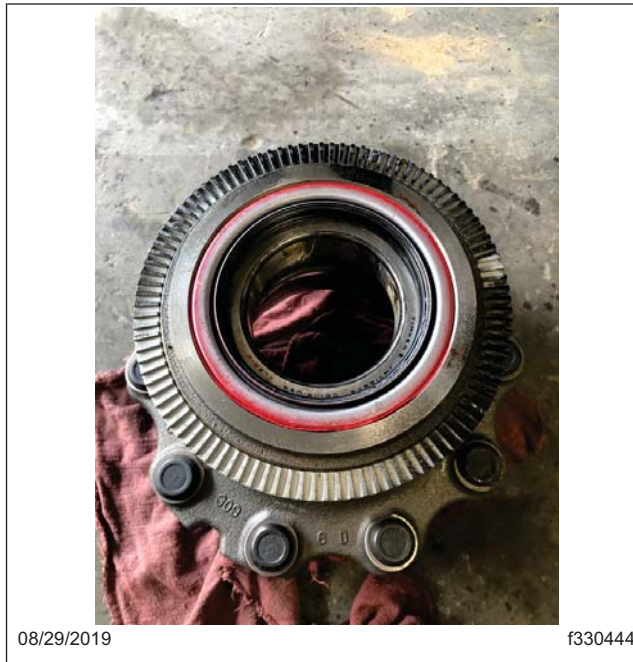
25. Using the hub seal installation tool install the hub seal into the hub bore. Do not force or hit the seal after it has reached the bottom of the bore, which can damage the seal. See [Fig. 25](#).

Fig. 25, Installed Hub Seal

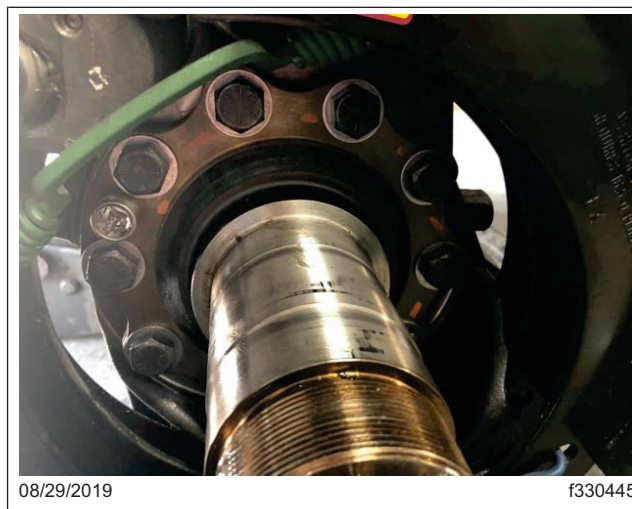
27. Install the remaining nine spindle bolts and then torque all 10 of them to 180 lbf-ft (244 N·m). See [Fig. 26](#).

Fig. 26, Installing the Spindle Bolts

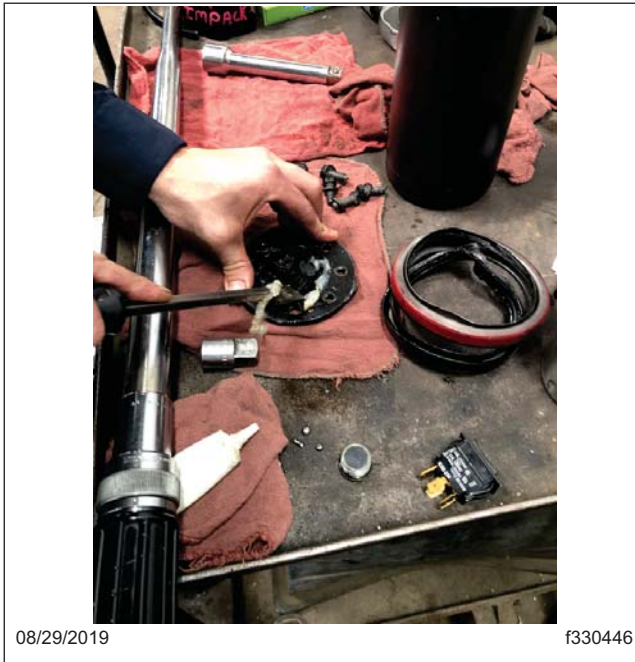
45. Torque the drive flange bolts to 190 lbf-ft (257 N-m) and torque the hub cover to 40 lbf-ft (54 N-m). See [Fig. 27.](#) and [Fig. 28.](#)

Fig. 27, Cleaning the Hub Cover

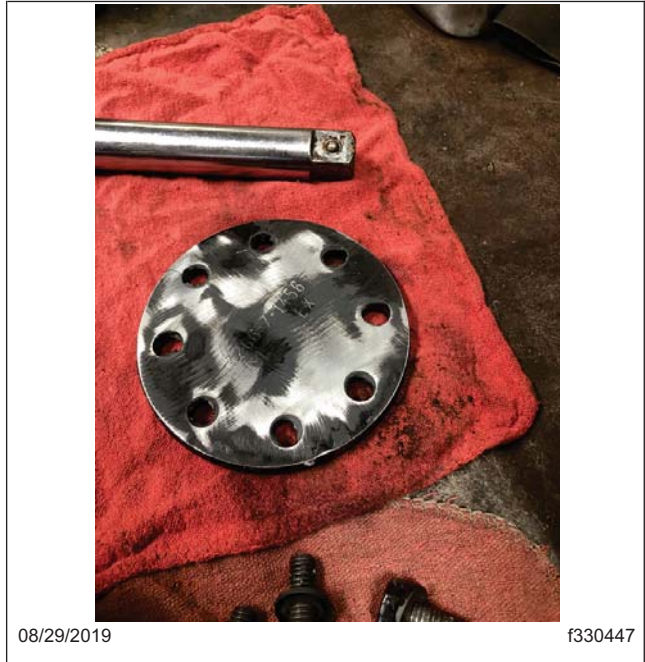
Fig. 28, Cleaned Hub Cover
