**REPAIR PROCEDURE: PCM REPROGRAMMING by MMDS (IDS)****UPDATED 3/28/2025 with CAUTION if file cannot be downloaded**

**Reprogram the PCM with the Mazda Modular Diagnostic System (M-MDS) using IDS 113.06 or later software.**

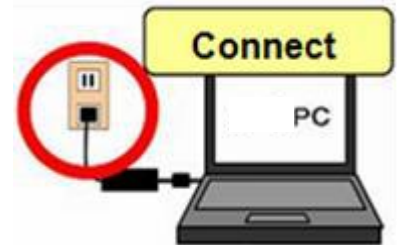
- a. Make sure that the following connections are firmly connected, and then do NOT touch the VCM and DLC cable to prevent from causing noise and poor connection.
- Between the vehicle-side connector and the DLC cable
  - Between the PC-side connector and USB port of PC

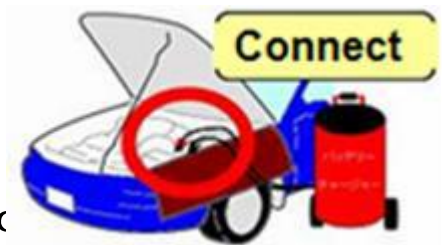
- b. Connect AC adapter to the PC in order to stabilize voltage fluctuation during reprogramming  
Do NOT use vehicle battery outlet as power source for the PC.

- c. During reprogramming, connect battery charger (charge current maintained within 10 to 15A) to the vehicle to stabilize voltage fluctuation.

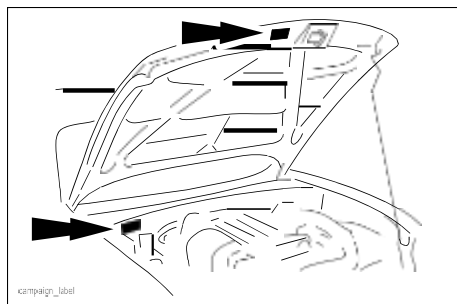
2. Affix it to the hood or bulkhead as shown:

1. Fill out a blue "Campaign Label" (9999-95-065A-06) with Campaign No: "3719F", your dealer code, today's date.
