**REPAIR PROCEDURE: PCM REPROGRAMMING by MMDS (IDS)****NOTE:**

**Service Caution for Reprogramming**

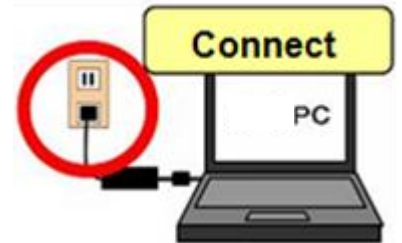
- a. Make sure that the following connections are firmly connected, and then do NOT touch the VCM and DLC cable to prevent from causing noise and poor connection.
  - Between the vehicle-side connector and the DLC cable
  - Between the PC-side connector and USB port of PC

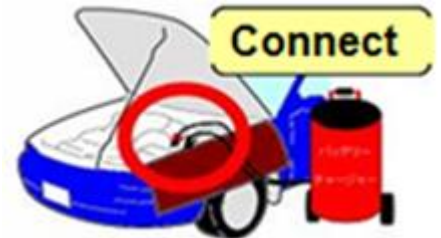
- b. Connect AC adapter to the PC in order to stabilize voltage fluctuation during reprogramming  
Do NOT use vehicle battery outlet as power source for the PC.

- c. During reprogramming, connect battery charger (charge current maintained within 10 to 15A) to the vehicle to stabilize voltage fluctuation.

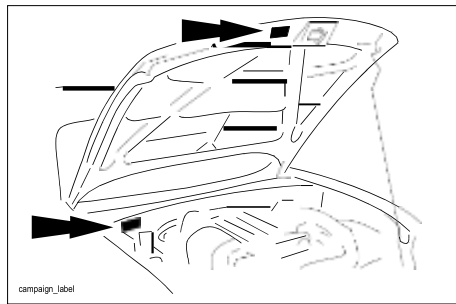
2. Affix it to the hood or bulkhead as shown:
