**AKB4 - Re-programming Airbag Control Unit (Stop Delivery/Recall Campaign)**

Model Line: **Panamera (970)  
Boxster (981)/Cayman (981)  
718 Boxster (982)/718 Cayman (982)  
911 (991)**

Subject: **Airbag control unit**

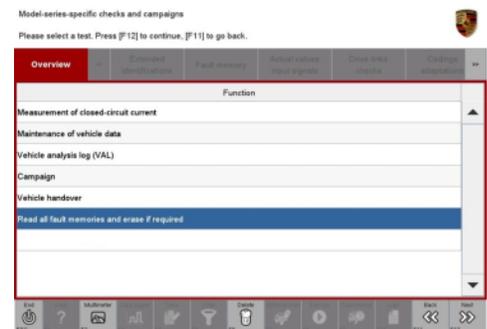
2.5 Press **•F12** ('Yes') in response to the question as to whether you really want to delete all fault memory entries.

The faults stored in the fault memories of the various control units are deleted.

*Erasing fault memories*

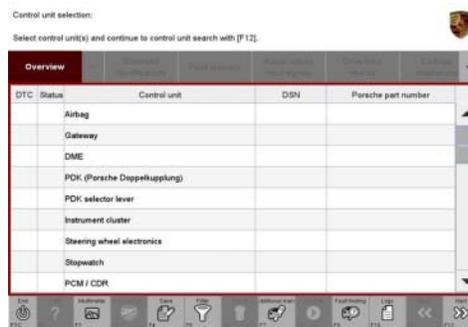
- 2.6 Once you have erased the fault memories, select the '**Overview**' menu to return to the control unit selection screen.

*Control unit selection*
