GROUP Safety Recall Campaign	MODEL 2019MY Optima (JFa)
	NUMBER SC179	DATE August 2019
SAFETY RECALL CAMPAIGN		
SUBJECT: JFA MFC/FCA OPERATION LOGIC IMPROVEMENT (SC179)

This bulletin provides the procedure to improve the logic of the Multi-Function Camera (MFC) / Forward Collision-Avoidance Assist (FCA) software on some 2019MY Optima (JFa) vehicles, produced from May 21, 2018 through May 29, 2019, which may cause the braking assist function to not work properly when the MFC/FCA system senses a potential frontal collision with a stationary vehicle. To correct this concern, install the improved logic to the MFC/FCA using the KDS ECU Upgrade function as described in this bulletin. For confirmation that the latest reflash has been installed to the vehicle you are working on, verify the ROM ID using the table on page 2 of this bulletin. Before conducting the procedure, verify that the vehicle is included in the list of affected VINs.

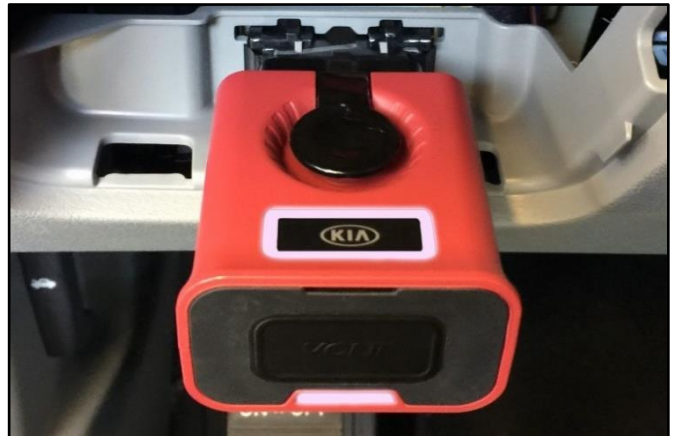
1. Connect the VCI-II to the OBD-II connector, located under the driver's side of the instrument panel.

The ECU upgrade function on KDS operates wirelessly. It is not necessary to perform the upgrade via USB cable.

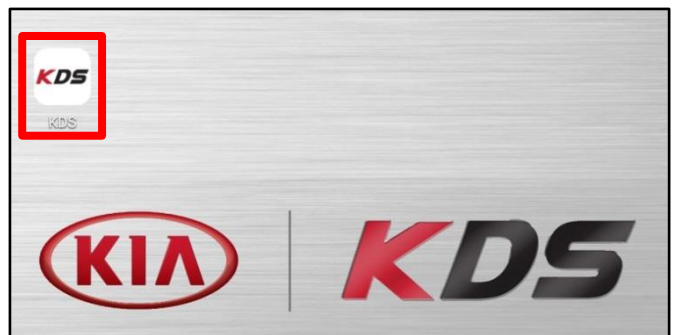
2. With the ignition ON, turn ON the KDS tablet. Select **KDS** from the home screen.

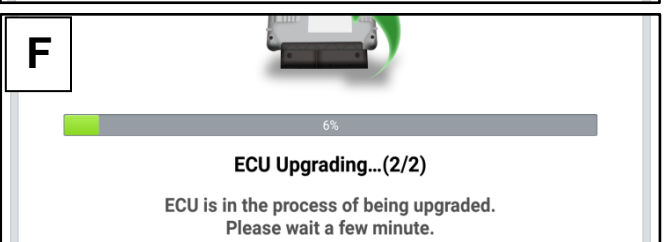
- The ECU upgrade will begin and the progress of the upgrade will appear on the bar graph. Upgrade part (1/2) (E) will download the upgrade event to the VCI-II. Upgrade part (2/2) (F) will upgrade the ECU.

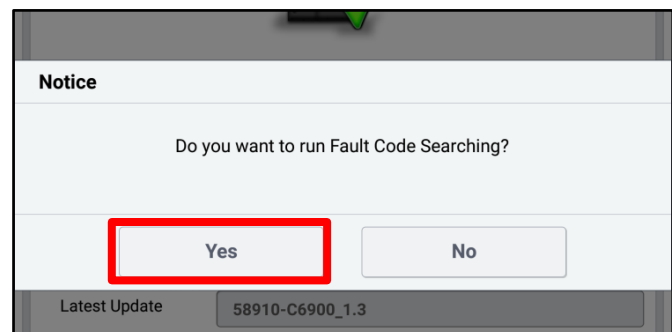
12. When prompted, select **YES** to check for Diagnostic Trouble Codes (DTC) and erase any DTCs stored such as EPS, ESC, and TPMS that may have been set during the upgrade.
