RECALL CAMPAIGN BULLETIN

VOLUNTARY RECALL CAMPAIGN 2018 FRONTIER; AV CONTROL UNIT (INFOTAINMENT) SOFTWARE UPDATE

CAMPAIGN ID #: R1911**NHTSA #:** 19V-654**APPLIED VEHICLES:** 2018 Frontier (D40)

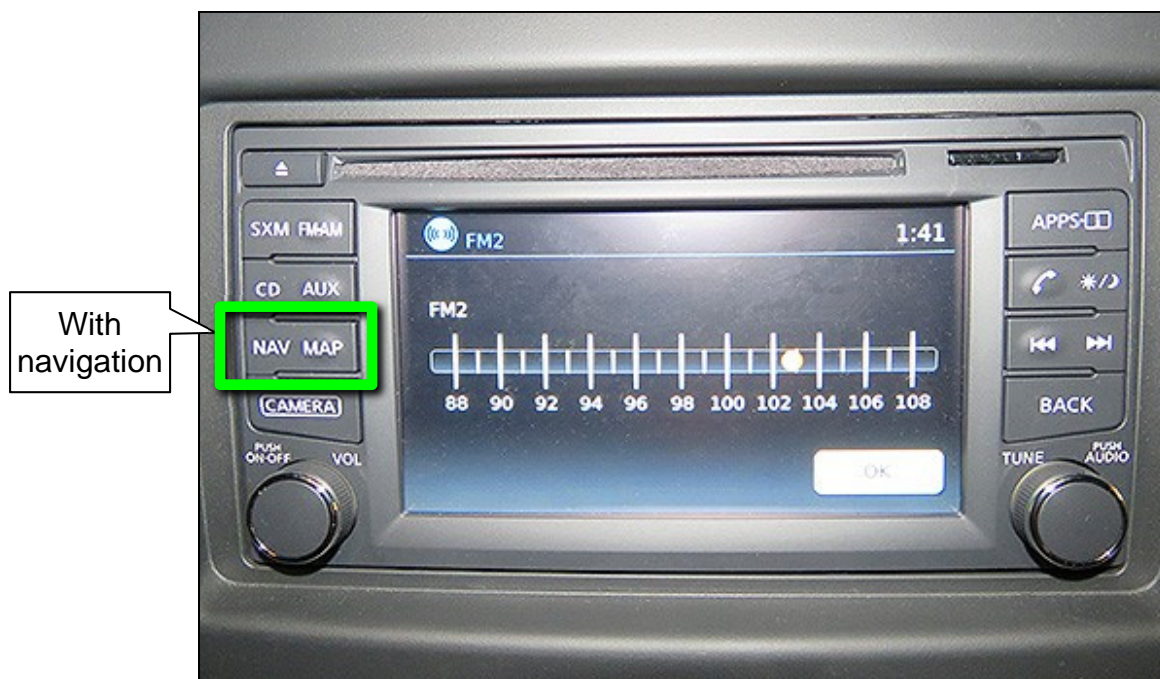
1. Confirm which audio system is equipped in the vehicle.
 - If the audio system is equipped with navigation (see Figure 1 below), go to step 2.
 - If the audio system is **NOT** equipped with navigation, skip to page 9, step 23.

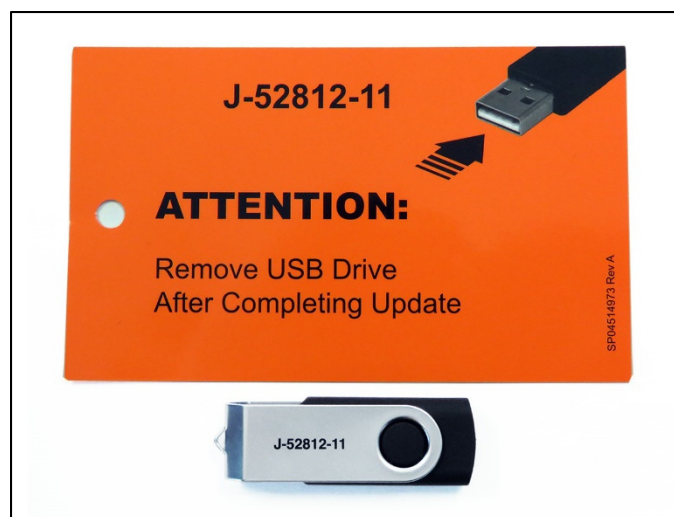
11. Insert special tool USB drive J-52812-11 into the vehicle's USB media port (see Figure 4 and Figure 5).

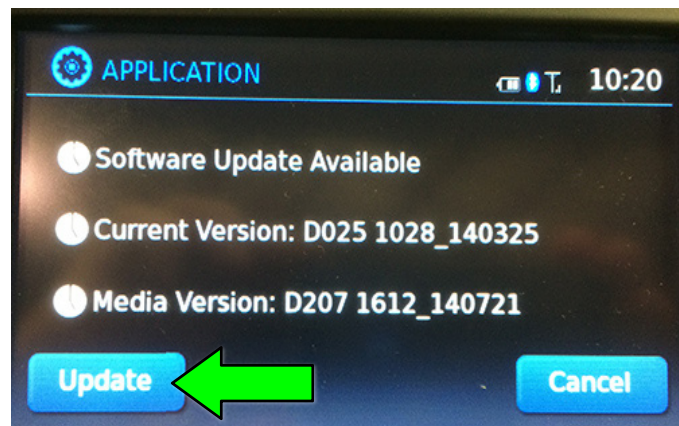
Figure 8

13. Wait for the **APPLICATION** screen to display (Figure 8).

14. Select **Update**.

HINT: After selecting **Update**, the screen will go black for up to 1 minute. **This is a normal part of the update.**

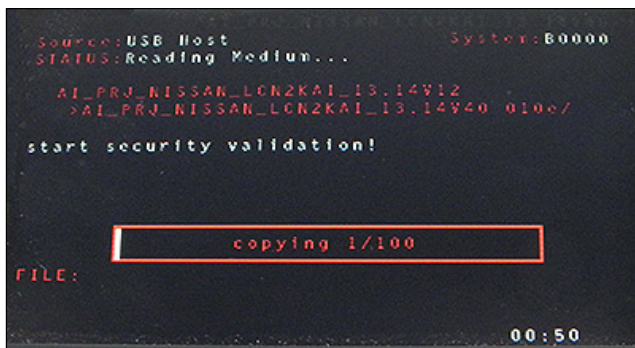
15. Wait until the update is complete (this can take up to 60 minutes).
- The screen in Figure 9 will be displayed during the update.
 - Figure 10 may display before the update begins. **DO NOT** remove the USB drive during the update.

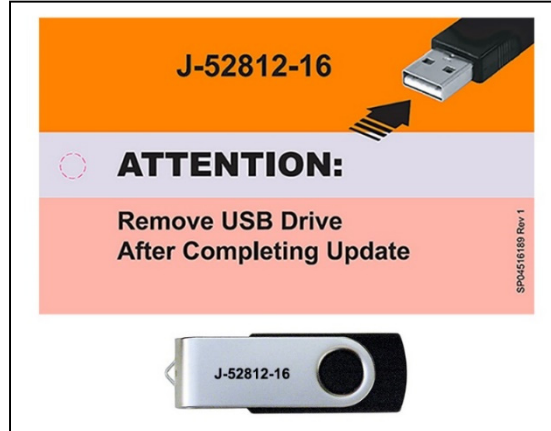
Figure 17

27. Insert the special tool USB drive J-52812-16 into the USB media port.

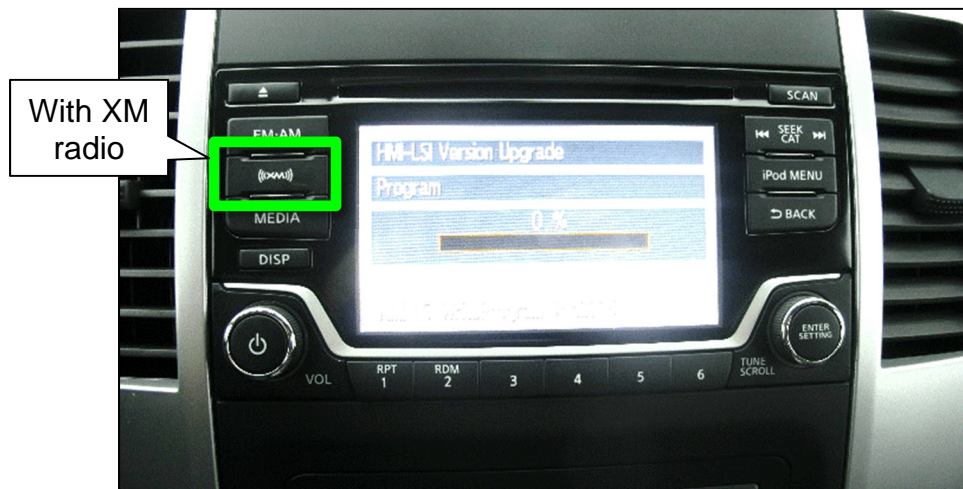
Figure 20

NOTE: Vehicles equipped with a XM radio will have a “XM” button as shown in Figure 20.

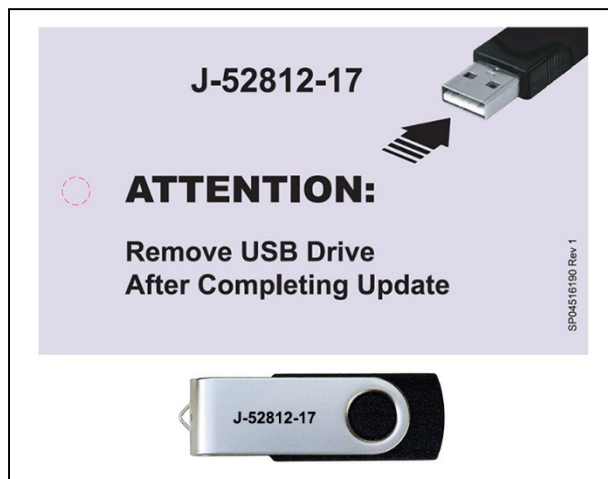
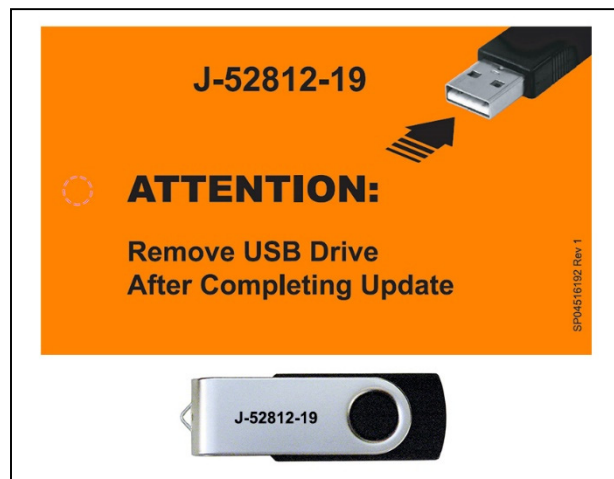
- If **EQUIPPED** with a XM radio, insert special tool J-52812-17 into the USB media port.
- If **NOT** equipped with a XM radio, insert special tool J-52812-19 into the USB media port.
