RECALL CAMPAIGN BULLETIN

VOLUNTARY RECALL CAMPAIGN 2018 - 2019 NV200 AND 2019 TAXI; AV CONTROL UNIT (INFOTAINMENT) SOFTWARE UPDATE

CAMPAIGN ID #: R1911
NHTSA #: 19V654
APPLIED VEHICLES: 2018 – 2019 NV200 (M20)
2019 NV200 Taxi (M30)

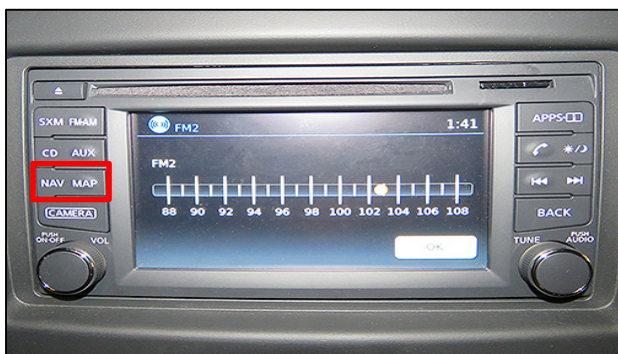
1. Confirm which audio system is present in the vehicle (see Figure 1 and Figure 2 below).
 - If the vehicle is equipped with navigation as shown in Figure 1, below, continue to step 2 below.
 - If the vehicle is **NOT** equipped with navigation, as shown in Figure 2, below, skip to step 20 on page 9.

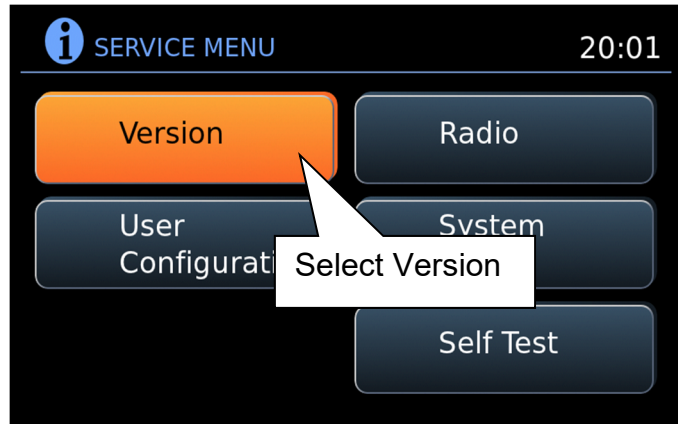
Figure 3

9. Select **Version**.

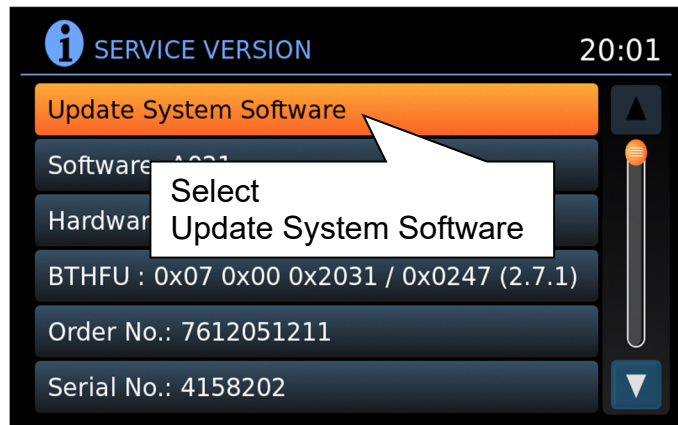
Figure 4

10. Select **Update System Software**.

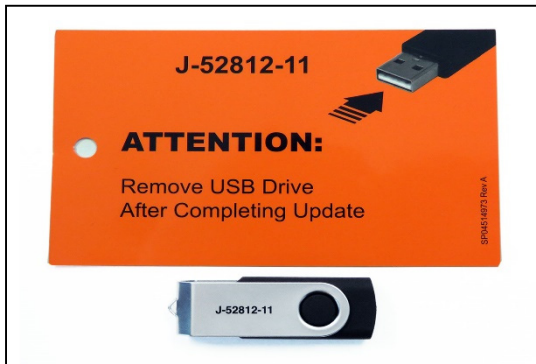
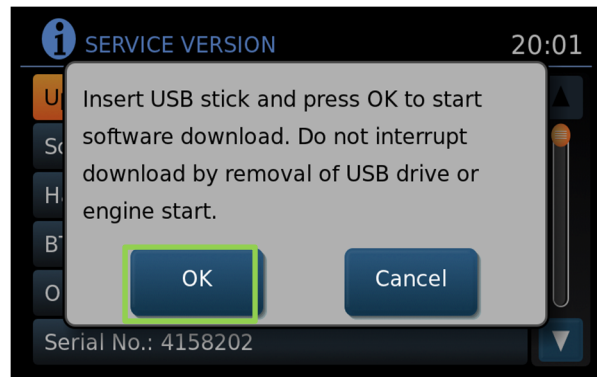
11. Insert the special tool USB drive J-52812-11 into the USB media port and select **OK**.

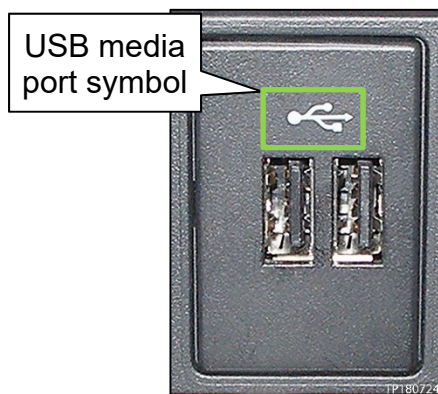
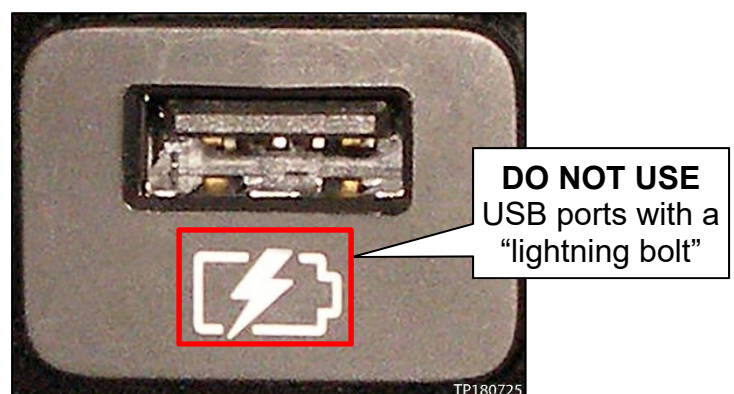
HINT: Charging ports are marked in the vehicle with a “lightning bolt” symbol.

NOTICE Do not insert the USB drive into a charging port. If used, the update software and/or USB drive may become damaged. Only insert the USB drive in a USB media port.

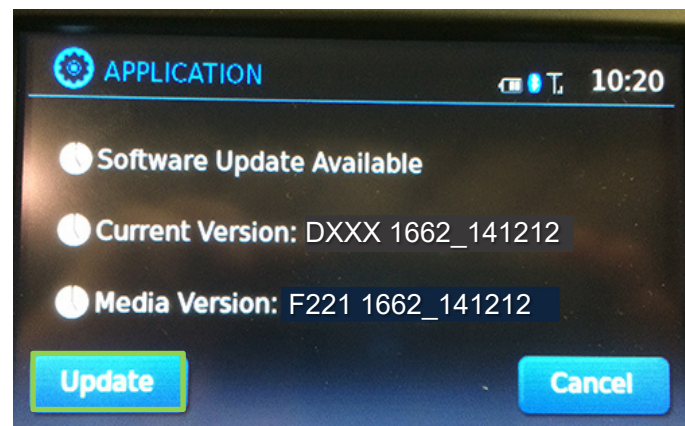
Figure 9

12. Wait for the **APPLICATION** screen to appear (Figure 9).

13. Select **Update**.

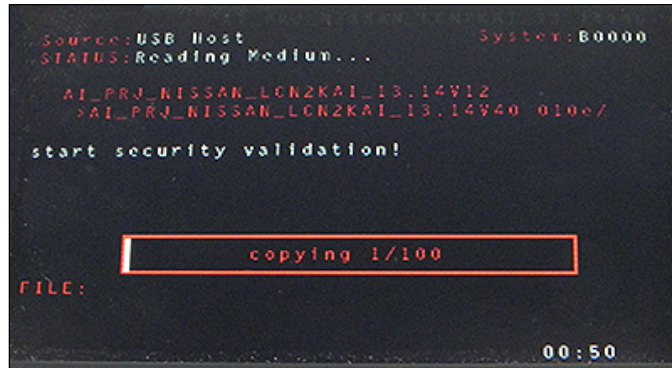
- The screen in Figure 10 will be displayed during the update.
- Figure 11 may display before the update begins. DO NOT remove the USB drive during the update.

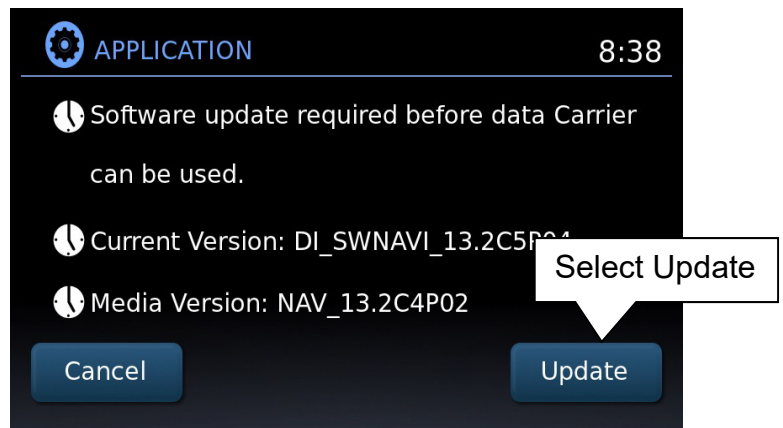
Figure 14

- After the map SD card is reinserted, the “APPLICATION” screen will display (Figure 14).

17. Select Update.

- If the APPLICATION screen is displayed (Figure 14), skip to step 17.
- If neither screen is displayed, the update is complete.

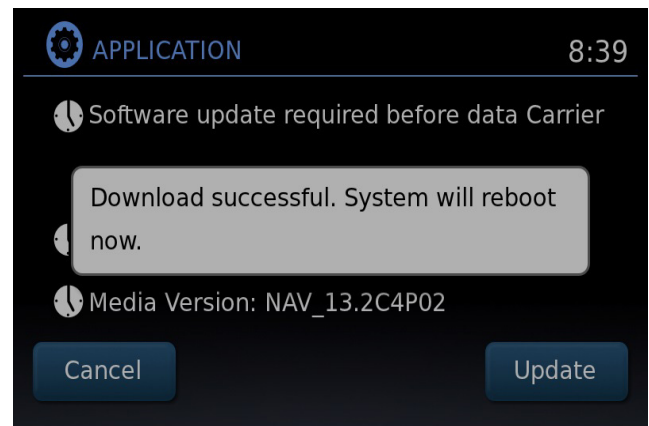
Figure 16

- The message “Download successful. System will reboot now” will display and the audio unit will reboot (Figure 16). After the system reboots, the update is complete.

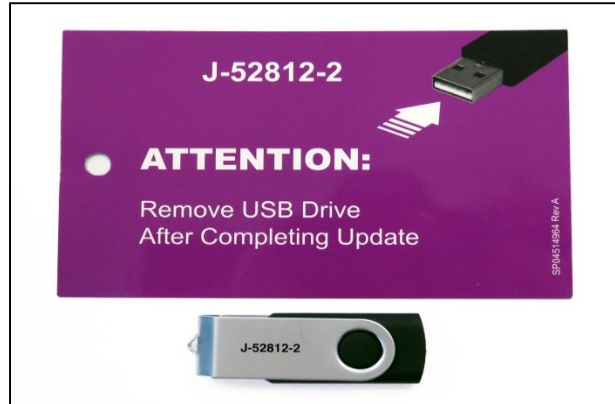
Figure 17

25. Turn the audio system OFF.
26. Insert the special tool USB drive J-52812-2 into the USB media port.

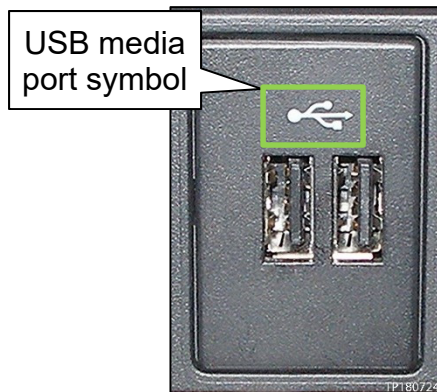
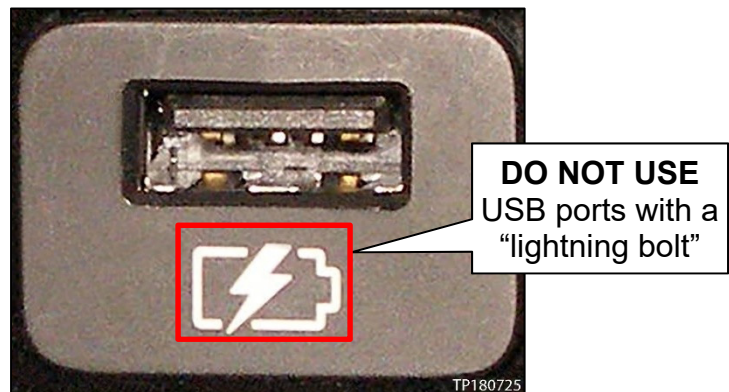
HINT: Charging ports are marked in the vehicle with a “lightning bolt” symbol.

NOTICE Do not insert the USB drive into a charging port. If used, the update software and/or USB drive may become damaged. Only insert the USB drive in a USB media port.
